**Reclamation Plan Amendment**  
for  
**Permanente Quarry**  
State Mine ID # 91-43-0004

**Santa Clara County**

**Lehigh Southwest Cement Company**

**April 2009**

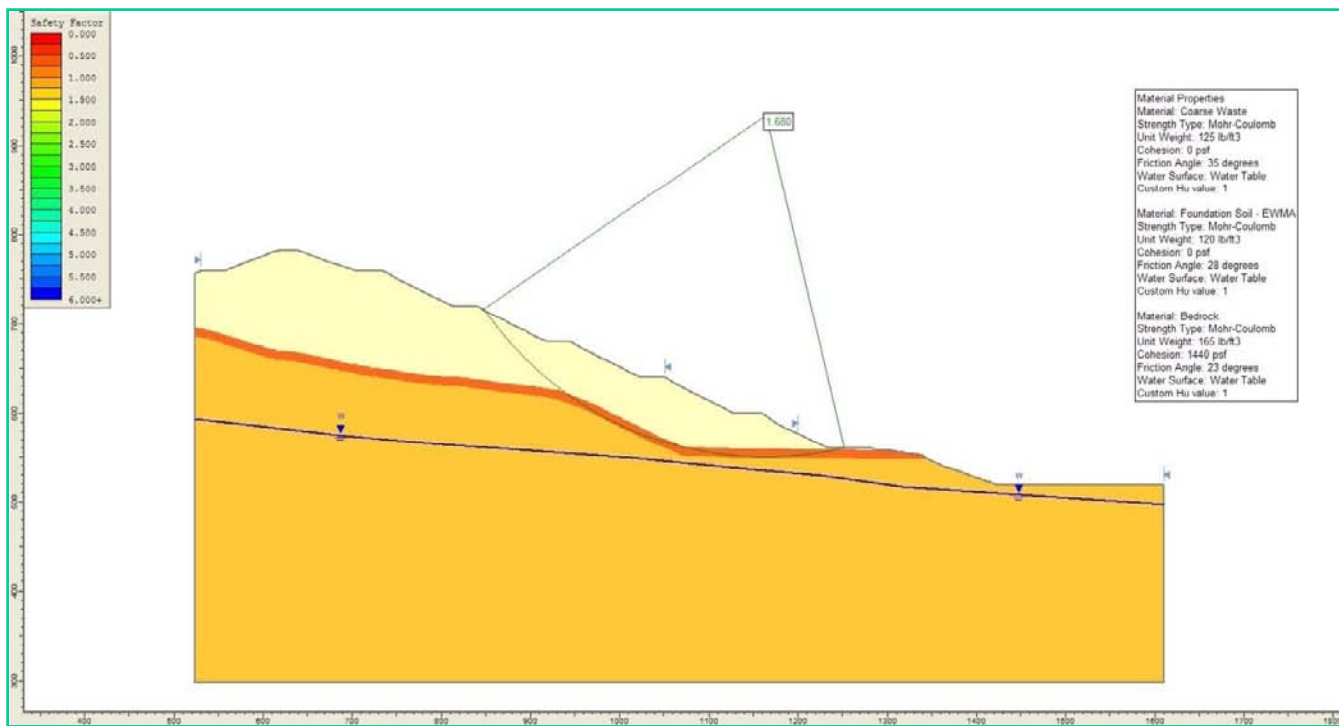
**SECTION E1 – STATIC  
GLOBAL FAILURE - CIRCULAR  
(FOS = 1.68)**

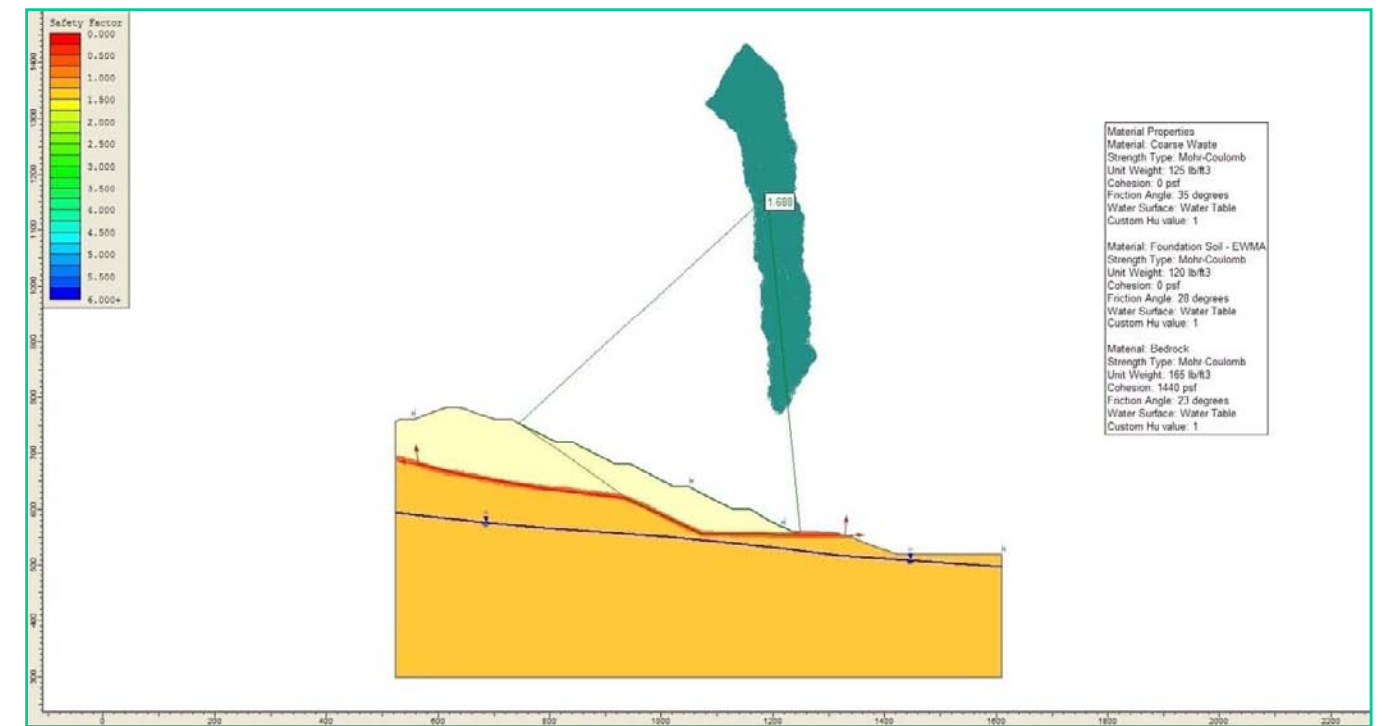
**SECTION E1 –STATIC  
GLOBAL FAILURE - BLOCK  
(FOS = 1.69)**

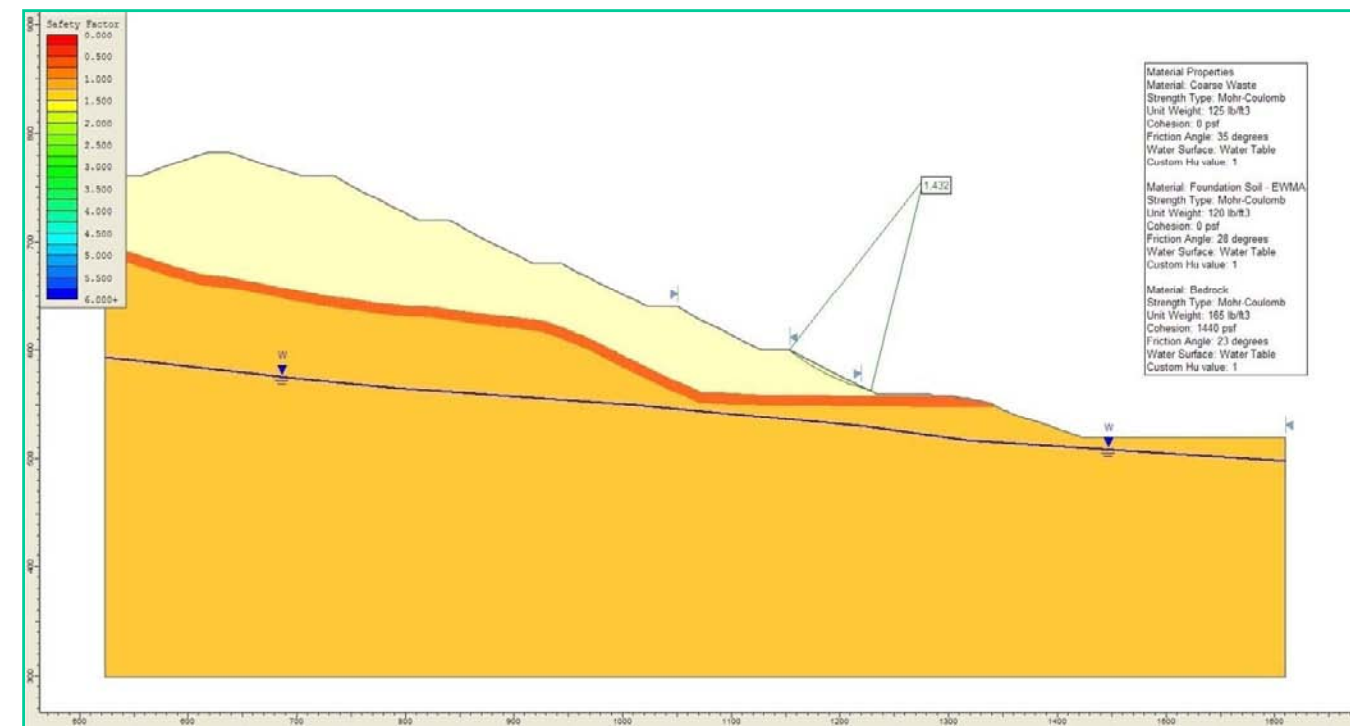
**SECTION E1 –STATIC  
SINGLE-LIFT FAILURE  
(FOS = 1.43)**

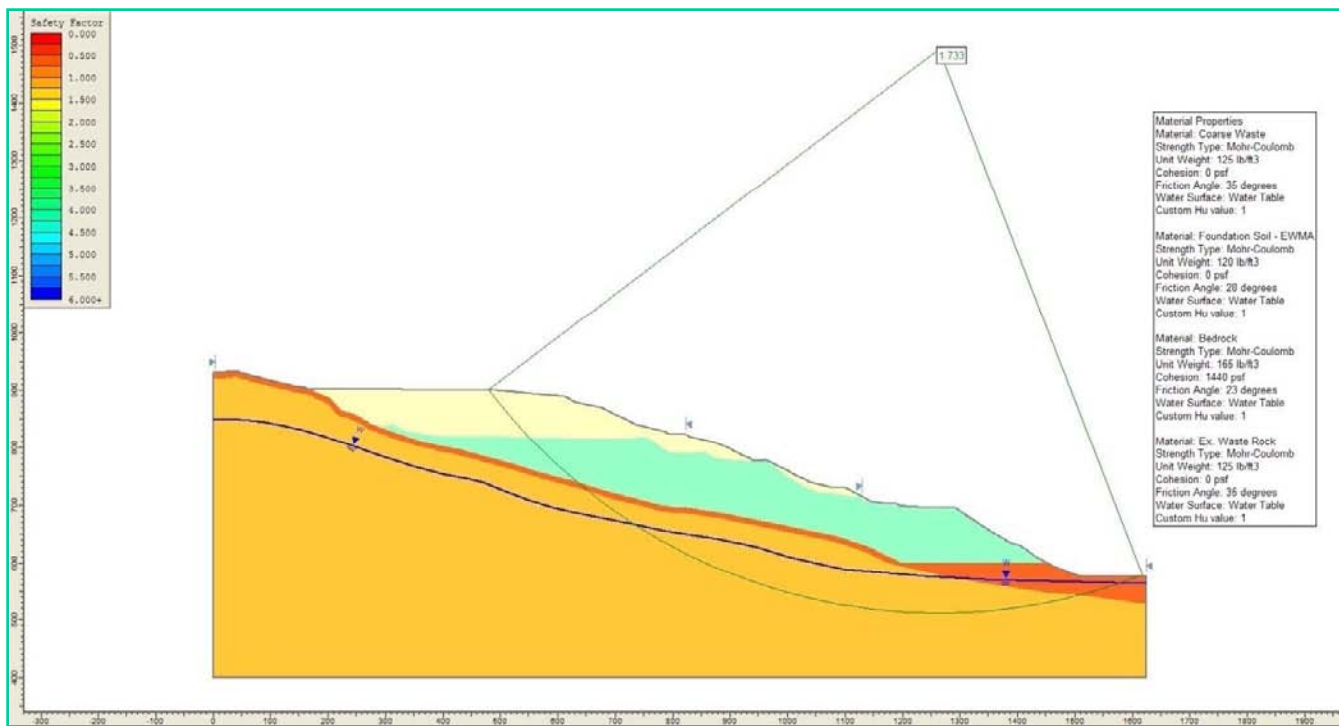
**SECTION E3 – STATIC  
GLOBAL FAILURE - CIRCULAR  
(FOS = 1.73)**

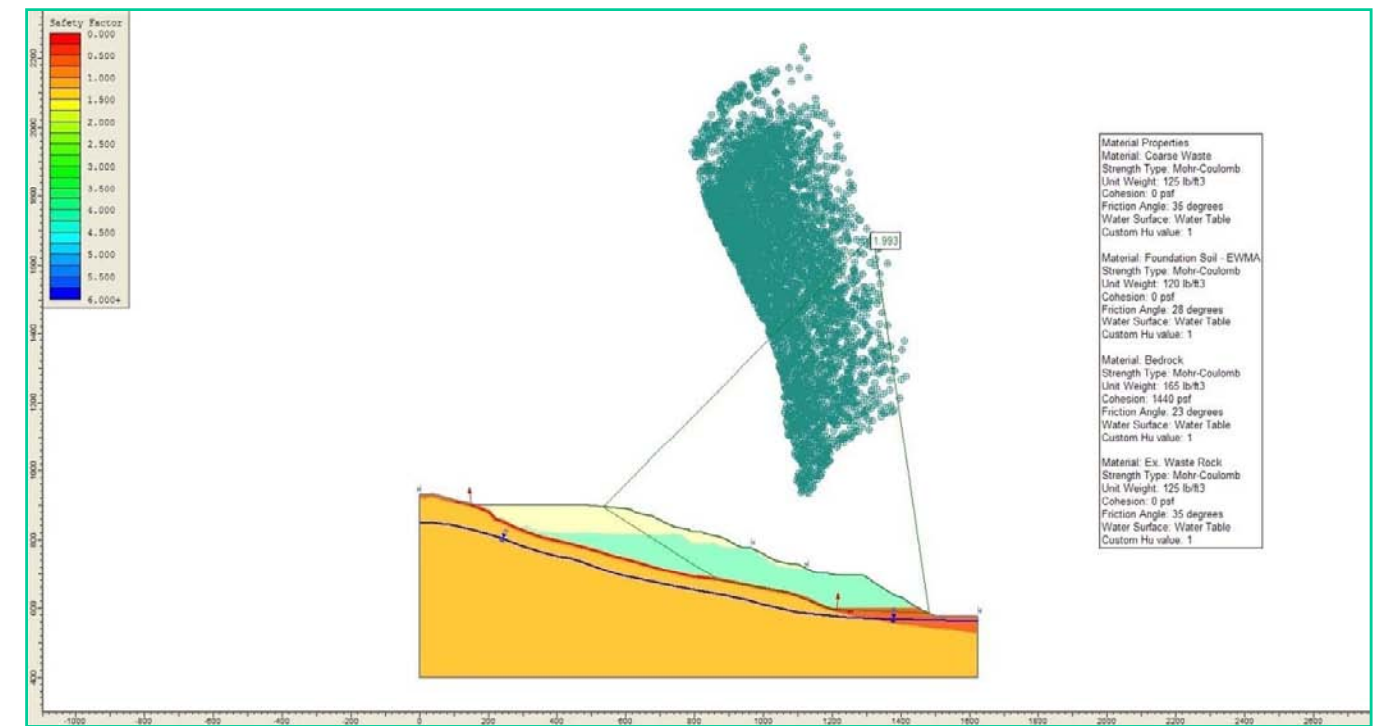
**SECTION E3 –STATIC  
GLOBAL FAILURE - BLOCK  
(FOS = 1.99)**

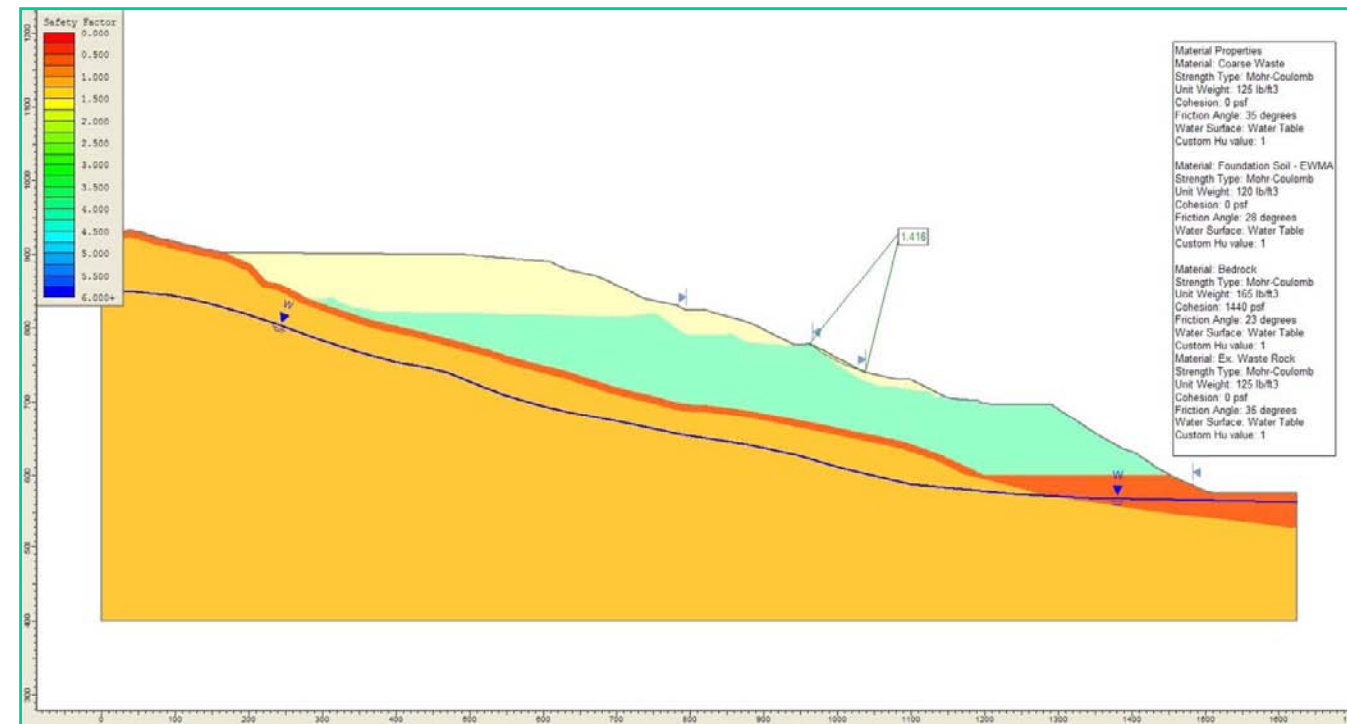
**SECTION E3 –STATIC  
SINGLE-LIFT FAILURE  
(FOS = 1.42)**

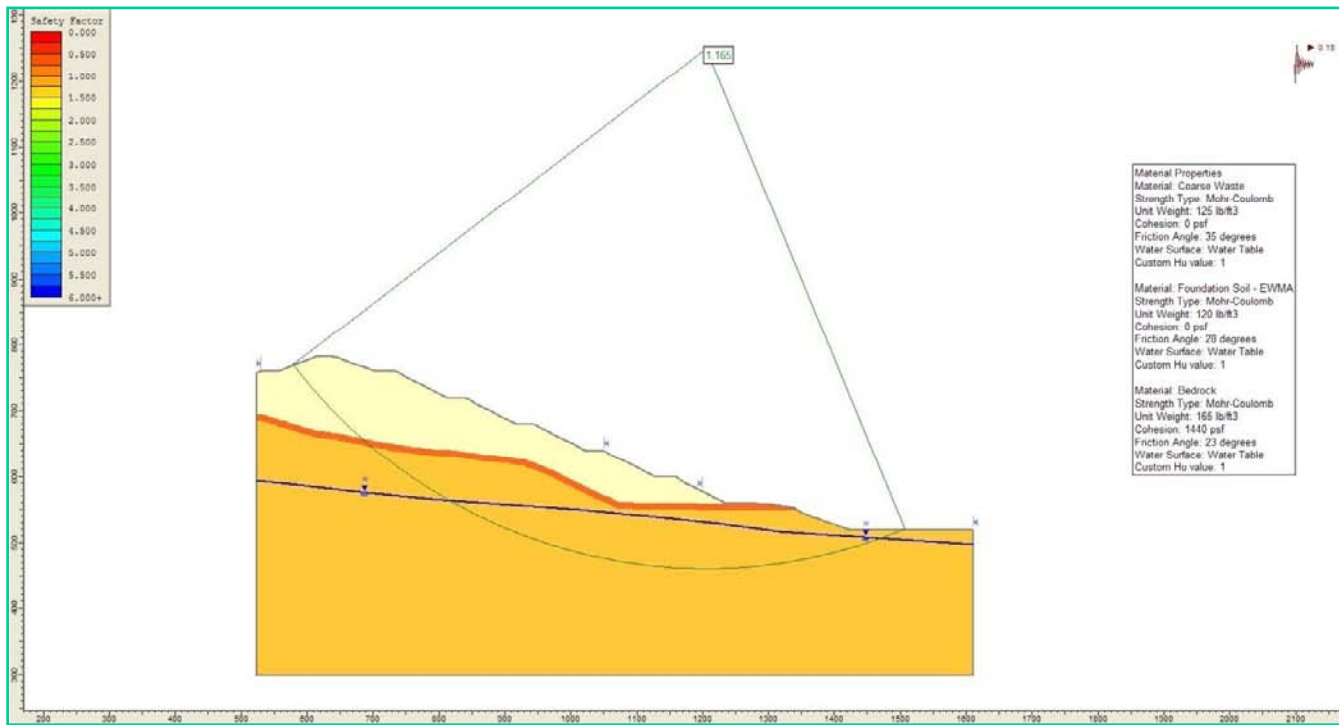
**SECTION E3 – PSEUDO-STATIC  
 GLOBAL FAILURE - CIRCULAR  
 (FOS = 1.17)**

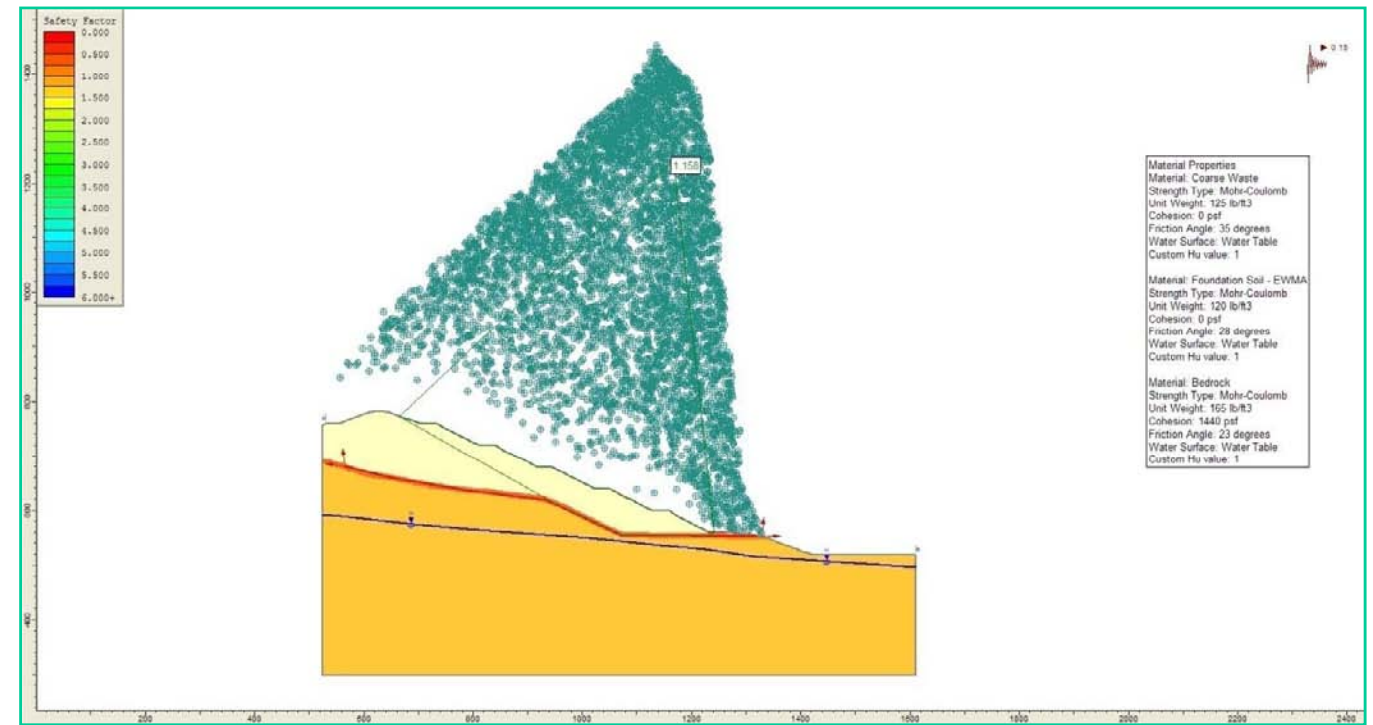
**SECTION E3 – PSEUDO-STATIC  
 GLOBAL FAILURE - BLOCK  
 (FOS = 1.16)**

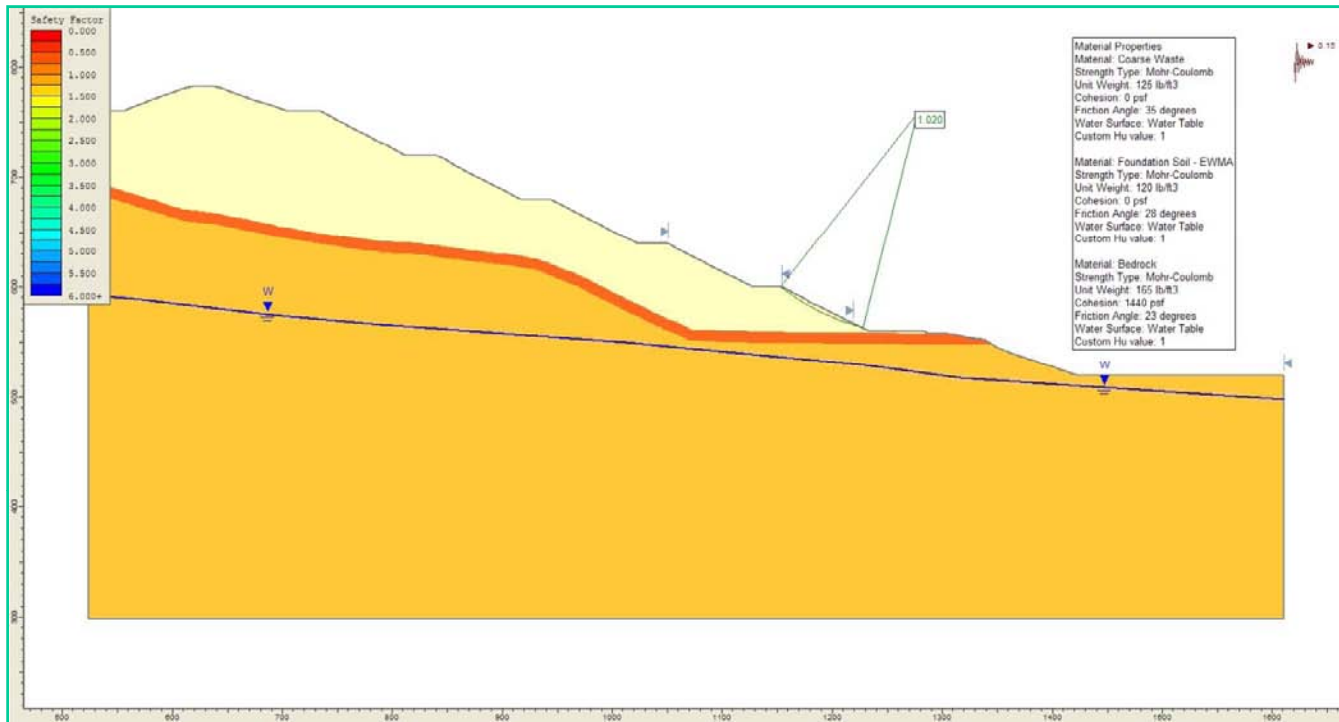
**SECTION E3 – PSEUDO-STATIC  
 SINGLE-LIFT FAILURE  
 (FOS = 1.02)**

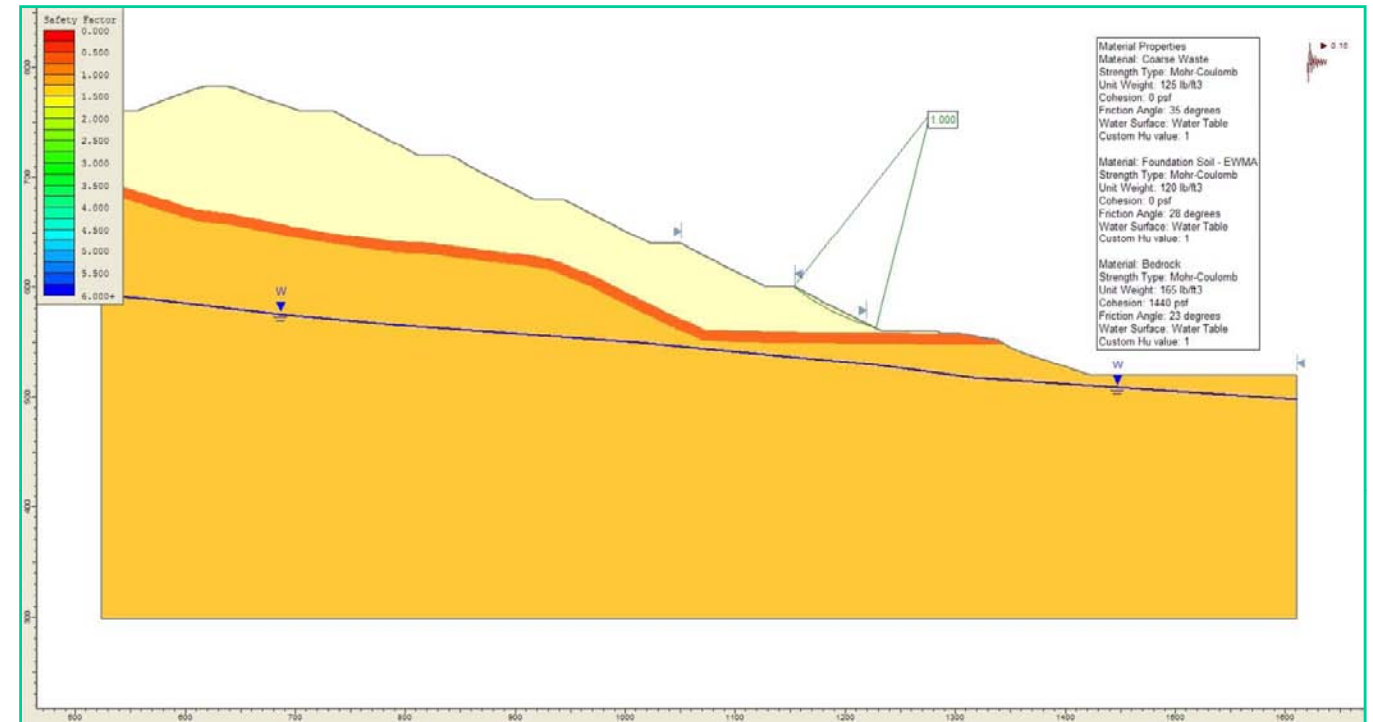
**SECTION E3 – YIELD ACCELERATION  
 SINGLE-LIFT FAILURE  
 (ky = 0.16g)**

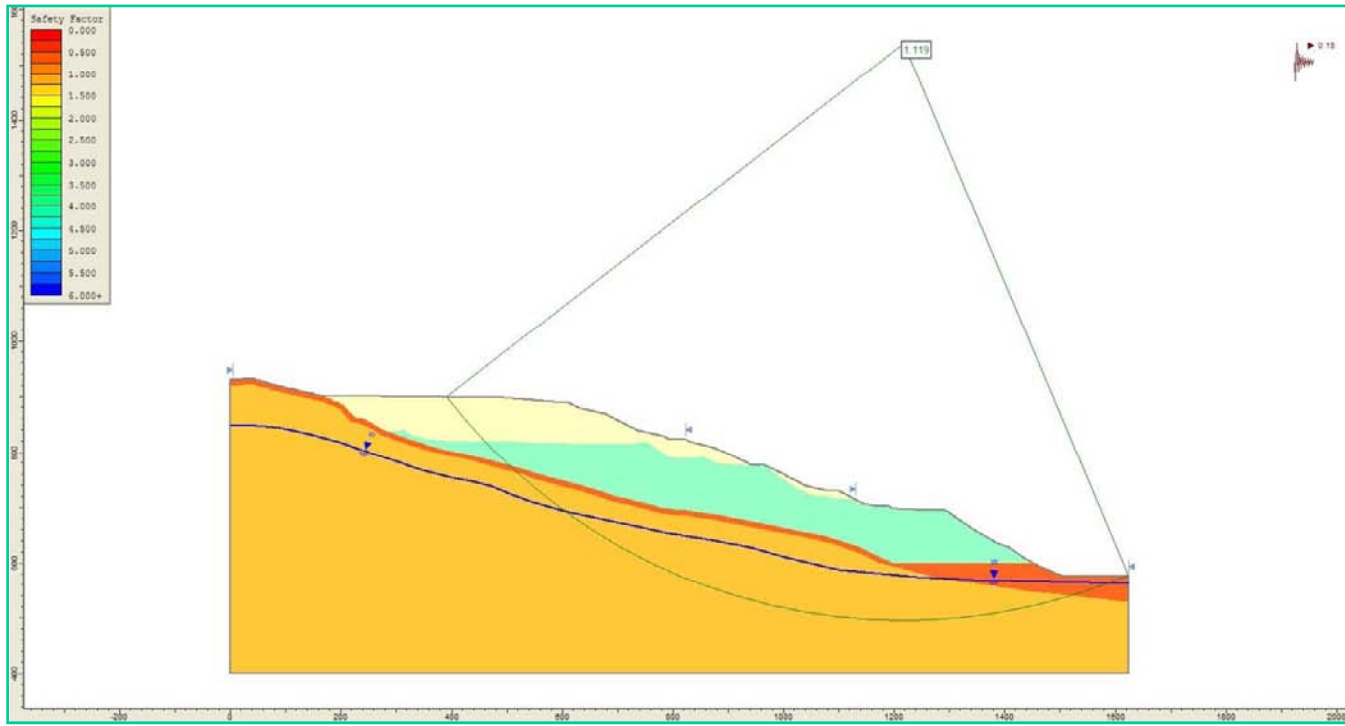
**SECTION E3 – PSEUDO-STATIC  
GLOBAL FAILURE - CIRCULAR  
(FOS = 1.12)**

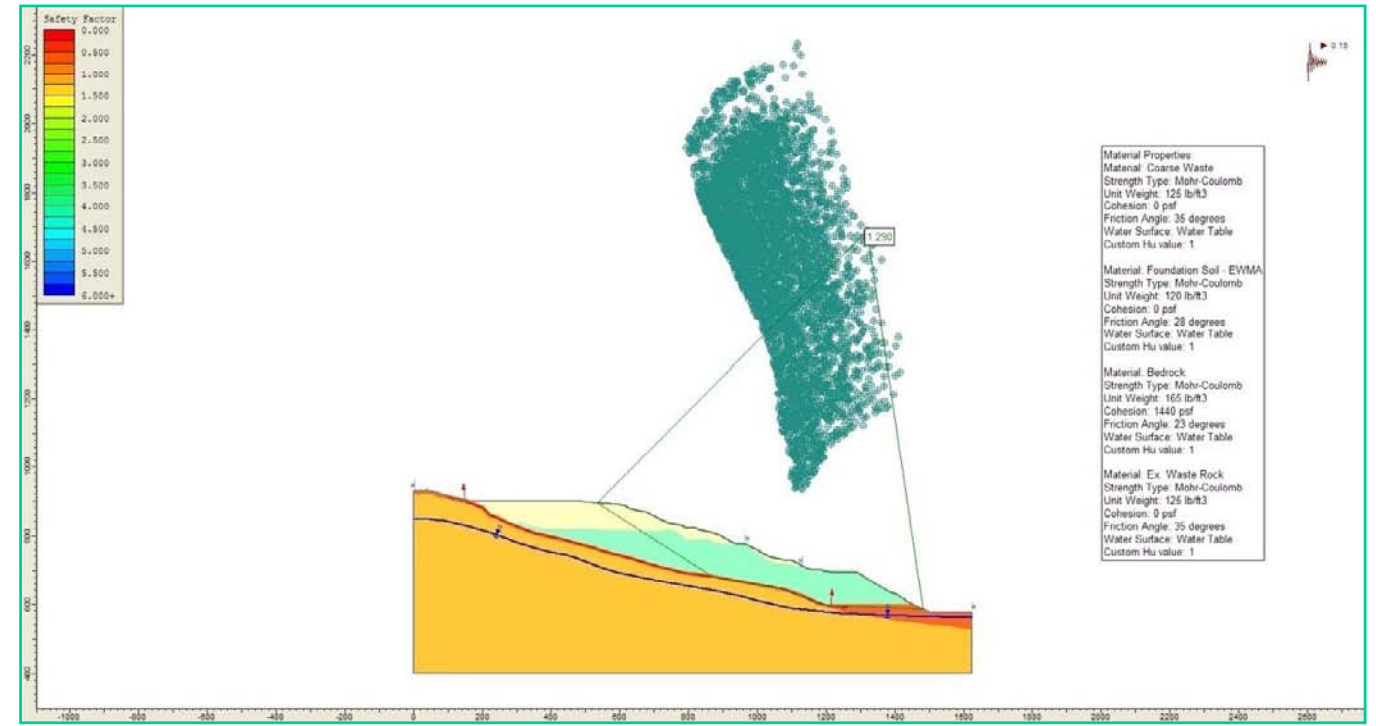
**SECTION E3 – PSEUDO-STATIC  
GLOBAL FAILURE - BLOCK  
(FOS = 1.29)**

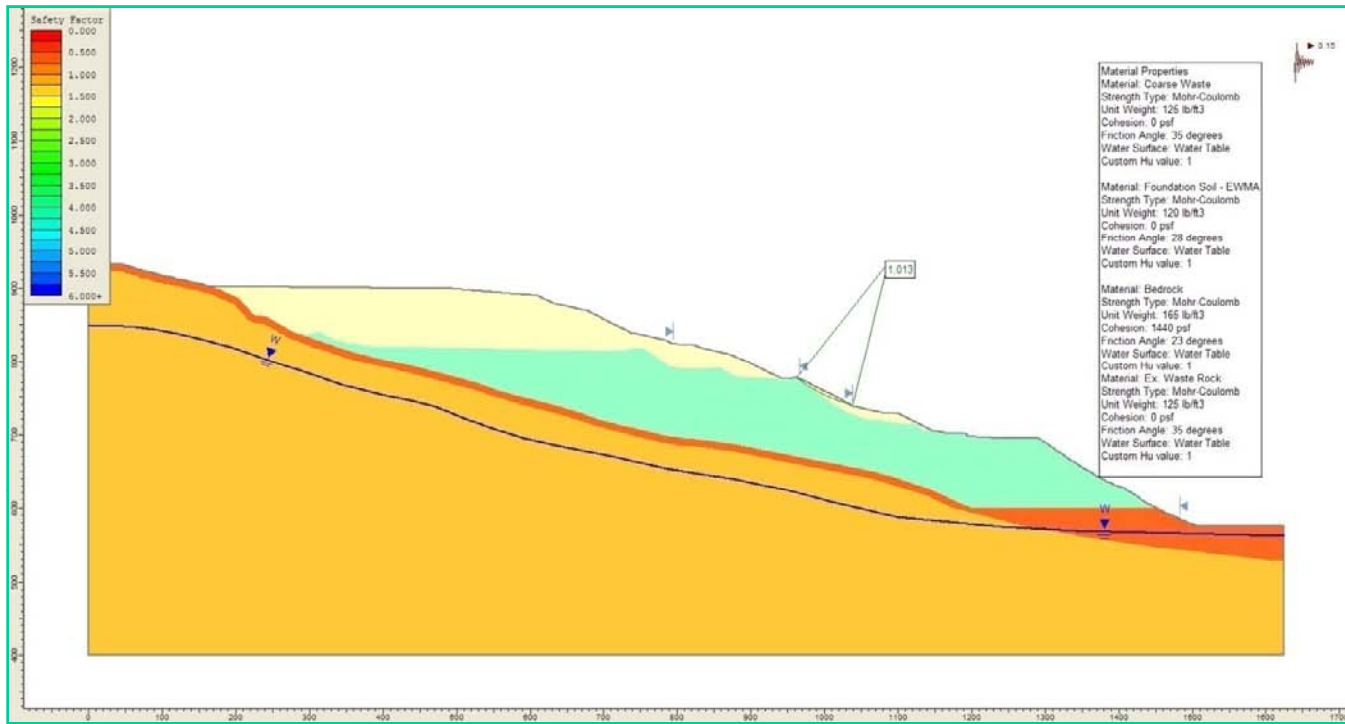
**SECTION E3 – PSEUDO-STATIC  
SINGLE-LIFT FAILURE  
(FOS = 1.01)**

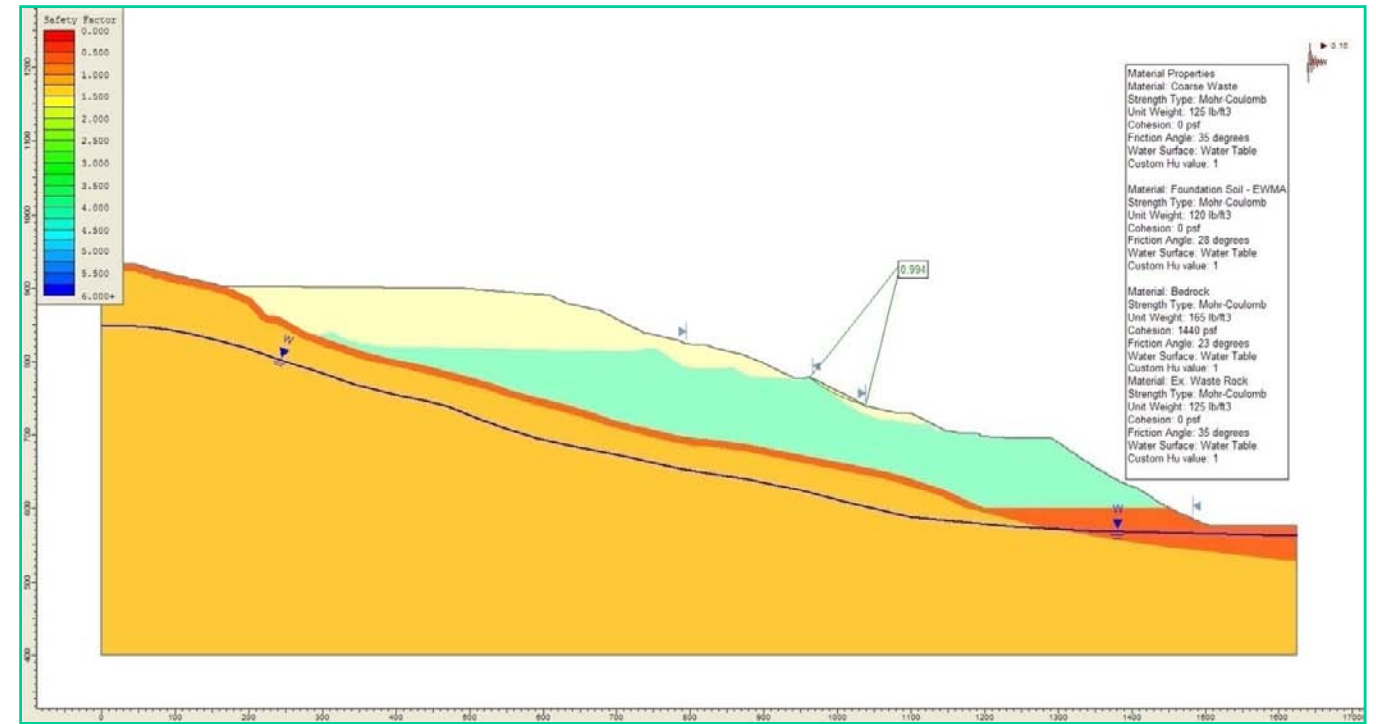
**SECTION E3 – YIELD ACCELERATION  
SINGLE-LIFT FAILURE  
( $k_y = 0.16g$ )**

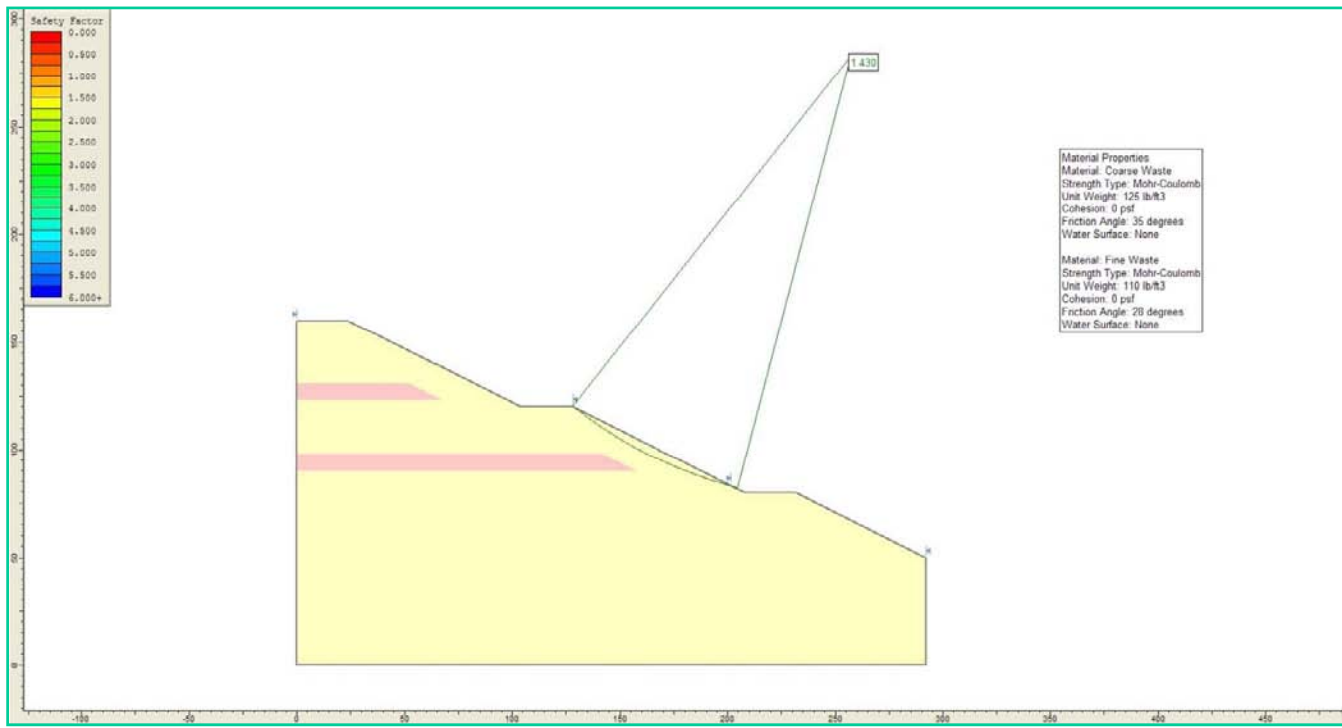
CONCEPTUAL SECTION – STATIC  
 LOCAL FAILURE - CIRCULAR  
 (FOS = 1.43)

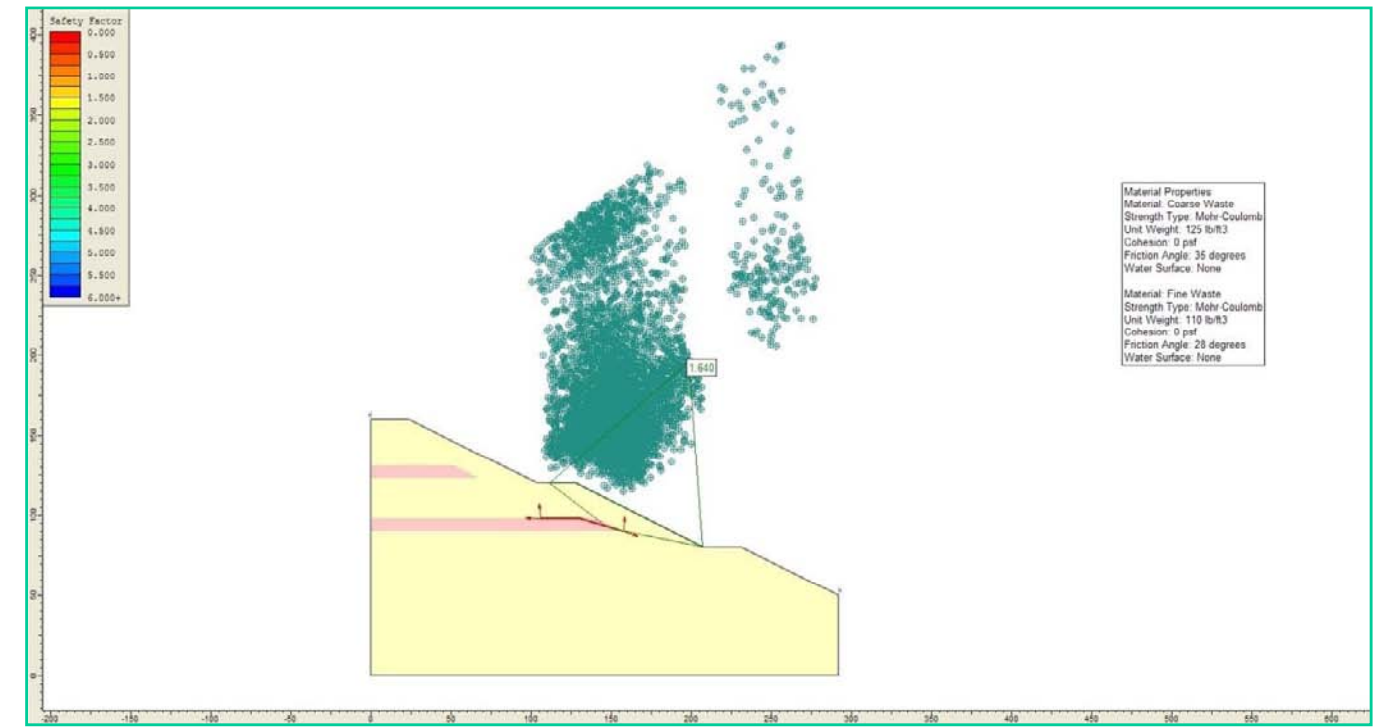
CONCEPTUAL SECTION – STATIC  
 LOCAL BLOCK FAILURE THROUGH FINE WASTE  
 (FOS = 1.64)

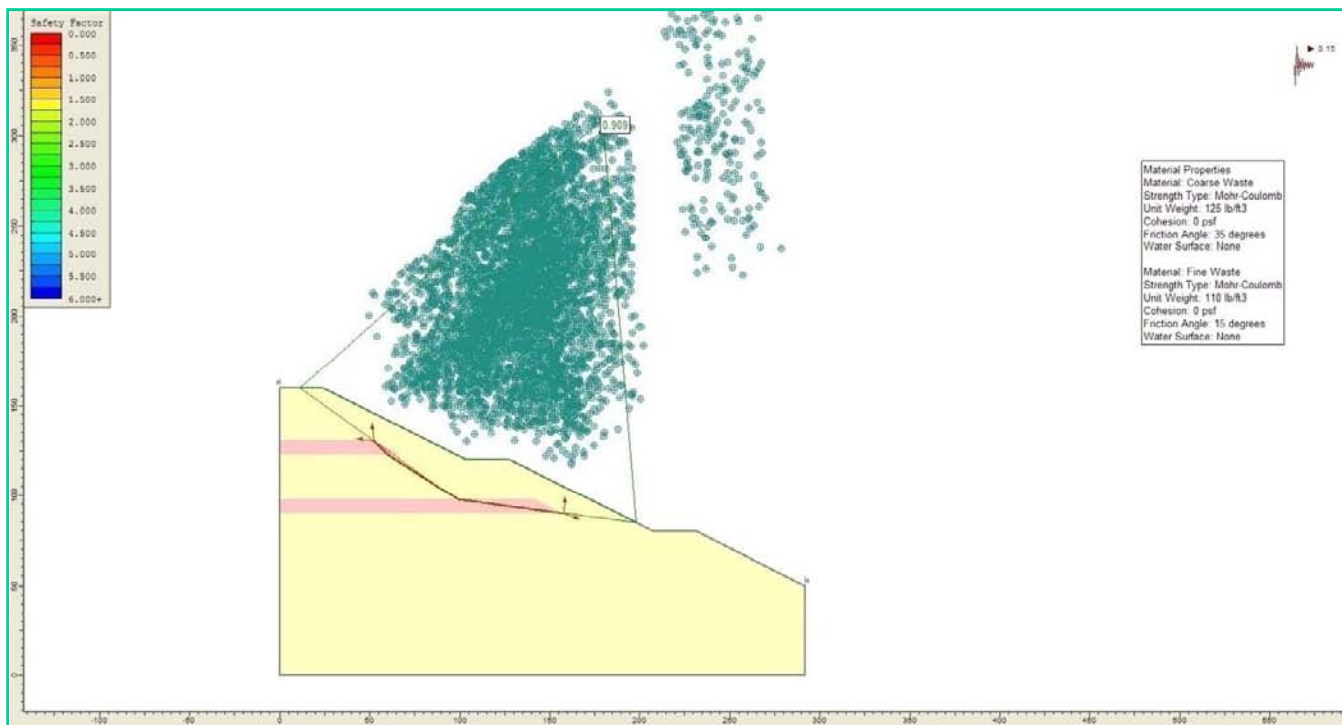
CONCEPTUAL SECTION – PSEUDO-STATIC  
 LOCAL BLOCK FAILURE THROUGH FINE WASTE  
 (FOS = 0.91)

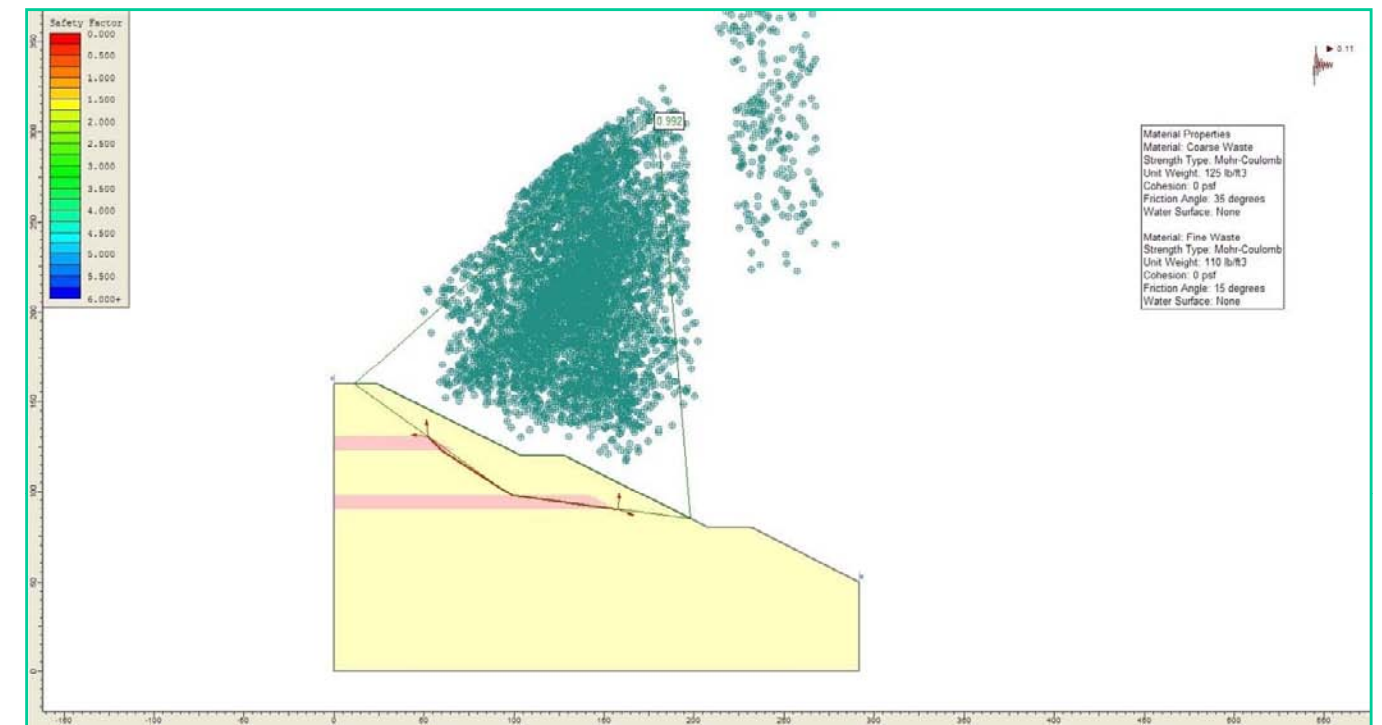
CONCEPTUAL SECTION – YIELD ACCELERATION  
 LOCAL BLOCK FAILURE THROUGH FINE WASTE  
 (ky = 0.11g)

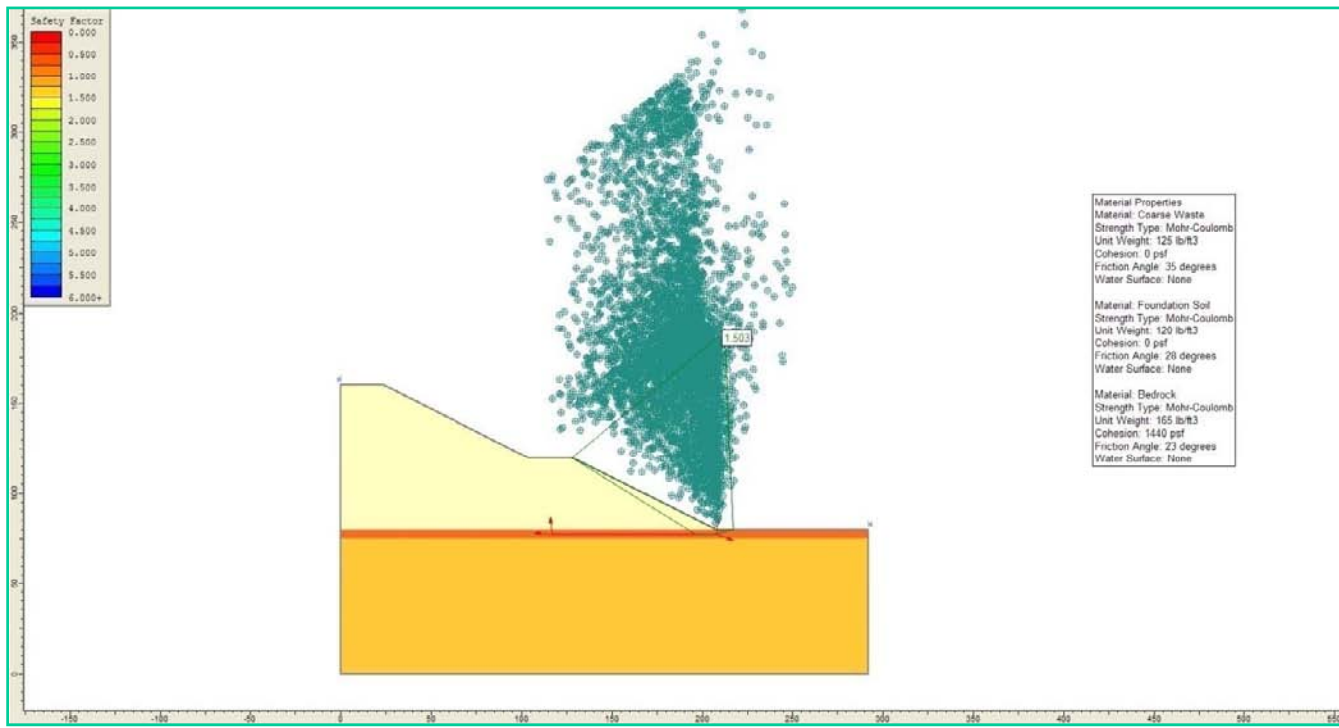
**CONCEPTUAL MODEL OF UNPREPARED SUBGRADE – STATIC  
 LOCAL BLOCK FAILURE THROUGH FOUNDATION SOIL (FLAT)  
 (FOS = 1.50)**

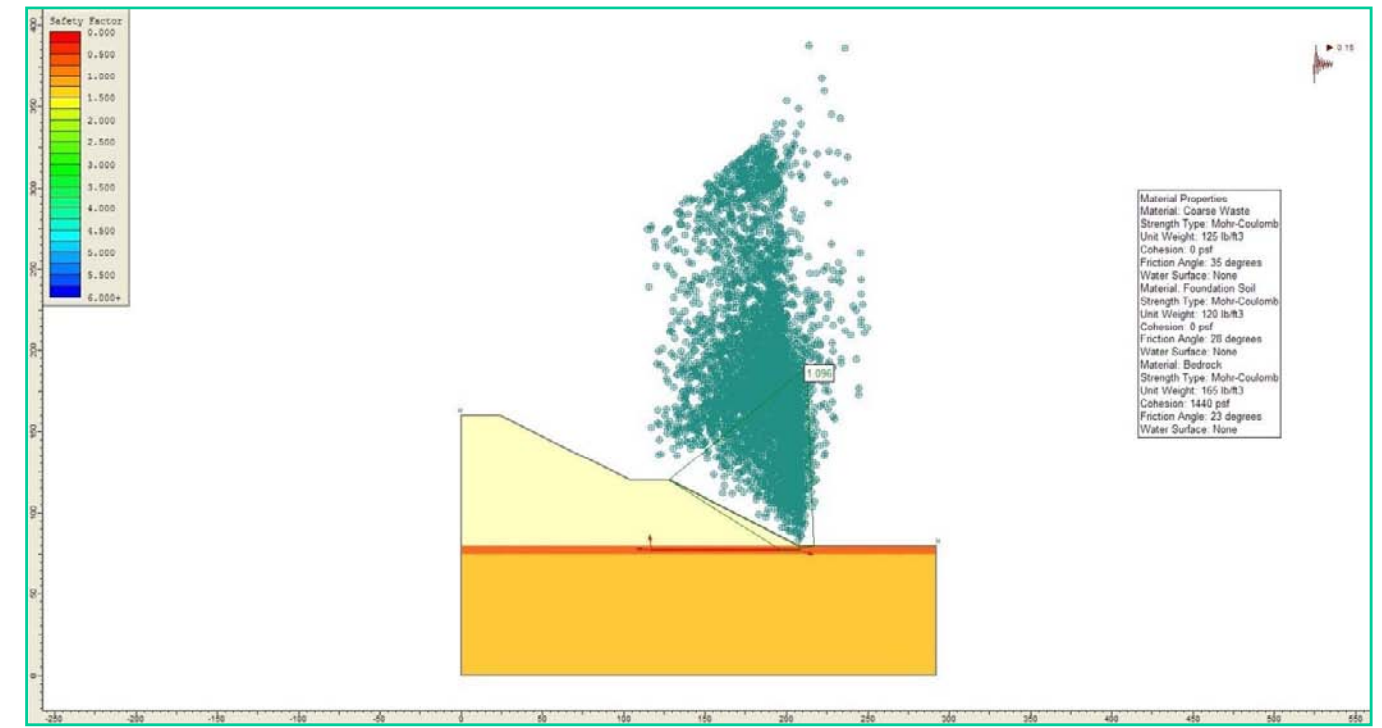
**CONCEPTUAL MODEL OF UNPREPARED SUBGRADE – PSEUDO-STATIC  
 LOCAL BLOCK FAILURE THROUGH FOUNDATION SOIL (FLAT)  
 (FOS = 1.10)**

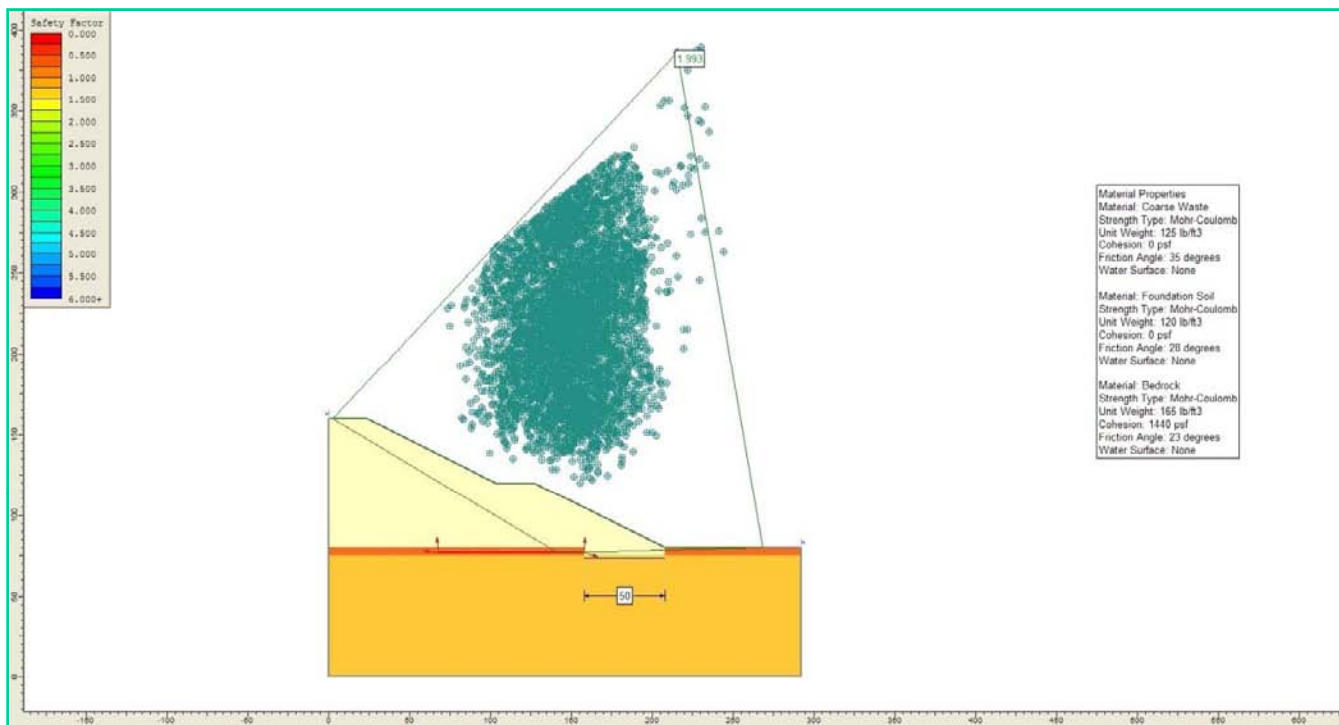
**CONCEPTUAL MODEL OF PREPARED SUBGRADE – STATIC  
 LOCAL BLOCK FAILURE THROUGH FOUNDATION SOIL (FLAT)  
 (FOS = 1.99)**

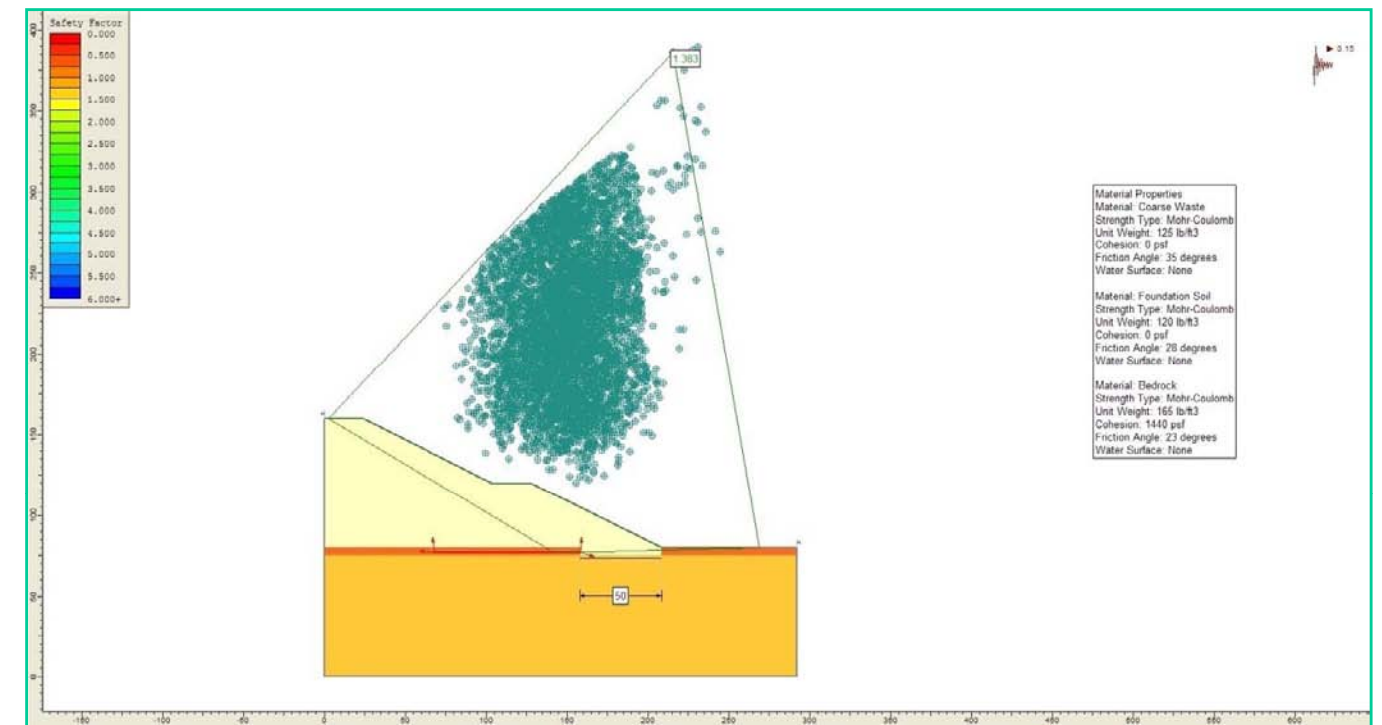
**CONCEPTUAL MODEL OF UNPREPARED SUBGRADE – PSEUDO-STATIC  
 LOCAL BLOCK FAILURE THROUGH FOUNDATION SOIL (FLAT)  
 (FOS = 1.38)**

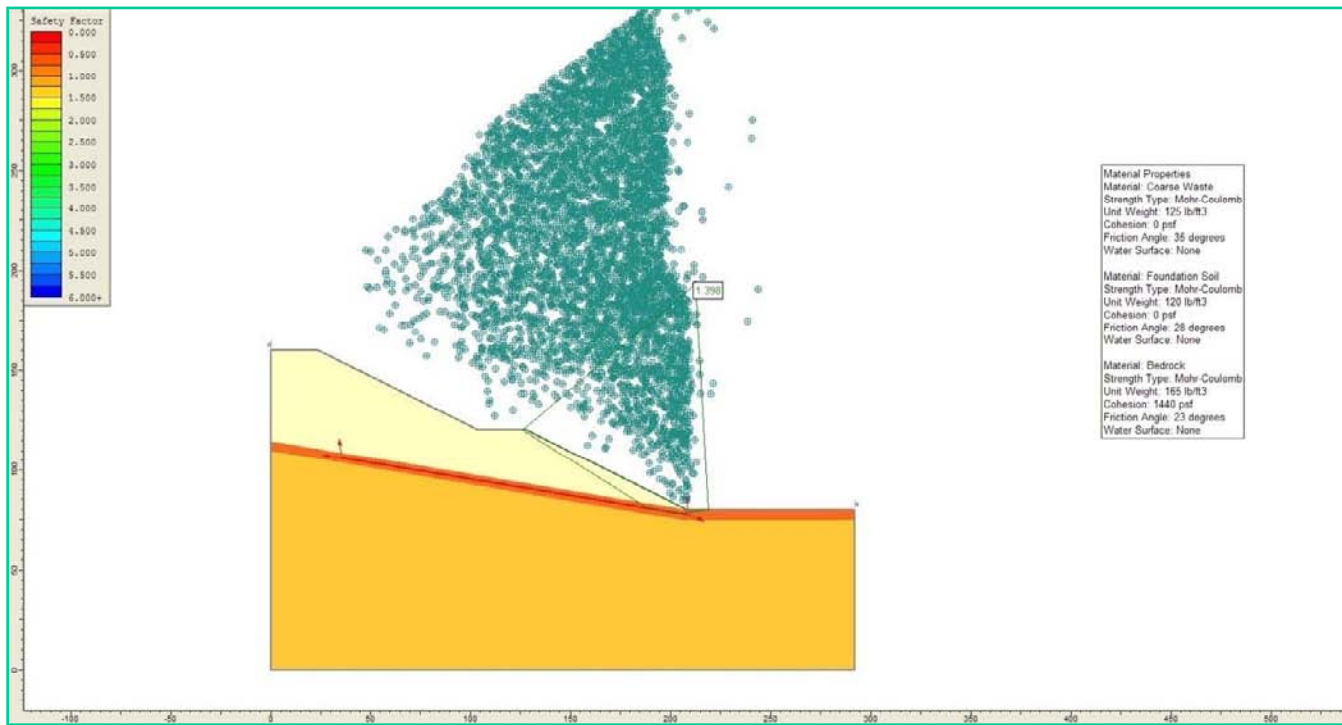
**CONCEPTUAL MODEL OF UNPREPARED SUBGRADE – STATIC  
 LOCAL BLOCK FAILURE THROUGH FOUNDATION SOIL (6H:1V)  
 (FOS = 1.40)**
