**Reclamation Plan Amendment**  
for  
**Permanente Quarry**  
State Mine ID # 91-43-0004

**Santa Clara County**

**Lehigh Southwest Cement Company**

**April 2009**

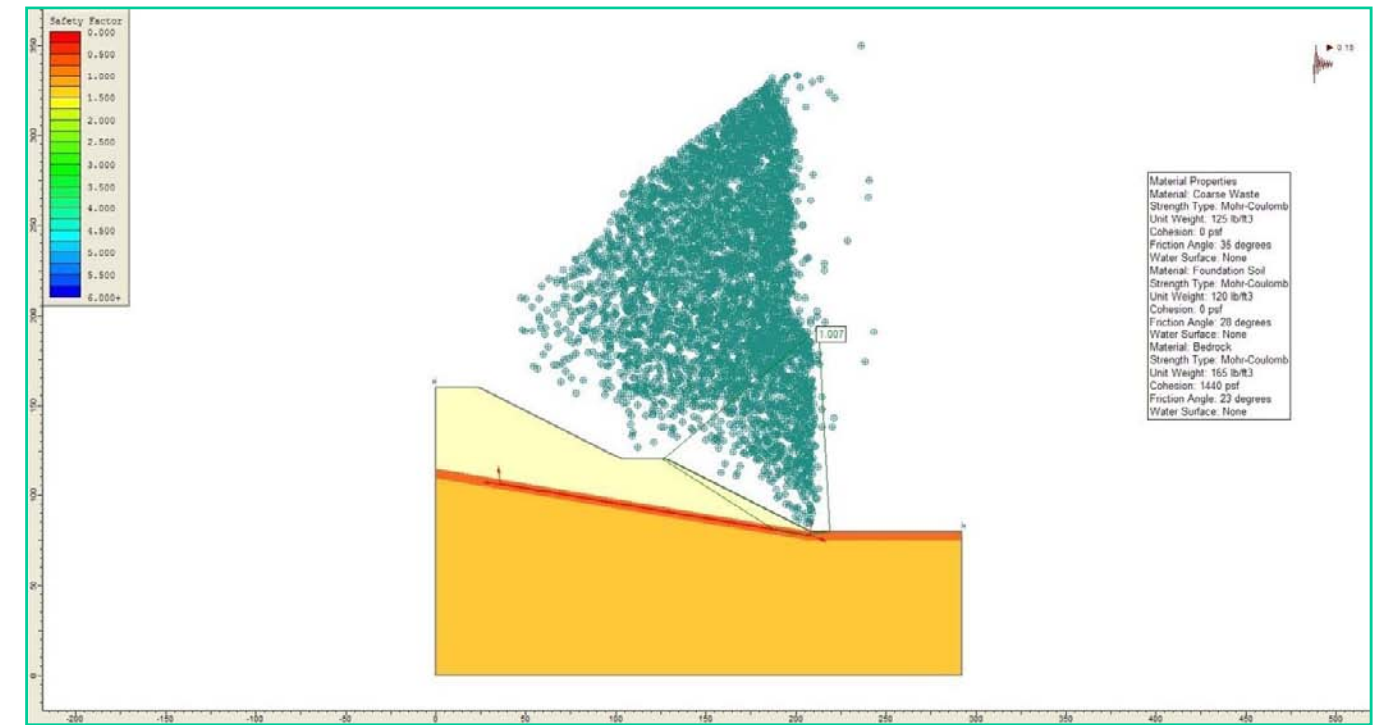
**CONCEPTUAL MODEL OF UNPREPARED SUBGRADE – PSEUDO-STATIC  
 LOCAL BLOCK FAILURE THROUGH FOUNDATION SOIL (6H:1V)  
 (FOS = 1.01)**

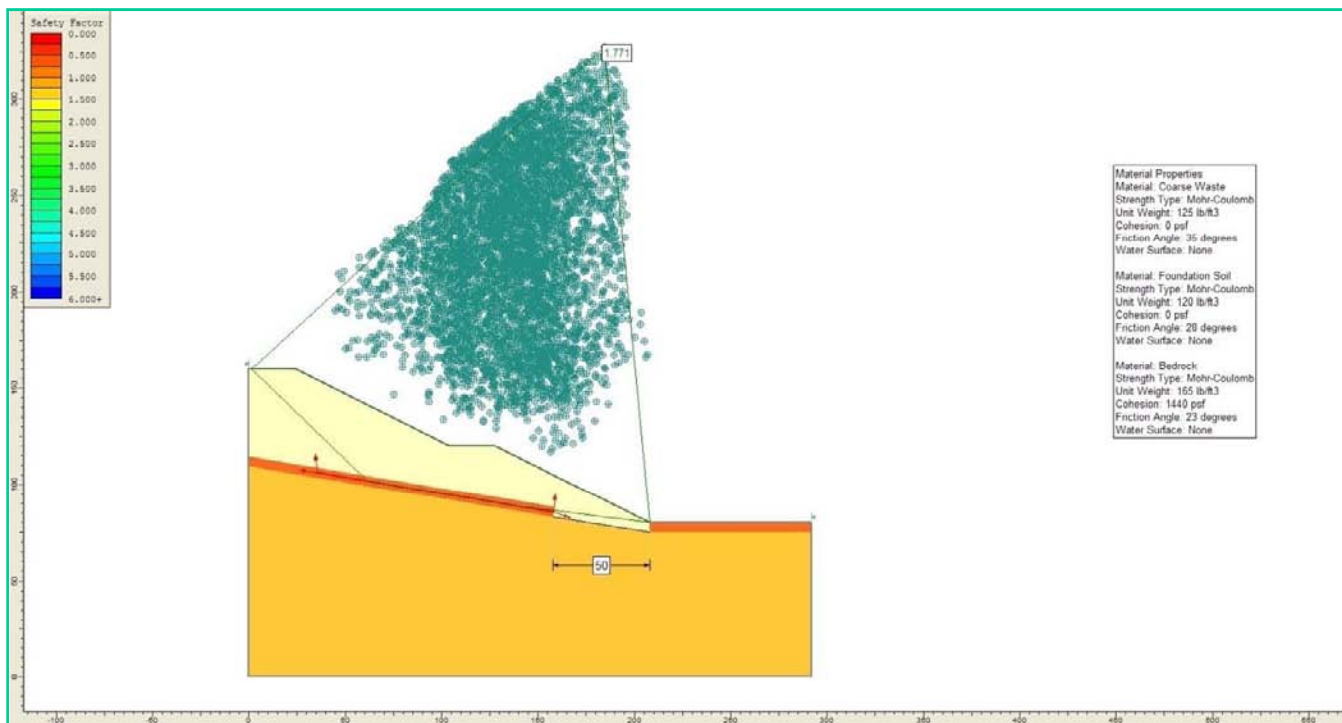
**CONCEPTUAL MODEL OF PREPARED SUBGRADE – STATIC  
 LOCAL BLOCK FAILURE THROUGH FOUNDATION SOIL (6H:1V)  
 (FOS = 1.77)**

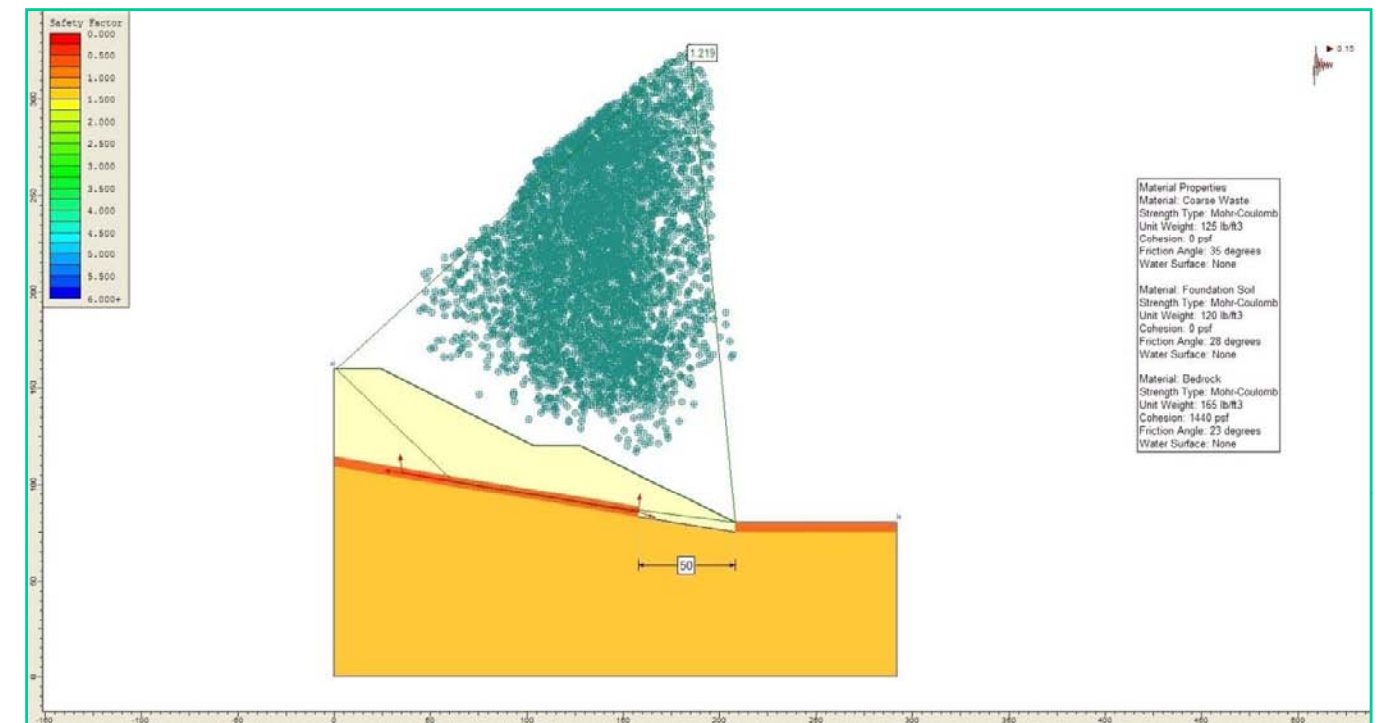
**CONCEPTUAL MODEL OF UNPREPARED SUBGRADE – PSEUDO-STATIC  
 LOCAL BLOCK FAILURE THROUGH FOUNDATION SOIL (6H:1V)  
 (FOS = 1.22)**

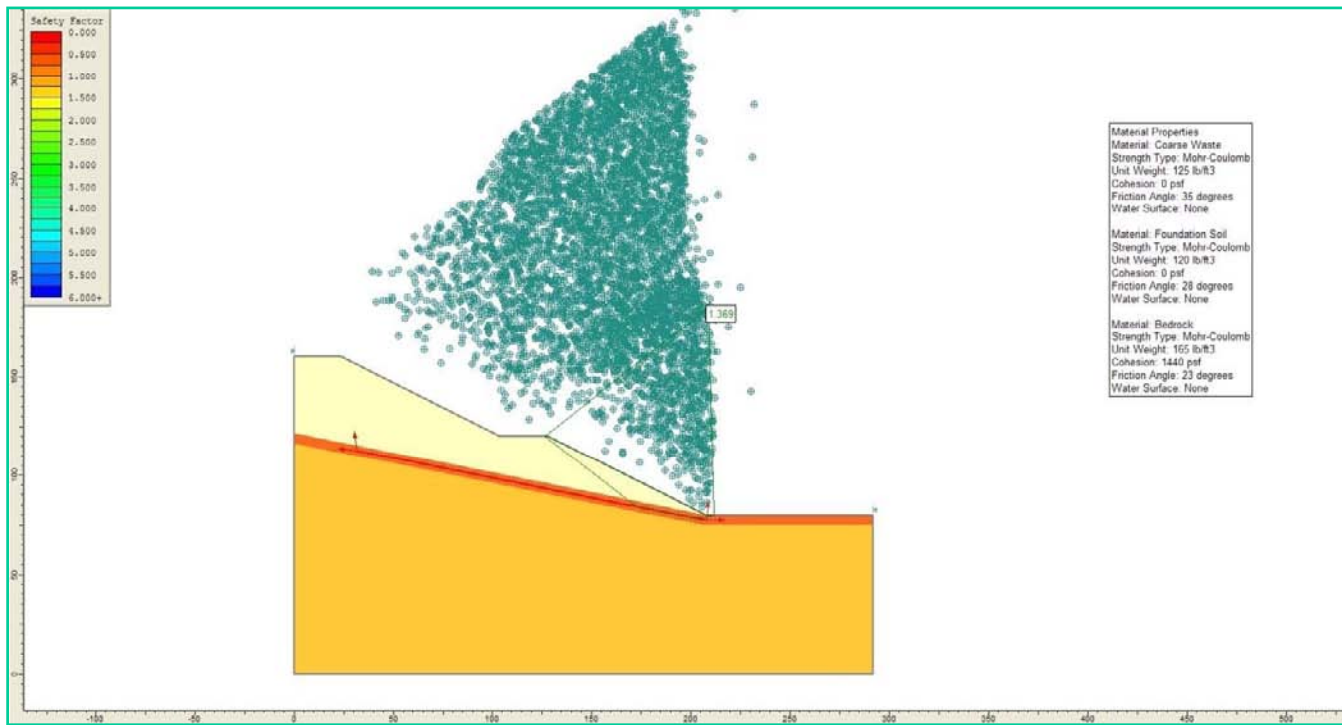
**CONCEPTUAL MODEL OF UNPREPARED SUBGRADE – STATIC  
 LOCAL BLOCK FAILURE THROUGH FOUNDATION SOIL (5H:1V)  
 (FOS = 1.37)**

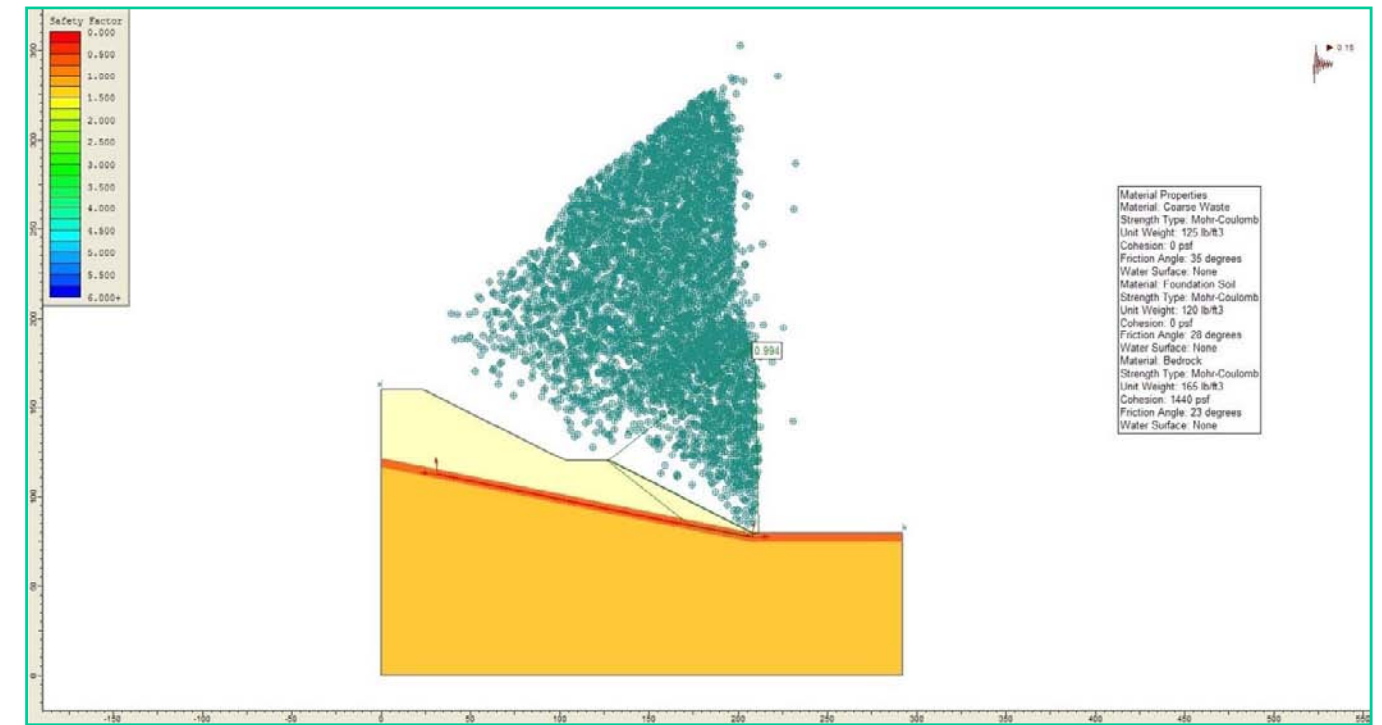
**CONCEPTUAL MODEL OF UNPREPARED SUBGRADE – PSEUDO-STATIC  
 LOCAL BLOCK FAILURE THROUGH FOUNDATION SOIL (5H:1V)  
 (FOS = 0.99)**

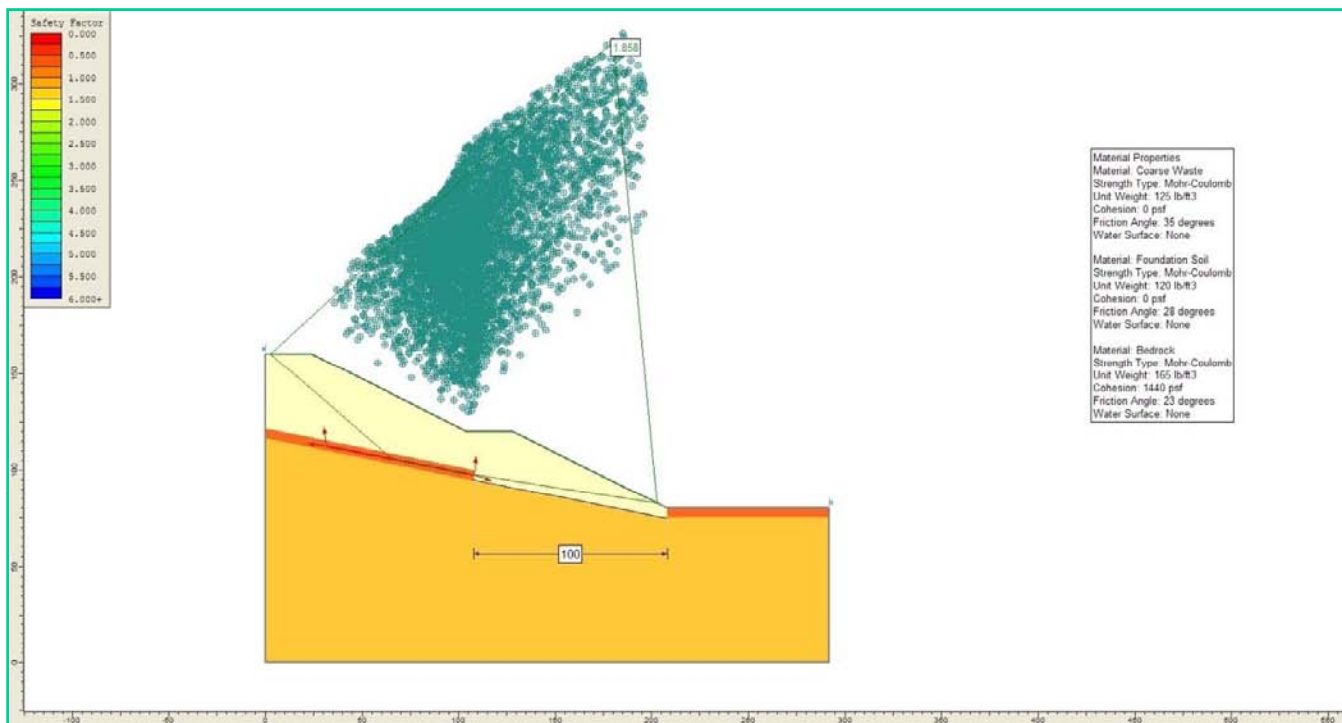
**CONCEPTUAL MODEL OF PREPARED SUBGRADE – STATIC  
 LOCAL BLOCK FAILURE THROUGH FOUNDATION SOIL (5H:1V)  
 (FOS = 1.86)**

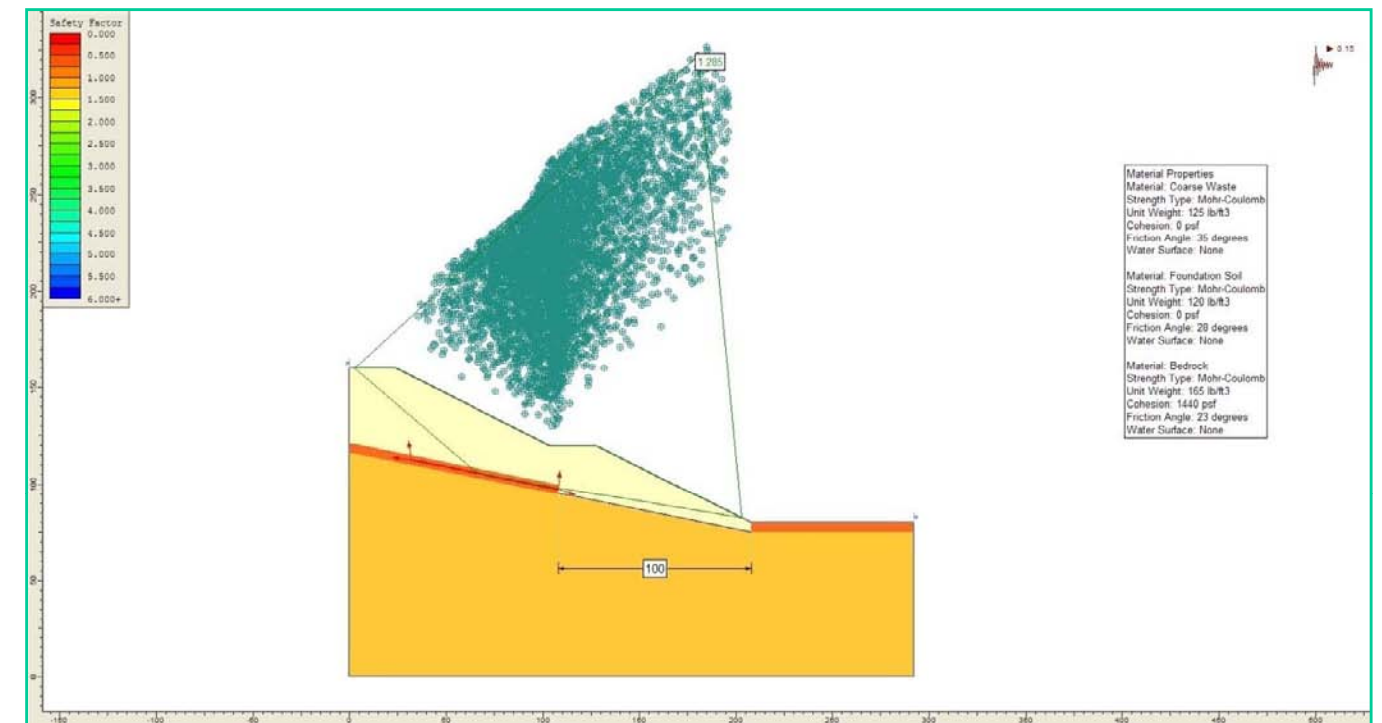
**CONCEPTUAL MODEL OF UNPREPARED SUBGRADE – PSEUDO-STATIC  
 LOCAL BLOCK FAILURE THROUGH FOUNDATION SOIL (5H:1V)  
 (FOS = 1.29)**

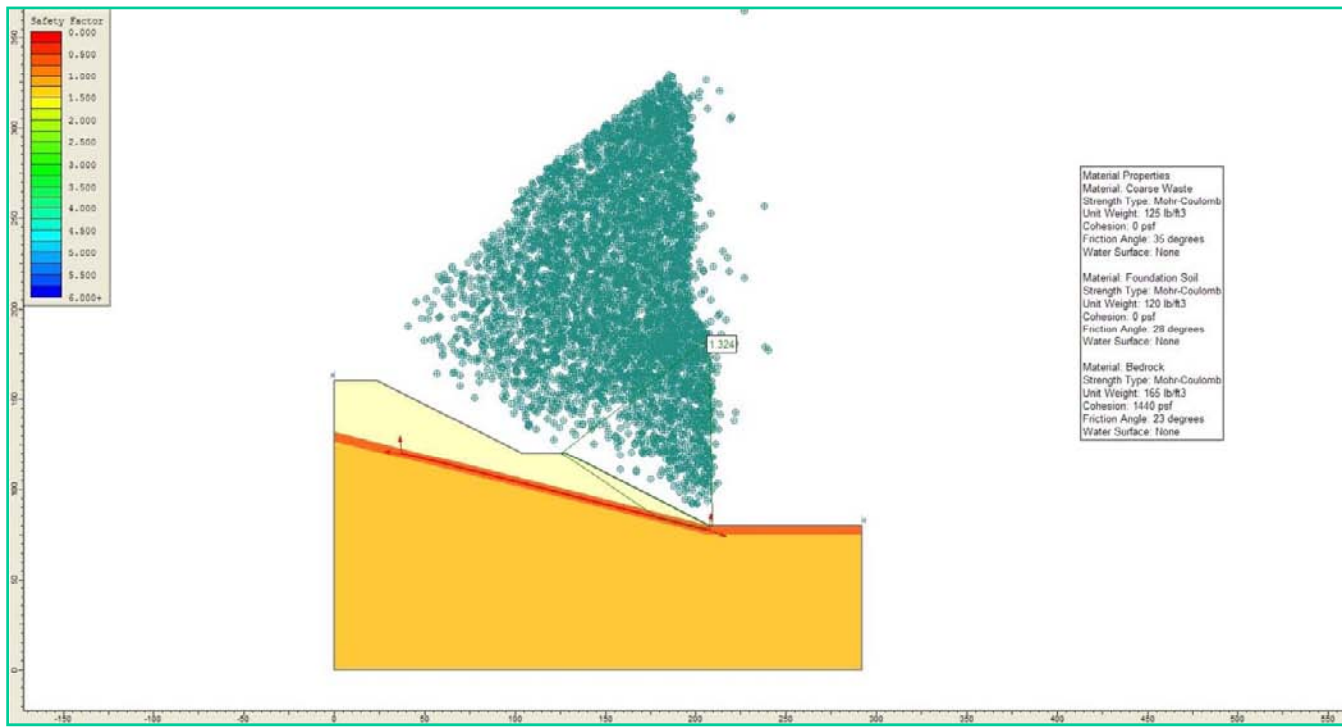
**CONCEPTUAL MODEL OF UNPREPARED SUBGRADE – STATIC  
 LOCAL BLOCK FAILURE THROUGH FOUNDATION SOIL (4H:1V)  
 (FOS = 1.32)**

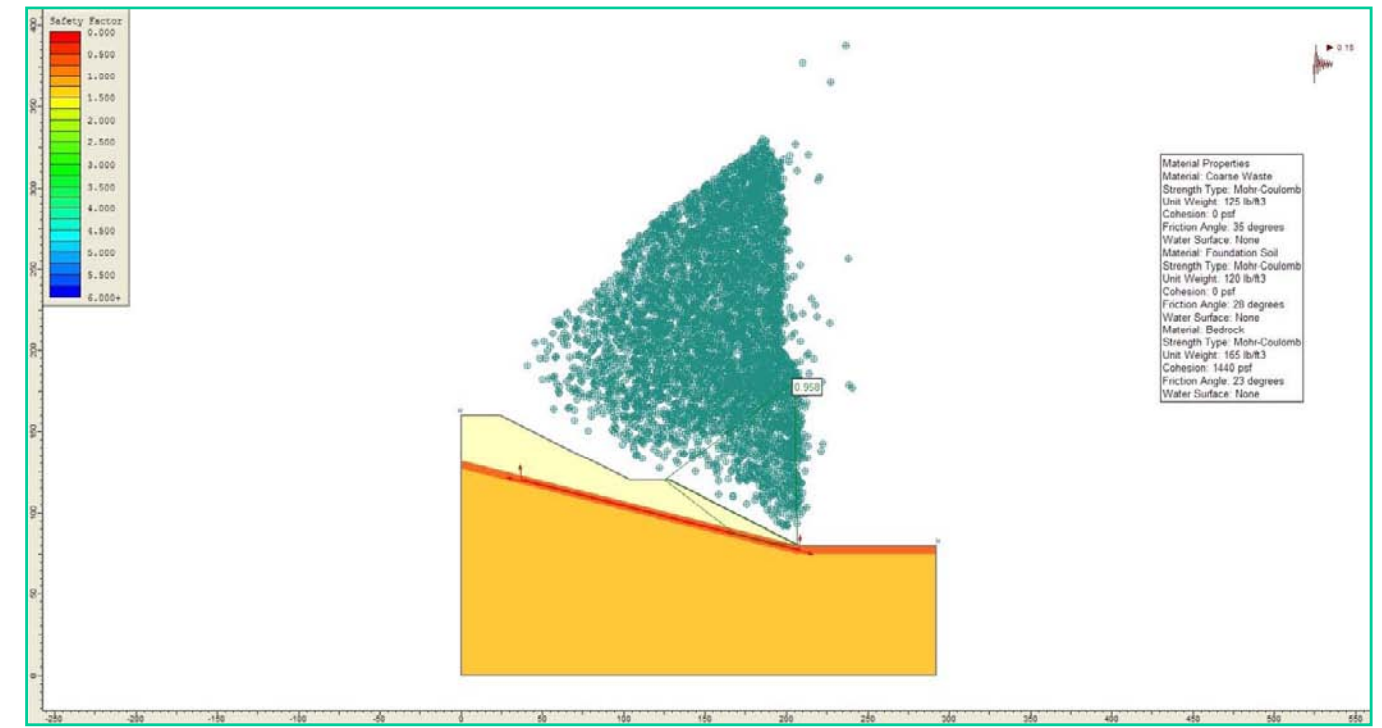
**CONCEPTUAL MODEL OF UNPREPARED SUBGRADE – PSEUDO-STATIC  
 LOCAL BLOCK FAILURE THROUGH FOUNDATION SOIL (4H:1V)  
 (FOS = 0.96)**

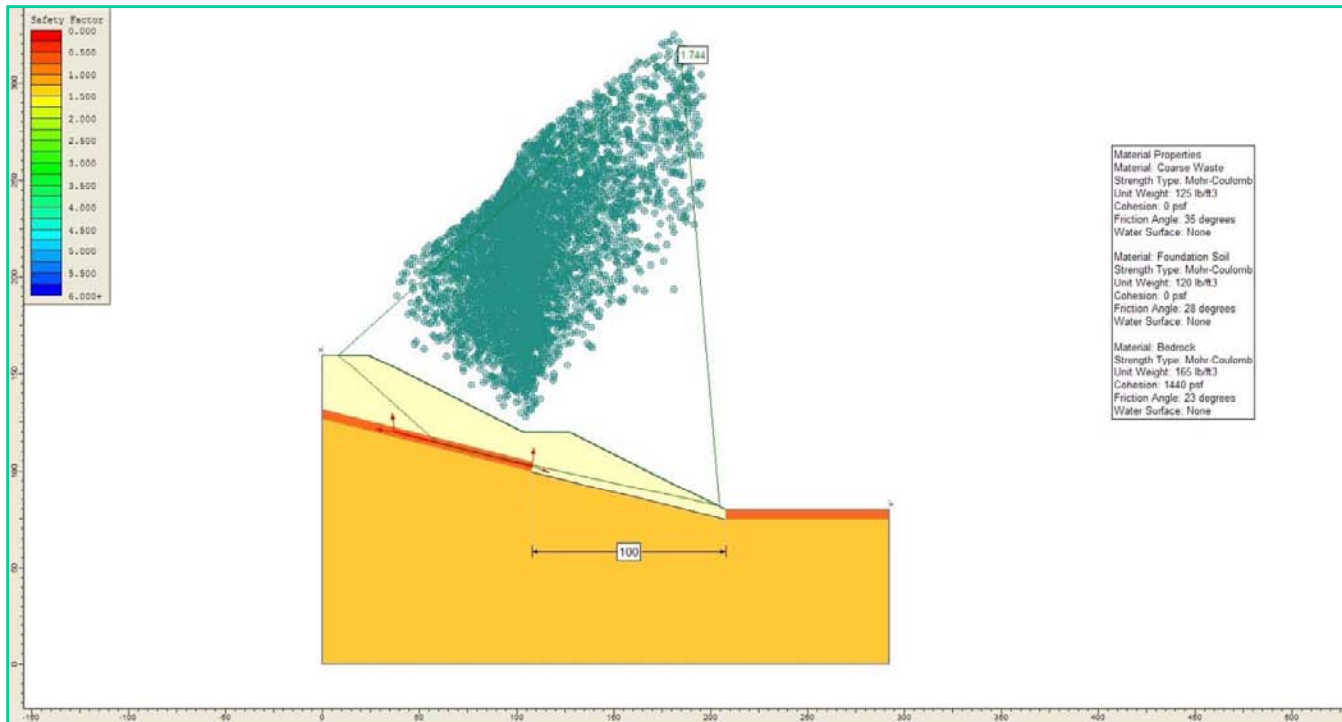
**CONCEPTUAL MODEL OF PREPARED SUBGRADE – STATIC  
 LOCAL BLOCK FAILURE THROUGH FOUNDATION SOIL (4H:1V)  
 (FOS = 1.74)**

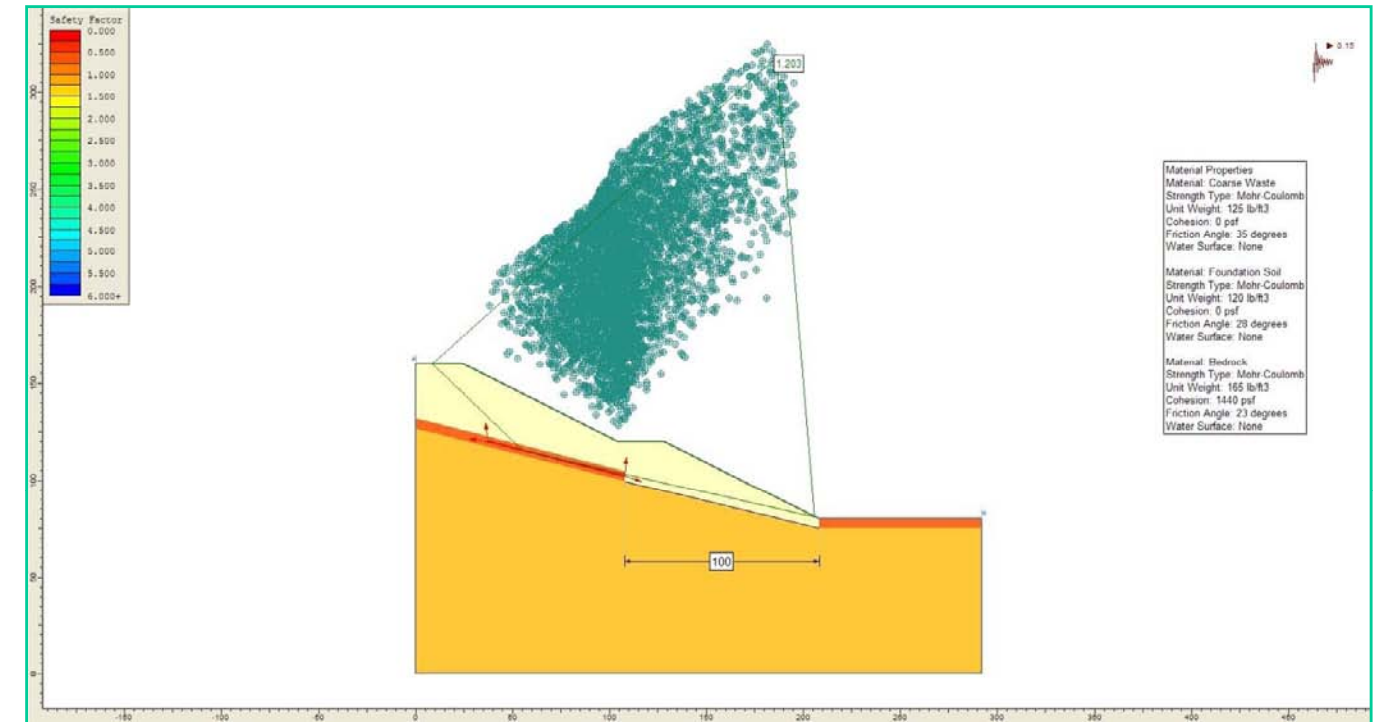
**CONCEPTUAL MODEL OF UNPREPARED SUBGRADE – PSEUDO-STATIC  
 LOCAL BLOCK FAILURE THROUGH FOUNDATION SOIL (4H:1V)  
 (FOS = 1.20)**

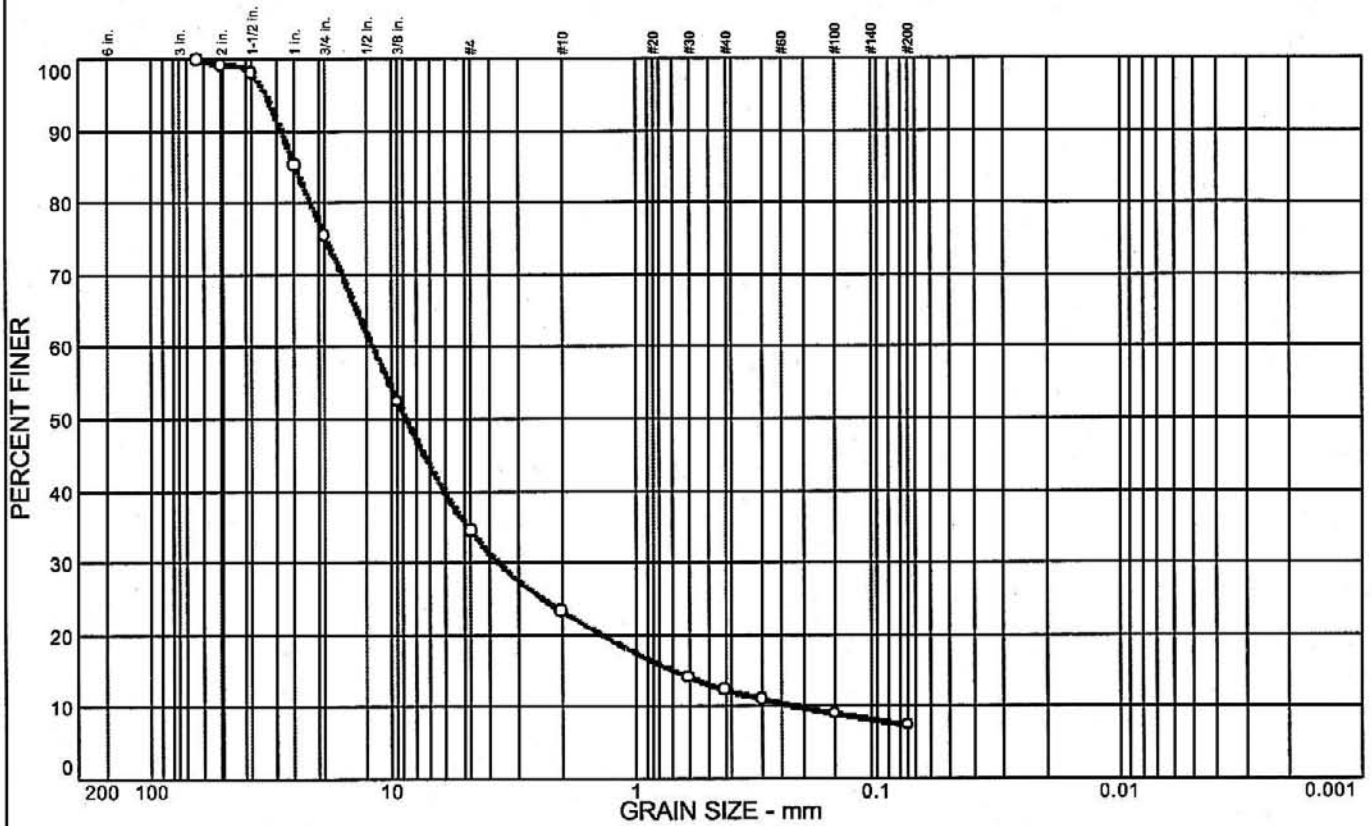
# Particle Size Distribution Report

% COBBLES	% GRAVEL	% SAND	% SILT	% CLAY	USCS	AASHTO	PL	LL
0	65.6	27.0	7.4

SIEVE inches size	PERCENT FINER		SIEVE number size	PERCENT FINER		SOIL DESCRIPTION ○ Gray Poorly Graded GRAVEL w/ Silt & Sand
	○			○		
2.5	100.0		#4	34.4		REMARKS: ○
2	99.2		#10	23.3		
1.5	98.0		#30	14.1		
1	85.3		#40	12.4		
3/4	75.5		#50	11.0		
3/8	52.4		#100	9.0		
GRAIN SIZE			#200	7.4		
D <sub>60</sub>	12.0					
D <sub>30</sub>	3.65					
D <sub>10</sub>	0.220					
COEFFICIENTS						
C <sub>c</sub>	5.05					
C <sub>u</sub>	54.84

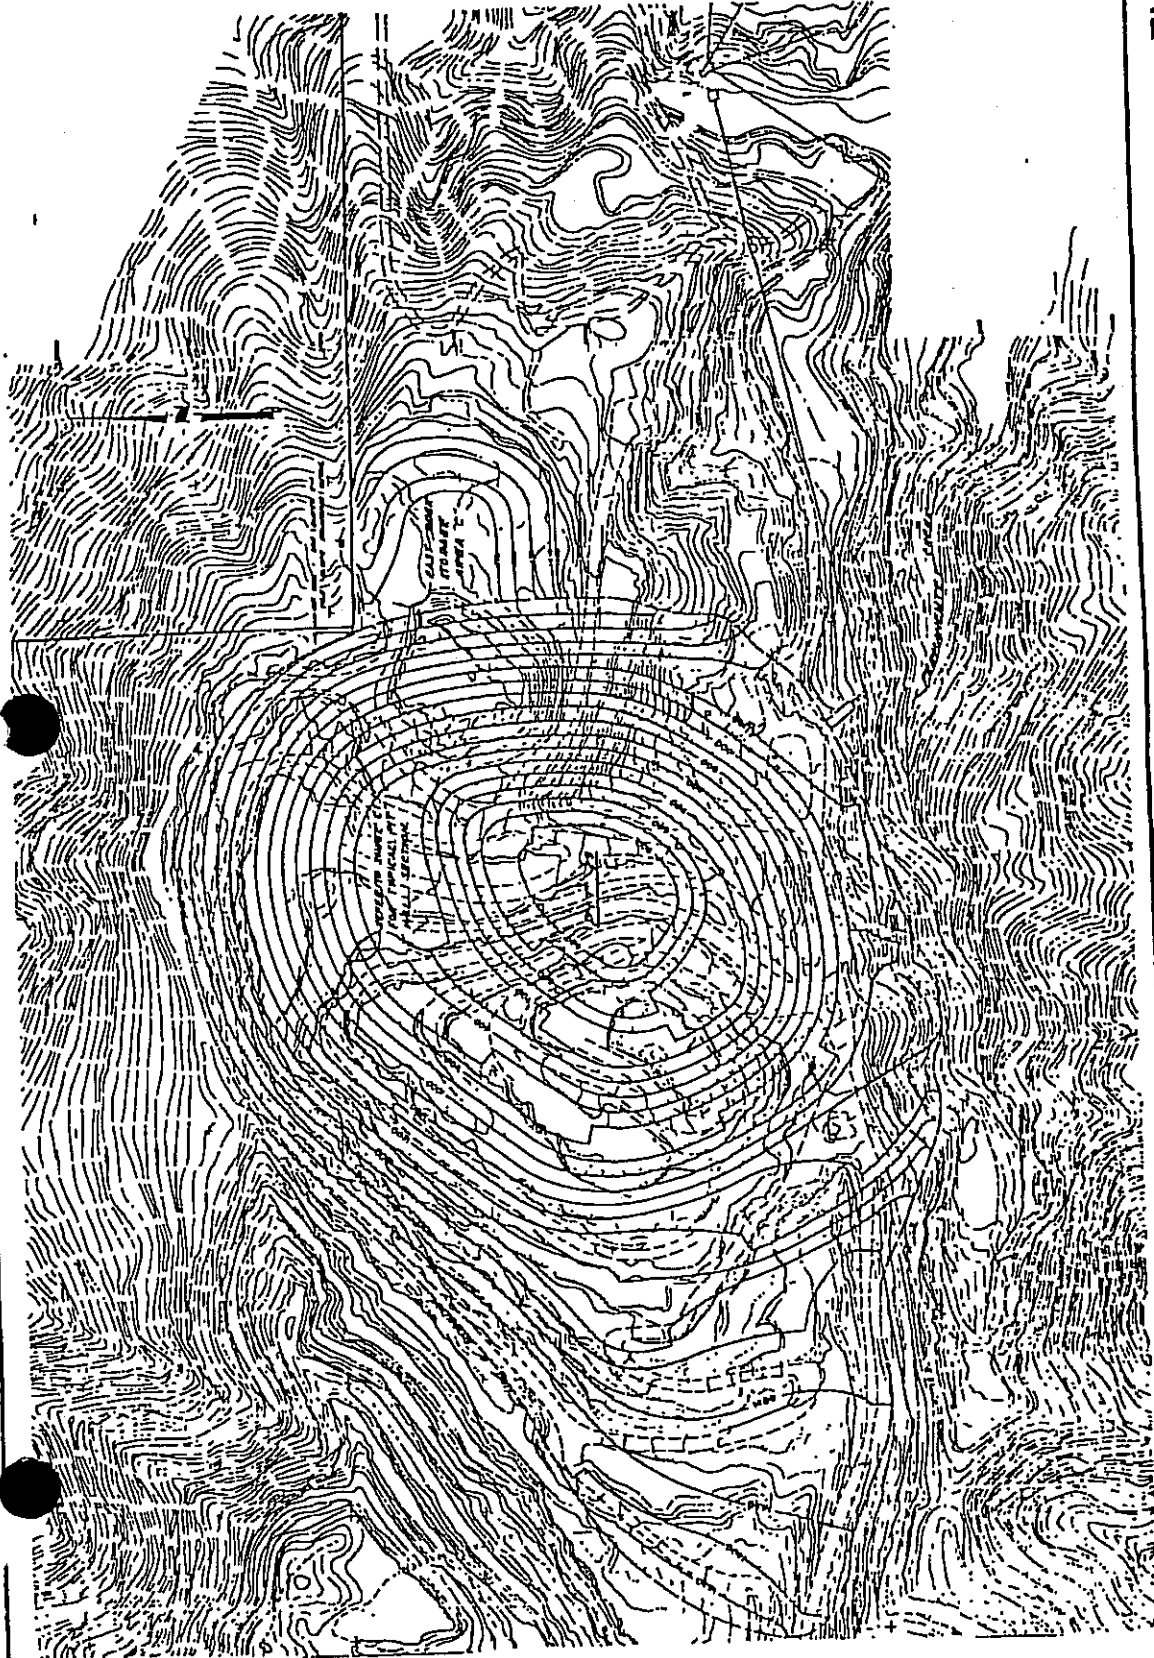
FIG. 6

The design for the reclamation plan is shown in Figure 6, which presents the excavation contours overlain on the existing topography. The overall pit slope for both the existing and future operations will be maintained at an angle of 45 degrees (1:1).

QUARRY PIT DESIGN
