# A CHURCH AND GRAVEYARD SURVEY IN COUNTY CLARE

## SURVEYED BY SIMON LARGE IN 2010

Version 1.0 as at 1st June 2011

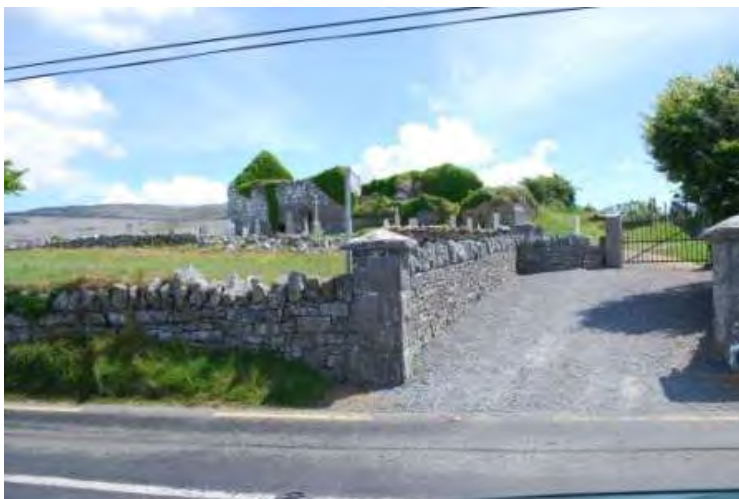
General Description: A large two cell church sitting in a prominent position overlooking the road, nearby coast visible from the church. The church is divided internally having a transept arch which leads to a chancel. There is considerable ivy growth on the south, west and east walls. It is particular intense on the south wall and is a cause for concern. Much of the chancel on the western end is destroyed by time, and is overgrown with ivy and other vegetation. The nave 6.6m wide x 17m long. The chancel is 4.8m x 9.5m. Wall thickness' are 0.75m.

West Wall General Description: The transept arch is to the western end of the church. And largely ruined. The western end of the chancel is breached. The chancel is generally in a poor condition. The west wall of the chancel is heavily covered in ivy, reduced to a height of 1.2m and has been breached at some time in the past.

East Wall General Description: Large single window. It is noted that the window is damaged, jamb stones have moved out of position. This may be due to the excessive growth of ivy.

Church Appraisal/ Recommendations: The ivy growth is extensive hiding much of the church fabric. There is evidence of ivy damage which will increase unless it is controlled.

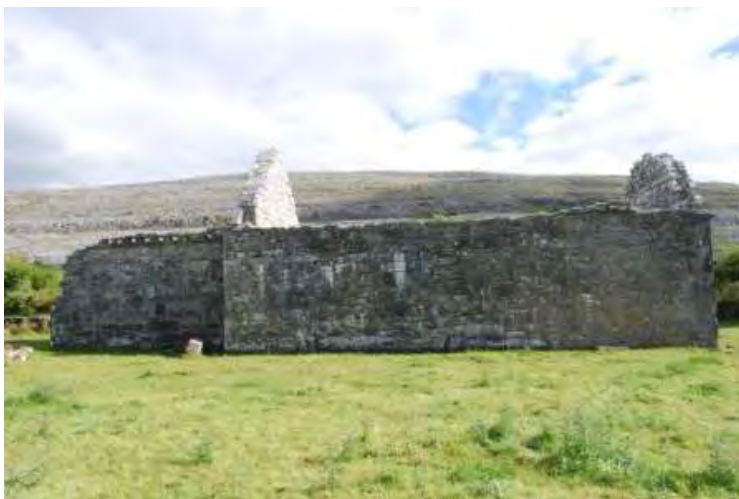
General Description: This is one of three early churches, the only two cell example, which are under the protection of the National Monuments Service and are maintained by them because of their significance. The church is divided by an upstanding transept arch. The nave is 13.5m by 6.3m; the chancel 6.3m x 5.4m, the walls 0.9M thick.

West Wall General Description: There is a square headed inclined door.

Church Appraisal/ Recommendations: None the church is fully maintained by National Monument Services

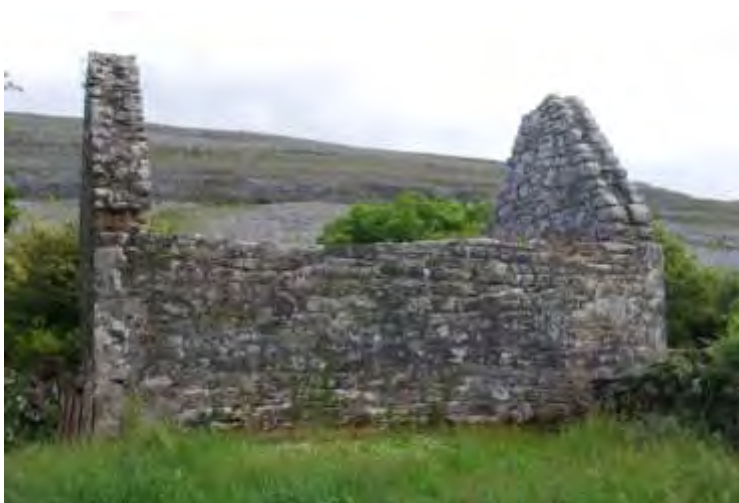
General Description: This is the second of three churches grouped together, in the National Monuments Service ownership and maintained by them. This single cell church measures 8.7m x 6.6m. Wall thickness 0.74m.

West Wall General Description: The door is located in the west wall of this church. The threshold survives in the door opening. Height of door is 1.9m, with a square head. The door is slightly narrow at 0.8m.

Church Appraisal/ Recommendations: None the church is fully maintained by National Monument Services

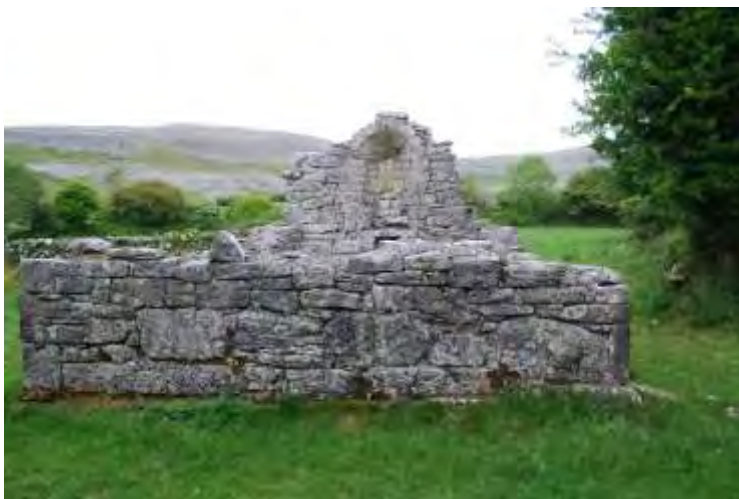
General Description: This the third of the three churches on this site and the smallest. The east gable survives to a reasonable height - 2m. The remaining walls much reduced in height. The walls are 0.7 m thick. The church is single cell, measures 3.4m x 6.6m.

West Wall General Description: There are no distinguishing features on this wall.

South Wall General Description: The door is in the south wall, survives at a width of 1.3m. A threshold was noted in the door opening.

Church Appraisal/ Recommendations: None the church is fully maintained by National Monument Services

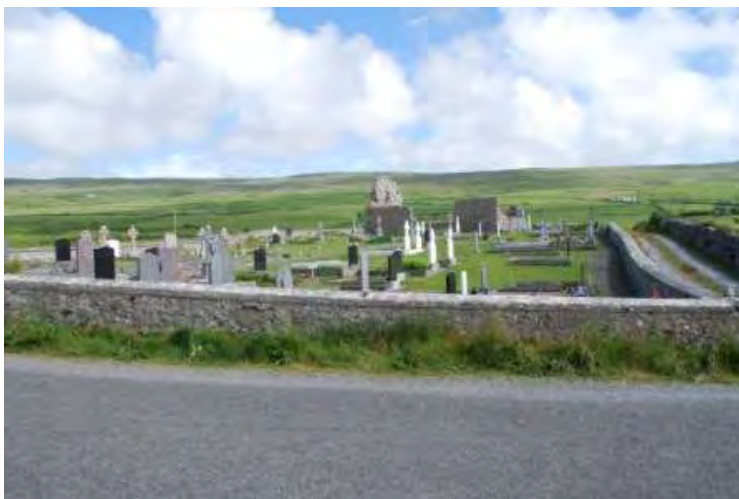
General Description: Church is single cell, in a poor state of repair with the east gable split over the window. A section of the north wall missing, and is split and leaning. Much of the south and west walls are reduced in height. The church measures 17.2m x 6.5m, wall thickness is 0.7m.

West Wall General Description: There are no features surviving in the west wall, and as noted the west wall is in a poor state of repair, and much reduced in height.

North Wall General Description: As noted in the general description, the north wall is in poor condition and no features survive.

East Wall General Description: Contains a single large window, width 2m. The internal keystones are missing

Church Appraisal/ Recommendations: The church has suffered considerable damage over time. Without maintenance the church will fall into ruin. However, repairs would be costly to preserve what remains. A full detailed record of the surviving remains be completed as a matter of priority.

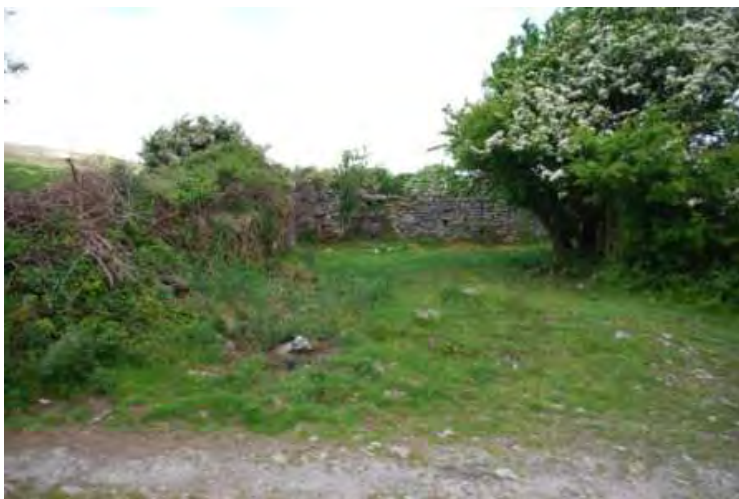
General Description: This is an unusual church in that there are gothic styled windows to the north. It was possibly "T" shaped but evidence for this is somewhat conjectural. The walls survive to a height of 2.1m. The main body of the church is 12.3m x 6.3m. The probable "T" to the south may have measured 5.5m depth and would have been circa 6m wide.

West Wall General Description: A window survives on the west wall, width 1.3m.

South Wall General Description: The south wall at the western end forms a corner extending south approx 5.5m. This is the evidence for a possible "T" or cruciform layout. The remainder of the south wall is tumbled or completely missing. Although some possible foundation stones were noted.

Church Appraisal/ Recommendations: The church is in poor repair. An archaeological investigation to determine the foot print would be useful. A full detailed record of the surviving remains be carried out as a priority.

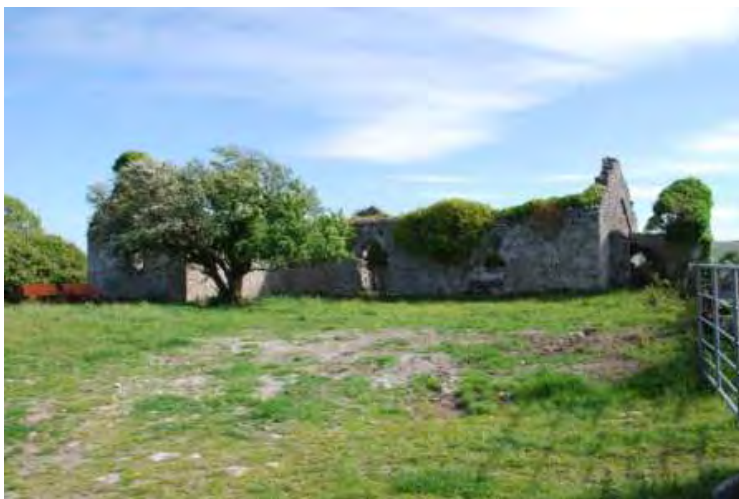
General Description: This church is in "T" or cruciform layout, both arms are c.22M, width 6.1M. The main body of the church is orientated EW with the base "T" extending north / south, at the eastern end. There has been extensive re-use of the church by a local farmer. Furthermore, a small structure is built on the east wall of the "T", a possible house -now some what ruined therefore its use difficult to assess. There is a small chapel added to the western end of the E/W church. All window openings are pointed.

West Wall General Description: The west gable has been opened to access a believed later built small chapel. The opening is partially blocked and overgrown. There is a blocked door on the west wall of the "T".

Church Appraisal/ Recommendations: The church has been used in connection with farming activity with a cattle-crush built against the east wall. The landowner should be informed of his responsibilities to a Recorded Monument

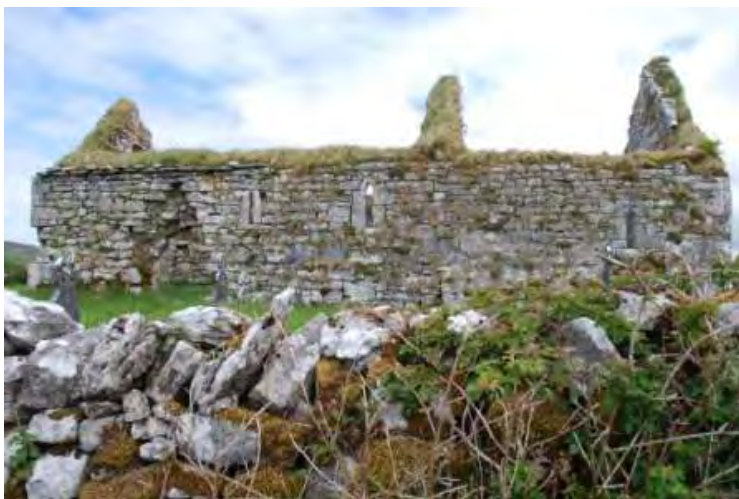
General Description: This is a two cell church with an internal transept arch, the door has been robbed out. The church measures 6.5m wide, 20.6m length. The church is situated in an accessible but remote location and is associated with a number of other archaeological structures within the immediate environs of the church. The choir is 7m in length and the main body of the church is 12.5m in length. The walls are 1.1m in thickness. The transept arch survives to its full height.

West Wall General Description: The west wall contains an upper and lower window. There are a number of corbels at the western end of the church.

Church Appraisal/ Recommendations: The door opening is weakened and will continue to deteriorate. The east window is weakened, by a vertical displacement on the northern side. The transept arch shows early signs of stress. A structural architectural survey to assess condition.

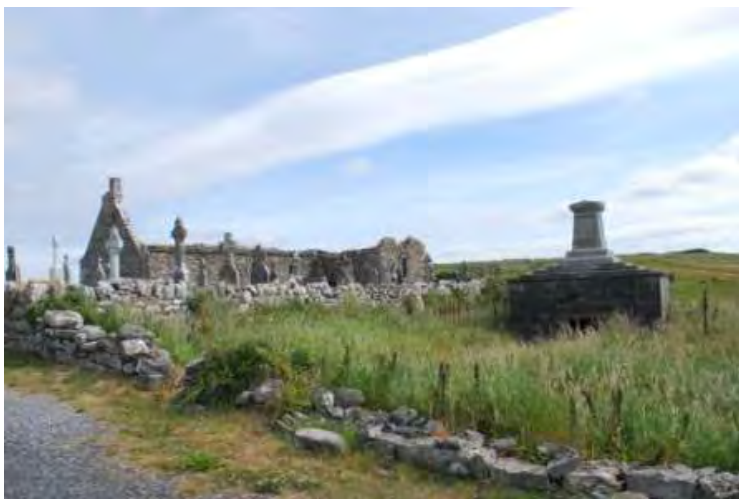
General Description: The church is laid out in an L-shape. The main church is orientated EW. At the western end of the church there is an extension to the south, which is entered through a transept arch. This extension appears to have been a later inclusion, some window elements are believed to have been taken from a now ruined nearby tower house. The main church measures 17.3m x 6m. The L-extension is roughly square at 4.4m. The east gable of the main church is completely ruined.

West Wall General Description: West wall contains a small square window, high up in the gable. The remains of a bell-cote survives at the apex of the gable. There is a window in the west wall of the extension.

Church Appraisal/ Recommendations: The south widow of the extensions requires urgent repairs. The door also requires repairs. A church in need of attention, that is presently in good /fair repair

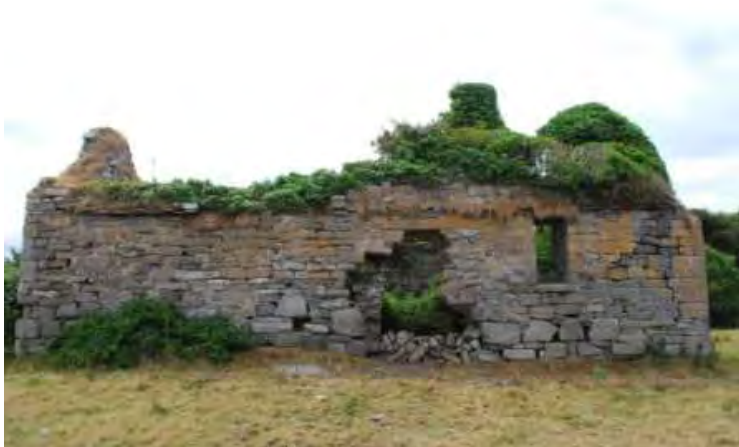
General Description: This church originally single cell, is in a very poor condition. The doorway has been robbed out and is extremely dangerous. The majority of the north wall is ruined to foundation level. The church appears to have two west gables, one in body of the church and one at the end. This is because a priest apartment was attached at a later stage to the smaller church. The overall dimensions are 16m x 6.1m. The wall thickness is 0.75m. The original church was circa 11m in length. The interior of the church is extensively overgrown and cannot be accessed with any ease.

West Wall General Description: As noted before, there are two west gables. The internal west gable comprises of two walls, the original wall of the church and a second wall which was built against it for the priests. This wall has an upper and lower door and an upper window - over door. The upper door appears to have provided access to a small choir stall in the church, while the lower door allowed the priests access at ground level to the church. There are corbels on both sides of this gable. The West gable of the priests house contains a single window. While no evidence survives, a belfry existed on the internal west gable-this was not evident.

East Wall General Description: Contains one large single window, hooded to the external. The window is in a poor state of repair.

The church is in poor repair. There are several interesting features. The door requires urgent attention. Clearing the overgrowth and evaluation of the structure.

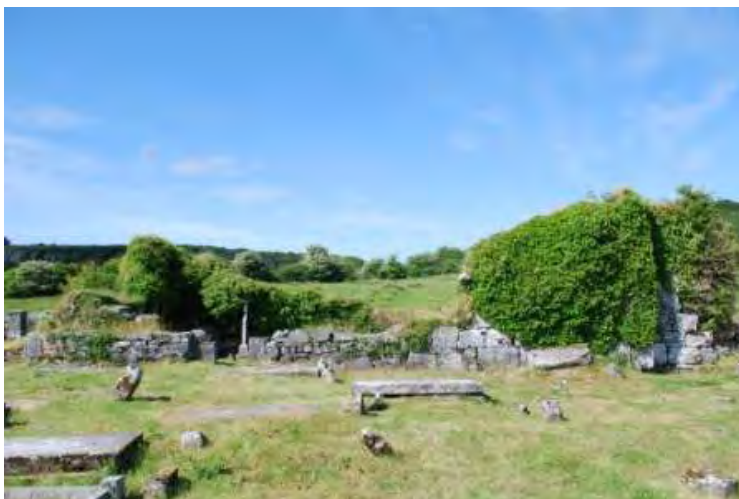
General Description: The church is two cell, now somewhat ruined, both gables and the south wall are considerably reduced. The north wall at the western end is also reduced and now survives as a grass covered ridge, similar to the west gable. There is considerable ivy growth on the upstanding walls. There are large stones included in the wall-build and the wall is stepped to the south and north, creating a nave. A foundation plinth survived along the north wall at the eastern end. The church is 17.3m x 6.15m. Wall thickness is 0.75m.

West Wall  
General Description: Little of the west wall survives. There were no features to record.

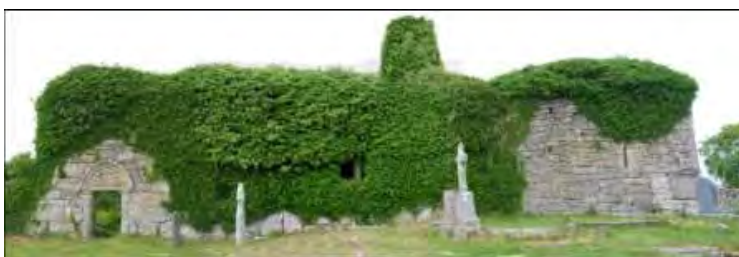
General Description: A two cell church, the south wall is extensively covered with ivy, the west gable is ruined, there is also extensive ivy growth on the north & east walls and part of the transept arch. Within the church at the western end there is considerable vegetative growth. The church is divided into two parts - nave and choir. The nave is 16m x 6.3m while the choir is 8.4 x 6m. They are separated by an upstanding transept arch.

West Wall General Description: West gable is missing and now exists as a grass covered tumble.

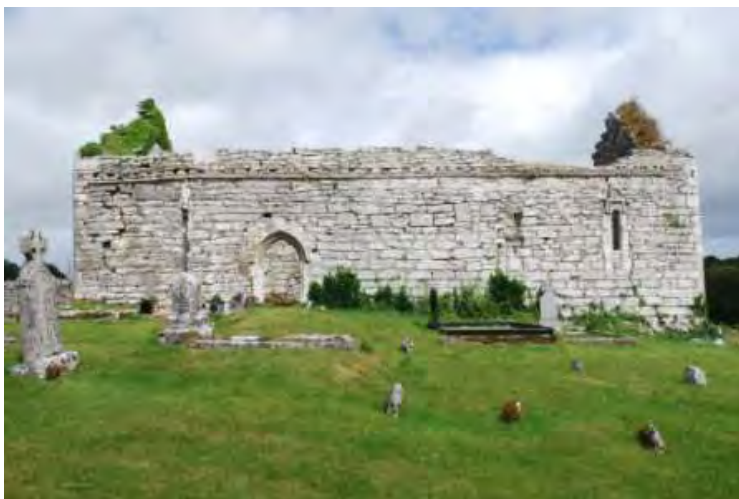
General Description: This church is single cell, generally in good condition, however there was some ivy growth on the east gable. The central window of the south wall is damaged. Inside of the church contains a number of burials. The church measures 18m x 6.4m. Wall thickness is substantial at 1.05m.

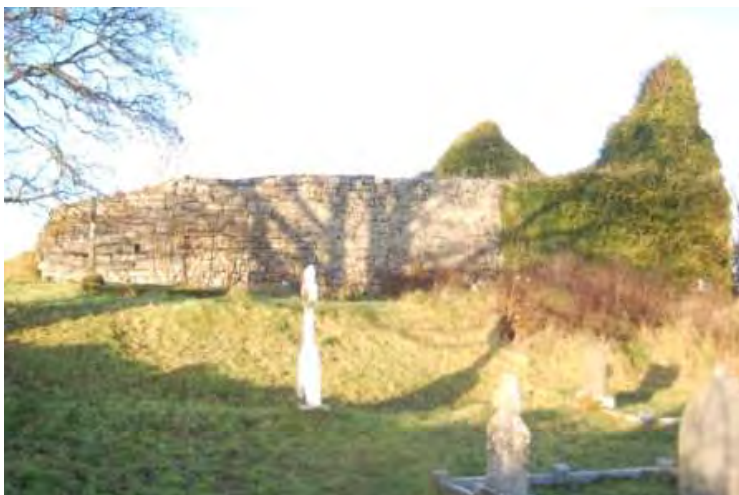
General Description: The church is "L" shaped with a priest house attached to the north wall. The church is 17M by 6.1M, while the chapel/priest's house is 5.7M by 4.8M. The walls are 0.76m thickness. The east window has a double ogee window. West gable is gone. There is considerable ivy growth.

West Wall General Description: the old church has no west gable surviving; however, the west gable of the priest's house has a high window. This confirms there was an upper floor, indicated by surviving corbels

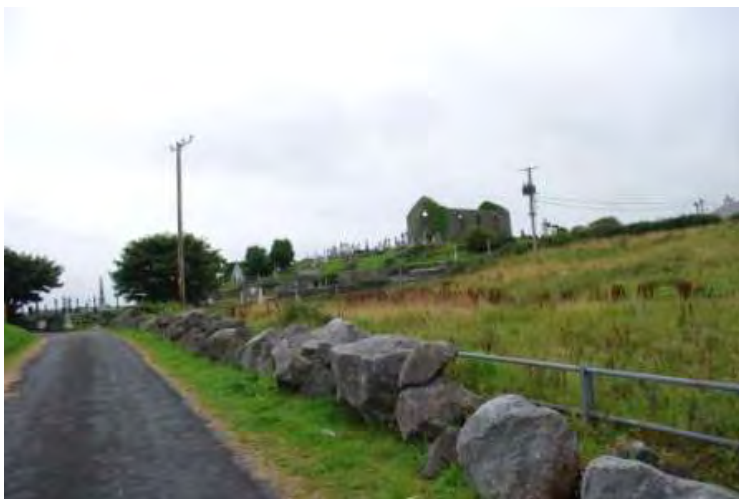
General Description: This is a large single cell church. Walls are upstanding to full height, style and conditions suggest that it is of modern construction. This is confirmed in the history as being built in 1778. Hence the layout of the church is at variance with most medieval churches. Church measures 14.2 x 6.9m. Wall thickness is 0.7m. Height of wall is 0.5m, Gable height is 7.5m. Some ivy growth to both gables

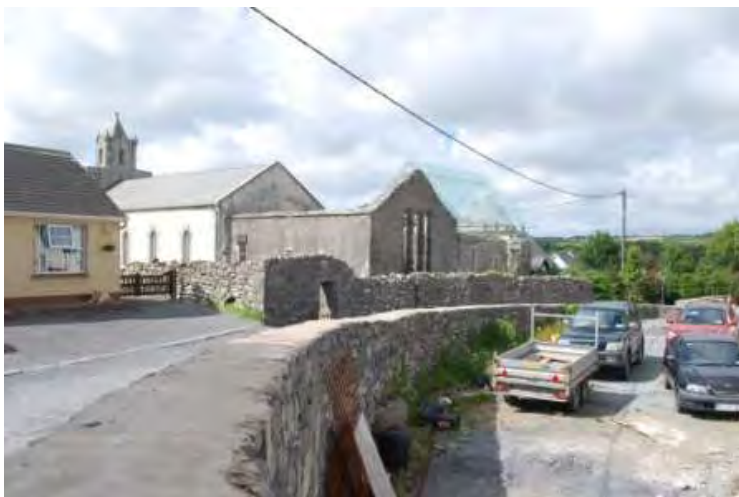
General Description: The western end of the early church has been replaced by the gable end of the modern church attached to it. Furthermore, a second later, but clearly early addition to the original church has been added to the north. The modern church is not included in the survey. The early church measures 12m x 7m and has a number of window and door openings. Door openings to the north may include a later doorway to allow access to the medieval extension. The medieval extension measures 11m x 10m, has its own separate entrance and a number of windows. A glass roof has been built over this portion of the church which now houses a number of early high crosses.

West Wall  
General Description: As noted above, the west wall of the early church is now replaced by the wall of the modern church. The west wall of the extension contains a door and window.

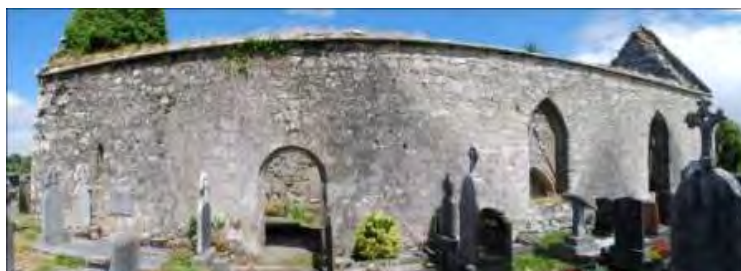
General Description: The church is single cell church, situated on high ground overlooking the road. Steps from the road access the church. The west wall is dominated by the Cross of Lorraine. The walls are vertical. There is no roof. Some ivy growth to the west and north walls.

West Wall General Description: The Cross of Lorraine is preserved on the exterior wall. The north and south walls project beyond the west wall.

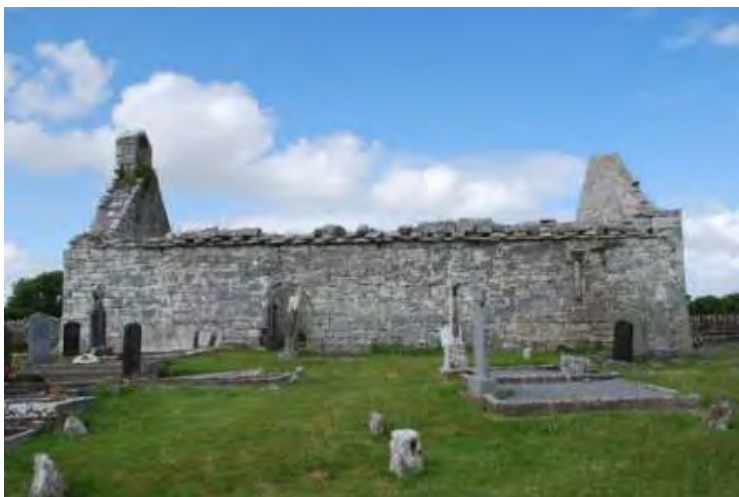
General Description: This is single cell church, upstanding with semi pointed south door and a single ogee window. There is a large window to the east gable, a double ogee. A bell-cot survives on the west gable. The walls are battered. The windows are hooded externally. The church measures 17.2m x 6.5m. The walls are 0.9m thick. What appears to be scaffold holes survives in the walls.

West Wall General Description: West gable has a bell-cot. No other features.

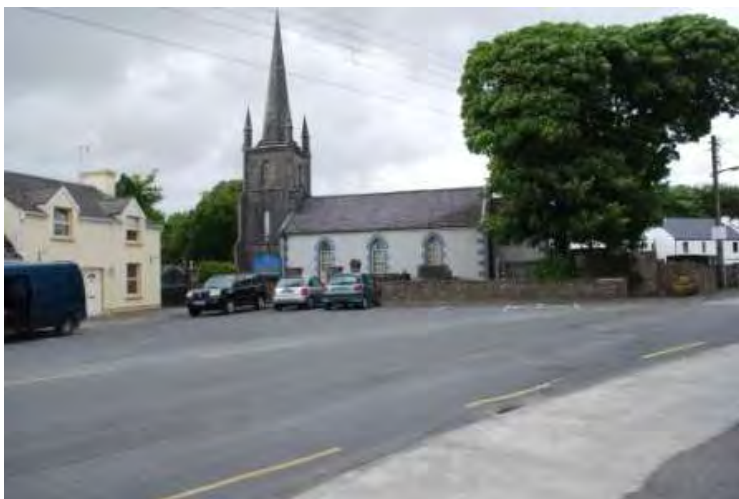
General Description: This was a former Church of Ireland church that had replaced the earlier church of which nothing survives. The modern church is now used as a heritage centre. There is a bell tower to west end; with a small extension to the east. The church measures 17.3m inch bell tower and is 8m wide. The bell tower is c. 6m x 3.3m. The small extension to east is 4.5m square.

West Wall General Description: The west wall is comprised of the bell tower and appears to be constructed of ashlar stone

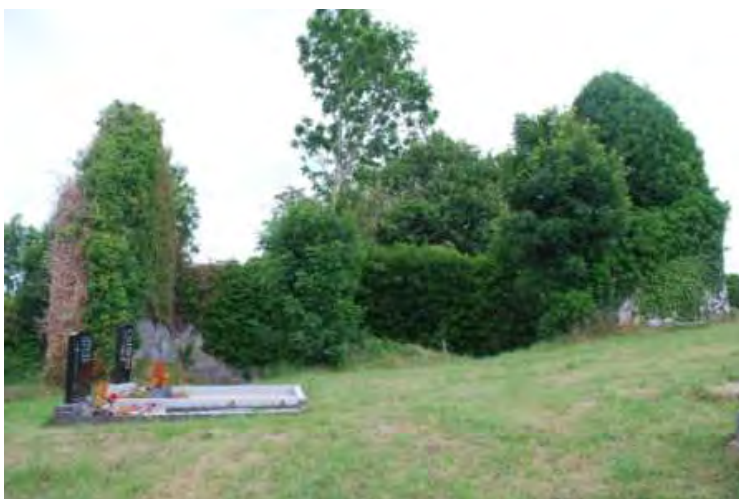
General Description: The church is single cell, in a remote location. Extensive and heavy ivy growth obscures any surviving features there fore limiting recording of features. There is believed to be an intact 3-bay east window but its condition could not be determined due to ivy growth. Much of the south wall is ruined although evidence of south window at east end. Ivy has been killed on west gable, but vine and branching survive. The church is 13m x 7m and the walls are 0.75m in thickness. Graveyard is L-shaped facing south and the graves to south and east of the church.

West Wall General Description: No features. Most of the ivy has been killed off.

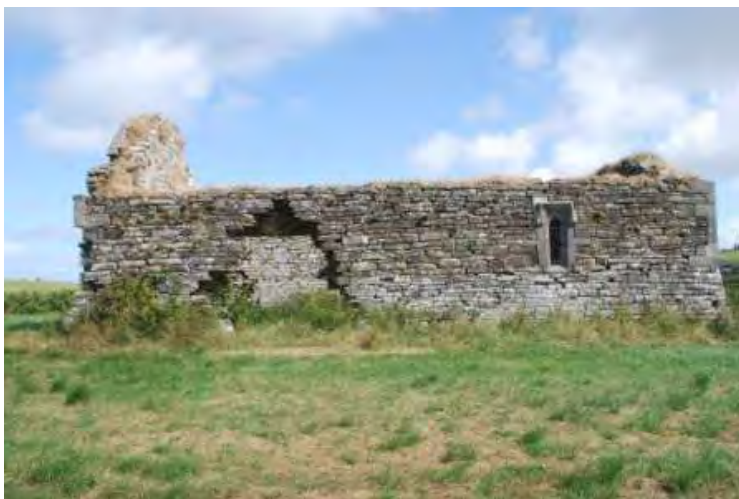
General Description: This is single cell church, the door has been robbed out and is in a dangerous condition. The remaining walls are upstanding and in good-fair condition. Measure 13m x 6m. Walls are .85m in thickness. The east gable survives to 4.3m and north and south survive to 3.2m. As noted it is built from limestone and shale, however limestone has been used on the corners and window jambs.

West Wall General Description: there are no surviving features, however some barge-stones. It was noted the walls were battered.

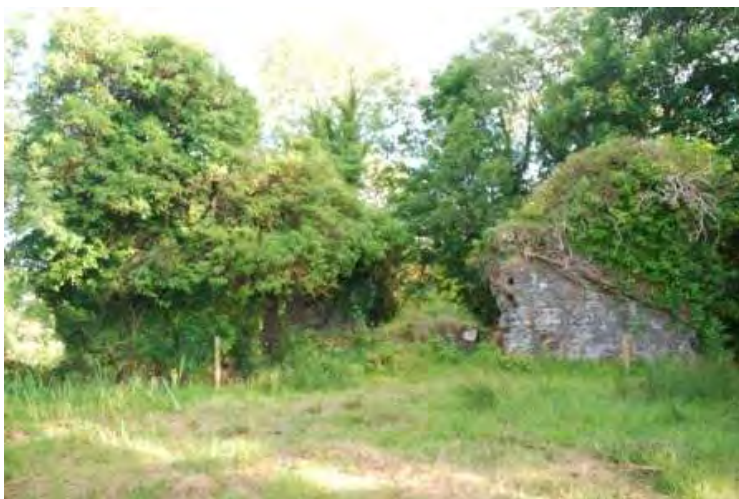
General Description: This is single cell church in a ruined state. There is extensive ivy growth vegetation and trees/shrubs. There is collapsed stonework inside the church. The north and south walls breached, while most of the west gable has fallen away into the stream valley immediately west.

West Wall  
General Description: Missing

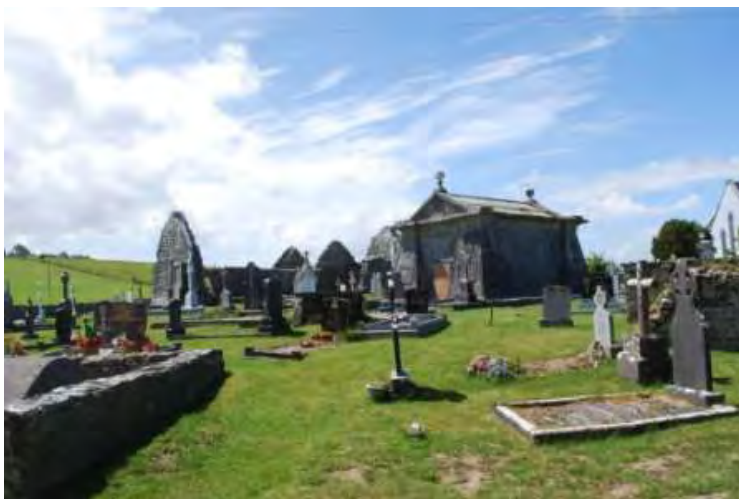
General Description: This an L-shaped church in Ruan village, situated behind a newer church. The L-shape comes from an extension built to the south wall at the western end. The extension is a later construction as it is not tied to the original church. Most of the north wall is missing and survives only to foundation level except a small portion of the western extent. The window in the south wall is evident but nothing survives to record. The door opening to the church is beside the extension which has its own separate door entrance. There are several vaults built against the church walls.

West Wall  
General Description: There are no associated features with the west wall.

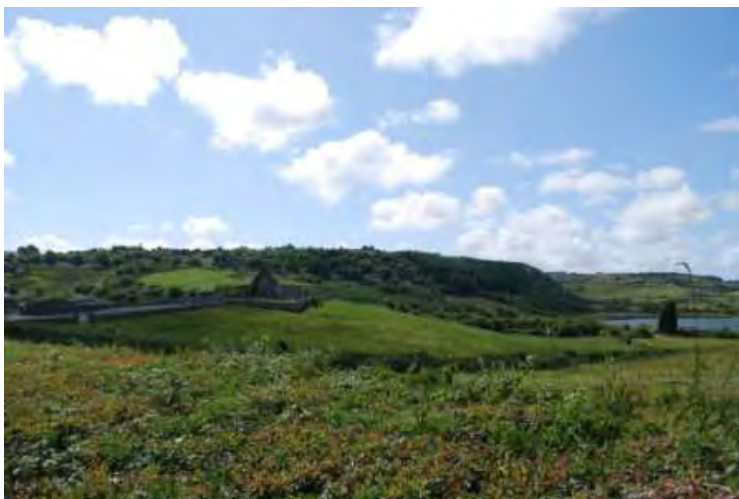
General Description: This is an early two bay church which has seen extensive alterations over different periods of time. As a consequence, 2 door openings survive, reflecting a change of attitude between earlier and later churches. The church is divided by a transept arch which creates a nave and chancel. The eastern gable of the chancel no longer survives. The nave of the church measures 13.5m x 7m, while the chancel is 5.7m x 5.6m. The opening of the transept is 2.9m. The walls measure 0.9m in thickness. There are several structures attached to south wall, mainly at eastern end. The church is situated on an elevated site.

West Wall  
General Description: The west wall contains the remains of an early door. The door is c. 1m in width, but is badly disturbed.

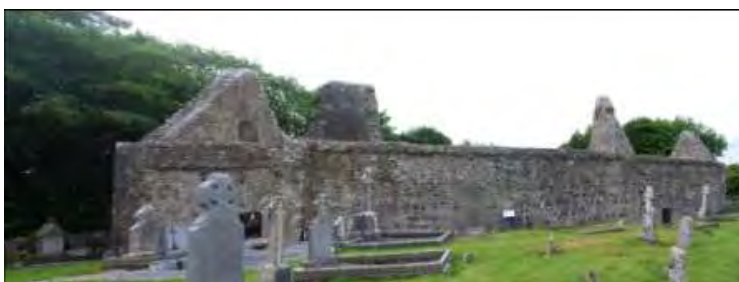
General Description: This church is a two cell church and another example of multi-period construction of, additions and alterations. The Romanesque style door is believed to have been relocated. The church is divided into a nave and chancel with a large transept arch. The transept supports an unusual double bell-cote. The north and south walls are "stepped" and this is at the western end and not associated with the transept arch. The walls are 0.7m in most cases, however some walls are 0.8m.

West Wall General Description: The west gable contains 2 windows, not directly overhead, but offset; a smaller square headed and large tapered headed window.

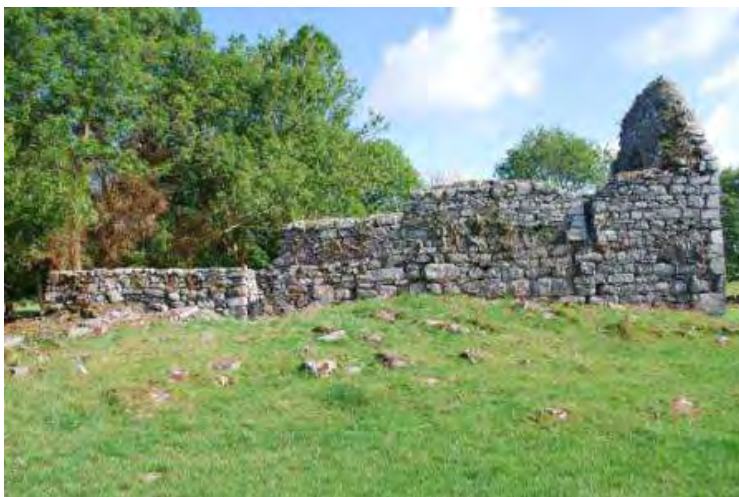
General Description: This is a single cell church in a poor state of repair, some evidence of rebuilding of collapsed walls, a dry stone technique has been employed. The rebuilding included a reinstatement of the door opening on the south wall. It is probably in the correct position, but this cannot be certain. The opening of the south wall window is in a poor condition, but is currently upstanding. To the north of the church is a rectangular area which may have been the site of a high cross or similar, it is noted that the east gable had "pulled" from both north and south walls. The church measures approx 15m x 4.3m and the walls are 0.8m thick.

Church Appraisal/  
Recommendations: The east gable, north wall and eastern end of south wall are probably original. The remainder of the structure has been "dry wall" repaired. The land owners be contacted to advise them of appropriate repairing and restoration guidelines.

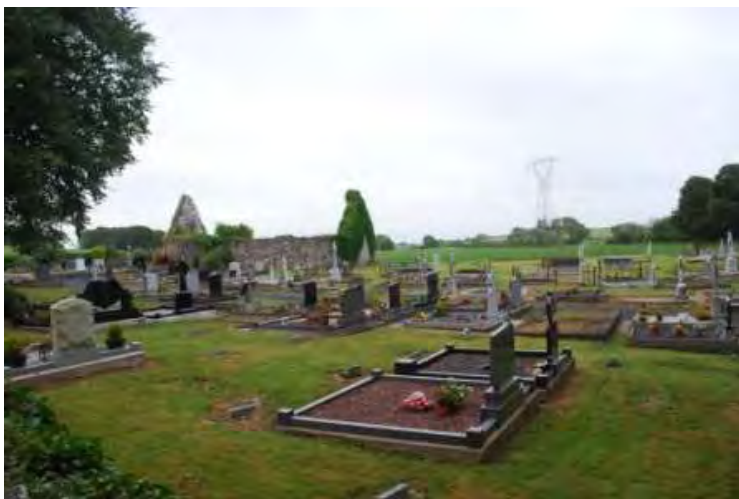
General Description: This is a single cell church. Recent repairs have been made to north wall which had partially collapsed. There is ivy growth on the west gable and part of both north and south walls. The eastern end of the church is supported by external buttresses. The church is 17m x 5.3m. Walls are 0.75m in thickness.

Church Appraisal/  
Recommendations: The walls are vertical and in good condition. The ivy growth is a concern. The ivy to cut back.

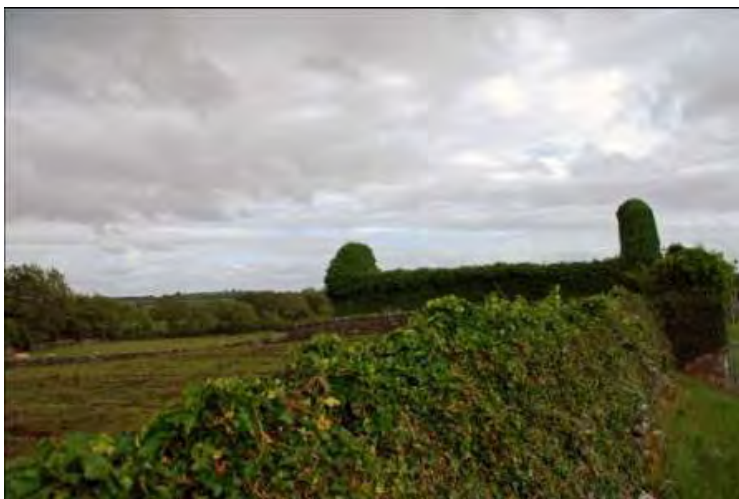
General Description: this is a single cell church. The structure is upstanding and appears to be in good order; however it is completely covered in well established ivy. As it is established some damage to the masonry is to be expected. All features of this church are obstructed by the ivy. The church is 19.5M by 5.3M, the walls 0.9M.

Church Appraisal/ Recommendations: The extensive ivy growth obscures what appears to be a church in good structural condition. The ivy should be cut back and the structure should be examined for damaged.

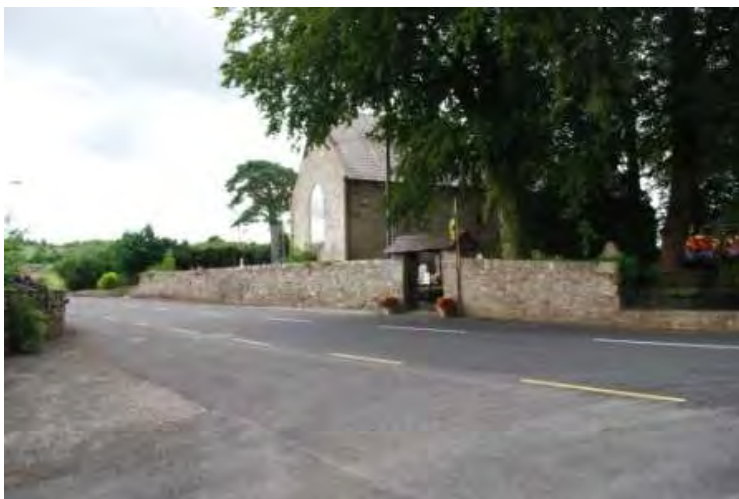
General Description: This church has now been converted to a heritage museum for the village of Tuamgraney. The building is fully roofed. The east, north and south walls are built on a plinth like structure; this would seem to provide a level foundation for the church as the ground slopes West to East. The church appears to be built from a sandstone and gritstone material. 25m x 8m in measurement.

West Wall  
General Description: The west gable has a tapered door, plain flat head over. There is a bell-cote over the west gable. There are 2 buttresses to the north west and south west.

East Wall  
General Description: Large window, constructed from wooden frame, later replacement. Above the present window arch is a second arch suggesting a different form of window had existed previously. The original arch has a decorated keystone. The north east and south east corners are finished with a decorated column of stone.

Church Appraisal/  
Recommendations: The church is in excellent condition. None

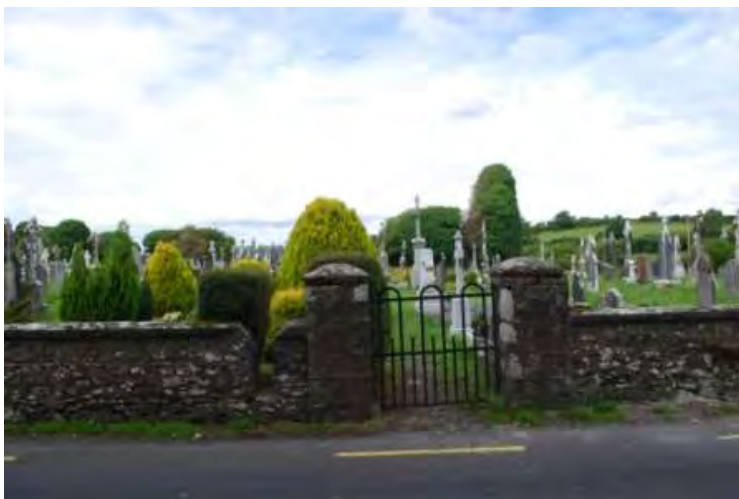
General Description: This single cell church is in a fairly ruined state and is heavily ivy covered. An intact east gable survives and part of both north and south wall. The remainder of the west gable and rest of north-south wall do not survive. The width of church approx 6.8m; surviving length is 9.5m; walls are 0.78m in thickness.

West Wall General Description: West gable had not survived

East Wall General Description: Double window with wide central mullion 0.5m. Height of window 2.8m, total width internally 2.9m. The head of the east window is missing.

Church Appraisal/ Recommendations: The church is an advanced state of ruin which is covered by heavy ivy growth. The ivy to be cut back and then the structure's condition evaluated.

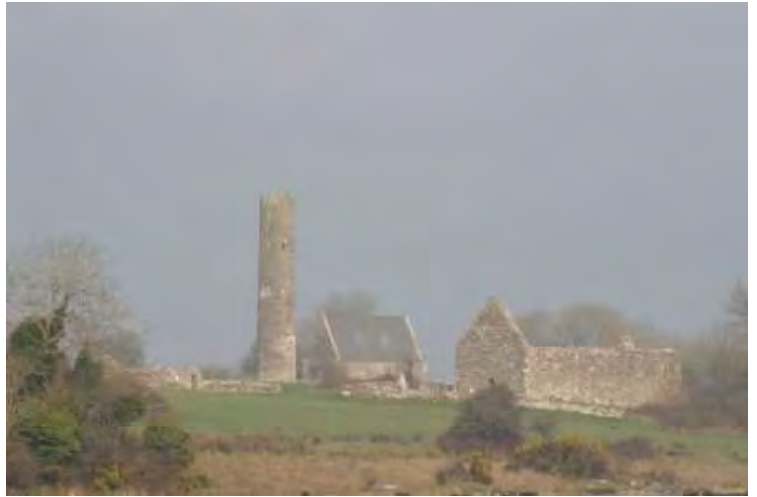
Condition: Good

Foundation: Bedrock

Masonry: Dressed Rubble

General Description: The entire island is a collection of churches from different periods, graveyards architectural fragments and bullaun stones all under the care of the National Monument Service.

Church Appraisal/  
Recommendations: This is the fifth church on the island and is also in good to excellent condition. Again it is maintained by the National Monument Service

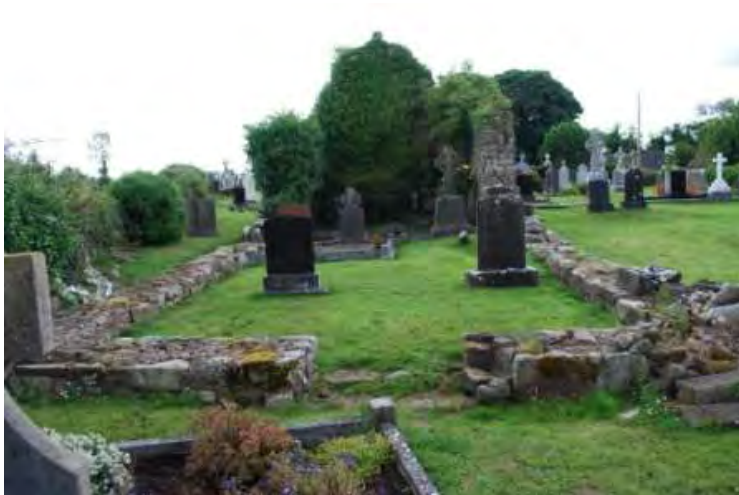
Monument No.	CL029A-003001	Church Name:	Meelick
Location:	Rural		
Townland:	Meelick		
Co-ordinates:	186880N,175958E		
Orientation:	E-W		
Category:	Early Christian		
Landscape:	Coastal		
Other_Description:			
Access:	Beside Public Road		
Condition:	Good		
Foundation:	Pad Stones		
Masonry:	Rubble

**General Description:** This was a single cell church. The east gable and part of the north and south walls survive. The full extent of north and south walls is preserved by the survival of the foundation courses. The west wall is also reduced to foundation level and a probable door opening survives in west wall. A large stone built arch has been attached to the south east corner of the church, which measures 16.1m x 5.3m; walls 0.8m thick.

**West Wall General Description:** Only foundation course survives of west gable; an opening believing to be the door recorded in this wall also.

**Church Appraisal/ Recommendations:** The church is largely ruined, but the surviving sections are in good repair. Ivy growth will become an increasing problem. Keep ivy cut back and maintain church.

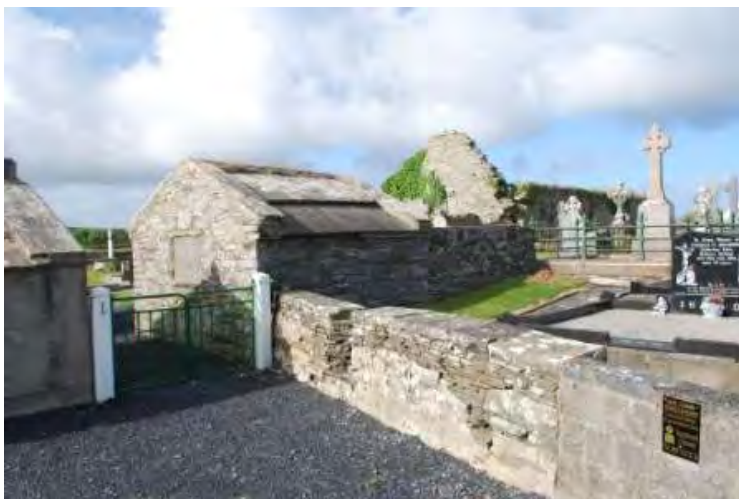
General Description: The church is single cell, in good condition and has been subject to two recent repairs to south wall, 1st in 2008 and 2nd in 2010, this was to correct excessive lean outwards of wall. The church measures 19.3m x 4.6m; walls 0.82m in thickness. The west gable is missing. The east gable while upstanding has pulled from north and south walls.

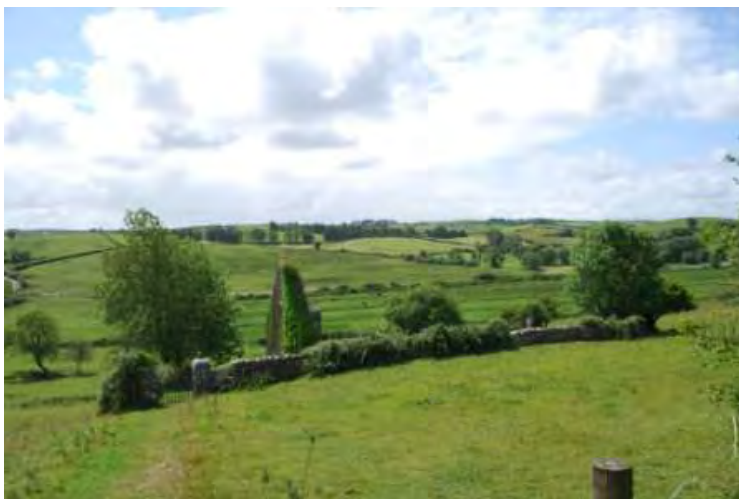
General Description: This single cell church is built on a steeply sloping ground, 30-40 degrees of slope to south. The walls are massive, this is to compensate for the sloping ground. There is an unusual 'outshot' construction at NW corner. The walls are capped with large flags. This would suggest that the church has been extensively repaired in the recent past. Half of the east gable is covered with ivy. The north wall is completely missing. Again because of slope there are steps up to the doorway on the south wall. The church measures 16m x 5.3m, walls are 0.98m thick.

West Wall General Description: There is a jutting overhang on the north west corner, where the west and north wall meet. The purpose of this feature is not fully understood; however, it may be to reinforce the corner against the slope of ground.

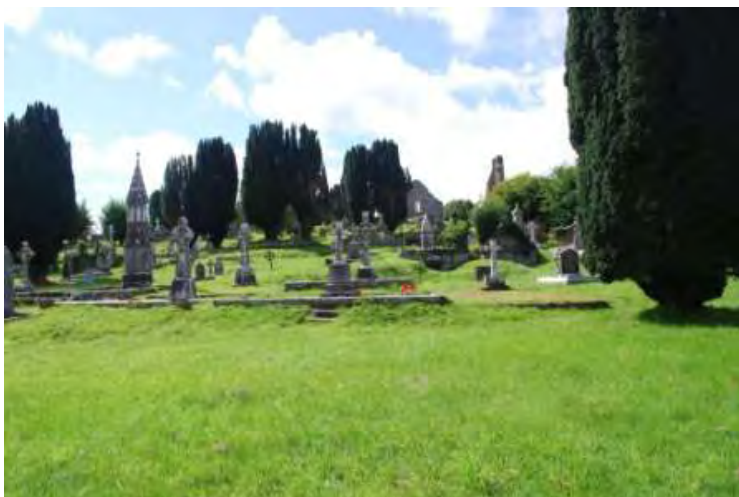
General Description: This church appears as a single cell; however, there are elements of this church that suggest earlier construction, possible early Christian. A section of the north wall is missing to foundation level. Interestingly, a window set in the west gable is off-set, not centrally located as is normal. It was also noted that a possible third window or slot survived at the corner of the south and east walls. This may be an indication of significant alteration to the layout of the church. The church is situated on high ground overlooking the graveyard to the east. The church is 16.3m x 6.3m; walls are 0.9m in thickness.

West Wall  
General Description: Contains a large round headed window with limestone jambs high up in the gable and as noted before is offset to the north wall.

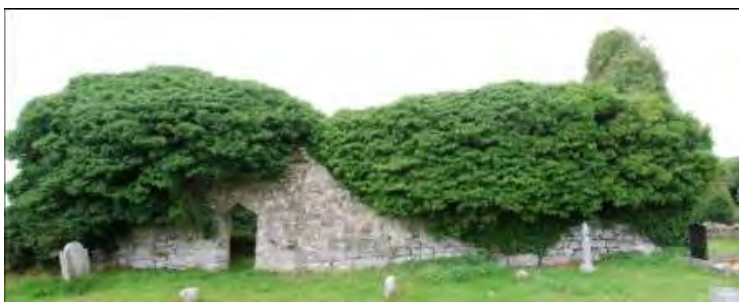
General Description: The church is single cell, heavily covered with ivy, obscuring much of the detail. The door head is pointed, however, it is a concrete construction and is not reliable. There is inclusion of some sandstone in the church walls. There are two projecting sandstone carved head/figures, one over the door, the other over the south central window. They are now worn and difficult to interpret. The church is 17.8m x 7.3m; walls are 0.75m thick.

West Wall General Description: Is reduced in height, heavily overgrown with ivy, no features were recorded.

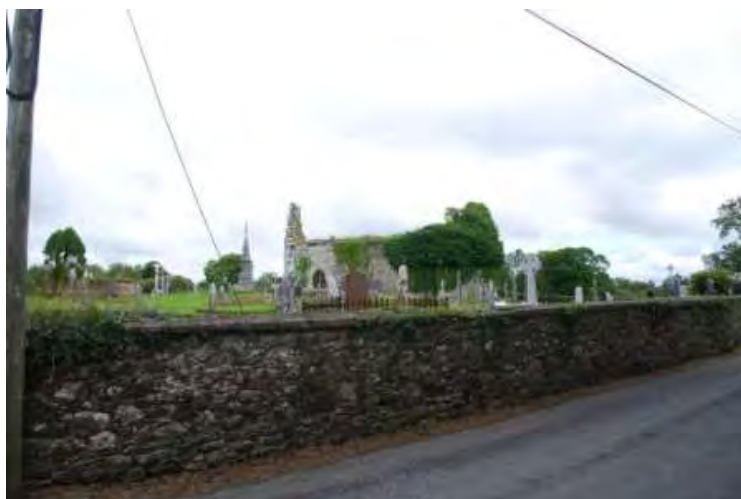
General Description: This single cell church is in fair condition; some cracks in walls in south wall. The eastern end is covered in ivy, which significantly obscures that part of the church. There is a buttress to the side wall built on a batter. This may be an indication of early instability and was a repair after the original construction. It was noted that some sandstone was used in the construction. The church is 13.6m x 6.1m; walls are 0.76m in thickness.

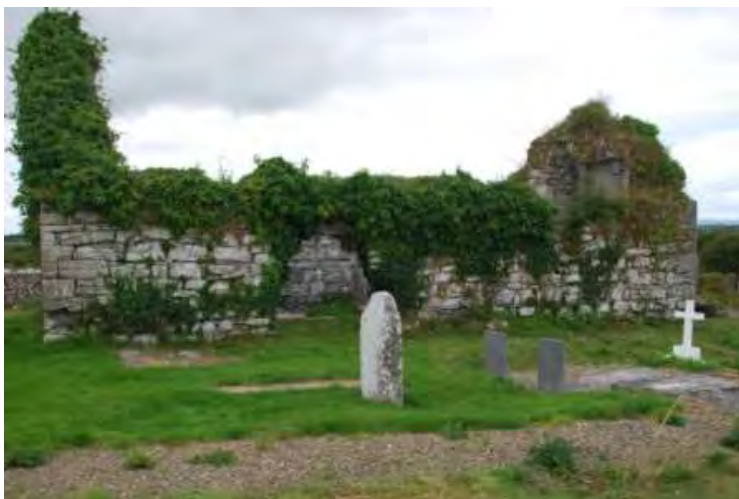
General Description: This single cell church is situated in fields some 150m from the laneway, but easily accessible. The door arch has been robbed out and there is little to prevent it from collapsing. There is extensive ivy growth on the east wall, which spreads to other walls. The south window is damaged; this may have been from the construction of an internal vault and memorial plaque on an east wall.  
The church is 11.3m x 5.5m; the walls are 0.9m thick.

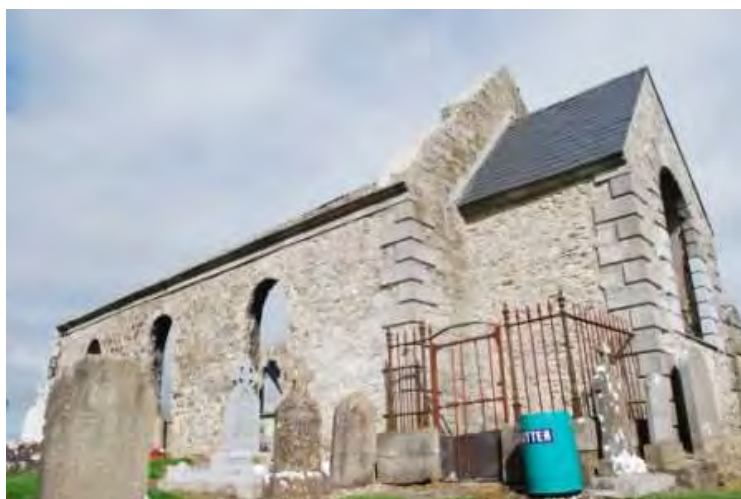
General Description: This is a large two cell church which is maintained by the National Monument Service. The church is divided into a nave and chancel. The chancel is roofed under slate. The church is well maintained. Stone work is excellent. The church overall measures 18.5m x 6.6m; the nave is 15m x 6.6m; the chancel 3.5m x 3.6m; the nave and chancel are separated by a transept arch. The thickness of the walls are 0.74m. There are 2 large memorials built into the north and south walls of the chancel.

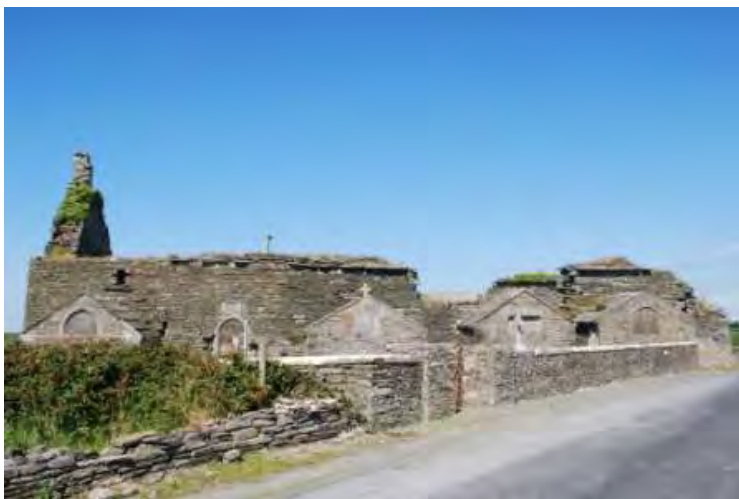
General Description: This is a single cell church 26.3m x 7.3m. The walls are 1.2m thick. There are two internal vaults, and numerous flat graves. The east gable is ruined. Two styles of construction survive in the north wall. There are two upper windows at the western end indicative of an upper level.

West Wall General Description: There is a damaged bell-cote over and a small upper window, a vault is built on the NW corner.

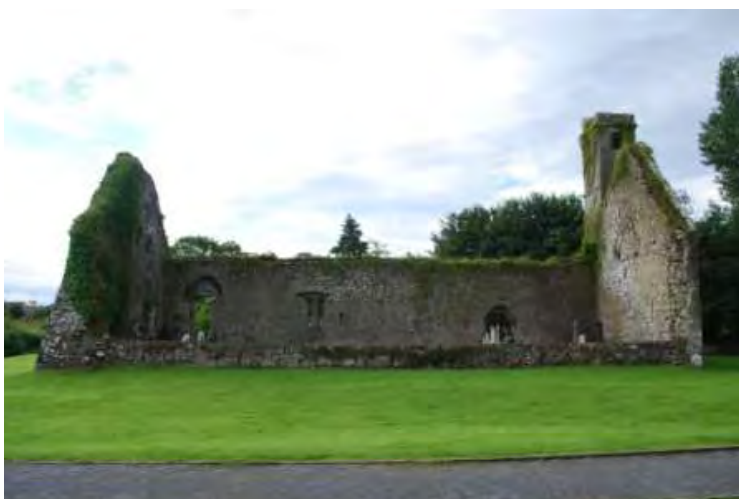
General Description: This is a large and impressive church which has a tower built to the south west corner, a later addition. The north wall is reduced to c. 1m height along entire length. The church is buttressed on 3 corners, probably contemporary with the tower, the NW excepted. The church measures 24m x 8.1m; walls are 0.78m thick. There is established ivy to the east gable, south wall and less to the west gable.

West Wall General Description: Contains a door in the SW corner, which allows access to the tower. The tower is built from cut blocks and there appears to be evidence of a chimney in the tower. There are windows and an upper door opening off the tower, indicating that the church had an upper floor level at least at the western end. No corbels survive to confirm this. There is evidence of a blocked upper window in the west gable. There are two carved heads high up on the SW corner of the tower.
