# A CHURCH AND GRAVEYARD SURVEY IN COUNTY CLARE

## SURVEYED BY SIMON LARGE IN 2010

Version 1.0 as at 1st June 2011

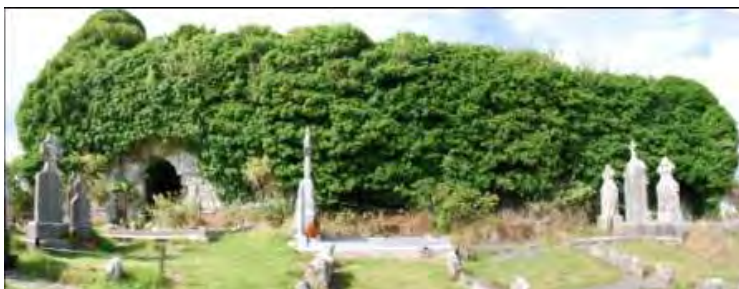
West Wall General Description:	<p>The west gable has 2 corbels and a large breach, which may or may not be the remnants of a opening, e.g. a door. No other details were observed save two corbels, as the wall is covered with extensive and heavy ivy growth.</p>		
South Wall General Description:	<p>The door as mentioned has been robbed out, but some jambs still survive. There are 2 corbels on the south wall to the west of the door. Immediately to the right of the door is a chest tomb and a vault. Ivy growth has obscured the window immediately east of the vault. There are 2 more windows at the eastern end of the wall, a double and single window which are now blocked with stone and largely obscured by ivy growth. The two small windows as described jut from the south wall to the south and this is defined by a fluted column.</p>		
North Wall General Description:	<p>A small window survives to the western end of the north wall. At the eastern end there is a large internal mausoleum. The average height of the walls is 1.2m.</p>

East Wall General Description:	<p>The east wall now lies completely shattered on the ground having collapsed some years ago. The stone work is covered in vegetative growth.</p>

Church Appraisal/ Recommendations:	The church is in poor condition with very heavy established ivy growth. The ivy to be cut hard back. The west gable stabilized and the overall structure evaluated.																
Graveyard Monument	CL042-83002																
Boundary Wall Type:	Stone																
Boundary Wall Description:	Good																
Extension Location:	South																
Graveyard Gen. Discussion/Appraisal:	All rave yard areas are maintained, however part of the graveyard around The church is closed to visitors, unsafe structure.																
Related Structures:	St. Luchtigern's Oratory																
Architectural Fragments:	carved door jamb arch stone, 170430N,143560E																
Graveyard General \Description	The old graveyard surrounds the church. There is a mausoleum in the older part to the south-west of the church. Beyond the old graveyard is a 2nd graveyard and beyond that a 3rd graveyard area. There is a holy well near the road in the 2nd extension graveyard area.																
GRAVEYARD MARKINGS:	<table> <tr> <td>Vault:</td> <td><input checked="" type="checkbox"/></td> <td>Chest Tombs:</td> <td><input type="checkbox"/></td> <td>Mausoleum:</td> <td><input checked="" type="checkbox"/></td> <td>Uninscribed:</td> <td><input checked="" type="checkbox"/></td> </tr> <tr> <td>High Crosses:</td> <td><input type="checkbox"/></td> <td>Flat:</td> <td><input checked="" type="checkbox"/></td> <td>Upright:</td> <td><input checked="" type="checkbox"/></td> <td>Pedestal:</td> <td><input checked="" type="checkbox"/></td> </tr> </table>	Vault:	<input checked="" type="checkbox"/>	Chest Tombs:	<input type="checkbox"/>	Mausoleum:	<input checked="" type="checkbox"/>	Uninscribed:	<input checked="" type="checkbox"/>	High Crosses:	<input type="checkbox"/>	Flat:	<input checked="" type="checkbox"/>	Upright:	<input checked="" type="checkbox"/>	Pedestal:	<input checked="" type="checkbox"/>
Vault:	<input checked="" type="checkbox"/>	Chest Tombs:	<input type="checkbox"/>	Mausoleum:	<input checked="" type="checkbox"/>	Uninscribed:	<input checked="" type="checkbox"/>										
High Crosses:	<input type="checkbox"/>	Flat:	<input checked="" type="checkbox"/>	Upright:	<input checked="" type="checkbox"/>	Pedestal:	<input checked="" type="checkbox"/>										
Owner:	not known																
Climate Effects:	Predicted increases in rain fall will accelerate deterioration of weakened elements of this structure.																
History:

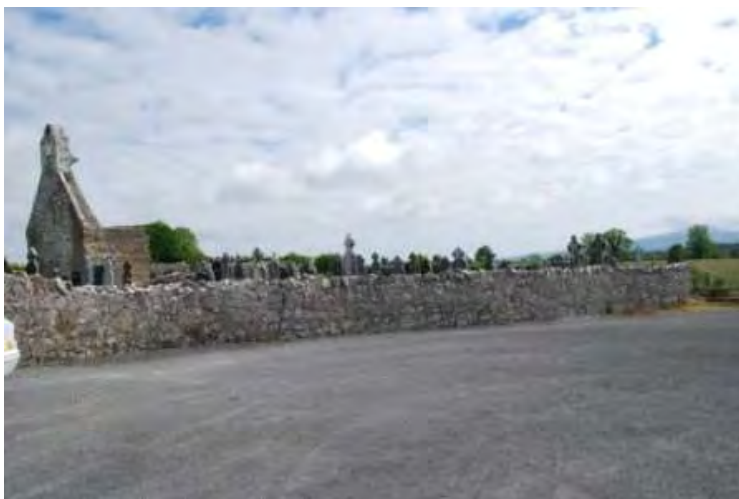
General Description: This single cell church has been subject past inappropriate repairs in that the south wall and west gable have been shuttered and concrete repaired. There is extensive cement jointing in the south wall; some 20m survives of the south wall, but appears to be disturbed. The west gable is twisted, there is a split in the north wall and it has pulled from the gable. There is an early iron X type tie in the east gable. There is red gritstone in the walls which appears to have been included as a decorative finish. A similar technique was noted at the Ballysheen Church. The church is 10.5m x 4.5m; walls are 0.9m thick.

West Wall  
General Description: The west wall contains a small high pointed window, which appears to be original and undisturbed. There is a bell-cote over the west gable, it is well constructed from cut dressed limestone; however, the arch stones have begun to slip.

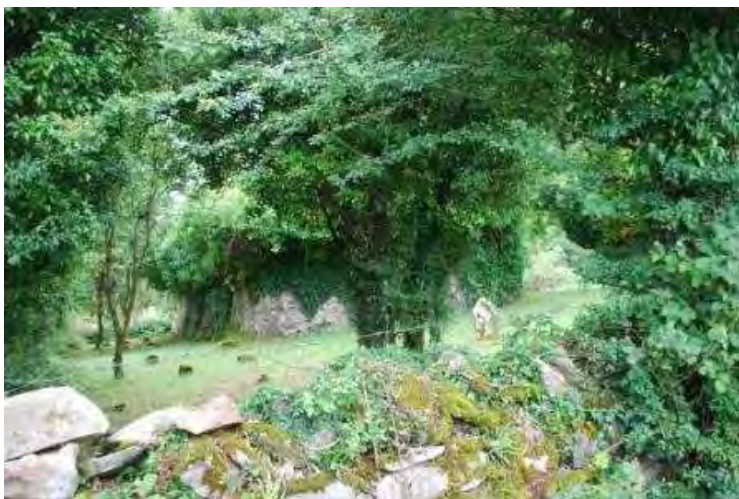
General Description: This single cell church is heavily overgrown with ivy, a number of trees and hedgerows obscure it from the road, Built from grit and sandstone, with occasional shale in pieces. The inside of the church is dominated by a large Mausoleum dedicated to Bentley Family. 8.34m in length. The door opening appears to have been altered in recent time as there are bricks over the door head. A mature Ash tree is growing into and out of the church wall at the south west corner. The church measures 14m x 6m. The walls are 0.75m thick.

West Wall General Description: Contains a single door, as noted head has been replaced by bricks and a spud stone survives. This maybe a later insert.

Church Appraisal/ Recommendations: The church is in fair/good condition, but over run with ivy and the south wall is damaged externally. The ivy to be cut back and the stability of the structure evaluated.

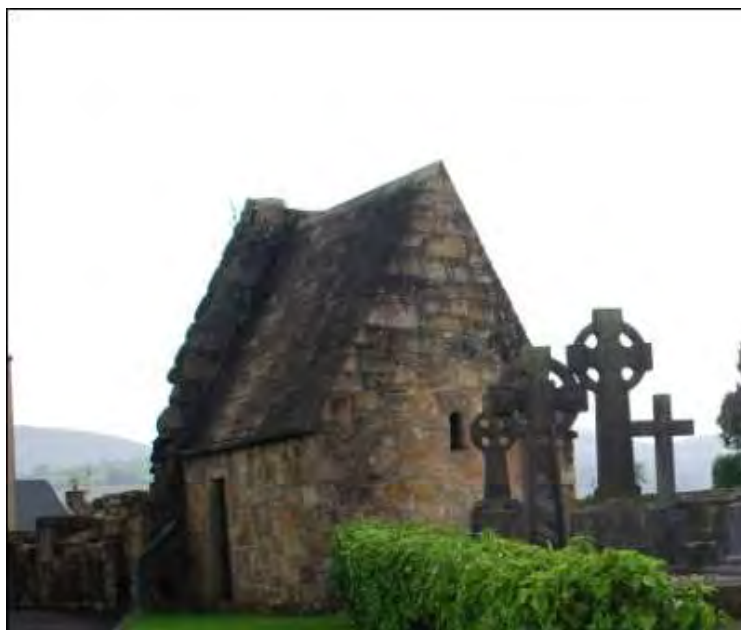
General Description: The present location of this oratory is beside the modern St. Flannan's Church. Originally constructed c.1000 AD, the oratory was on Friar's Island in the Shannon River. When the electrification on the Shannon began, water levels would rise and this small oratory would be submerged; therefore, it was removed and rebuilt on its present location. The oratory is in 2 parts, nave and chancel. The overall dimensions of the building are 12.5m x 5m. The chancel is 4.5m in length. A transept wall divides the nave from the chancel. The roof of the chancel is under slate.

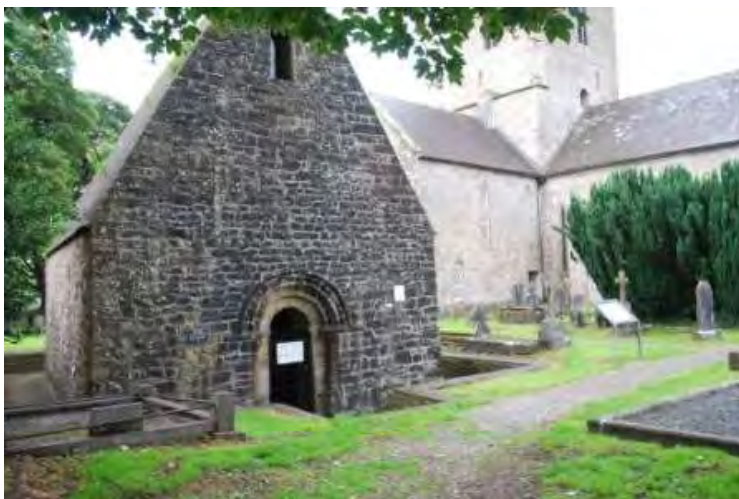
General Description: This is a large stone roofed oratory, situated adjacent to a more recent church and surrounded by the graveyard on north and west sides. The oratory has a barrel vault and a door at both the east and west end. The base of the church sits below the level of the present graveyard and is defined by a low stone wall with a tarmacadam surface between wall and church.

West Wall General Description: Similar in design to east gable in that there is a simpler door arch with a window high in the gable above the door. There are corbel on the external wall on either side of the door. The door opening is plain, suggesting that there was a 2nd structure built onto the western side of the oratory, with no public access.

Church Appraisal/ Recommendations: Excellent condition, none

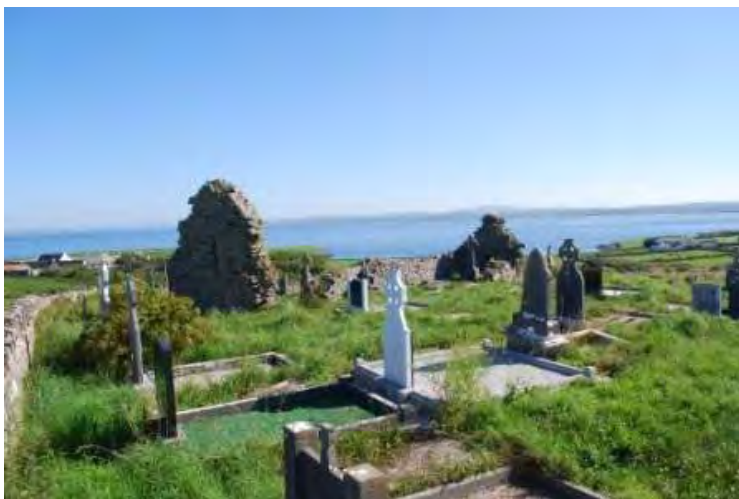
General Description: This single cell church is in a poor state of repair, with a section above the north and south wall missing. It was noted at an informal buttress repair was made on the north wall at the eastern end. The church is 21.2m x 4.2m the walls are 0.76m thick.

West Wall General Description: Contains a single round headed window.

South Wall General Description: There are 2 windows, one at the east and one at the west. The central area of wall is missing and is probably associated with the door.

North Wall General Description: There are no features associated with the north wall save the buttress repair at the east end.

Church Appraisal/ Recommendations: The church is considerably ruined with several interesting surviving features. A full detailed record of the surviving remains be carried out as a priority.

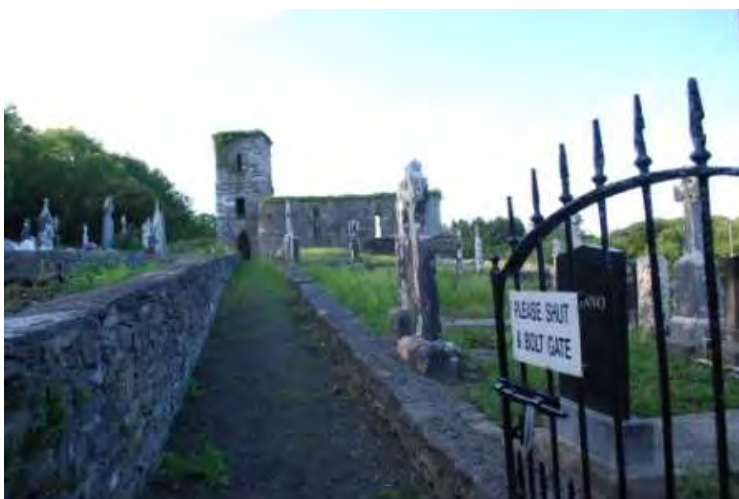
General Description: This is a recently built church c.1809, one of 4 churches to have been built during this period. This is believed to be the only upstanding example. The church is unusual in that it has rounded corners to the eastern end with a bell tower to the west. Building material is varied with the use of cut block, shale and flagstone, with limestone in the construction. Evidence survives for a choir stall at the western end of the church where the church was entered through the bell tower. It should be noted that brick was also used in construction, notably in internal features. The ground slopes away steeply to the north and east. The main body of the church is 13.5m in length, 8.2m wide, bell tower is 2.5sqm to the west. There is some variation in wall thickness, but on average they are 0.7m

West Wall General Description: The west wall is dominated by the bell tower. There is a door at ground level that permits entrance to the church. Immediately above that is another which allows access to choir stall. The external west wall has a window.

Church Appraisal/ Recommendations:	This is the only surviving example and therefore worthy of maintained preservation. The church to be maintained with appropriate repairs, in particular the door arch, and several windows require attention			
Graveyard Monument	CL050-011002			
Boundary Wall Type:	Stone			
Boundary Wall Description:	Good			
Extension Location:				
Graveyard Gen. Discussion/Appraisal:	Little to maintain, but graveyard has a neglected appearance.			
Related Structures:	none			
Architectural Fragments:	none			
Graveyard General \Description	The churchyard is situated to the north of the church on slightly sloping ground, divided by central path. A large mausoleum/vault is built against bell tower, western end.			
GRAVEYARD MARKINGS:	Vault: <input checked="" type="checkbox"/>	Chest Tombs: <input type="checkbox"/>	Mausoleum: <input type="checkbox"/>	Uninscribed: <input type="checkbox"/>

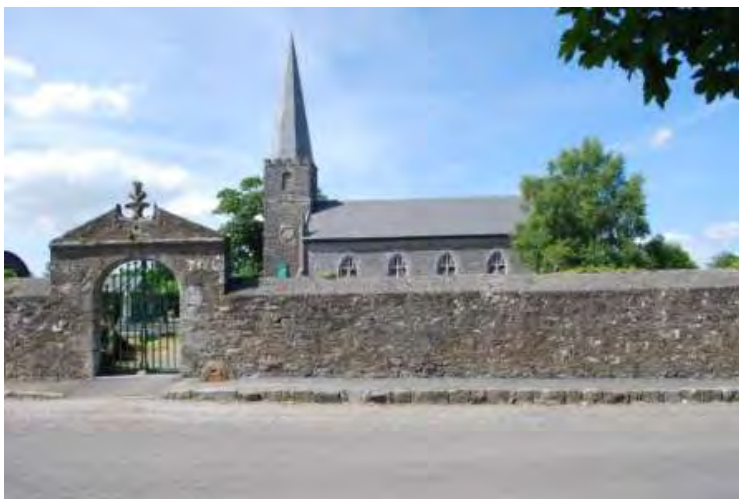
General Description: This is a Church of Ireland Anglican Church, which was not open on day of inspection. There is a bell tower attached to western end. This church has been built on the site of an earlier church, of which no evidence survives.  
The church is 24m long, 10,3m wide; bell tower 4.3m x 3m.  
There are no remains of the old church.

West Wall  
General Description: Bell tower with steeple, built on a batter.

Church Appraisal/  
Recommendations: Excellent, none

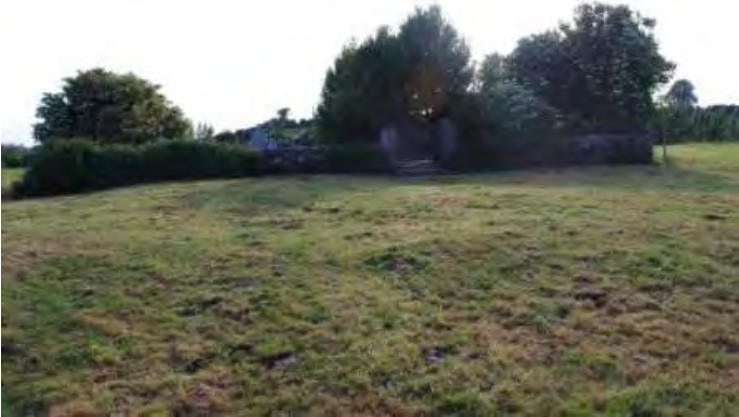
Monument No.	CL051-094001	Church Name:	Drumline
Location:	Rural

Townland:	Drumline		
Co-ordinates:	164828N,141989E		
Orientation:	E/W		
Category:	Mediaeval		
Landscape:	Farmland		
Other_Description:			
Access:	Beside Laneway		
Condition:	Poor		
Foundation:	Not Visible		
Masonry:	Dressed Rubble		
General Description:	<p>Little of this church survives; the east gable and the corner of the north wall. It is heavily ivy covered. Width 6.2m, length c.21m; the walls are 0.76m thick.</p>		
West Wall General Description:	no remains		
South Wall General Description:	A foundation course survives.		
North Wall General Description:	A ivy covered corner survives, 1.5m height. There are no features.		
East Wall General Description:	The east gable is reduced to 1.5M height and covered in ivy. No features survive.		
Church Appraisal/ Recommendations:	<p>The church is ruined with little surviving. The ivy to kept trimmed back. A full detailed record of the surviving remains be carried out as a priority..</p>

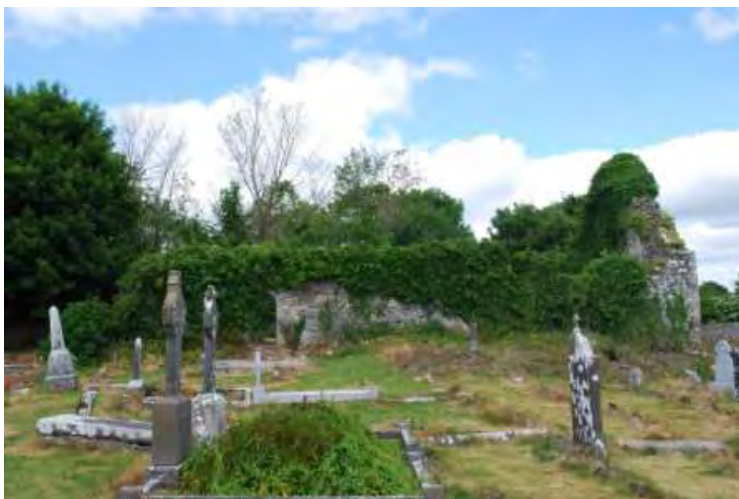
General Description: This single cell church has suffered considerable deterioration. The walls are also ivy covered, [this was cutback early 2010 but growth is still vigorous. C.5Ms of the North wall has split and collapsed externally. The west gable is gone. While the south wall in the door area has twisted. The church is 15.2m by 5m the wall thickness 0.74m.

West Wall  
General Description: Gone

South Wall  
General Description: There is a door at the western end and two windows, both obscured by ivy. The head is missing from the easterly window. The door arch is semi-pointed. Again the windows are made with jambs of red gritstone. The south wall has twisted, the beginning of collapse.

Church Appraisal/  
Recommendations: The church contains important features which are endangered. The S door is falling out, the north wall half collapsed and heavy ivy growth. The north wall to be repaired and north door reinstated. Ivy brought under control & then the structure accessed.

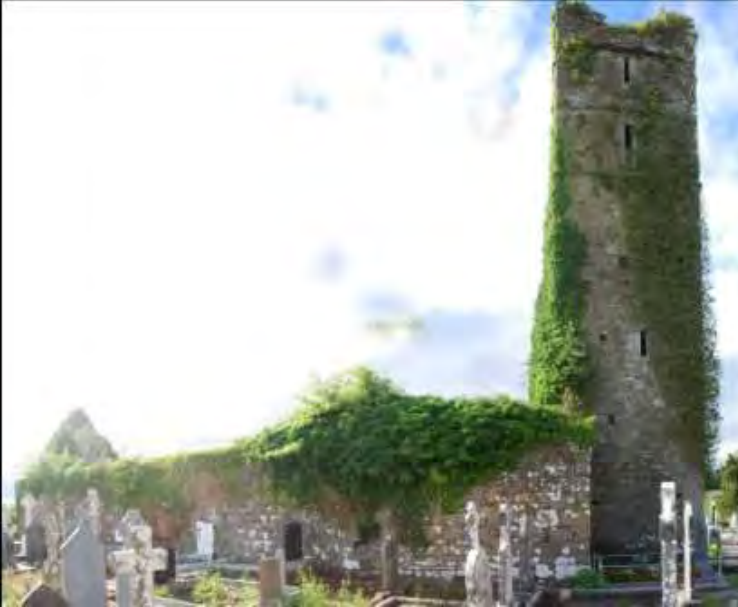
Monument No.	CL059-036001	Church Name:	Killadysart
Location:	Rural

Townland:	Killadysart		
Co-ordinates:	158192N,125325E		
Orientation:	E-W		
Category:	Mediaeval		
Landscape:	Coastal		
Other_Description:			
Access:	Beside Laneway		
Condition:	Fair		
Foundation:	Not Visible		
Masonry:	Dressed Rubble		
General Description:	<p>This is a large single cell church, 23m in length x 6.4m in width, with substantial walls, 0.76m thick, to which a later bell tower was added to the west. The bell tower is heavily covered with ivy, however the ivy does not appear to be at such a level of growth to be pulling excessively. However given the height of the bell tower and its general condition (it was struck by lightning in the past) the ivy growth is a cause for some concern. The east gable and window are impacted, with some disturbance of stonework evident, most notable the east gable arch stone. The ivy growth also extends to the north and south walls.</p>

West Wall General Description:	<p>The west wall has been opened with a large double relieving arch which accesses the bell tower. The west wall of the bell tower has 3 windows. It is noted that the west wall is also built on a batter.</p>		
South Wall General Description:	<p>The south wall contains 2 doors. The main door to the church, the jambs are of dressed limestone with hood over. There is a second smaller door at the eastern end of the south wall. There are in addition 2 windows, one between the 2 doors mentioned and a window at the eastern extent of the south wall. There is a niche under the easterly window. There is another niche at the western extent of the south wall, which is now partially blocked.</p>		
North Wall General Description:	<p>The north wall of the church has no features to record. While the north wall of the bell tower contains 3 windows.</p>		
East Wall General Description:	<p>The east wall contains a large window obscured by ivy that is hooded on the outside. This hood is damaged i.e. evidence of slippage.</p>

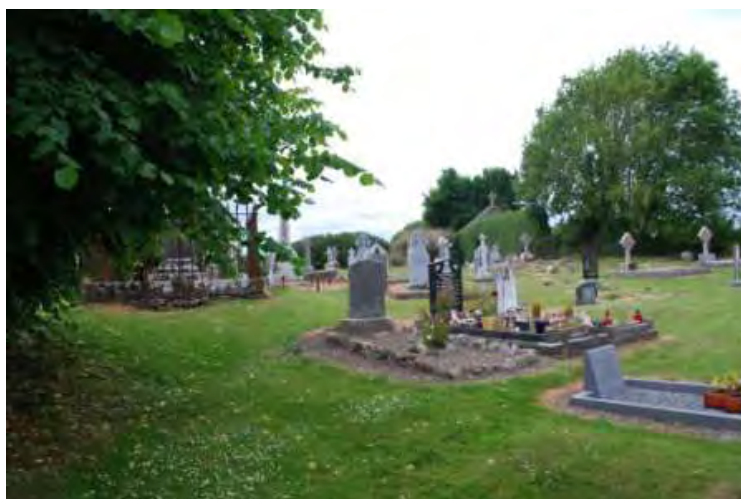
General Description: This single cell church is extensively covered in ivy except the west gable. The east gable is largely ruined. The western end of the church is dominated by O'Donoghue burials. A low wall with iron railings and a gate bisect the church from the north to south wall, beyond which are numerous O'Donoghue burials. The west gable appears to have been extensively repointed (rebuilt?) for the O'Donoghue burials. Most notable all mortar joints are raised, square finished. The doorway is splayed with a round head. The church measures 13.3m x 5.3m and wall thickness are 0.9m.

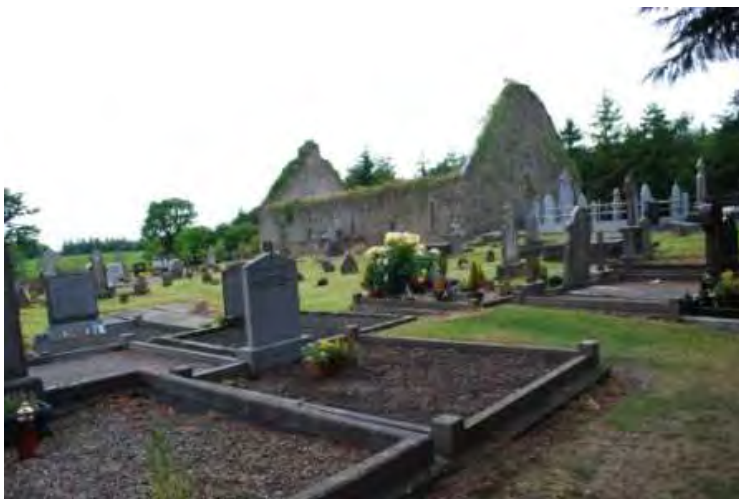
Monument No.	CL061-011001	Church Name:	Bunratty
Location:	Urban		
Townland:	Bunratty East		
Co-ordinates:	160882N,144904E		
Orientation:	E-W		
Category:	Mediaeval		
Landscape:	Undulating		
Other_Description:			
Access:	Beside Laneway		
Condition:	Good		
Foundation:	Not Visible		
Masonry:	Rubble

**General Description:** This is a large single cell church which unusually contains a door and window to the north wall, the door may be a later addition, however it is in the same style as the main door in the south wall. The north window is a triple ogee window. The walls of the church are built on a batter. A number of burials and a large mausoleum have been inserted to the inside of the church. One mausoleum with steps down can be accessed by the north wall door. The door jambs are similar to those in the south wall, however this door maybe a later addition. The church is 22.6x 8.1m, wall thicknesses are 0.88m. Gable walls appear to survive to full height.

**West Wall General Description:** There was probably a bell-cote on the west wall, but this is largely ruined. A number of barge stones survive on the west gable.

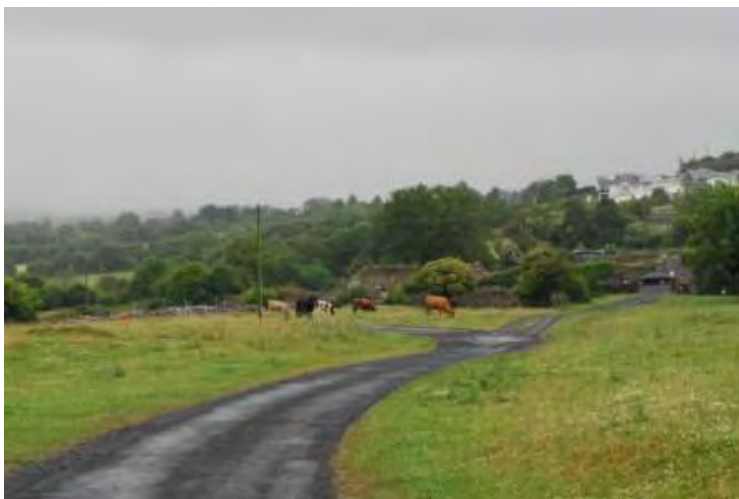
General Description: This church is situated below the railway line which runs parallel to the main road, both east of the church. There is a large car park to the east of the church which extends the full length of the graveyard. The church is much reduced, with only a section of the south wall which was repaired in 2008 under architectural archaeology supervision. Only the foundations of the east wall survive. The entire north wall is upstanding to a height of 3m, however, this wall is in part in poor condition and a section has rolled on itself, best described as 'bellied'. A small corner of the west wall survives, but the remainder of the west wall as with the rest of the south wall are completely removed. The church is c. 15m in length and 6.5m in length, walls are 0.8m thick.

West Wall  
General Description: Only the corner to the north survives.

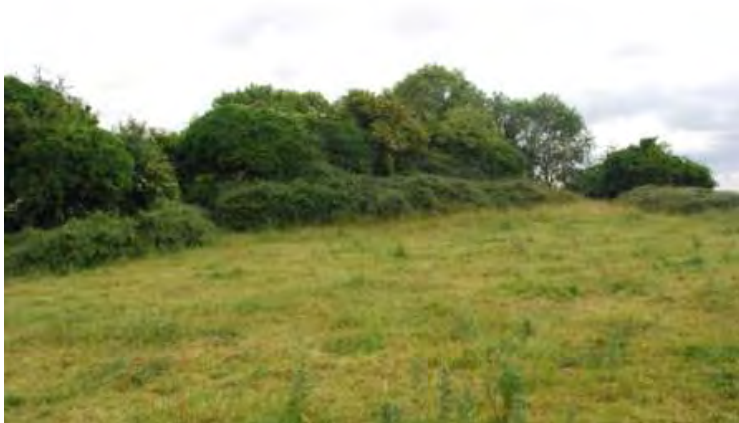
General Description: This single cell church is situated on slightly raised ground, a few hundred meters from the Galway-Limerick bypass, near the Tower house of the same name. The site is completely overgrown, with ivy, bramble and elder trees. The walls are split and stonework is missing, rendering the building dangerous, for that reason there was limited access to the internal features of the church. Inside the church was as overgrown as the outside, few features were noted and recorded. The church was 20m x 6.5m, the walls 0.9m in thickness.

West Wall General Description: There is an opening, possibly a window. This was the only point of access.

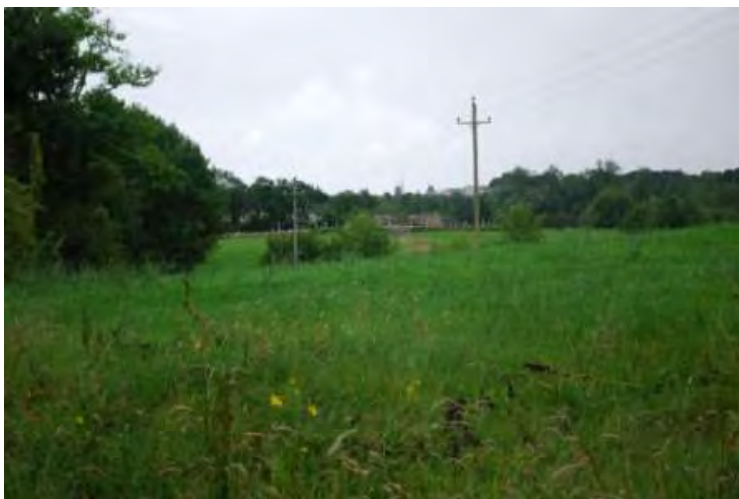
General Description: The church fabric that survives has been extensively repaired, giving it a very square and upright appearance. A door opening survives, with some dressed blocks to north west corner. The north wall at the western extent is considered to be the most original part of the church. The building survives at 10.6m x 5.2m, walls are 0.75m thick.

West Wall  
General Description: No features survive.

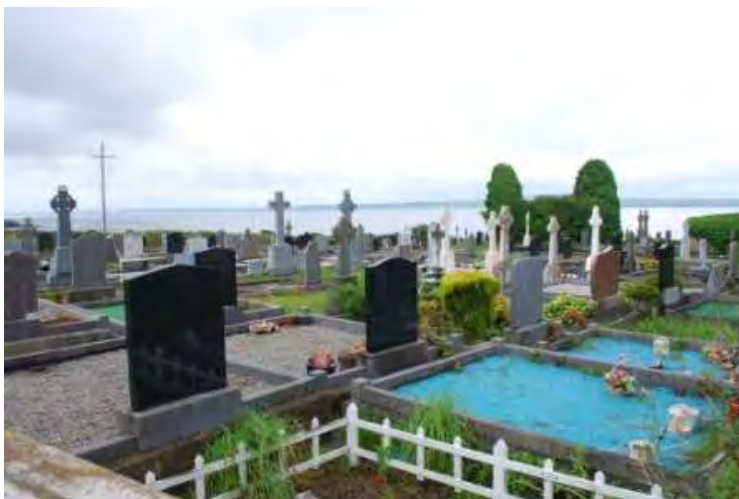
General Description: This is a small single cell church extensively covered in ivy. Contains a square headed door in the west gable. The interior of the church is almost completely filled by two large mausoleums, most of the length, leaving a narrow corridor to the east. The name 'Morney' appears on both mausoleums. Church is 5.3m x 3.6m, walls are 0.85m in thickness.

West Wall General Description: Contains a square headed door.

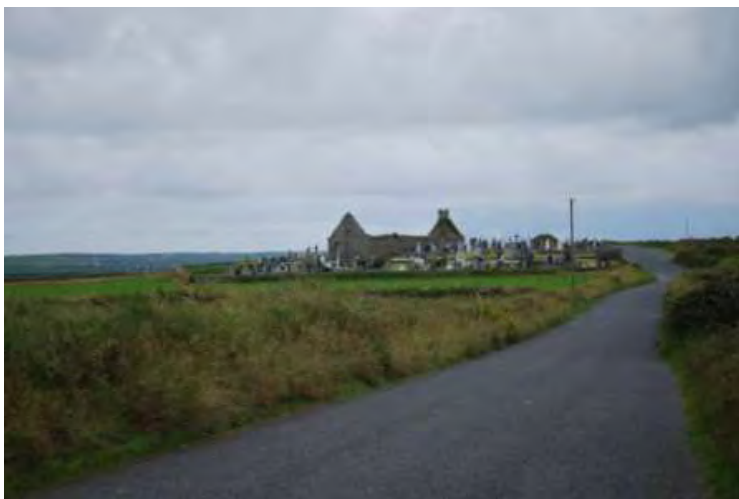
General Description: This is a long single cell church, in which a number of architectural features survive. Notably the roof corbels, with a double string course and a large number of block holes suggesting internal wooden structures in the past. The church is built on sloping ground West-East gradient. The church is situated within easy access to the coast. The church is 23.3m x 6.6m, walls are 0.85m thick.

West Wall General Description: Contains a small square headed window, a bell-cote survives on the west gable.

Church Appraisal/ Recommendations: The church is good condition, but there is some stress to the southeast corner. Regular ongoing maintenance.

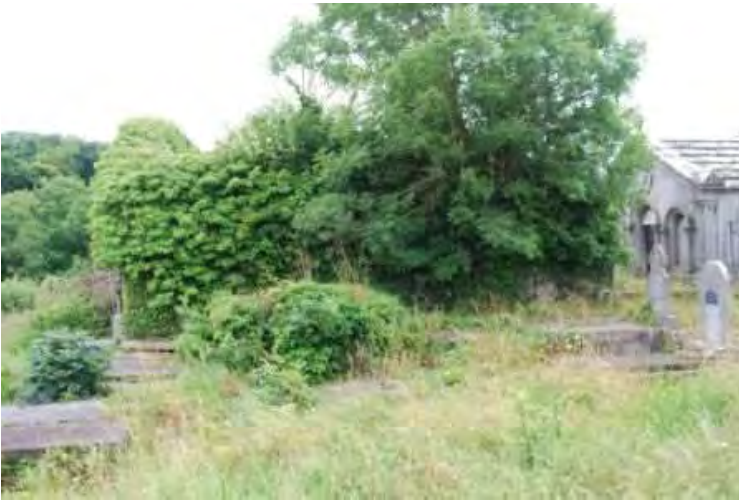
Monument No.	CL067-011001	Church Name:	St.Senan's Church of Ireland
Location:	Urban

Townland:	Kilrush		
Co-ordinates:	154970N,099999E		
Orientation:	E-W		
Category:	Mediaeval		
Landscape:	Other		
Other_Description:	Edge of Kilrush town.		
Access:	Beside Public Road		
Condition:	Fair		
Foundation:	Not Visible		
Masonry:	Dressed Rubble		
General Description:	<p>This early two cell church is situated behind St.Senan's Church of Ireland. Only a portion of this church now survives, a large portion of the main body including the western wall and parts north and south wall were destroyed in order to make way for the Vandalur Mausoleum. The transept arch and chapel survive, although they have been subject to alterations. The transept arch has been in filled and what was believed to have been the original doorway in the main body of the church is inserted into the in filled transept arch. There are steps down through this doorway into the chancel area. The chancel is 6.4m x 3.5m, the width of the nave is 6.04m, the length is lost. Wall thickness is 0.85m.</p>

West Wall General Description:	Nothing survives.		
South Wall General Description:	<p>The south wall of the chancel has pulled from the east gable and is also heavily overgrown by ivy. 5m of the south wall of the nave survive. There are possible features, but this is unreliable because of the nature of alterations and impact to this area of this church.</p>		
North Wall General Description:	<p>North wall of nave and chancel are without features. The transept arch which was at the east end of nave is a high arched well built opening. The east window in the chancel appears to be now blocked with stone and heavily obscured by dense ivy growth.</p>		
East Wall General Description:	<p>The east contains a large central window covered with ivy.</p>

Church Appraisal/ Recommendations:	The ivy growth needs to be cut back. An architectural conservation survey should be completed to determine the condition of the structure.			
Graveyard Monument	CL067-011002			
Boundary Wall Type:	Stone			
Boundary Wall Description:	Fair			
Extension Location:				
Graveyard Gen. Discussion/Appraisal:	The graveyard is extensively over grown and largely abandon to the south of the modern church			
Related Structures:	none			
Architectural Fragments:	carved stone, 154970N,099999E			
Graveyard General \Description	The graveyard is extremely neglected and overgrown with trees, brambles, long grass etc. The graveyard extends in all directions of the church and to rear of modern church. The area to the north of the modern church to the road appears to be the only area that is maintained. There is a high stone wall with gates. Lower stone walls bound the other three sides.

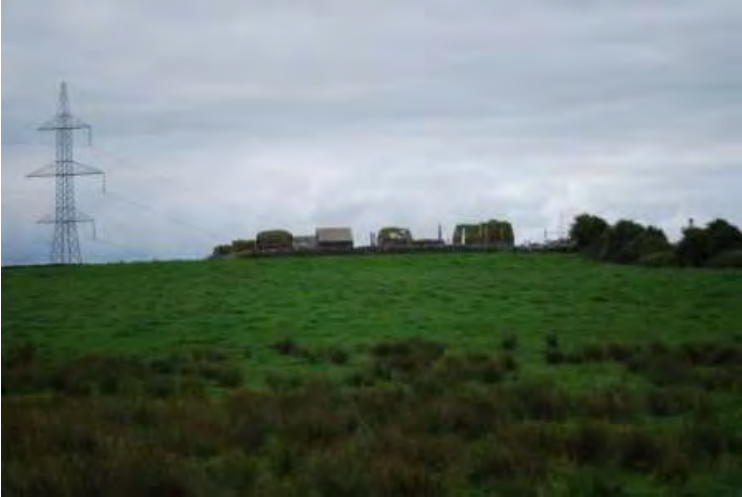
Monument No.	CL067-021003	Church Name:	St. Senan's Church (Molougha)
Location:	Rural

Townland:	Molougha		
Co-ordinates:	154568N,105063E		
Orientation:	E/W		
Category:	Early Christian		
Landscape:	Farmland		
Other_Description:			
Access:	Beside Public Road		
Condition:	Fair		
Foundation:	Not Visible		
Masonry:	Dressed Rubble		
General Description:	This the second of three small churches, also single cell. It is a ruined state with the walls down to c1.2m height. A window to the east gable survives.		
West Wall General Description:	There are no features to record.		
South Wall General Description:	There are no features to record.		
North Wall General Description:	There are no features to record.		
East Wall General Description:	The position of a window survives, now used as an impromptu altar.		
Church Appraisal/ Recommendations:	The church walls are stable enough because of their reduced height. The walls be maintained.

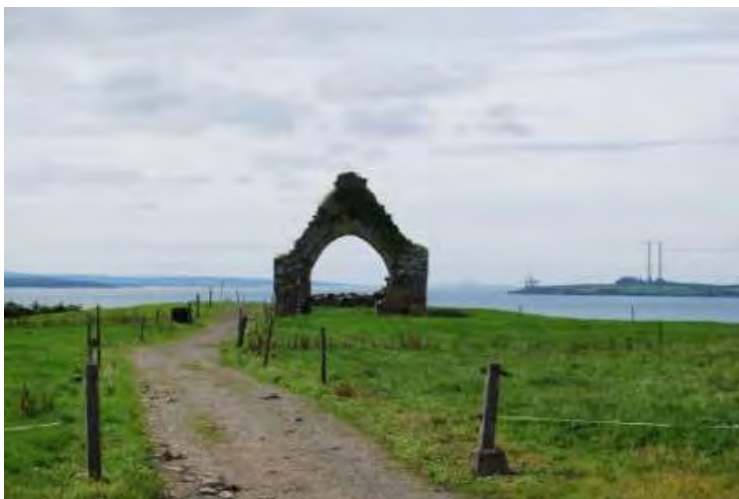
General Description: Only a portion of the full extent of this two cell church survives, namely an eastern transept arch, a section of the north wall, possibly complete, a western wall which appears to be largely reconstructed, but is believed to be in the correct position and represents most of the true width of the western end of the church. The south east corner also survives, but only a small section. What survives is believed to be the nave with a chancel to the east. This is confirmed by the presence of a number of out-jutting stones that almost certainly tied the chancel to the transept wall. The transept arch is 4.2m, the entire transept was c. 7.2m in height. The walls were 0.8m in thickness. The surviving portion of the church is approx 8m in length, width 5.3m.

West Wall  
General Description: The west wall is c. 5m in length, is only 0.7m high and largely rebuilt, recently and is believed to be in the true location. No associated features to record.

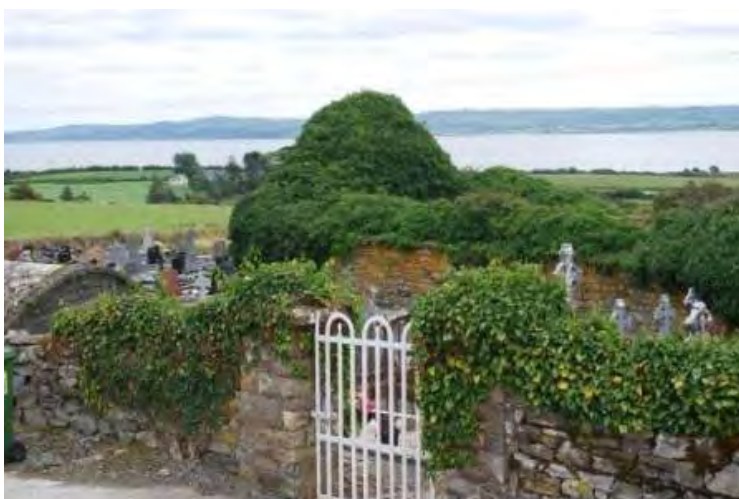
General Description: This single cell church is heavily covered in ivy which obscures much of the church. It is 20m x 9.9m. The south wall is built on a batter. The walls are thicker than usual at 1m. The west gable is largely ruined. The church is situated at the northern edge of the graveyard, with sufficient room for a pathway behind and a number of mausoleum/vault type burials on both sides of this approach path.

West Wall General Description: There are no features. It is largely ruined and overgrown.

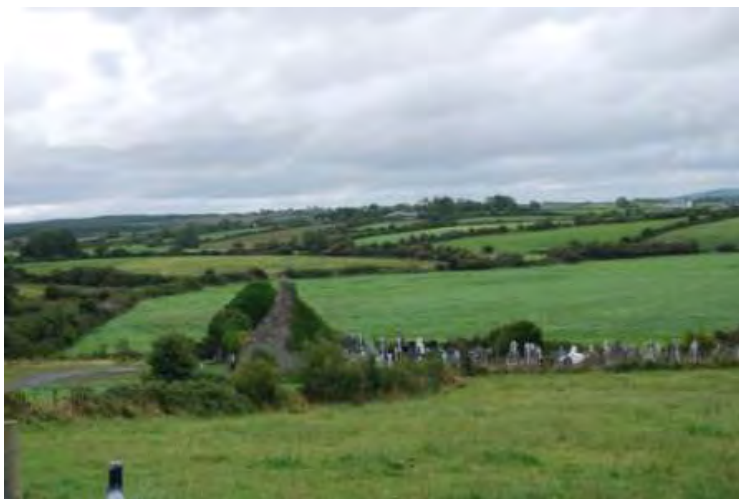
General Description: This single cell church is situated in low lying land, with a boundary wall for the graveyard immediately north of the church. It has an interesting feature in the west gable, an internal ledge. The church is 22.3m x 5.9m, the walls are 1.1m thick. There is extensive and heavy ivy growth to all walls.

West Wall General Description: Contains no wall features, save the ledge mentioned in the general description. There is a bell-cote over, which is damaged in that on the northern side some stones are missing. Barge stones could be indentified on the west gable.

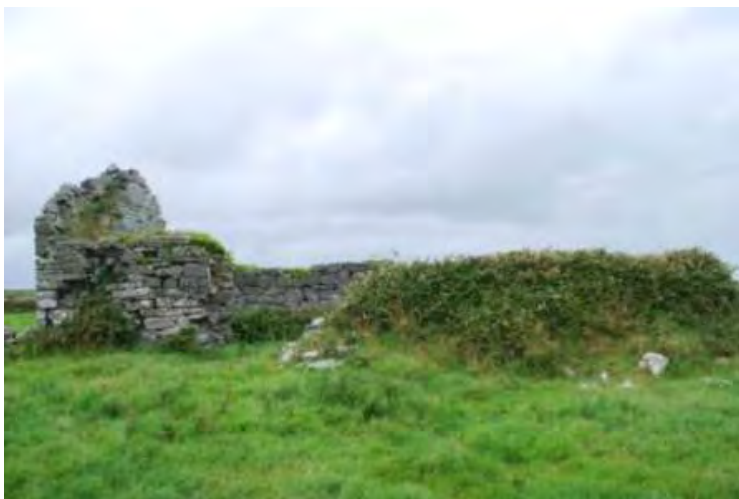
General Description: This single cell church is situated near the coast, is heavily overgrown with brambles and established nettles. The church is on farmland, belonging to Pat Magner, contact number 0659058157. Visits to this site should be organised with Mr. Pat Magner. The church is 8.8m x 4.5m. Little of the church could be recorded in detail due to extensive overgrowth. There is the base of a high cross, which lies to the south of the church. No graveyard could be detected.

West Wall General Description: No features could be recorded due to extensive overgrowth.

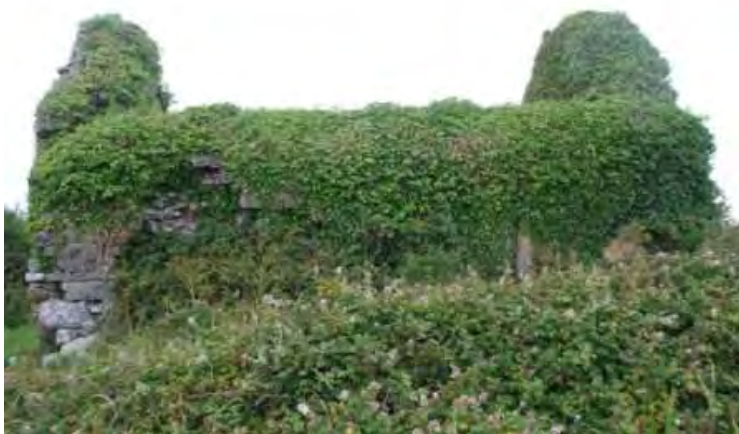
General Description: This is a small single cell church, 6.8m x 4.7m, walls are 0.7m thick. The construction is mixed, flagstone and shale, dressed rubble and very large stone reminiscent of cyclopean construction. The church is largely overgrown with ivy, particularly at the east end also the north and south walls. Within the church at the eastern end, there seems to have been the creation of a deliberate partition of two low walls parallel to the east-west gable, that turn 90 degrees to the east window, creating a walkway 0.65m wide, directly in front of the east window. A large broken slab in two pieces may well be the altar stone. This stone is located west of the east window.

West Wall  
General Description: The west wall contains a door which is largely robbed out. A single edge survives that suggests that it was formerly arched.

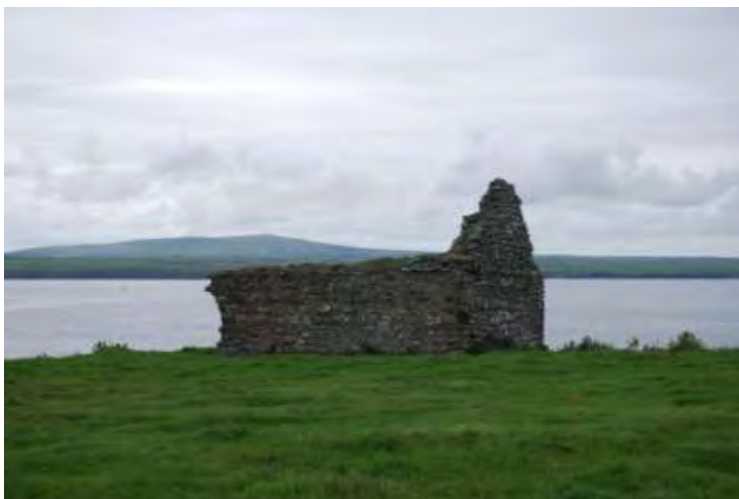
General Description: This single cell church is, as the name suggest is situated on a slightly elevated position, overlooking the coast, it would have been clearly visible from the sea. It is largely ruined with the east gable completely missing as well as partions of the south wall and north wall. Its survives as 6.6m in length, 3.6m width. Thickness is 0.76m. It was noted that the door tapers slightly, 10cm wider at the base, it has a square head over.

West Wall General Description: There are no features. The gable is believed to survive to most of its height.
