MEDIEVAL AND POST-MEDIEVAL CROSSES

A THREAT-RELATED ASSESSMENT 2010-11

Prepared by Dyfed Archaeological Trust
For Cadw

RHIF YR ADRODDIAD / REPORT NO. 2011/1
RHIF Y PROSIECT / PROJECT RECORD NO. 100384

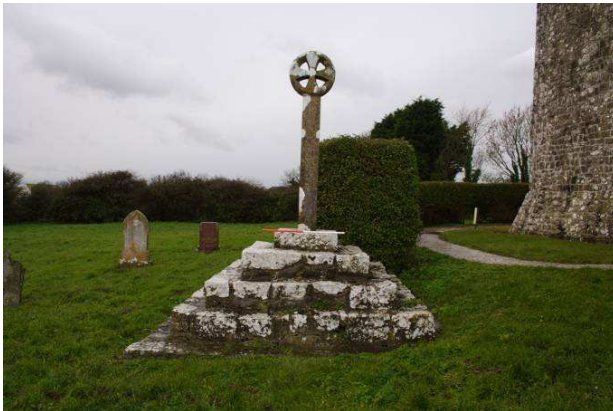
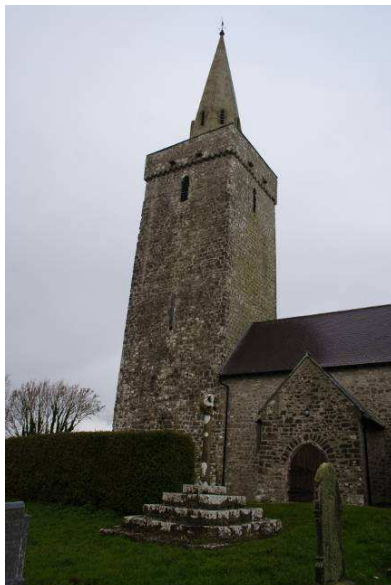
A RCAHM visit to this site in 1922 recorded '..a restored cross, the shaft and head in one piece; it stands upon a base of three steps'. The Ordnance Survey, after a visit in 1965, considered the steps to be 'original' and the cross shaft and head to be modern. The monument lies some 6m to the south of the southern porch of the church and comprises a roughly square (3.4m sq. bottom step) platform of four steps to a height of c.1.2m upon which lies a 0.76m sq. by 0.2m high socket stone containing a 1.68m high chamfered (octagonal) shaft topped by a separate 0.6m diameter wheel cross to a height of 0.64m. The cross and shaft are unweathered and modern. The platform steps are well mortar pointed (recently repointed?) and may represent an original base for an earlier, perhaps medieval, churchyard cross.

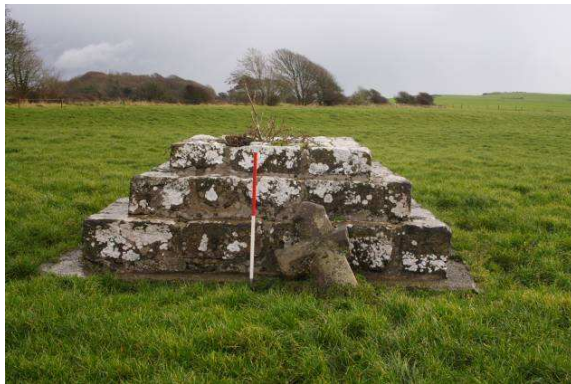
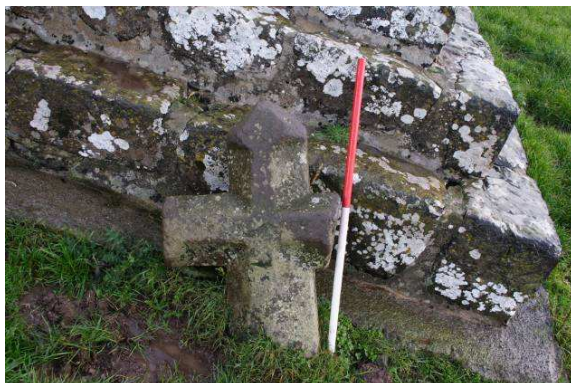
PRN 591; NAME: PARK HOUSE FIELD; VILLAGE CROSS
TYPE: Village Cross; **PERIOD:** Medieval
NGR: SR98149610
COMMUNITY: Stackpole; **COUNTY:** Pembrokeshire
CONDITION: Damaged; **STATUS:** NPP; **FORM:** Other Structure

A 3m sq by 1.05m high 3-stepped mortared limestone cross-base situated in the field some 76m to the south-east of Park House (PRN 6982). The base lies on a modern concrete foundation set in the ground. At the time of a recent site visit a fragment of the, possibly original, stone cross-head (of hard reddish sandstone) was lying against the bottom step of the base; the cross arms are chamfered and appear octagonal in section; one end is complete, the other truncated. The cross-head is chamfered to a point at the top but is truncated at its lower, shaft, end; the cross measures 0.86m from top to bottom and the cross arms are 0.6m long in total, with the whole fragment measuring c.0.21m thick. No cross shaft was present on the site or in the near vicinity. The base was restored, in its original location, in the mid-1970s under the auspices of Baron Bernard von Friesen immediately prior to the sale of the Stackpole Estate by the late Lord Cawdor (pers comm. the owner of Park House, daughter of the Baron). The RCAHM in 1925 recorded the presence of the three-stepped base and described loose stones lying around it as part of the cross pillar, no mention is made of the cross head being present at that time. The monument is considered to be the in situ village cross of the deserted medieval village of Stackpole.

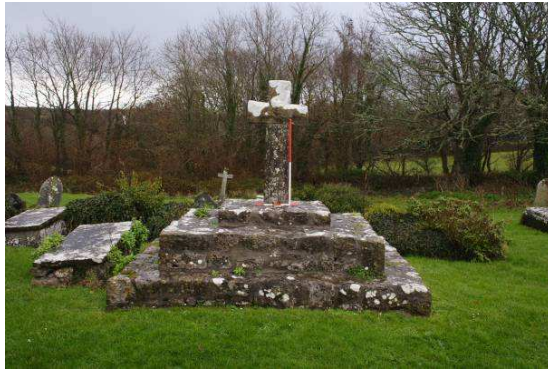
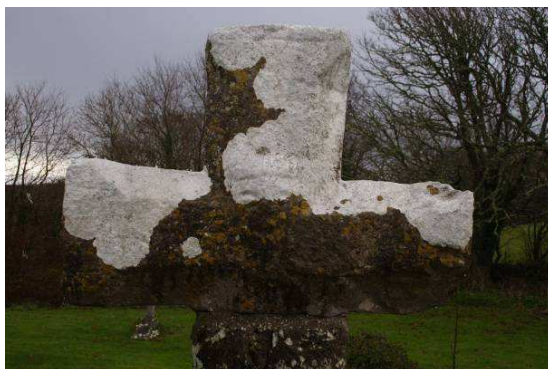
PRN 628; NAME: ST MICHAEL'S CHURCH

A c.3.1m square by c.0.83m high stone base of three steps supporting a 0.94m high octagonal shaft topped by a 0.49m high by 0.68m wide three-armed cross head. At the intersection of the cross, on its west side, a face has been carved in relief. The cross head is also octagonal but does not appear to truly match the style of the shaft, which suggests that the two elements may be of different periods, so the cross may therefore be a reconstruction. There is a centrally located hole drilled into the top of the cross head that may be evidence of the former presence of a finial. The RCAHM in 1925 considered the cross to be 'probably of 14th C date'. The base may be original but appears to have been relatively recently restored. The monument lies to the south of the church on the east side of the path leading to the south porch.

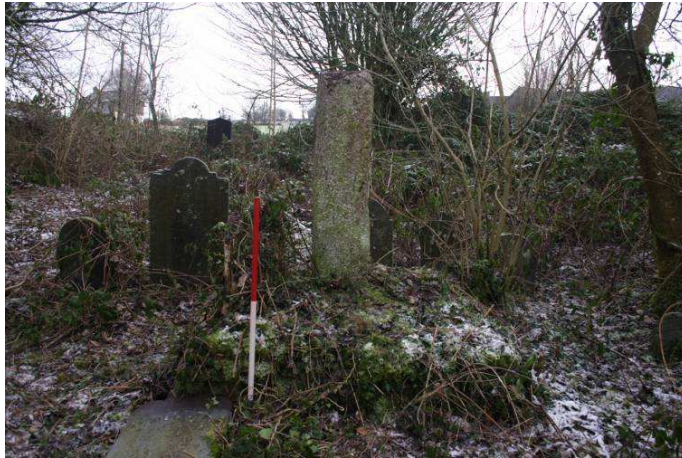
PRN 1110; NAME: ST TEILO'S STONE; CILRHEDYN CHURCHYARD
TYPE: Cross; **PERIOD:** Medieval
NGR: SN27803488
COMMUNITY: Clydey; **COUNTY:** Pembrokeshire
CONDITION: Near Intact; **STATUS:** None recorded; **FORM:** Other Structure

The probable shaft of a churchyard cross, minus its head, situated in the churchyard to the south of the ruins of Cilrhedyn church. The monument comprises a 1.35m high upright monolith measuring 0.4m E-W by 0.3m N-S, approximately rectangular in plan, and situated centrally upon a 0.38m high mortared roughly hewn shale base measuring 1.8m E-W by 1.7m N-S. A recess sculpted into the east side at the top of the stone, to a depth of 0.17m and height of 0.31m, was recorded by the RCAHM in 1925 as having formerly accommodated a sundial, which had gone by that time. The stone reputedly bore Ogam inscriptions but the Ordnance Survey observed none during their visits to the site in 1966 and 1977. It is possible that chisel marks present on the stone, still discernible today (especially on its SW edge), were mistakenly interpreted as Ogam. A visit to the site in December 2010 found the churchyard heavily overgrown and neglected.

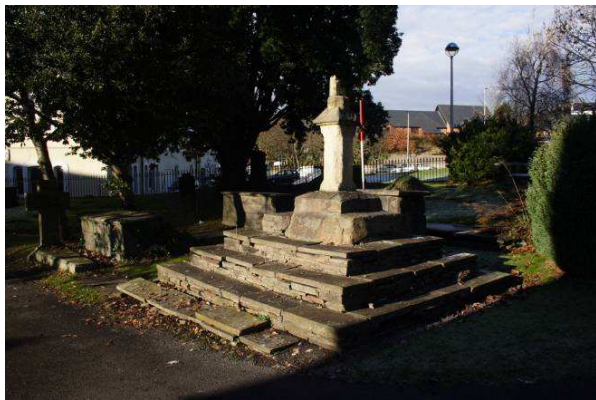
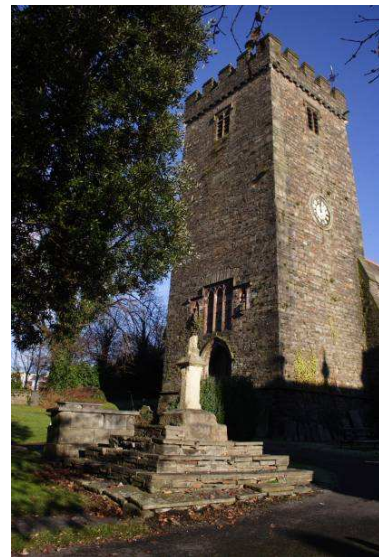
PRN 1187; NAME: ST ELLI'S CROSS

The RCAHM in 1917 described the churchyard cross, situated to the southwest of St. Ellwy's church west entrance, as a modern replacement of an earlier one, but added nothing more. In 1967 the Ordnance Survey described the monument as consisting 'of a medieval cross-base upon a calvary of five steps, surmounted by a modern cross-shaft'. The five-step rectangular platform (calvary) of neatly hewn mortared sandstone flags measures 4m E-W by 3.6m N-S at its base to a height of c.1m; the fifth step is restricted to being only 0.23m high by c.0.9m wide by 0.4m deep and is built up against the west side of a sculpted, nearly 1m square, sandstone monolith that acts as the cross plinth or socket stone. The plinth is itself partially stepped in appearance with a sculpted ledge or recess at a height of 0.3m around its east and northern sides to a level depth of 0.26m and 0.1m respectively; the height of the plinth stone is c.0.57m with the top equally chamfered on all sides to form a smaller square platform that accommodates the cross shaft. All that remains of the 19th century cross are three shaft elements of broached and chamfered yellow limestone or bathstone to a height of about 1.5m. The plinth stone is unusual and may represent an original medieval element. The stepped platform, which may also have medieval origins, was badly in need of consolidation at the time of the site visit in December 2010.

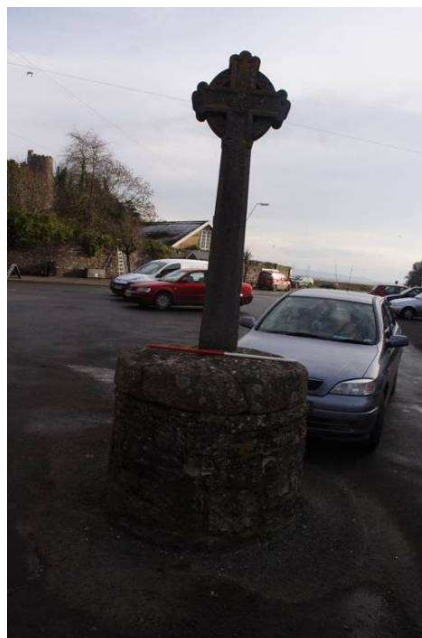
PRN 2170; NAME: GRIST THE
TYPE: Cross; **PERIOD:** Medieval
NGR: SN3006110725
COMMUNITY: Laugharne Township; **COUNTY:** Carmarthenshire
CONDITION: Restored; **STATUS:** listed building 9630 grade II; **FORM:** Other Structure

A c.1.23m diameter by 0.22m high circular socket-stone containing a modern cross standing on top of a 0.8m high cylindrical mortared stone rubble plinth in an open space known as "The Grist" in Laugharne. The socket stone, or cross base, was considered by the RCAHM in 1917 as being 'ancient'; the Ordnance Survey, in 1967, described the stone as 'probably medieval' and 'incorporated in the base of a modern market cross'. The stone, which resembles a millstone, may have its origins from the grist mill that once stood nearby and from which The Grist got its Name:. However, the area is still also known as Cross Square and the RCAHM considered that it may have only changed its Name: as a result of the removal of the original cross and shaft leaving only the circular stone base. The monument has Grade II listed building status.

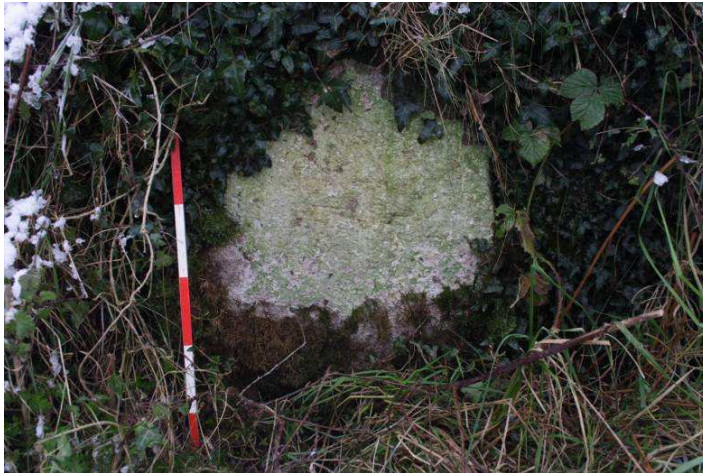
PRN 2417; NAME: SEALYHAM FARM

A cross-carved stone set in what appears to be a hedgebank, but is in fact a length of vegetation-covered stone boundary wall, on the south side of the road immediately to the east of a house named Dolwerdd. The stone is at least 0.65m high (where exposed above ground) and no greater than 0.99m wide; its depth is unknown because of its incorporation into the stone boundary. The exposed flat face of the stone has a 0.27m high simple Latin cross incised centre-left, which is obscured by an accumulation of lichen and moss growth. Nancy Edwards (2007) considers the cross-type as atypical of early medieval examples, concluding only that its date is uncertain. Historically, the stone was first described by Laws and Owen in the Pembrokeshire Archaeological Survey between 1897 and 1906 but it became 'lost' until rediscovered in 1983. The amount of vegetation surrounding the stone and its close proximity to the road make it potentially vulnerable to loss or damage.

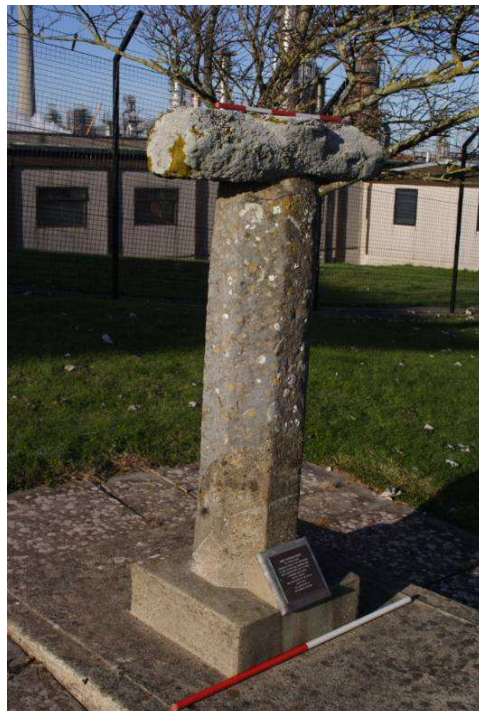
PRN 3221; NAME: CROSSCOMBE;POPTON CROSS
TYPE: Cross; **PERIOD:** Medieval
NGR: SM9100002360
COMMUNITY: Hundleton; **COUNTY:** Pembrokeshire
CONDITION: Moved; **STATUS:** NPP; **FORM:** Other Structure

A T-shaped stone cross comprising a 1.21m high by 0.29m chamfered octagonal shaft supporting a horizontal 0.75m long by 0.17m high by 0.29m chamfered cross piece. The cross arms are heavily weathered compared with that suffered by the shaft to the extent that the previously octagonal shape now appears cylindrical; the carving evident centrally, less weathered on the east side, indicates the continuity of chamfering from the shaft up to the now missing upper element to the cross. Close to the top of the eastern side of the shaft there is a hole indicating, perhaps, the shafts use sometime as a gatepost. The monument is set in a modern concrete two-stepped base and is situated at the entrance of the Chevron oil refinery close to its staff car park and reception building; a plaque, recording the re-erection, in 1964, of the probably 14th century cross in its present location on the completion of the Pembroke refinery, sits at the base of the shaft on its eastern side. The RCAHM recorded (in 1922) a stone base of 3 steps on which stood an octagonal and plain stone shaft 4ft high supporting the 29 inch long diagonal arms of a cross with the upper member missing. At that time they were situated to the south of West Popton village at the crossroads. The Ordnance Survey (in 1965) described a T-shaped cross moved to NGR SM9100 0236 and set in a modern socket, remarking that it has been restored with the cross arms being of a different stone and later in date. A local man reported to the OS that he remembered the shaft being found in a field known as Cross Combe *circa* 1907 (at NGR SM907 035) before being re-positioned on the stone base at the village crossroads (at NGR SM9039 0335); the cross arms were possibly added at that time. The fact, however, that the cross arms are more heavily weathered may indicate that that element is in fact older than the shaft.

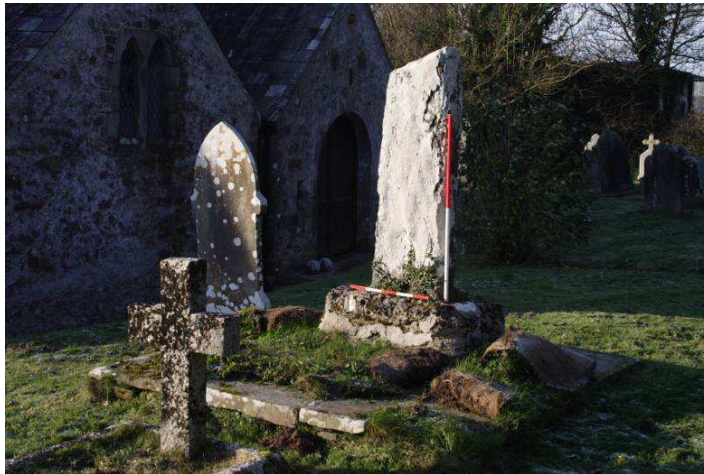
PRN 3242; NAME: RHOSCROWDDER CHURCHYARD

An upright monolithic slab measuring 1.34m high by 0.43m wide by 0.2m thick set in a rectangular socket stone and standing on a nearly square single stepped (c. 0.20m high) stone slab platform. The socket stone at first site appears to be either weathered concrete or a degrading block of grey limestone (the Ordnance Survey in 1965 described it as a pumice-type stone), the presence of moss and other vegetation cover makes it difficult to fully characterise. There is evidence of possible chamfering on the edges of the west side of the stone but not on the east side edges. The whole slab is covered with thick white lichen which may obscure any inscription or incised cross that may be on it (there is no record of any such markings however). There is much evidence of ongoing weathering and the stone is exfoliating/flaking quite readily. Unusually, the monument is located on the north side of the church, some 11m upslope to the north of the north transept. The Ordnance Survey described the slab as having the appearance of a boundary stone rather than a medieval churchyard cross or pillar stone. The monument has Grade II listed building status grouped with St Decumanus's Church and the church hall.

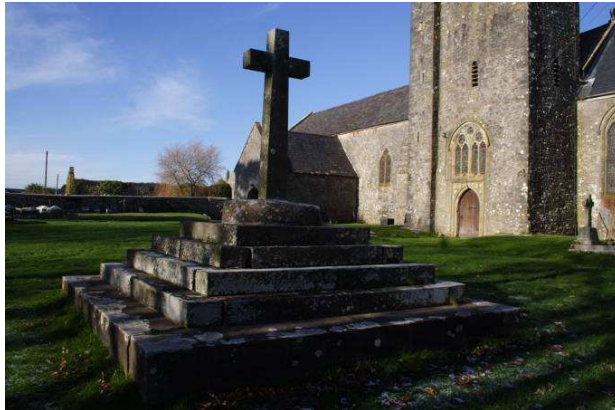
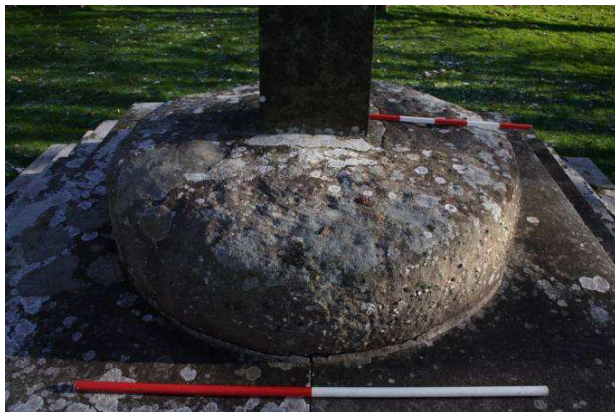
PRN 3276; NAME: MONKTON PRIORY
TYPE: Churchyard Cross; **PERIOD:** Modern
NGR: SM97970142
COMMUNITY: Pembroke; **COUNTY:** Pembrokeshire
CONDITION: Restored; **STATUS:** None recorded; **FORM:** Other Structure

It is recorded in *Archaeologia Cambrensis* (1882) that the churchyard cross was pulled down circa 1847 and some of the pieces placed within the church tower. The present cross (said to be in the same location as the original) is modern and set in a circular socket stone, measuring 1.2m diameter by 0.26m high, that resembles an old millstone. The socket stone may be the original stone from the former medieval churchyard cross. The cross is situated on a modern square five-stepped platform that bears a commemorative inscription 'To the Glory of God and the Memory of the Unnumbered Dead' over three steps on its eastern side; commemorating disarticulated human skeletons recovered from between the nave and chancel during restoration and building work in the church in the late 19th century. The monument is located in the churchyard to the south of St. Nicholas' Priory church.

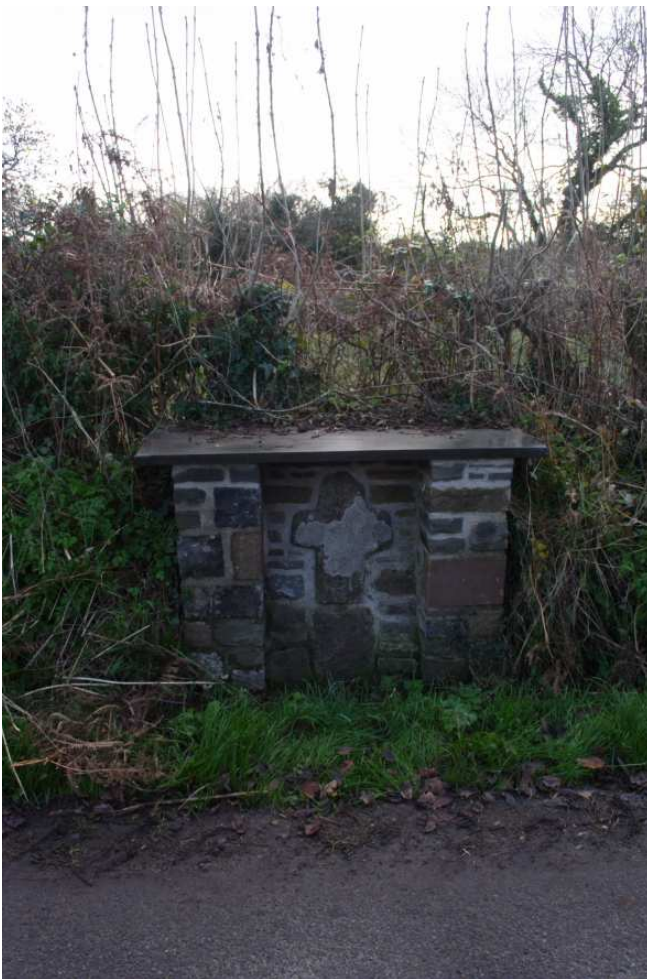
A plain Latin cross-head built into the wall of a specially built masonry alcove set in the hedgebank on the south side of the road about 1km from the village of Jeffreyston. The cross is 0.52m high by 0.37m wide (cross-arms) and is of roughly hewn stone. The cross was originally discovered during the demolition of a nearby 'clom'-built cottage and placed in its current location by a former parish rector. Most authorities consider it to be medieval and it has also been conjectured that it is the original head of the Jeffreyston churchyard cross (PRN 3477) viz: Nancy Edwards (2007), in her discussion of the stone, states that the cross-head is the top of the later medieval cross, still standing in the churchyard, and has now been replaced with a modern head.

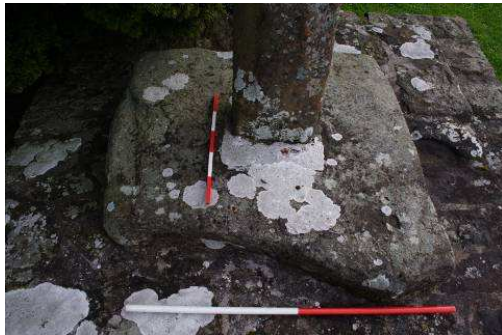
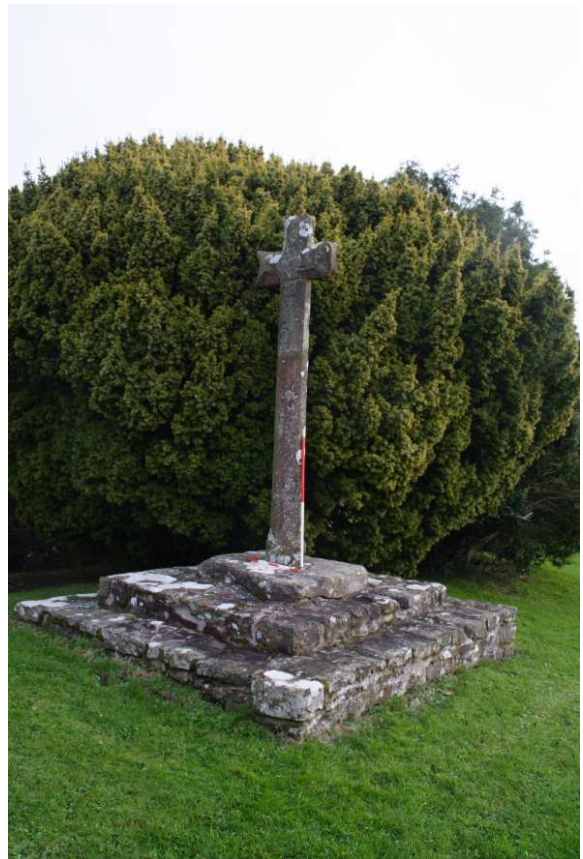
PRN 3477; NAME: ST JEFFREY & ST OSWALD'S CHURCH

A 2.4m high octagonal shafted cross with an equal armed cross-head measuring c.0.7m wide situated in the churchyard close to the southeast corner of the church tower. The cross is set in a crude roughly hewn rectangular socket stone that rests centrally on a two-stepped masonry platform. The shaft appears to be broach-stopped at its base and is tapering; there are two elements to the shaft, the smaller upper one has the remains of an iron pin in it indicating past repair and there are two newer looking rivets at the top of the lower element (all are on the west side). It is possible that the upper element of the shaft had been lying elsewhere and was added at a later date once re-discovered (*cf* photo in Rees, S 1992 and later DAT photos). The cross-arms are octagonal with widening ends. The RCAHM, in 1925, considered that the head was modern with the rest being original. It is described generally as a 14th century preaching cross by Sian Rees (1992); J Rigg of the OS (1965) considered that the cross-head and shaft were 'coeval and may be a modern restoration', whilst implying that the restored two-stepped base and socket stone may be original. Some authorities think it possible that the roadside cross (see PRN 3476) situated some 0.6km to the southwest of the church is the original cross-head to this monument.

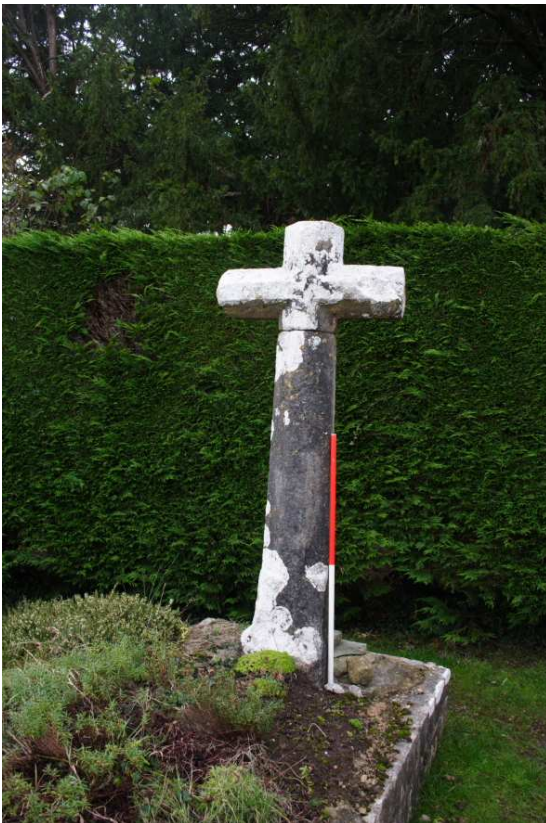
A 1.75m high stone cross situated on a restored single-step rectangular masonry base some 2m to the south-west of the south-west corner of Upton chapel. The cross comprises a 1.32m high tapering octagonal shaft, broached at its base up to circa 0.5m, surmounted by a 0.43m high by 0.75m wide octagonal cross-head. A small, concrete-filled hole in the top of the cross-head indicates the probable former presence of a finial. No socket stone is visible as the rectangular base has been turned into a raised bed and is planted with shrubs and flowers. A late 18th to early 19th century painting of Upton Castle by Warwick Smith shows the cross, complete with a spherical finial, situated on a two-step stone base and in the same location as it is today. The general condition of the cross is good with only slight damage to the top of the shaft and the northern arm of the cross-head. The monument is listed as part of a group listing, Listed Building Grade II, along with Upton Castle and the chapel.

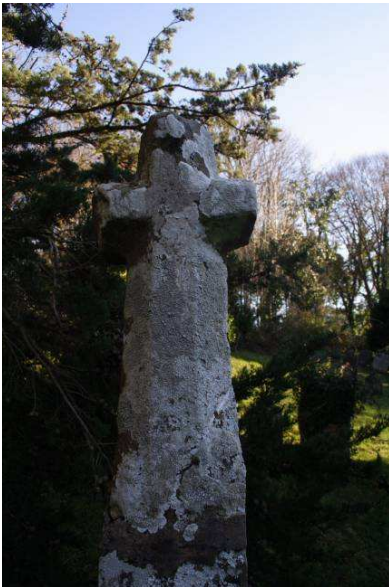
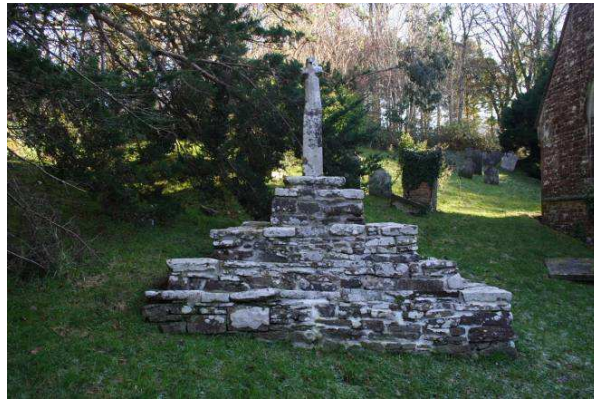
PRN 3643; NAME: ST ISSELL'S CHURCH
TYPE: Churchyard Cross; **PERIOD:** Medieval
NGR: SN13260583
COMMUNITY: Begelly; **COUNTY:** Pembrokeshire
CONDITION: Restored; **STATUS:** NPP, listed building 18443 grade II; **FORM:**
Other Structure

A medieval churchyard cross located, unusually, on the north side of St. Issel's church some 5m from the north porch. The monument comprises a restored four-stepped masonry base (circa 3.1m square by 1.38m high) upon which is set a 1.41m high cross set in a socket stone. The cross comprises a 0.71m high by 0.22m square plain lower shaft of sandstone (probably modern) with a combined shaft and cross-head measuring 0.6m high by 0.25m above. The upper element has broach stops at its base with the remaining parts, including the cross-arms, being octagonal in section; it is possible that the cross-arms have been truncated, hence their stubby appearance. It is considered that the upper, cross, element is medieval. The socket stone measures 0.62m by 0.55m by c0.10m high and may be an original feature; two metal pegs have been driven or drilled into the surface of the stone to the north and south of the cross. The monument has Grade II Listed Building status.

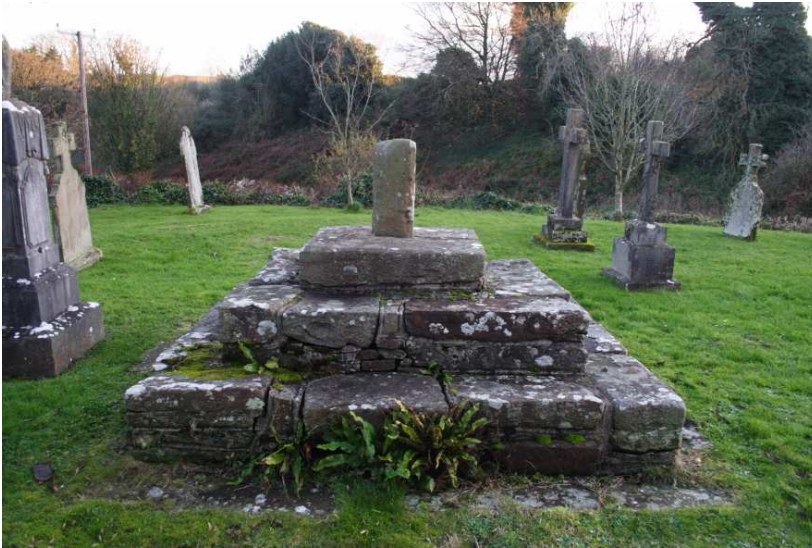
PRN 3662; NAME: AMROTH CHURCH

The remains of a churchyard cross comprising a restored four-stepped rubble masonry base with a 0.6m high by 0.3m by 0.12m upright fragment of cross shaft centrally set on top of it. The shaft fragment is much weathered but there is a hint that it was chamfered and it may have at sometime appeared octagonal in section. The RCAHM, after a visit to the site in 1915, described it thus 'a fragment of the stem of a tall cross stands upon its original base'. The base may be original but it is much restored. There is a commemorative stone tablet on the second step of the base on its west side with the inscription 'PREACHING CROSS CIRCA 900'. The monument has Grade II Listed Building status and is located in the churchyard to the south of St. Elidyr's church.

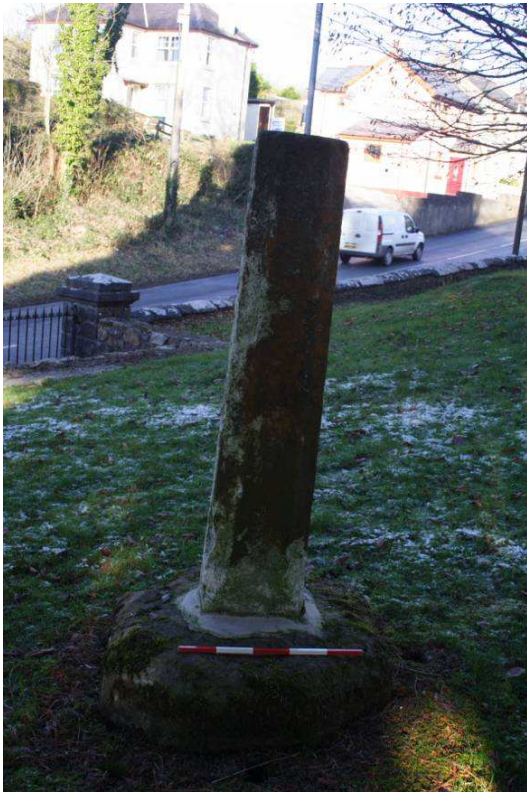
A 1.35m high tapering octagonal sandstone cross-shaft, with broached stops near its base, and set in an octagonal socket stone, is located in the churchyard to the southwest of St. John's church. The octagonal socket stone is chamfered and measures 0.8m across by 0.25m high; the cross-shaft appears to have recently been re-set into the socket with concrete. The cross was moved to the churchyard from its original siting at SN1131 1168, shown on the 1907 edition of the 25" Ordnance Survey map. The cross is mentioned by Richard Fenton in his Historical Tour Through Pembrokeshire (1811).

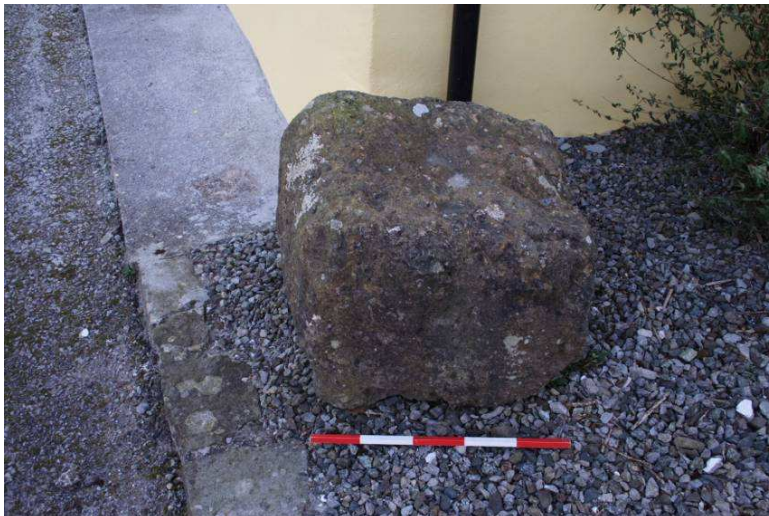
PRN 3754; NAME: SQUARE STONE THE
TYPE: Cross, Stone; **PERIOD:** Medieval, Unknown
NGR: SN1049013990
COMMUNITY: Narberth; **COUNTY:** Pembrokeshire
CONDITION: Moved; **STATUS:** None recorded; **FORM:** Other Structure

A dressed stone measuring 0.4m by 0.4m by 0.5m (roughly a cube), thought by the RACHM in 1925 to be a possible base or pedestal for a cross, is situated close to the northwest corner of Stone Ditch Farm. No socket is apparent on any of the five exposed sides and no other markings visible. Locally, the stone has been referred to and become known as 'The Lucky Stone'. There is no physical evidence to lend credence to the theory that the stone was ever used as a pedestal for a cross and there is no history of there being a cross in the vicinity.

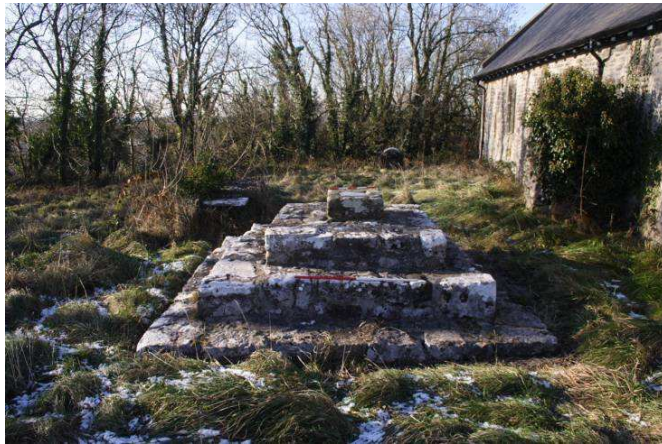
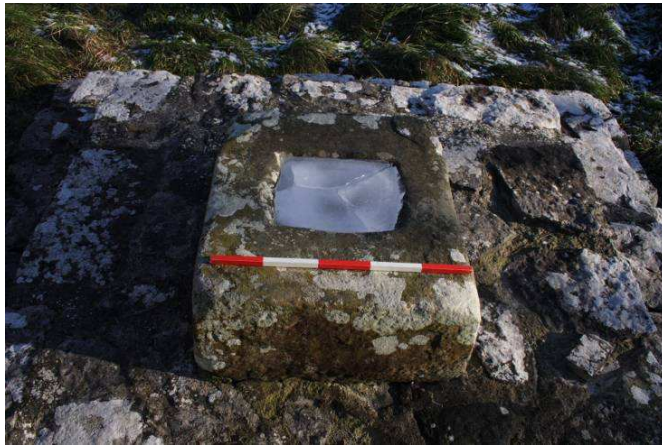
PRN 3782; NAME: ST ELIDYR'S CHURCH

The base and socket stone for a churchyard cross are situated 2m south of the southeast corner of the church. The rectangular socket stone measures 0.54m by 0.64m by 0.23m high and sits centrally on a c. 0.75m high three-stepped 3.17m by 3.54m restored masonry base. There are some incised lines (or scratches?) on the upper surface of the socket stone that may be the weathered remnants of decoration. The socket itself is centrally located and measures 0.28m by 0.24m.

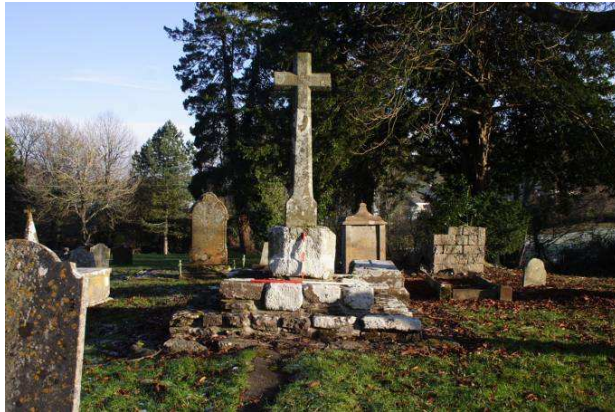
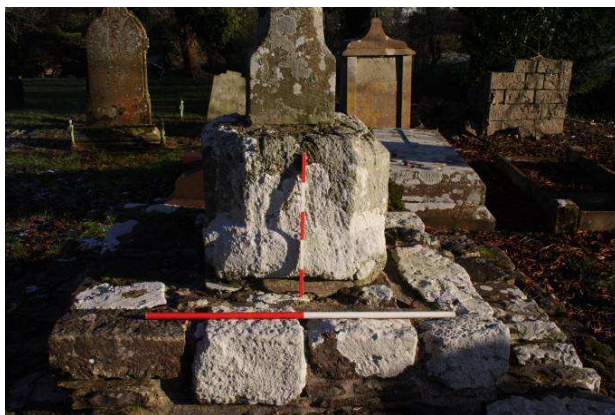
PRN 3791; NAME: ST PETER'S CHURCH
TYPE: Churchyard Cross; **PERIOD:** Medieval
NGR: SN15521442
COMMUNITY: Lampeter Velfrey; **COUNTY:** Pembrokeshire
CONDITION: Restored; **STATUS:** None recorded; **FORM:** Other Structure

A 0.54m high two to three-stepped restored masonry cross base and original socket stone surmounted by a modern cross is situated in the churchyard to the south of St. Peters church. The base measures 2.9m by 2.57m and the broached rectangular socket stone is 0.56m high by 0.64m by 0.86m, both elements are considered to be medieval. The modern cross comprises a 1.26m high tapering broach-stopped octagonal shaft and a 0.6m by 0.6m equal-armed octagonal Latin cross-head. The RCAHM, after a visit to the site in 1918, recorded the presence in the churchyard of what they considered to be part of the cross-head of the original cross; and in 1965 the Ordnance Survey confirmed the presence of the fragment at NGR SN1553 1444. However, by 1975 (OS) the original cross-head was missing although the then vicar thought that it was still present somewhere in the churchyard. During a visit to the churchyard in December 2010 the cross-head was not found, but recent vegetation clearance undertaken had revealed stockpiles of worked stone/architectural fragments at the northern and eastern boundaries of the churchyard; the missing cross-head may be hidden amongst the collected stone.

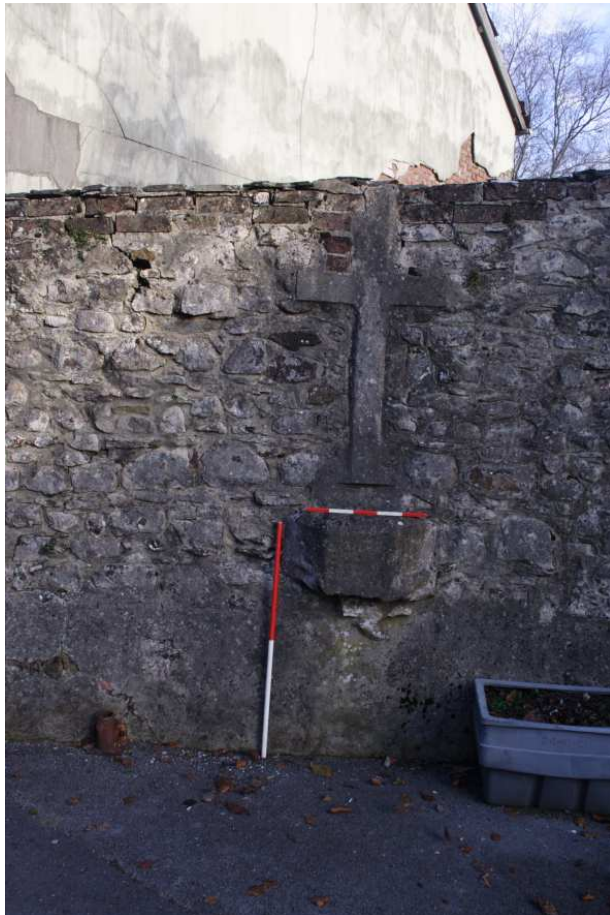
PRN 5051; NAME: ST MARY MAGDALENE'S CHURCH
TYPE: Cross; **PERIOD:** Medieval
NGR: SN28151574
COMMUNITY: St Clears; **COUNTY:** Carmarthenshire
CONDITION: Moved; **STATUS:** None recorded; **FORM:** Other Structure

Parts of the base, or socket stone, and shaft of a cross have been built into the outer wall of the churchyard, immediately to the left of the gateway. The two fragments have been enhanced with concrete in relief to appear as if a whole cross. The socket stone may be octagonal (only three faces protrude from the wall) and appears to be chamfered on its upper surface; the exposed part measures 0.65m wide by 0.3m high with each exposed face averaging 0.28m wide. The shaft element is 0.66m high by 0.1m (average) wide and is much weathered. Edward Lhuyd, in 1699, recorded the existence of fragments 'of a popish cross near ye churchyard gate'. The RCAHM, in 1925, quoted Lhuyd and reported the presence of the cross built into the wall.

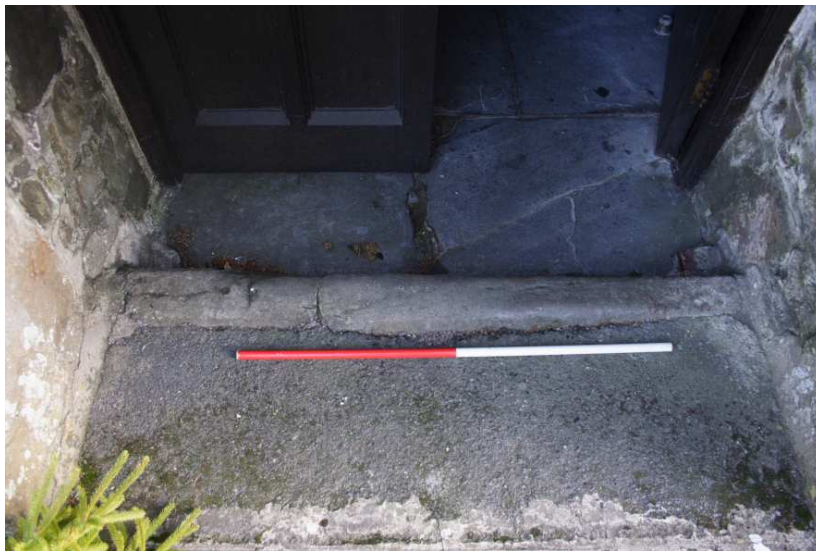
PRN 5052; NAME: ST MARY MAGDALENE'S CHURCH
TYPE: Cross; **PERIOD:** Medieval
NGR: SN28151574
COMMUNITY: St Clears; **COUNTY:** Carmarthenshire
CONDITION: Moved; **STATUS:** None recorded; **FORM:** Other Structure

There are two stone slabs incorporated into the threshold of the west doorway of St. Mary Magdalene's church, one of which is said to be part of one of the crosses mentioned by Edward Lhuyd in 1698 (RCAHM, 1917). The two stones may have formerly been one slab that has subsequently broken, both stones exhibit wear from being constantly walked upon. There is no evidence available to prove the veracity of the claim and no markings on the visible parts of the stones to indicate their former use, if any.

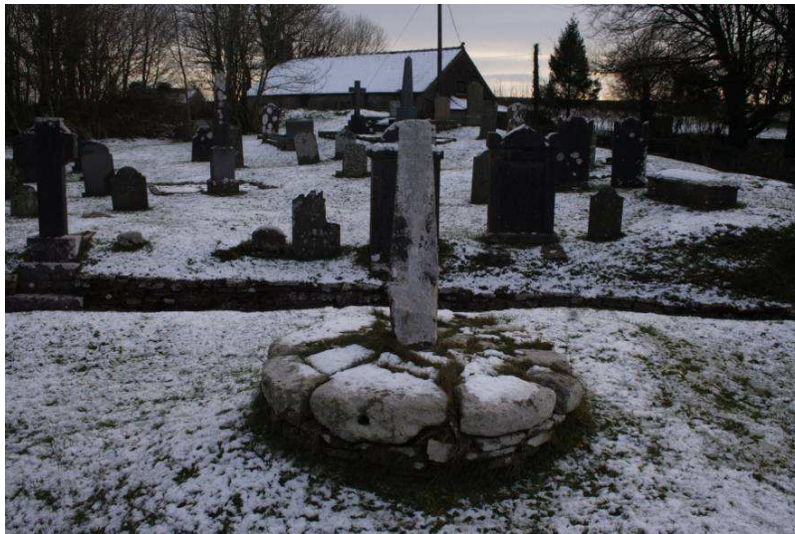
Situated on the south side of the churchyard is a circular, c.1.45m diameter, stone-built cross base surmounted by a centrally located 1.11m high tapering upright stone slab that appears to be the crude shaft for a cross. There are no incised markings or inscriptions on the slab but a small socket hole has been drilled into the westerly edge of the top, centre, of the stone; the small hole may have held a cross-head or finial representative of a cross. Another small hole has been drilled into the east face of the shaft some 0.25m down from the top. The circular base, c. 0.35m in height, is composed of two courses of medium and large stones some of which appear to have been specifically dressed to form a circle. It is possible that the dressed stones are all that remain of an original single circular base stone (like a millstone?) with the other stones having been added during a period of restoration. At least two of the base stones have holes drilled into them. At its base the shaft is 0.2m square in plan; at a height of 0.2m and above it appears rectangular in plan, averaging 0.1m by 0.24m and tapering to a maximum width of 0.16m at its tip. The monument is Grade II listed building status.

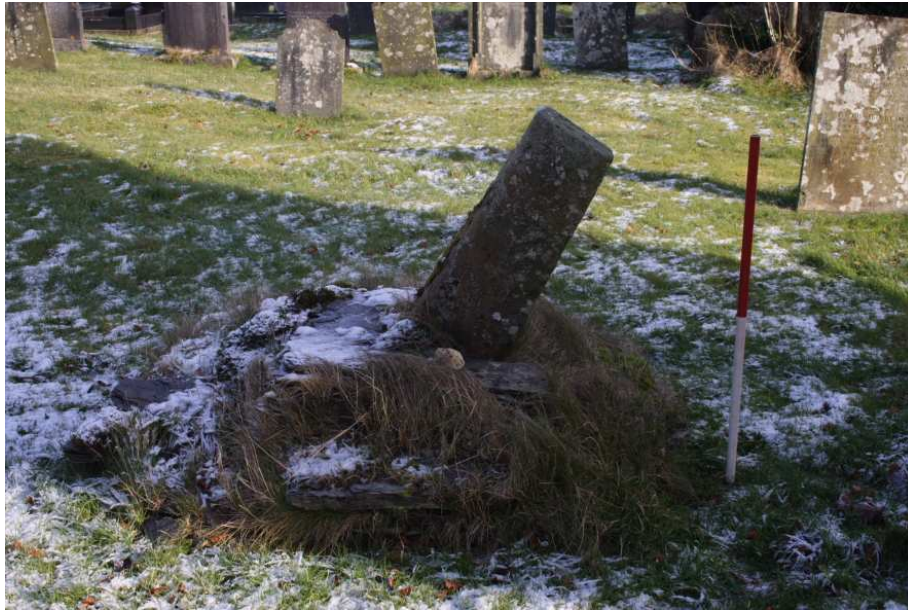
PRN 7401; NAME: ST GWINIO'S CHURCH
TYPE: Churchyard Cross; **PERIOD:** Medieval
NGR: SN26112644
COMMUNITY: Llanwinio; **COUNTY:** Carmarthenshire
CONDITION: Damaged; **STATUS:** None recorded; **FORM:** Other Structure

A 0.5m high by 1.3m by 1.4m two-stepped cross base, surmounted by a 0.8m (high) long by 0.18m by 0.24m rectangular stone cross-shaft, is located in the churchyard to the south of St. Gwinio's church. The base comprises a mix of slate and sandstone slabs to a height of 0.5m; the upper step is topped by a slate or phyllite slab with a socket-hole cut into it that holds the shaft. The base was covered by vegetation and snow at the time of the site visit in December 2010 so full characterisation was not possible. The shaft leans quite markedly to the south but is firmly set. There are four small holes drilled into the top of the shaft along with two small rectangular slots, all of these features being contained within a 0.13m square shallow recess carved into the stone; it is possible that a sundial may at sometime have been affixed to the top of the shaft. A RCAHM visit to the site in 1912 recorded only the presence of the cross base and shaft, no mention was made of either a cross-head or a sundial.

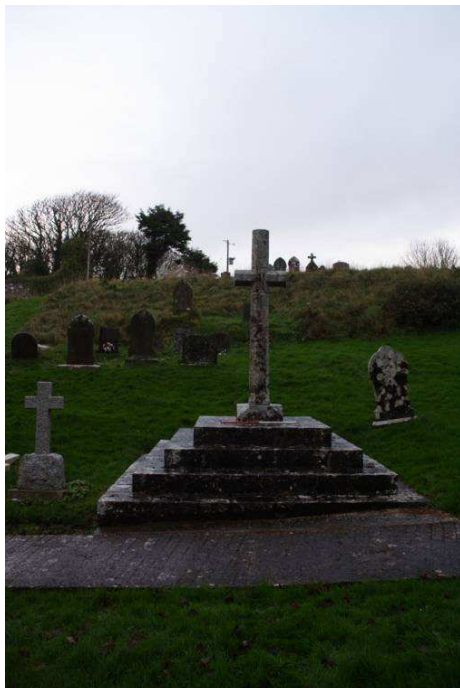
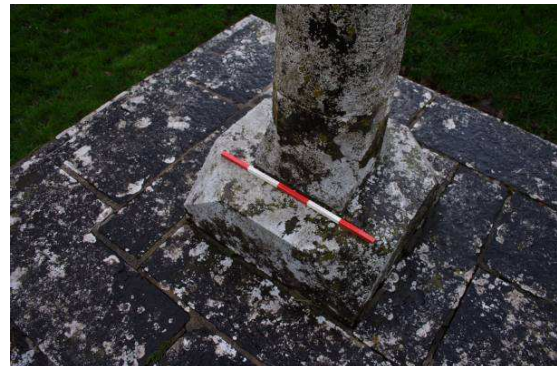
The cross base and cross in the churchyard to the south of Castlemartin parish church appears at first sight to be wholly modern, or at best much restored. The RCAHM (1925) expressed the latter whilst the Ordnance Survey (1965) described the monument as 'entirely modern'. The masonry cross base is of four steps, 3.7m square and is 1.23m high; it appears to be modern, given its general good condition, solid construction and unweathered appearance. A centrally located broached stone plinth on the base, measuring 0.6m square by 0.23m high, is surmounted by a cross comprising four elements: the base of the cross shaft is octagonal in section, broached, and measures 0.29m square by 0.29m high upon which is the main shaft, also octagonal in section, measuring 1.25m in height and tapering slightly up from 0.29m to 0.25m wide; the horizontal cross-arms, a single element, are octagonal in section, span 0.71m and are 0.34m high. The upper, vertical arm, also a single element, is 0.55m high, octagonal in section and 0.23m in width and depth. The main shaft element appears to be slightly differently worked than the other parts of the cross, being less smoothly finished, perhaps suggesting that it may be earlier. The Ordnance Survey, 1975, considered the possibility that 'two portions of the shaft' may be original. The cross has Grade II listed building status.

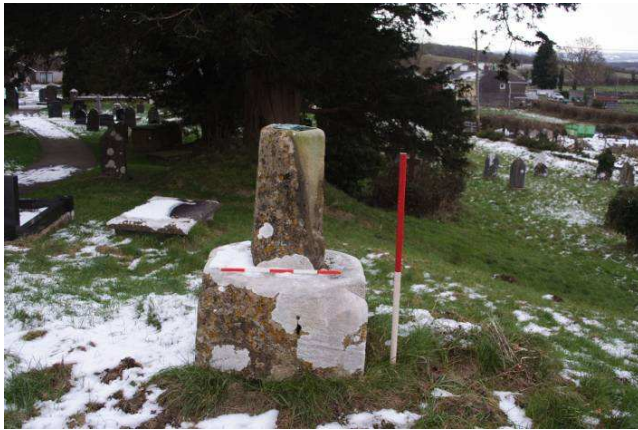
A broach or hip-stopped carved limestone cross-base or socket-stone measuring 0.68m square and 0.45m high surmounted by a 0.59m high octagonal broached lower fragment of cross-shaft is all that remains of this churchyard cross. The bronze faceplate of a sundial, without a gnomon, is fixed to the top of the shaft. The cross remains are considered to be late medieval in date, and the monument has Grade II listed building status in its own right.

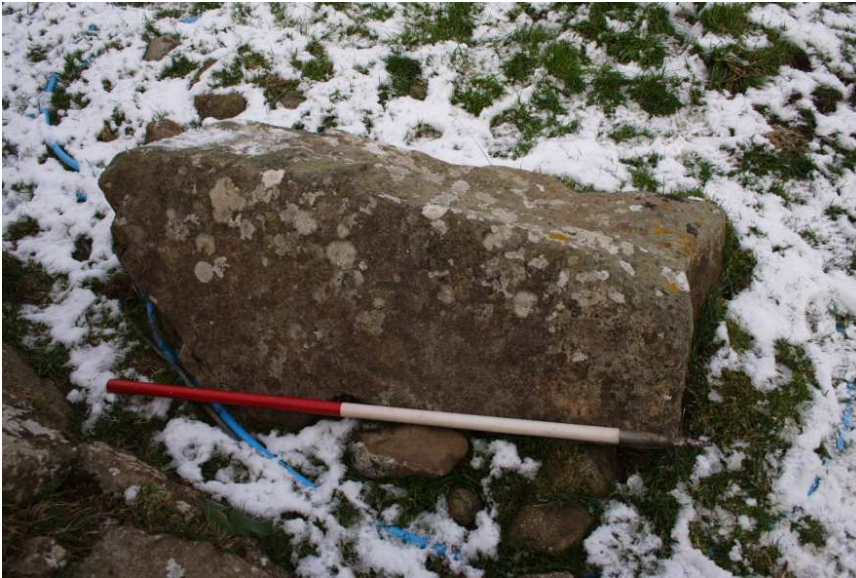
A recumbent monolith measuring 1.2m long by 0.5m by 0.6m lying on the ground next to the hedgebank in a field adjacent to the east side of the track leading to Garn Folch cottage. A local resident came across the stone in 1972 and wrote to J M Lewis, the then Assistant Keeper at the National Museum of Wales in Cardiff, saying that she thought it had been inscribed with a cross. J M Lewis wrote back saying that it could be an early Christian monument and that he would visit the site; however he forgot about the site for a number of years (until 1976) eventually informing DAT of its existence and it was then included on the HER. A site visit was eventually undertaken in late November 2010! There are definite scratches on the stone, but these appear to be the result of either glaciation or perhaps machine derived; with a very keen eye of faith it may be possible to discern a cross but I could not. It was too cold to make a rubbing, but that may decide the matter once and for all. Probably not an antiquity. Nancy Edwards did not include it in her 2007 study of Early Med. Inscribed Stones.

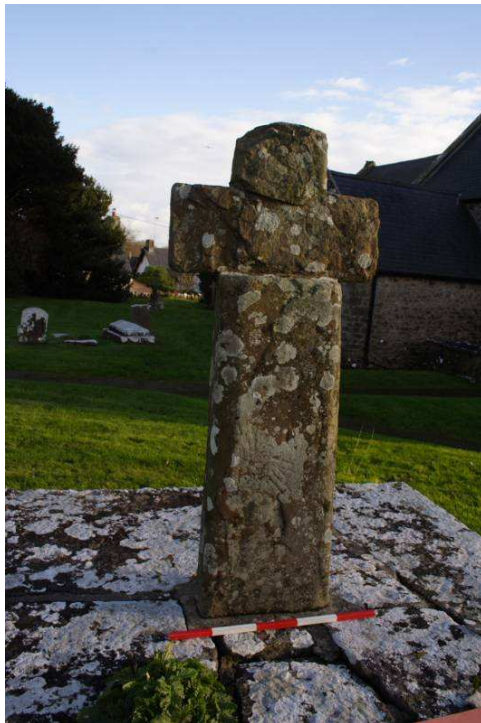
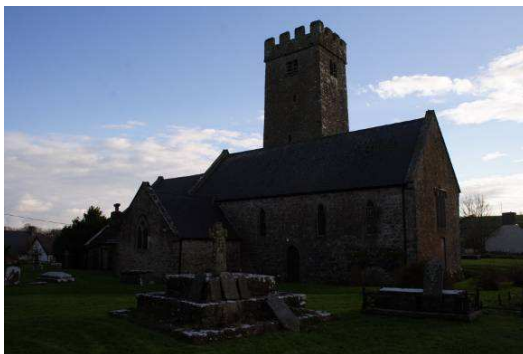
A restored three-stepped 3.53m square by 1.0m high masonry base surmounted by a 1.14m high simple Latin stone cross is situated some 10m to the north of the NW corner of St. Florence church. The cross comprises a 0.8m high chamfered shaft, which tapers up from 0.32m to 0.28m in width, topped by a 0.47m wide by 0.34m high cross-head that appears to have been fractured and repaired (the upper arm has been cemented onto the horizontal cross-arms). The cross elements are all very weathered and appear oval in section as a result, even though they are all chamfered and were originally octagonal in section. There are several radiating lines incised on the west face of the shaft, which may be the weathered remains of original ornamentation.

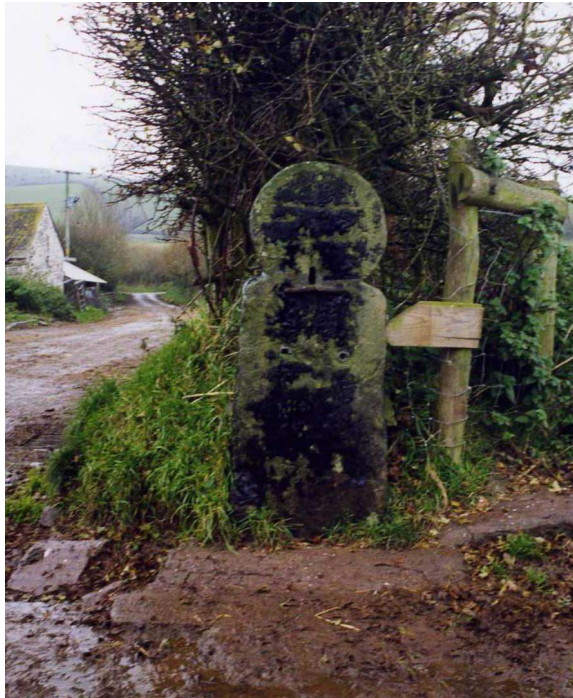
A c.1.2m high by 0.4m wide stone carved into the shape of a wheel-headed cross, with sculpted ornamentation, and used as a gatepost on Mwche farm, was discovered during an archaeological appraisal for the Tir Gofal farm scheme (DAT Report No. 39110) in 1999. A site visit in December 2010 established that the stone is still in the same location but has been partly buried beneath a new hedge boundary leaving only its upper half exposed (the photograph shows how it appeared prior to the creation of the new boundary). The stone is quite clearly a 'rough-out' for a cross; could be associated with the Pilgrims Graves at St. Michael's church, Trefenty (PRN 61397) or the nearby Pilgrims Rest at St. Teilos church at Llandeilo Abercowyn (PRN 2186). Could also have functioned as a roadside preaching cross on the important medieval pilgrims route to St. Davids.

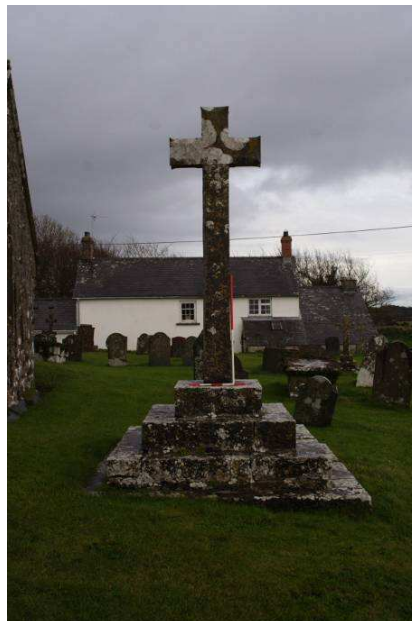
A 2.3m square by 0.93m high four-stepped masonry base surmounted by a 2.5m high Latin cross stands in the churchyard to the south of St. Twynell's church. The cross comprises a 1.98m high broached octagonal stone shaft topped by a 0.83m wide by 0.52m high concavely chamfered equal-armed cross-head. The cross appears relatively unweathered and in good condition which suggests that it may be relatively modern, so too the base. The cross has Grade II Listed building status.

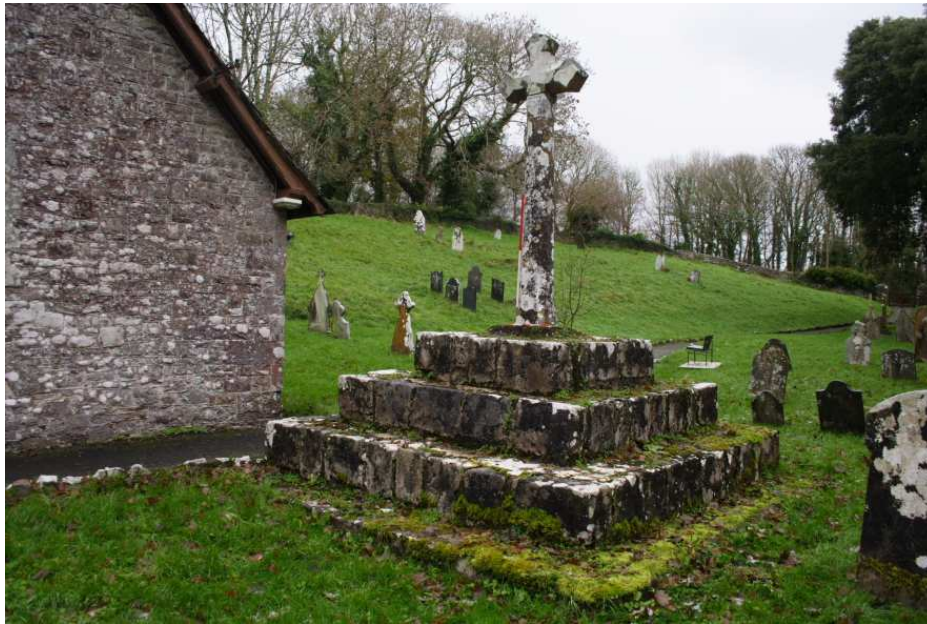
A c. 3.7m square by 1.29m high four-stepped masonry base surmounted by a 2.66m high Latin cross stands in the churchyard 1.5m to the south of the southeast corner of St. Elidyr's church. The octagonal chamfered stone cross shaft is 2.02m high and tapers from 0.3m by 0.26m at its base to 0.2m by 0.2m at the top. The horizontal cross-arms, a single element measuring 0.82m long by 0.2m high and 0.2m deep, are finely chamfered with diamond-square carved pointed ends. The top vertical cross-arm, also a single element, is chamfered with a pointed end and measures 0.32m high, 0.26m wide and 0.2m deep. The cross-arms are considered to be modern; the shaft is in very good condition but may be original. The shaft is set centrally into the base by shuttered concrete. The cross has Grade II Listed building status.
