MEDIEVAL AND POST-MEDIEVAL CROSSES

A THREAT-RELATED ASSESSMENT 2010-11

Prepared by Dyfed Archaeological Trust
For Cadw

RHIF YR ADRODDIAD / REPORT NO. 2011/1
RHIF Y PROSIECT / PROJECT RECORD NO. 100384

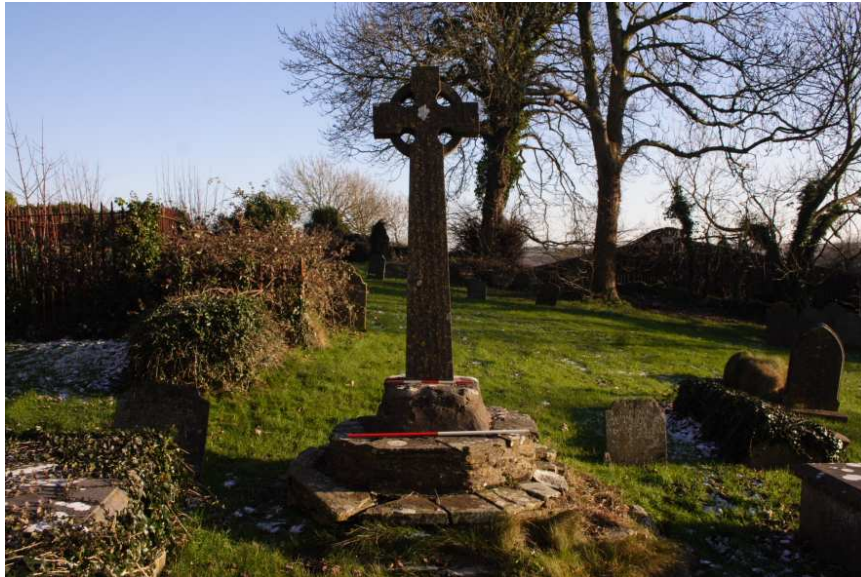
Some 9m south of the church chancel, in the churchyard, is a 19th century monolithic Celtic cross surmounting a roughly square tapering socket stone centrally situated on a four-stepped octagonal rubble masonry base. The 0.6m square chamfered socket stone is very weathered and may be an original medieval feature. The stepped base is much in need of consolidation and may also be an original feature. The cross has Grade II Listed building status.

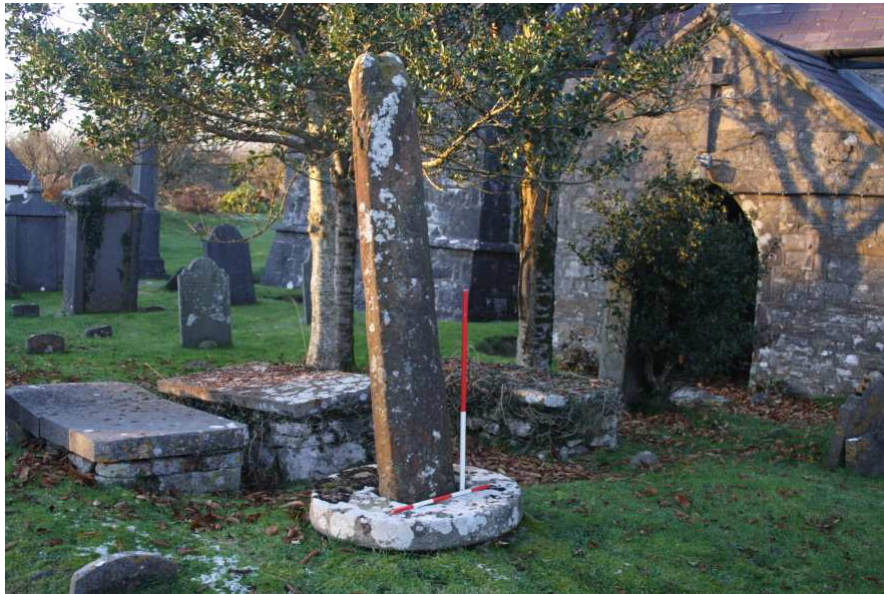
In the churchyard, close to the south porch of St. Lawrence's church, is a circular socket stone containing a leaning (to the south) monolith considered to be the remnant shaft of a medieval churchyard cross. The shaft is of red sandstone and measures 2m long, tapering up from 0.29m by 0.24m at the bottom to 0.2m by 0.18m at the top; the edges of the stone are chamfered suggesting that it was at one time octagonal in section though it now appears more rectangular, with softer edges effected by the chamfering. At the top of the shaft there is a centrally located carved rectangular socket (mortise) measuring 4cm by 3cm and c. 2cm deep, which may have previously held a cross-head. Additionally there are two small circular drilled holes close to the top of the shaft on its west side. The socket stone, of light grey coloured sandstone(?), has a diameter of c. 0.67m and is c. 0.4m high; roughly centrally located is a 0.23m by 0.33m rectangular socket cut through the stone which accommodates the shaft monolith. The socket stone has the appearance of a millstone and is near perfectly worked. The monument has Grade II listed status.

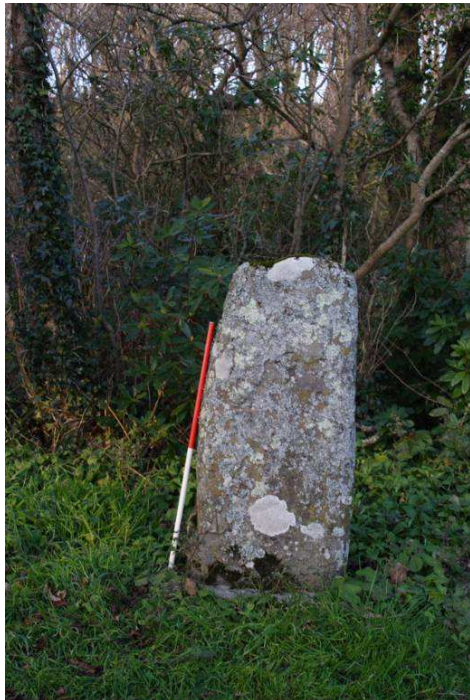
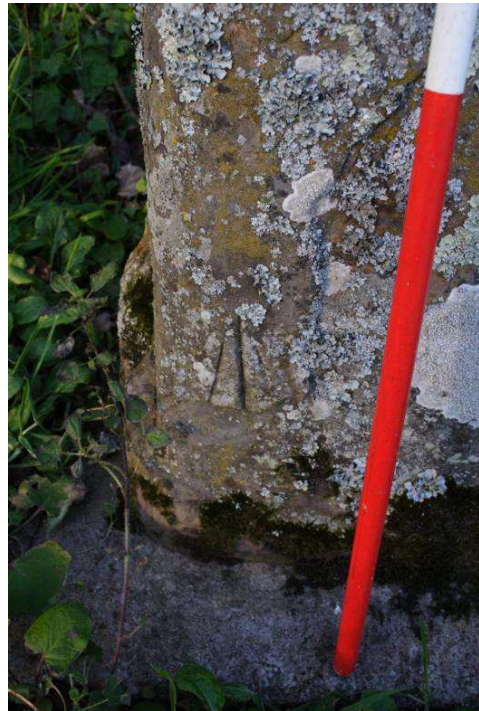
A sandstone monolith 1.29m high by 0.6m (tapering to 0.47m wide at top) by 0.25m set in concrete and overlooking the grounds of Dale Castle downslope to the south. The stone formerly stood at the intersection of Dark Street and High Street in Haverfordwest (at NGR SM 9526 1559) and is said to have been inscribed to the memory of one William Nichol who gained martyrdom by fire there in April 1588 as a Protestant under Queen Mary. The stone is much weathered now and suffering from ongoing flaking; the only possible trace of an inscription are a few lines carved into the stone on the bottom left corner of its southern face. Heavy lichen growth may be obscuring any further evidence of inscription. The stone was moved from Haverfordwest for 'safe keeping' sometime in the mid 19th century. In 1912 a machine-polished and inscribed red Balmoral granite pillar (PRN 3010) was erected at the original site in Haverfordwest to renew the commemoration, and stands there to this day.
