Marys Peak

Bonneville Power Administration Communications Site Project

Draft Environmental Assessment
October 13, 2020

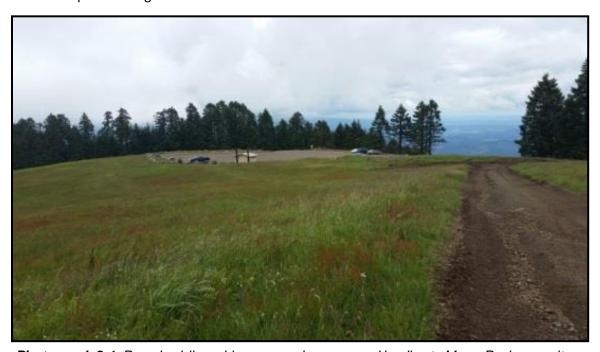
The BPA communications site is accessed by an unpaved 0.65-mile long access road that begins at the paved public parking lot located below the Marys Peak summit (Photograph 2-1). Vehicle access to the unpaved road to the summit is restricted by a locked USFS gate near the parking lot. Most of the access road is on USFS lands, but about 0.18 mile (948 feet) is on BLM lands. The road is not maintained on a regular basis. It is about 12 feet wide and rutted and scoured in some areas. The access road also serves as a public hiking trail.

Photograph 2-1. Paved public parking area and access road leading to Marys Peak summit.

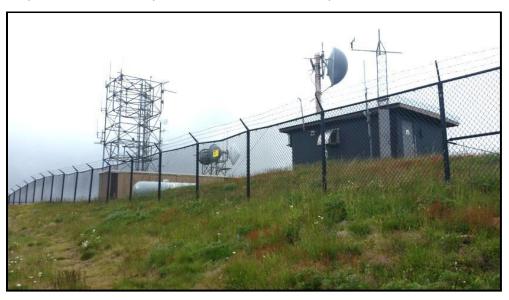
Photograph 2-6. Marys Peak communications site, looking west.

Two structures are located on the south side of the BPA communications building (Photograph 2-6). A BPA anemometer is attached near the top of a 20-foot tall structure that is bolted to a concrete footing. The second structure, owned and maintained by BLM, is a 15-foot tall steel pole with a 6-foot long VHF whip antenna and a temperature and relative humidity meter.

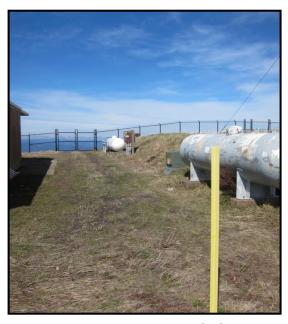
Photograph 2-7 (left). The electrical station service pedestal with BPA and USFS meters. **Photograph 2-8.** BPA propane tank (foreground right) and USFS propane tank (background).

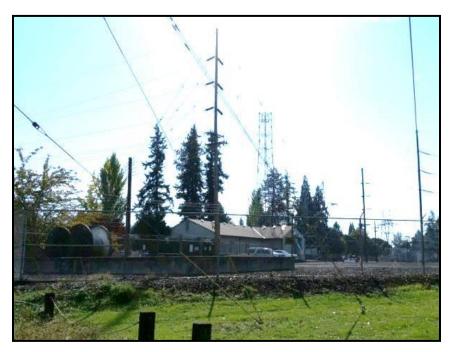
Photograph 2-11. BPA Albany Substation viewed from Hazelwood Park.

The BPA Albany Substation is located about 1 mile west of U.S. Highway 99 on Queens Avenue SW, in the City of Albany, Linn County, Oregon. The substation is located within a chain link fence immediately adjacent to Queens Avenue SW, the Calapooia River, and Hazelwood Park and directly across the road from Chase Orchards Subdivision (Photograph 2-11). Under Alternative 2A and Alternative 3C, some work would be conducted at the BPA Albany Substation.

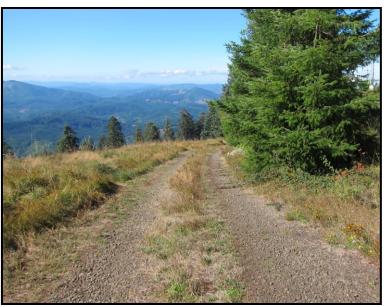
Photograph 2-13. West Point Spur access road NF-112, facing west.

The CPI site is accessed from an unpaved National Forest road (NF-112; Photograph 2-13) which begins at a gate off of Marys Peak Road about 7.2 miles from Highway 34. NF-112 is about 0.37 miles long between the gate and the CPI site. About half of its length is on SNF lands; the other half is on City of Corvallis lands. NF-112 is currently not regularly maintained by either landowner. It is rutted in some areas but usable for maintenance vehicles.

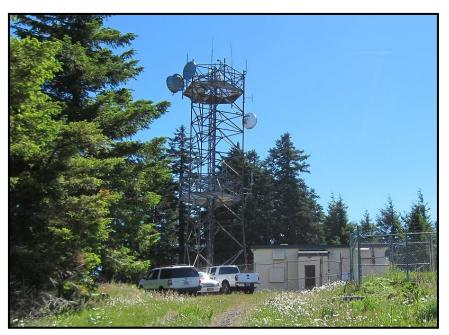
Photograph 2-14. CPI West Point Spur communications site, facing east.

a building with equipment, an approximately 80-foot tall steel-lattice structure that supports microwave communications dishes and two VHF whip antennas, and a diesel tank protected under a steel cover (Photograph 2-14). The 0.25 acre site is surrounded by a chain link fence. Vehicles generally park in the graveled area immediately outside the fence.

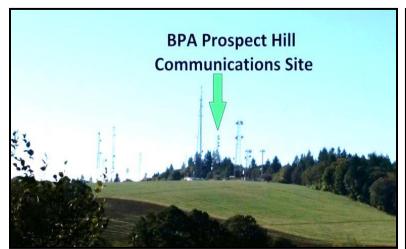
Photograph 2-15 (above). BPA Prospect Hill communications site and nearby communications sites owned and managed by other entities.

The BPA Prospect Hill communications site is located about 5.3 miles west of Interstate-5, and about 7 miles southwest of downtown Salem in Marion County, Oregon. There are other non-BPA communications sites at Prospect Hill, (Photograph 2-15). Under Alternative 4, some work would be conducted at the existing BPA Prospect Hill communications site.

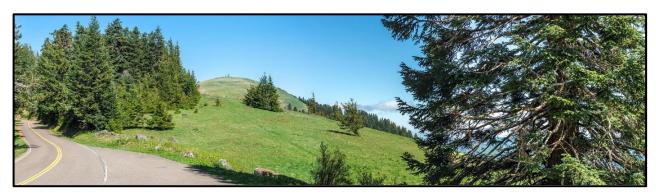
Because most of Marys Peak Road travels through dense forest, Saddle Meadow pullout provides the first opportunity for visitors to stop and engage in prolonged, unobstructed views of the Marys Peak summit (Photograph 3-16). The landscape is characterized by an upland meadow, sloping to the south, bordered by mixed conifer forests in the foreground. Marys Peak creates a discrete, rounded skyline. The existing USFS communications structures are silhouetted against the sky, appearing grey and silver in color and smooth in texture, with distinct vertical lines that contrast with the coarser textures and colors of the meadow. Other communications site facilities are shorter in stature, and appear broad in form and white in color. The fence around the facility is evident, but not a dominant feature.

Photograph 3-16. View of the Marys Peak summit from Marys Peak Road at Saddle Meadow pullout (KVA 1), looking east-southeast.

The scenic integrity is low to moderate because, although the landscape character is naturally appearing, the existing communications facilities are co-dominant with the valued landscape character.

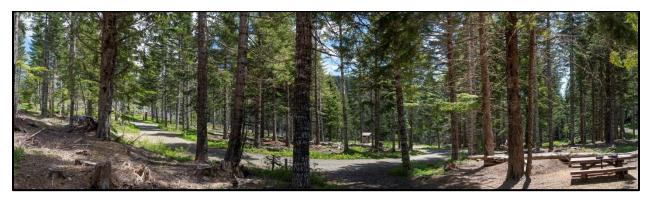
At Marys Peak Campground, Campsite #2 has a distant view of the summit of Marys Peak (Photograph 3-17). The landscape is characterized by the dense stand of conifers which appears uniform and creates a sense of enclosure. Views are limited to the immediate foreground and the shallow slope of the campground is juxtaposed against the steeper slopes of Mary Peak. The camping facilities introduce curvilinear lines (campground road) and geometric forms (sign posts and restroom).

Photograph 3-17. Viewfrom the Marys Peak Campground (KVA 2), looking southeast.

The USFS communications structure on Marys Peak appears silhouetted through the trees but it is subordinate to the dense forest in the foreground and middleground. The scenic integrity of the landscape is medium because, although the campsite facilities and road are evident, they are visually subordinate to the surrounding forest and, although the USFS communications structure can be seen through the dense forest canopy from some locations within the campground, it is not focal to the view.

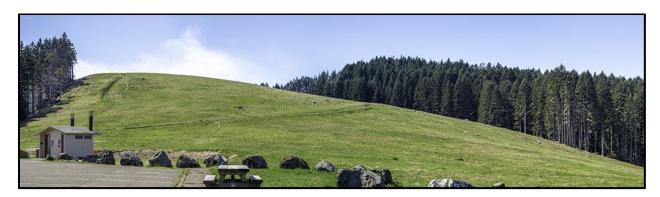
From the public parking area there is a view toward the summit of Marys Peak (Photograph 3-18). The parking lot and associated viewpoint provide the first opportunity for visitors to experience views from Marys Peak and serves as a gateway for their recreational experience. The landscape is characterized by the juxtaposition of a broad sloping meadow enclosed by surrounding coniferous forest and, to the east, by the broad panoramic view of the Willamette Valley and Cascade Mountains. The summit of Marys Peak is screened by dense conifers. The access road and recreation facilities are evident, but do not dominate the landscape. Viewers at this location are expected to engage in prolonged views to the east and more intermittent views of Marys Peak.

Photograph 3-18. View from the public parking area off Marys Peak Road (KVA 3), looking south-southwest.

The parking lot is broad and rectilinear, with grey asphalt appearing rough in texture. The facilities appear geometric, but small in scale, such that the straight lines and smooth texture remain subordinate to the surrounding landscape. The top portion of the existing USFS communications structures can be seen above the forest stand and are apparent in the skyline. The scenic integrity of this KVA is high because, although recreational facilities are evident looking to the southwest, the landscape character of Marys Peak appears natural.

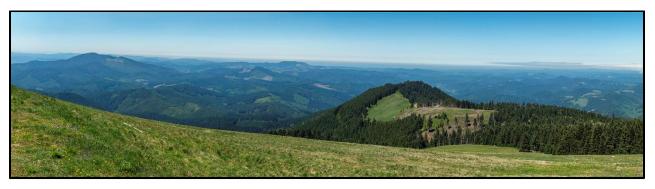
At the summit of Marys Peak, the view to the west includes the West Point Spur communications site and beyond (Photograph 3-20). The landscape is characterized by the sloping open meadows in the foreground and middleground, with expansive Coast Range panoramic views to the Pacific Ocean.

Photograph 3-20. View from Marys Peak summit access road (KVA 7), looking west-northwest.

Though evidence of modification exists in the form of ground scarring in the middleground and timber harvest in the background, these deviations appear subordinate to the broader landscape character of the Coast Range. The existing communications structures on West Point Spur are apparent, as their tall, vertical forms extend above the tree line and their grey color and smooth texture contrast with the regular texture and green color of the conifers. The scenic integrity is low to moderate because, although the landscape character appears natural, deviations such as the ground scarring areas are codominant.

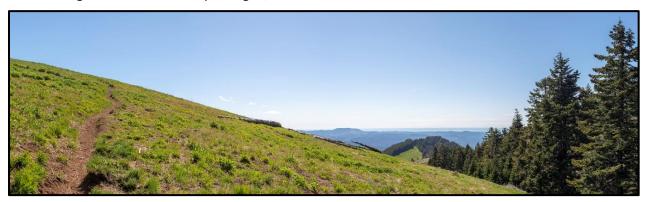
Along the Meadowedge Trail, hikers cross the steeply sloping West Meadow below Marys Peak which dominates the landscape character (Photograph 3-21). The brown color and soft texture of the exposed dirt of the trail contrasts with the green color and regular tufted texture of the meadow, creating a distinct, irregular line leading to the summit. The forest creates a discrete edge to the meadow where the vertical structure of the coniferous trees meets the meadow vegetation. Viewer experience on the Meadowedge Trail is considered prolonged, as views would be sustained as hikers cross the meadow.

Photograph 3-21. View from the lower portion of the Meadowedge Trail (KVA 8), looking south.

The communications structures located at West Point Spur are visible from the Meadowedge Trail, rising above the coniferous forest, against the western horizon. The Marys Peak communications structures appear silhouetted against the rounded horizon of the Marys Peak summit. Scenic integrity is moderate because the communications structures are subordinate to the natural character of the Marys Peak landscape.

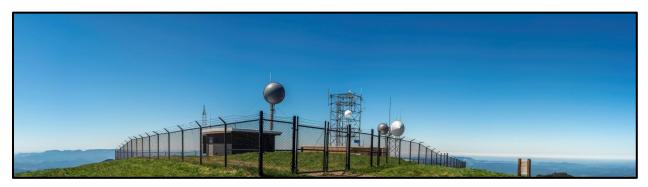
From the northeast corner of the communications site at the Marys Peak summit, viewers have a 360-degree panoramic view of the surrounding landscape (Photograph 3-22). The landscape is characterized by the flat, grassy top of Marys Peak in the foreground, which slopes moderately downward on all sides.

Photograph 3-22. View from the Marys Peak summit picnic table (KVA 9), looking southwest.

The existing Marys Peak communications facilities are a dominant feature at this location, with the communications site occupying the majority of the summit. The facility appears industrial, with tall steel-lattice structures and buildings that appear spread out and lack order, all surrounded by a chain-link fence topped with barbed wire. The facility introduces geometric forms, vertical horizontal lines, and smooth textures that contrast with the softer lines, green colors, and coarse textures of the surrounding landscape. Views to the west are partially obstructed by the communications facility, with the backdrop extending across the Coast Range to the Pacific Ocean. Although some viewers may be accustomed to the communication facility, a high sensitivity to potential change in the viewer experience is assumed. The scenic integrity is very low because the industrial appearance of the communications structures dominates the landscape character.

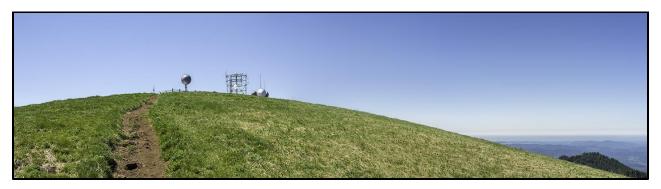
At the intersection of the Summit Trail and Meadowedge Trail, the Summit Trail emerges from the forest and continues through the meadow to the summit (Photograph 3-23). When hikers emerge out of the forest, Marys Peak is directly in front of the viewer, dominating the experience. The Meadowedge Trail leads down the open meadow to the west, into the forest. The landscape is characterized by the grassy meadow, communications structures, and broad horizon of the Coast Range and Pacific Ocean. The exposed dirt of the trail contrasts with the surrounding green meadow, creating a distinct line and directional line leading to the facility. The stippled-coarse coniferous forest of West Point Spur is visible in the middleground to the west. Beyond West Point Spur, the panoramic view extends west across a smooth patchwork of timber harvest and forest to the Pacific Ocean.

Photograph 3-23. View from the intersection of Marys Peak Summit Trail and Meadowedge Trail (KVA 12), looking southwest.

When approaching the summit, the Marys Peak communications structures are focal, unobstructed and silhouetted against the panoramic backdrop of the Coast Range. The existing communication structures disrupt the smooth arc of the Marys Peak Summit, appearing discordant. Scenic integrity is low because the smooth texture and rounded form of the microwave dishes attract attention and, collectively, communications structures dominate the landscape character in the foreground to middleground.

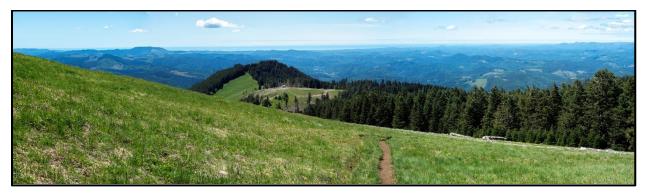
Photograph 3-24. View from the upper portion of Meadowedge Trail (KVA 13), looking west.

Scenic integrity is predominately moderate in the foreground and middleground because ground scarring from timber harvest is visible and dominates the foreground. One small structure and its access road are visible at the clearing in the middleground. The existing communications structures associated with West Point Spur are apparent, as their tall, vertical forms extend above tree line. The light grey color and smooth texture of the structures contrast with the surrounding soft to coarse texture and green color of the vegetation. Looking to the west, the landscape character appears natural, but

The upper portion of the Meadowedge Trail is immediately below Marys Peak, to the west of the existing communications site (Photograph 3-24). While similar to the view from the summit of Marys Peak, looking west, the location is in closer proximity to West Point Spur. The landscape is characterized by open meadow and forest mosaic in of the foreground/middleground and the expansive western panoramic view in the background. The bold color and form of the meadow and contrasting forest edge creates a sense of enclosure that creates dominance in the foreground landscape. The foreground appears as a steep, grassy meadow bordered on the northern side by dense coniferous forest. The panoramic view of the Coast Range and pattern of open meadows, timber harvest, and dense forest, provides context to the landscape features in the foreground-middleground. The view extends across the ridgelines to the Pacific Ocean. Viewer experience on the Meadowedge Trail is considered prolonged, as views would be sustained while hikers cross the meadow.

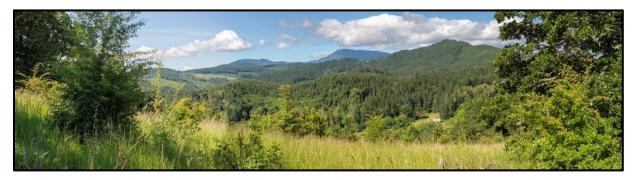
Photograph 3-26. View from Wren Hill (KVA 5), looking southwest.

Primary viewer groups from this KVA are the residents of the Wren Hill Residential Estates. Viewer experience is considered prolonged to sustained from residential areas. Viewer concern is considered high, as the viewshed is considered central to the character and quality of this residential area. The scenic integrity is considered medium because, although the valued landscape character appears slightly altered due to past timber harvest, these features are subordinate to the rugged forest landscape of the Coast Range and the existing communications structures at Marys Peak are not visually evident.

KVA 5 is located at a cul-de-sac at the west end of Wren Hill Residential Estates, on a steep slope of the northern edge of Highway 20, within an oak savanna (Photograph 3-26). Large estates are terraced between the oaks. Views extend to background distance zones, with prominent views of Marys Peak and the forested hills and mountains of the Coast Range. The landscape character of Wren Hill is considered natural appearing, dominated by the forested mountains of the Coast Range. Areas of timber harvest are evident, creating distinct geometric shapes where harvested areas meet mature forest. The varied stand age results in a mosaic of green color and varied texture.

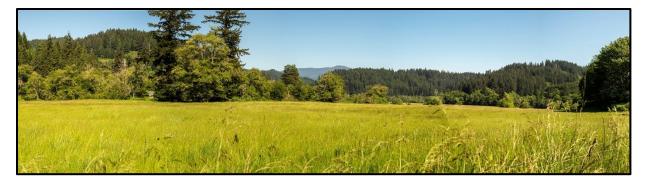
Photograph 3-28. View from the community of Harlan (KVA 11), looking east-southeast.

KVA 11 is located in the community of Harlan, due west of Marys Peak (Photograph 3-28). The landscape is characterized by broad open meadows, enclosed by the forested peaks of the Coast Range. The landscape is natural appearing, with agriculture and modest residential and commercial structures. Marys Peak is a prominent landform in the viewshed; the open meadows at and near the summit appear distinct on the horizon. Existing communications structures at Marys Peak and West Point Spur are visually evident and skylined.

Primary viewer groups in Harlan are residents. Viewer concern is assumed to be medium to high, as potential change to community character could be a concern. Viewer experience is prolonged to sustained from residences and community buildings. The scenic integrity is considered very high, because the surrounding landscape contributes to a sense of place within the Coast Range.

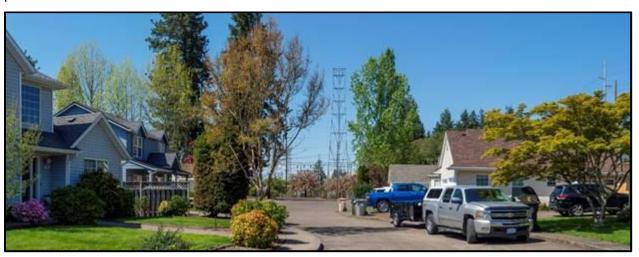
Photograph 3-29. View of the communications structure within the BPA Albany Substation from the residential neighborhood on Orchard Lane (KVA 14), looking west.

Primary viewer groups in the subdivision are residents. Viewer concern is assumed to be high, as potential change to community character could be a concern. Viewer experience is sustained from residences. Views of the communications structure are considered direct but would vary depending on location within the neighborhood. Residents have some views of the steel-lattice structure from their homes, driveways, and yards. Intervening vegetation, such as tall conifers, block some views. The scenic integrity is considered very low-moderate, because the communications structure and electrical infrastructure within the BPA Albany Substation are evident in the backdrop of neighborhood. While they detract from the intactness of the residential neighborhood character, this infrastructure was present before the subdivision was constructed.

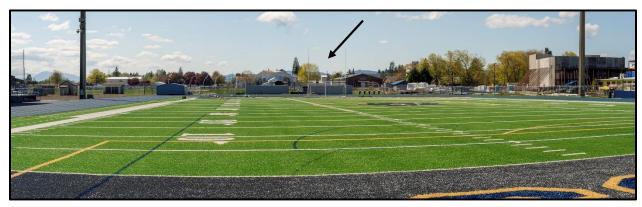
The primary viewer groups associated with KVA 15 are assumed to be students and spectators. Viewer concern is assumed to be low, as viewers' attention is focused on activities in the field. Viewer experience is sustained and views of the communications structure are considered direct but in the distance. The scenic integrity at West Albany High School (KVA 15) is considered medium. The communications structure is detectable in the backdrop due to the straight, narrow, and vertical line (see Photograph 3-30); however, it appears subordinate to the foreground features.

Photograph 3-30. View of the communications structure within the BPA Albany Substation from the West Albany High School (KVA 15), looking west.

KVA 15 is located about 0.5 miles east of the BPA Albany Substation (Photograph 3-30). West Albany High School is characterized by the school buildings and surrounding residential neighborhoods and includes a football field and track. Views from this KVA are dominated by the flat surface and horizontal lines of the football field and irregular horizon formed by houses and treetops in the distance.

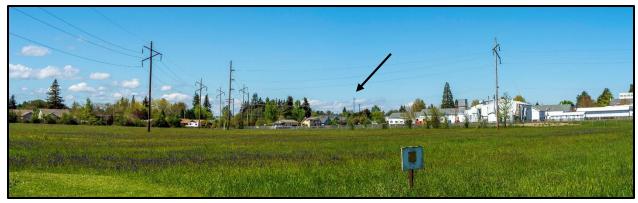
The primary viewer group associated with KVA 16 is assumed to consist of residents. Residents would have sustained views and their level of viewer concern is considered high. The viewer experience for motorists is considered transient, primarily experienced from a moving vehicle. The views of motorists of the communications structure would be primarily peripheral and from a distance. The scenic integrity is considered low to moderate, influenced by the presence of transmission lines and poles and small-scale commercial buildings. The communications structure at the BPA Albany Substation is subordinate to other existing features in the backdrop, perceptible as a straight, grey, vertical line silhouette.

Photograph 3-31. View of the communications structure within the BPA Albany Substation from Liberty Street (KVA 16), looking west.

KVA 16 is located about 0.4 miles east of the BPA Albany Substation, where Liberty Street passes between open space and a residential area on the east side of Liberty Street (Photograph 3-31). The landscape is characterized by a broad, open meadow enclosed by surrounding residential and commercial structures. The landscape is natural appearing, with elements of the built environment primarily expressed as residential and commercial structures.

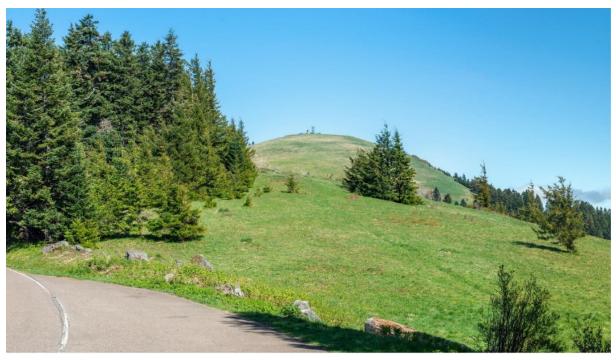
Marys Peak Road at Saddle Meadow Pullout

Alternative 2A Simulation

Overall scenic integrity of the Mary Peak SBSIA would remain the same as existing conditions under Alternative 2A but visual changes would be evident, resulting in a **moderate** permanent impact on scenic resources.

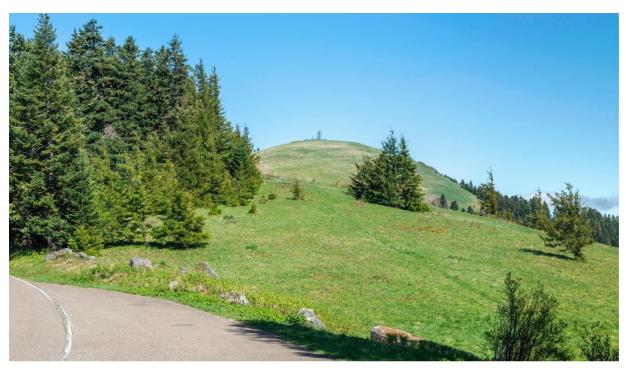
Marys Peak Road at Saddle Meadow Pullout

Alternative 3C Simulation

Actions associated with Alternative 3C would be most evident at the summit, where visual contrast of the proposed structure would be strong due to the proximity, scale, and linear, geometric form and industrial character of the structures relative to the surrounding landscape. Like existing conditions, the proposed structures would be a dominant element in the landscape.

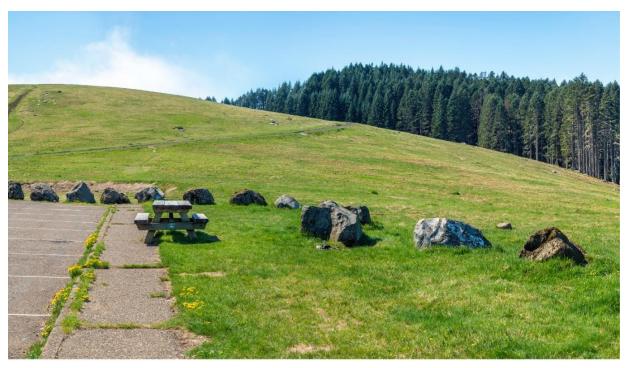
Parking Area at Marys Peak Road

Alternative 2A and 3C Simulation

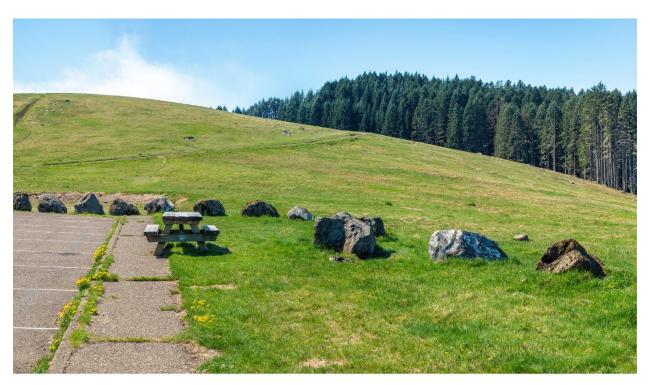
Parking Area at Marys Peak Road

Alternative 4 Simulation

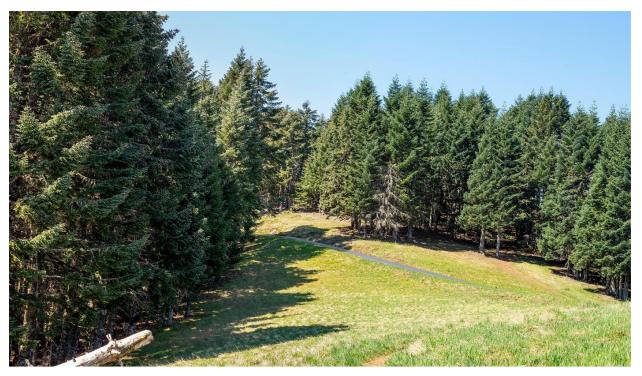
Summit Trail (Lower Portion)

Alternative 2A and 3C Simulation

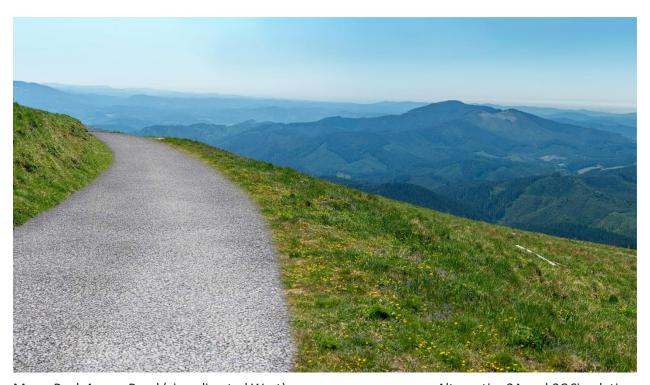
Marys Peak Access Road (view directed West)

Alternative 2A and 3C Simulation

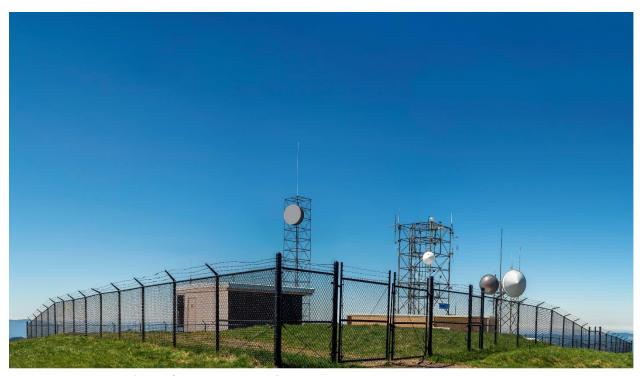
Marys Peak Summit (View from Picnic Table)

Alternative 2A Simulation

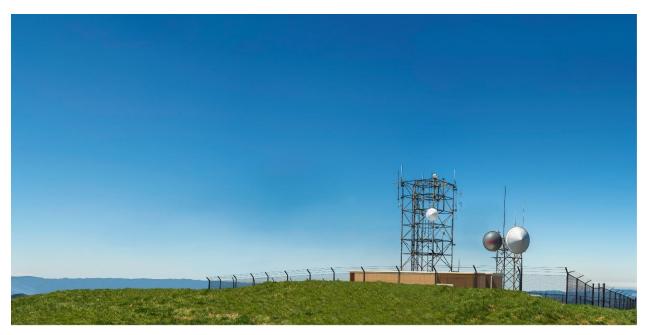
Marys Peak Summit (View from Picnic Table)

Alternative 4 Simulation

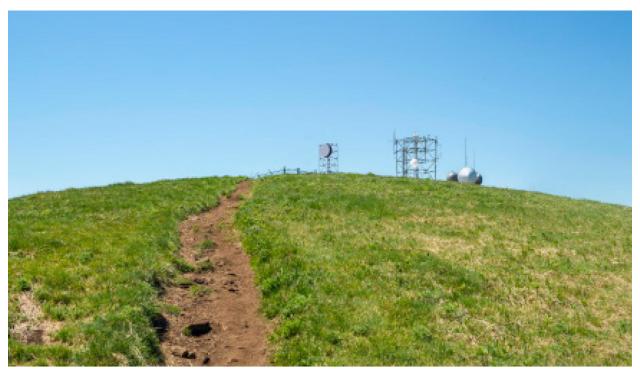
Marys Peak Summit Trail and Meadowedge Trail Intersection

Alternative 2A Simulation

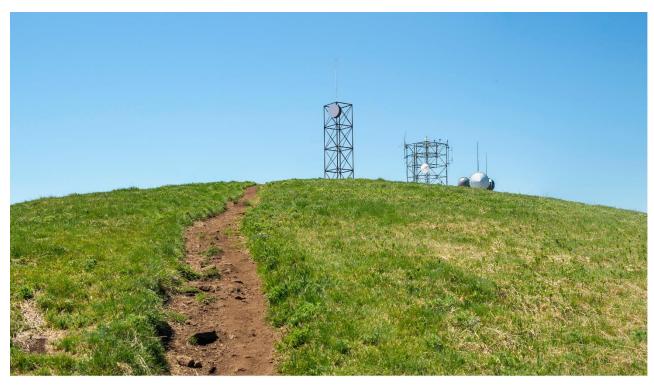
Marys Peak Summit Trail and Meadowedge Trail Intersection

Alternative 3C Simulation

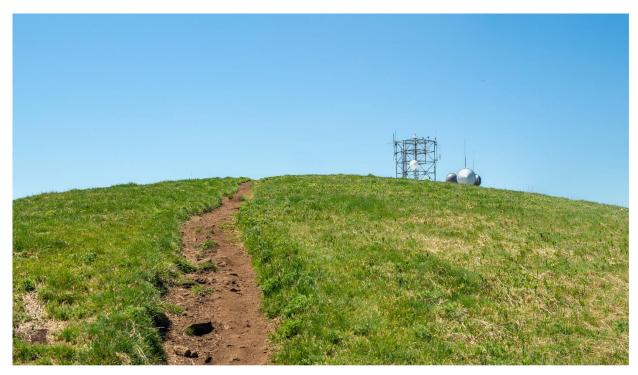
Marys Peak Summit Trail and Meadowedge Trail Intersection

Alternative 4 Simulation

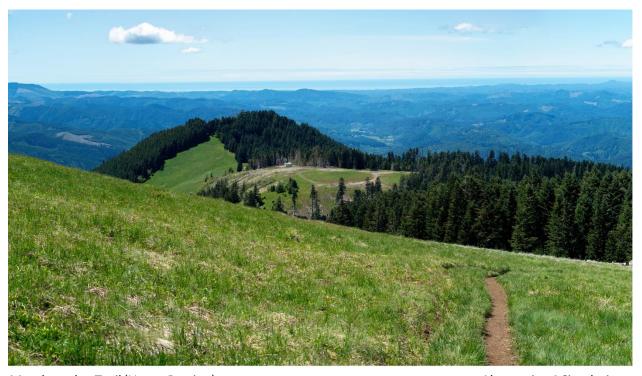
Meadowedge Trail (Upper Portion)

Alternative 4 Simulation

Alternative 4 would result in the least change of all the action alternatives from existing conditions (KVA 13; See Appendix E, page E-13). Equipment added to the existing CPI structure at West Point Spur would not be visible from most of the viewing areas in the Marys Peak SBSIA. Tree cutting at West Point Spur could result in increased visibility of the existing CPI steel-lattice structure from Marys Peak Road, with visibility greatest when the structure is back-lit (e.g., at sunset). Motorists and bicyclists traveling Marys Peak Road would briefly view the tree-cutting area from an inferior viewer position, a **low** impact. Vegetation clearing could also be evident from Marys Peak Road, and from the viewing areas to the west along the lower and upper Meadowridge trail and from the summit. However, overall scenic integrity would not change as a result of Alternative 4 and would remain low to moderate due to the existing ground scarring east of the CPI site. Permanent impacts from Alternative 4 would be **low**.

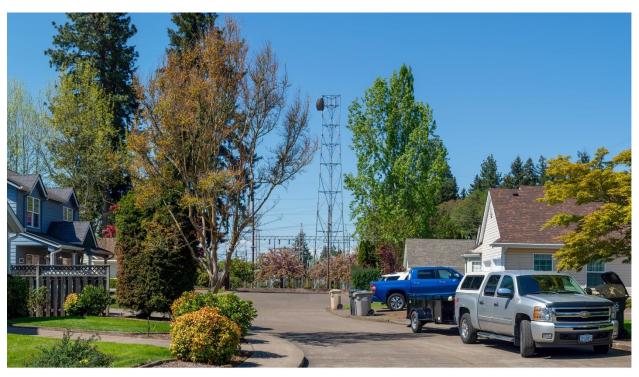
Orchard Lane Alternative 2A Simulation
