**Final
Environmental Assessment
and
Finding of No Significant Impact
for the
Installation and Temporary Operation of
Bypass Pumps at Bonito Lake,
Lincoln County, New Mexico**

U.S. Army Corps of Engineers
Albuquerque District
4101 Jefferson Plaza NE
Albuquerque, New Mexico 87109

March 2013

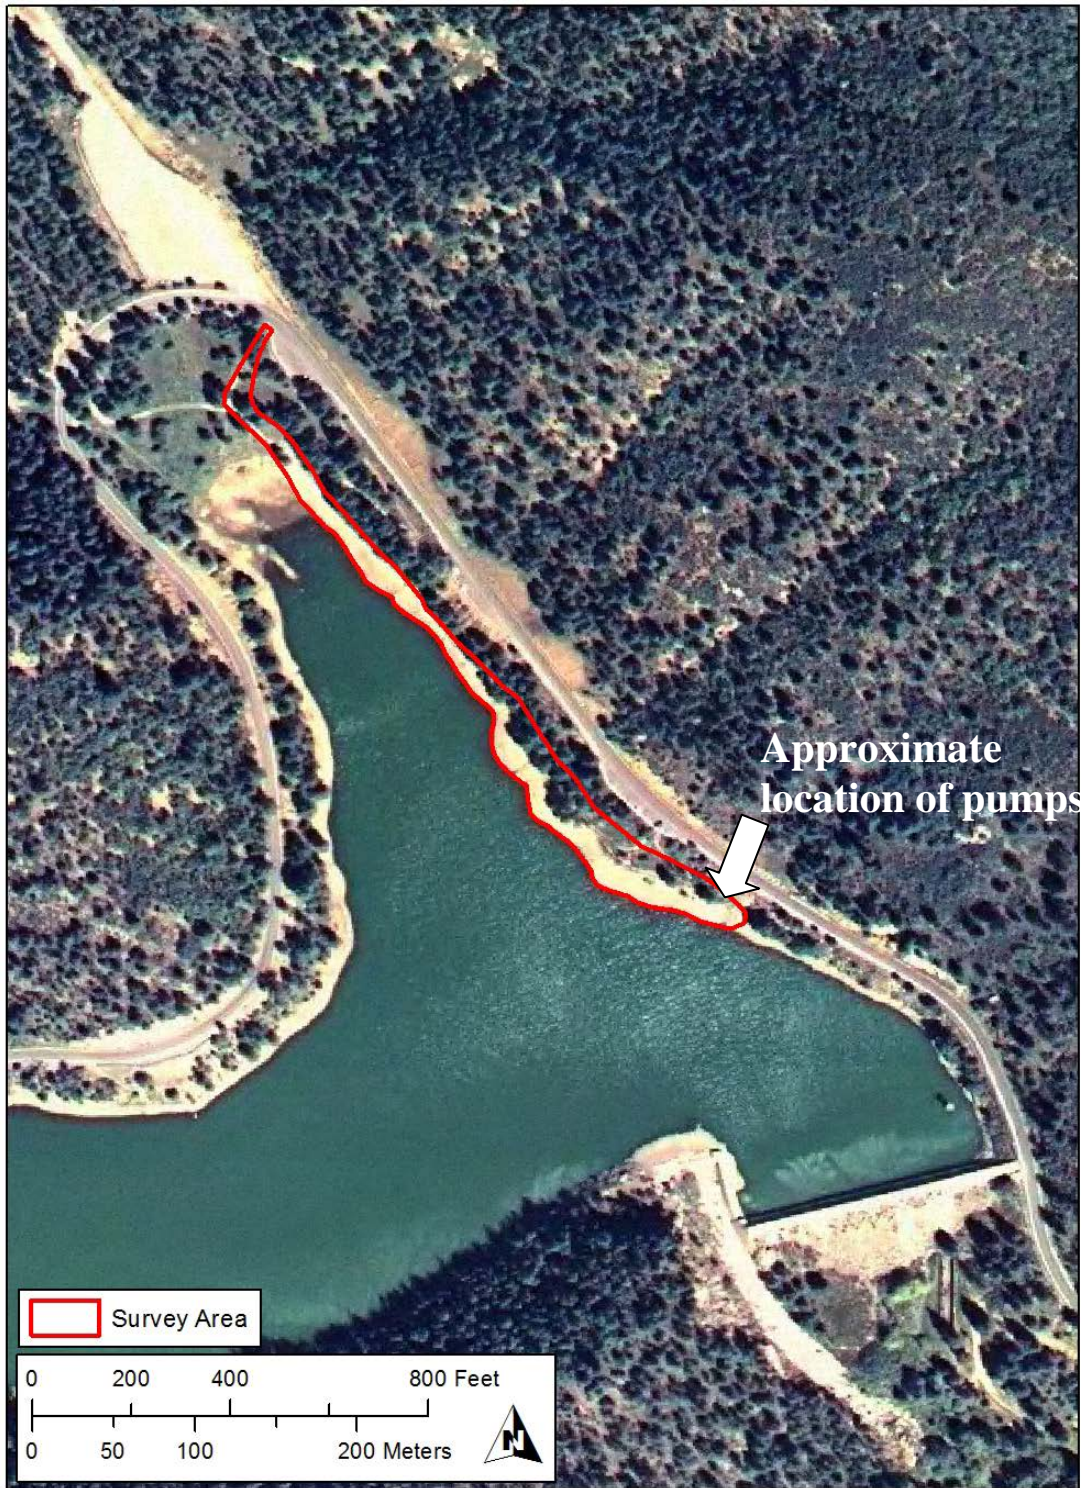
Figure 4. Archaeological Survey Area within the NE 1/4, Section 12, Township 10 South, Range 12 East. Adapted from 2005 NAIF aerial Imagery.

On 30 July 2012, a Corps archaeologist conducted an archaeological survey of the disturbed project area (Figures 3 and 4). The intensive pedestrian survey was conducted by walking linear transects spaced no more than 10 meters apart. No artifacts, cultural features, or historic properties were observed during the Corps survey. The survey covered 100 percent of the project area APE; a total of approximately 2.0 acres. The area has been heavily used for recreational activities, primarily for access to the lake shore for fishing. The project area is located immediately downhill from the Bonito Lake access road. The project area has been heavily disturbed by several past construction projects (Figures 5-10), most notably, the original construction and subsequent maintenance of the access road, now paved, to Bonito Lake that includes construction of bank stabilization structures downhill from the road (uphill from the APE) and the installation of water drainage culverts that drain water from the road surface down to the lake shore. Other construction projects include walkway and stair structures to provide public recreational access to the lake shoreline. In addition, the shoreline area has been disturbed by nearly a century of wave action from the lake. Generally, the hillside is steep and would have been unsuitable for prehistoric or historic occupation. The Corps' negative archaeological survey report entitled *A Cultural Resources Inventory of 2.0 Acres for Emergency Pumping Activities Associated with the Little Bear Wildfire, Bonito Lake, Lincoln County, New Mexico* (Report No. USACE-ABQ-2012-007, NMCRIS No. 125052) was submitted to the New Mexico State Historic Preservation Officer on August 22, 2012. Based on the negative archaeological survey and the prior disturbed nature of the area, the Corps is of the opinion that the use of the access route and pumping/staging area resulted in "No Historic Properties Affected."

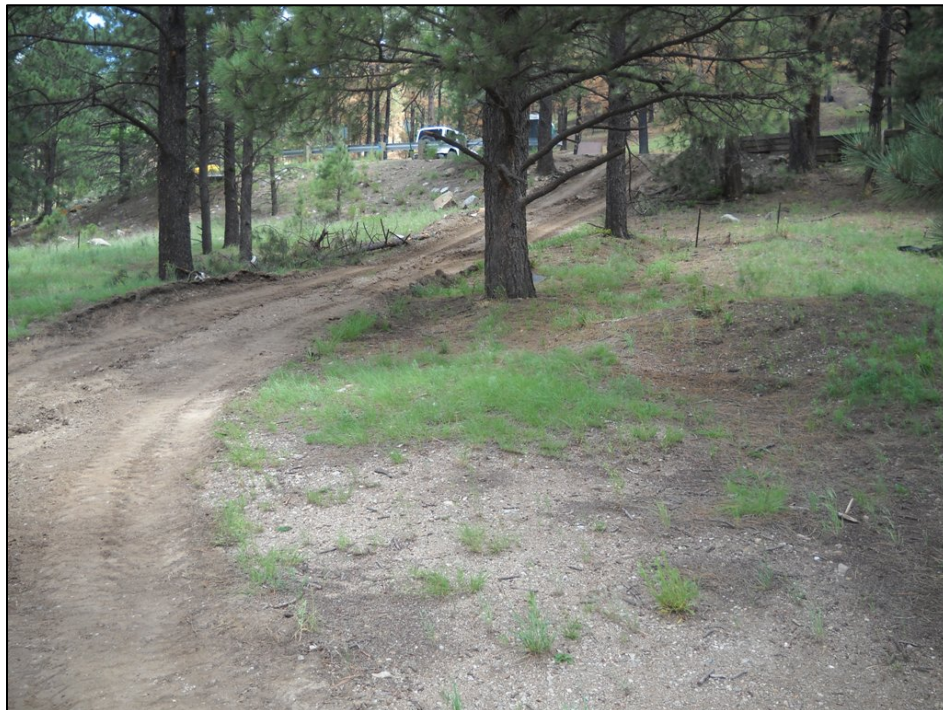
Figure 5. Access point of entry from the paved Bonito Lake road. Photograph No. 4642; 7-30-2012.

Figure 5. Access point of entry from the paved Bonito Lake road. Photograph No. 4642; 7-30-2012..... 18

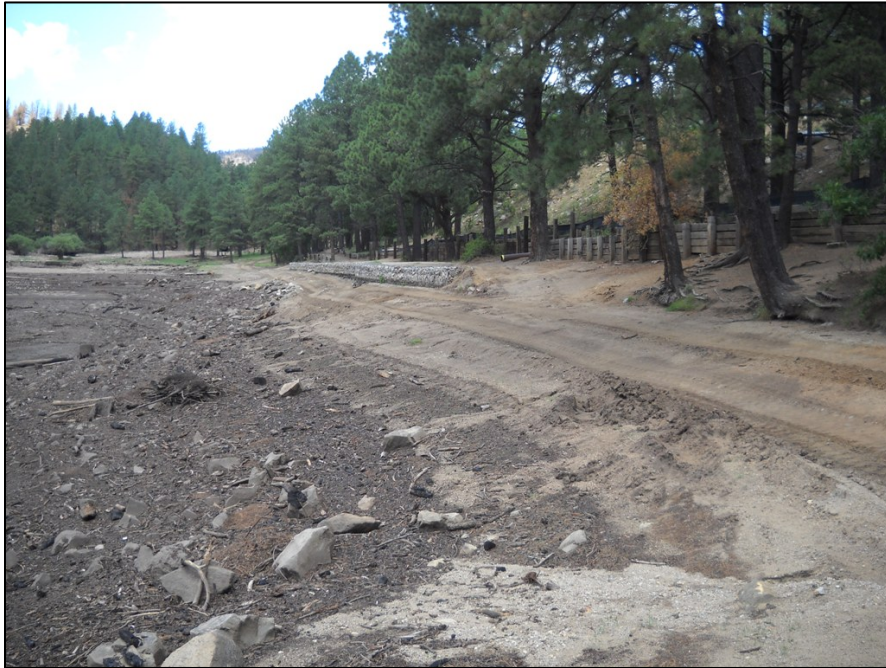
Figure 6. Access route along the east shore of Bonito Lake showing rock-filled gabion baskets for shoreline bank protection, railroad-ties for hill slope protective works, and two roadside rainwater drainage culverts, upper right. View approximately to NW. Photograph No. 4649; 7-30-2012.

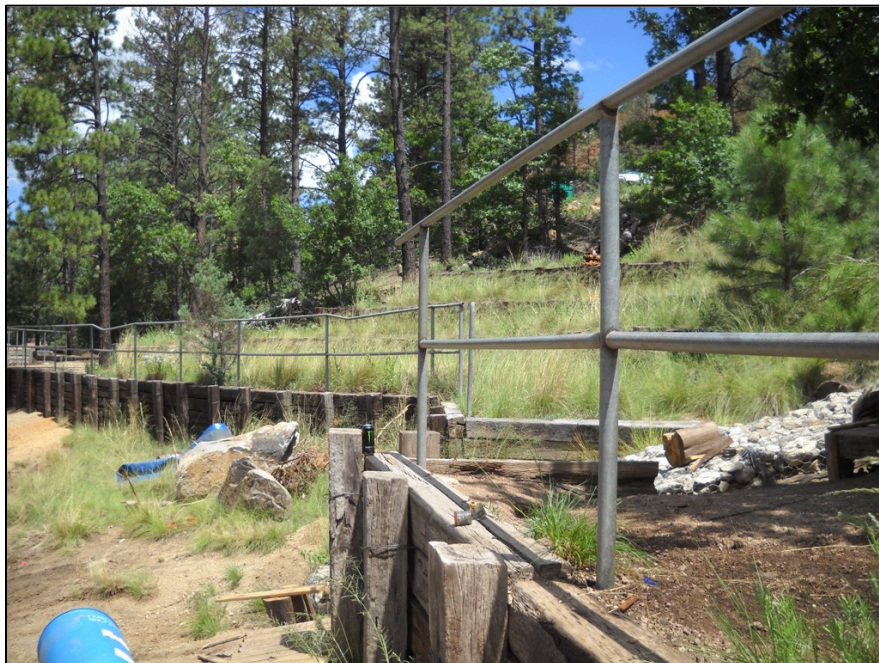
Figure 7. Photograph showing railroad-ties for hill slope stabilization, rock-filled gabion baskets for roadside rainwater drainage, and hand-railing for public access to the Bonito Lake shoreline. View approximately to N. Photograph No. 4631; 7-30-2012.

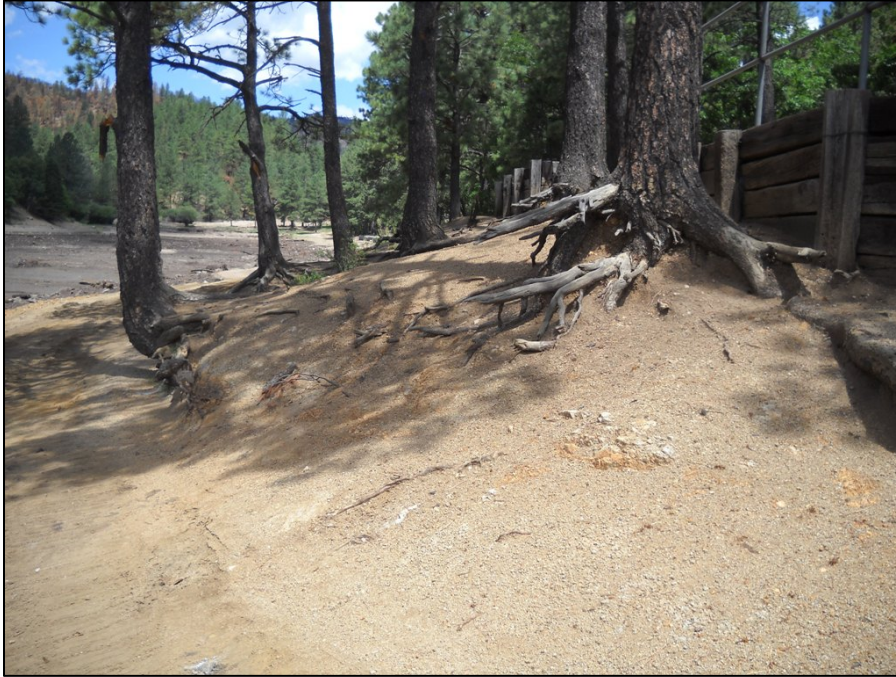
Figure 8. Photograph showing effects of wave action erosion and railroad-tie bank stabilization with hand-railing for public access to the Bonito Lake shoreline. View approximately to NW. Photograph No. 4634; 7-30-2012.

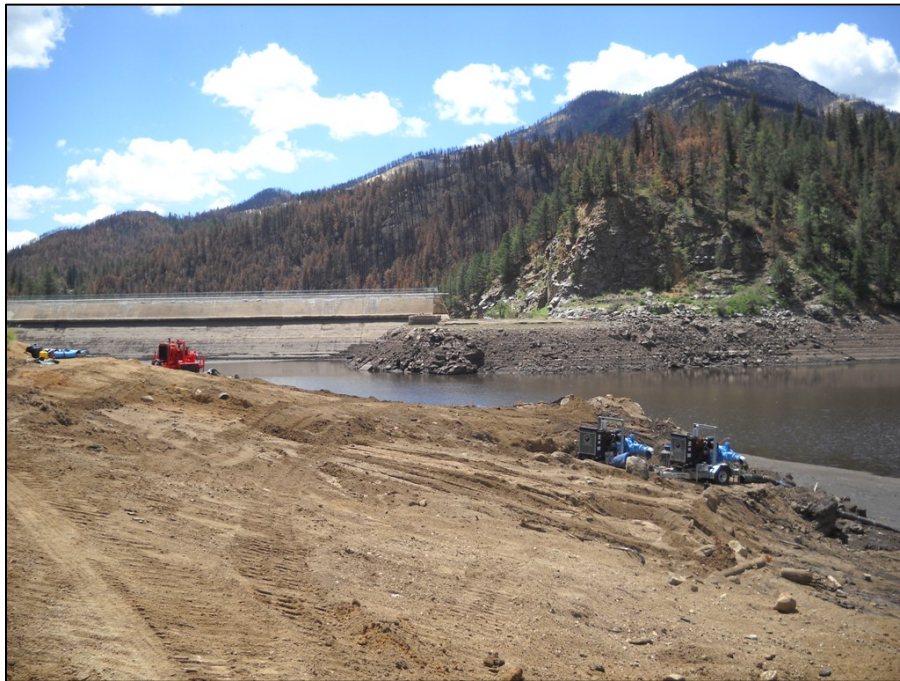
Figure 9. Photograph showing the staging area where fire debris has been cleared and lake side portable pumps have significantly lowered the lake. As lake levels are lowered, the pumps are moved lower. View approximately to S. Photograph No. 4636; 7-30-2012.

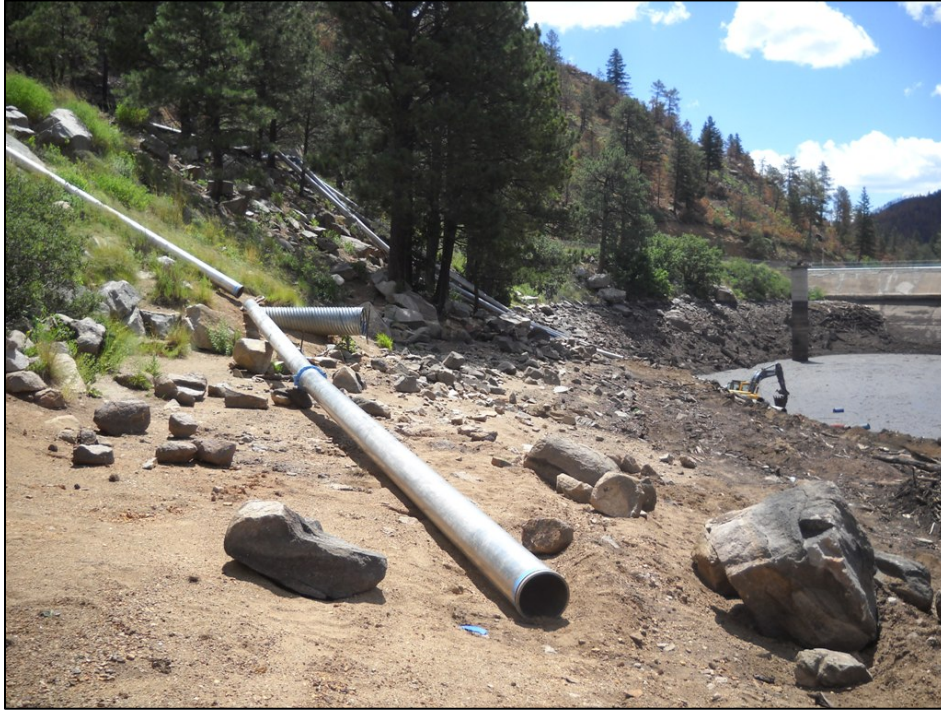
Figure 10. Photograph showing the piping from the pumps that carry water to the Bonito Lake road surface to be delivered downstream. Backhoe in the background is installing a pump closer to the lakeshore. View approximately to SE. Photograph No. 4621; 7-30-2012.
