# Salt-marsh restoration: evaluating the success of de-embankments in north-west Europe

Mineke Wolters<sup>a,b,\*</sup>, Angus Garbutt<sup>b</sup>, Jan P. Bakker<sup>a</sup>

<sup>a</sup> *Community and Conservation Ecology Group, University of Groningen, P.O. Box 14, 9750 AA Haren, The Netherlands*

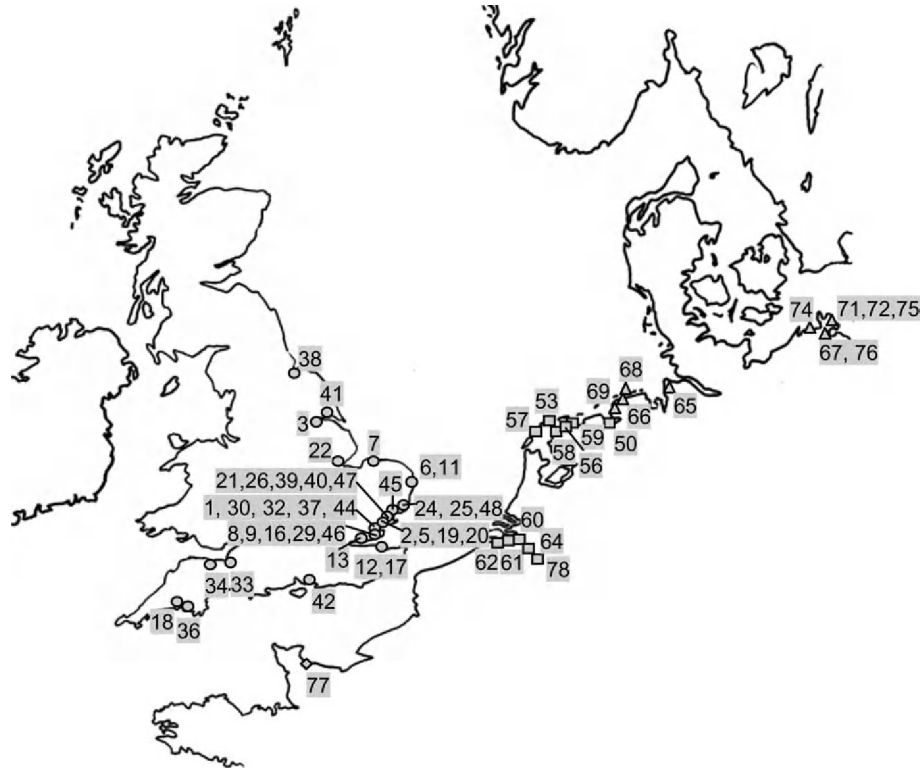
Fig. 1. Location of salt-marsh restoration sites for which information on year of breach, type of scheme and area was available ( $n = 70$ ). Different symbols are used for different countries. For sites names and detailed information see Appendix A. Lettering to indicate multiple sites at one location are omitted on the map for clarity.

east coast (Fig. 1). However, they rarely exceed 100 ha in size and the total restoration area of these 48 sites (2007 ha) is lower than that of the ten German sites (2590 ha) (Fig. 2). For fifty percent of the sites, embankments were accidentally breached during storm surges, in particular in 1897 and 1953. The oldest accidentally breached embankment reported in the literature dates back to 1802. The first deliberate de-embankment was executed in 1991 (Northey Island, site Nr. 30b), after which between one and seven new de-embankments were initiated in north-west Europe each year (Fig. 3). Habitat creation/restoration is the most common reason for de-embankment, especially in the Netherlands, Belgium and Germany (Fig. 3). In many cases this habitat creation is driven by European legislation e.g., the Habitats Directive, which requires member states to designate special areas of conservation (Pethick, 2002). Flood defence is another major reason for de-embankment, as the re-creation of a saltmarsh in front of a sea defence is considered a cost-effective way of improving safety to the hinterland.

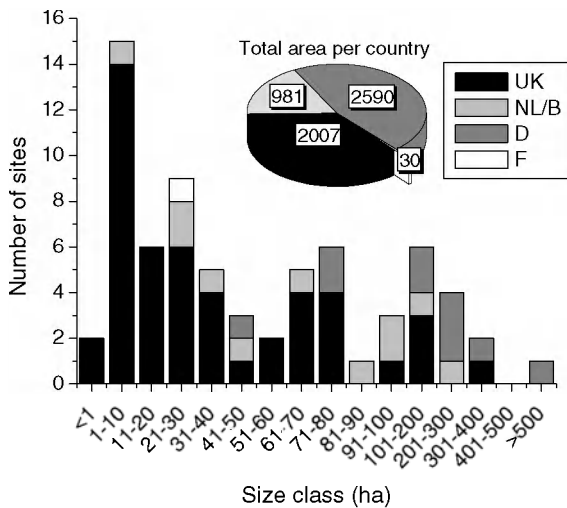
Fig. 2. Frequency distribution of sizes of sites ( $n = 70$ ) and total area per country (UK:  $n = 48$ ; NL/B:  $n = 11$ ; D:  $n = 10$ ; F:  $n = 1$ ).

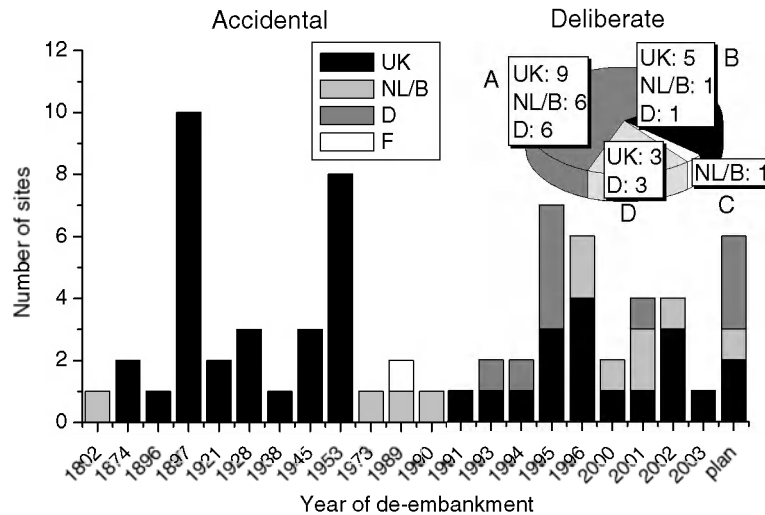
Fig. 3. Year of de-embankment and main reasons for deliberate de-embankment with the number of sites per country for each category (A: habitat creation or restoration; B: flood defence; C: gaining experience; D: unknown).

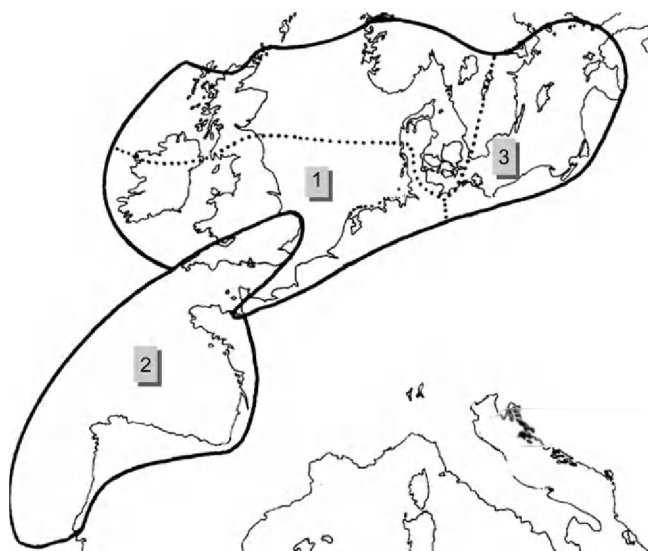
Fig. 4. Biogeographical regions of salt-marsh vegetation. 1. Central North-Atlantic; 2. Southern North-Atlantic; 3. German Baltic (adapted from Dijkema et al. (1984)).

On the basis of a differential influence of climate and sea currents on the distribution of salt-marsh plants in north-west Europe, we have classified our study sites into two distinct biogeographical regions, following Dijkema et al. (1984). The two regions are: (i) the Central North-Atlantic, extending from Scotland and south Scandinavia to North France, and (ii) the Southern North-Atlantic, covering south and south-east England, Brittany, south-west France and north-west Spain (Fig. 4). In addition, the German Baltic shore is treated as a separate region because the salinity of the submerging water, tidal range and geomorphology are very different from the North-Atlantic region (Dijkema, 1990).

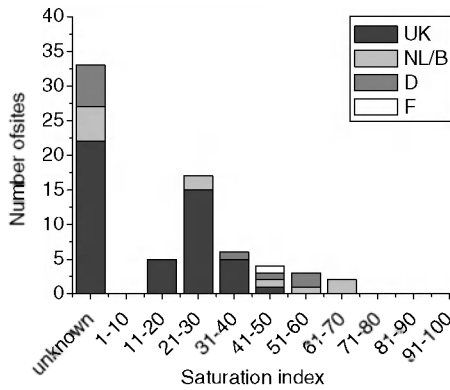
Fig. 5. Frequency distribution of saturation indices for 70 de-embankment sites.

Species lists were available for only 37 out of the 70 study sites (Table 1). The saturation index for the different sites ranged from 18% to 64% (Table 1). In comparison, the saturation index of 40 established marshes in the Wadden Sea region, ranged from 56% to 92% (Dijkema and Wolff, 1983). Restoration sites in the United Kingdom were the least diverse, with the majority of the sites having saturation indices below 30% (Fig. 5). Species that were absent from all restoration sites included *Spartina maritima*, *Poa subcoerulea*, *Puccinellia fasciculata*, *Carex serotina*, *Blysmus rufus*, *Oenanthe lachenalii*, *Ononis repens spinosa*, *Limonium binervosum*, *Frankenia laevis* and *Limonium bellidifolium*. Many of these species are characteristic of high-marsh and transition state communities. More research is needed to establish whether these species are nationally or regionally rare and missed as a result of insufficient sampling effort, or whether their absence is due to limited dispersal capabilities, abiotic or biotic constraints within the restoration sites. The most common species were *Salicornia* spp., *Suaeda maritima*, *Aster tripolium* and *Puccinellia maritima*, which were encountered in more than 80% of the sites (Fig. 6). These species often occurred in more than 61% of the plots in a particular restoration site and are characteristic of pioneer and low-marsh communities.

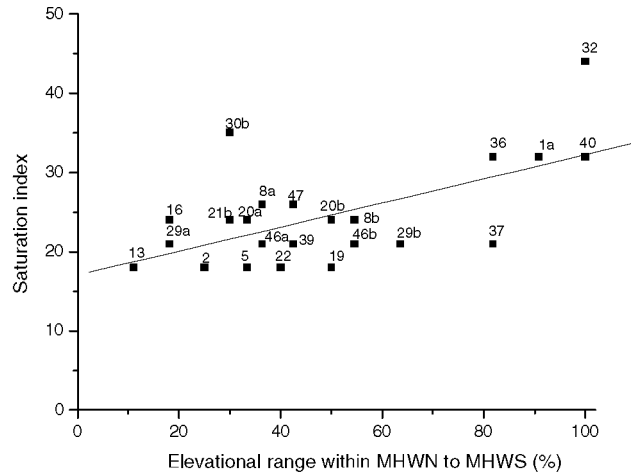
Fig. 7. Relationship between saturation index and percentage elevational range falling within mean high water neap (MHWN) to mean high water spring (MHWS) tide levels ( $n = 24$ ,  $P < 0.01$ ,  $R^2 = 0.37$ ).

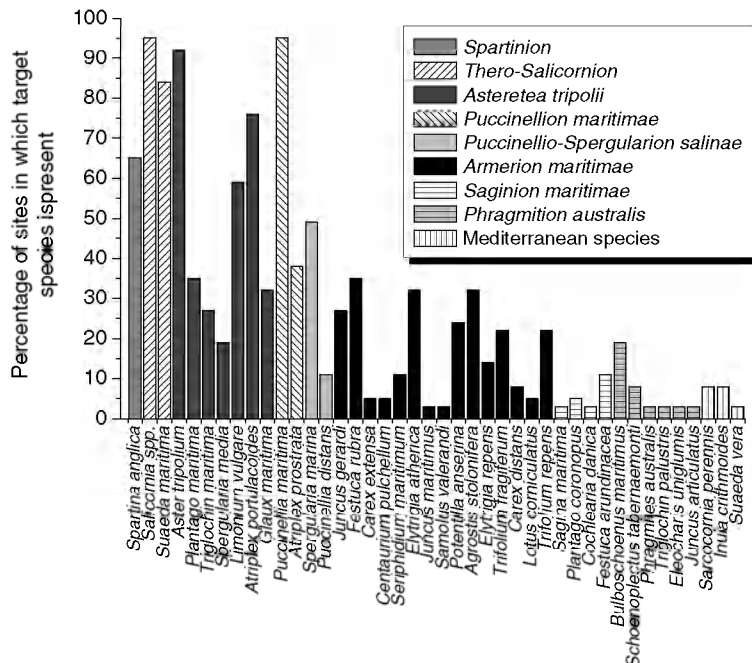
Fig. 6. Percentage of sites in which a target species occurs ( $n = 37$ ). Species are arranged by their syntaxonomical class (Schaminée et al., 1998).

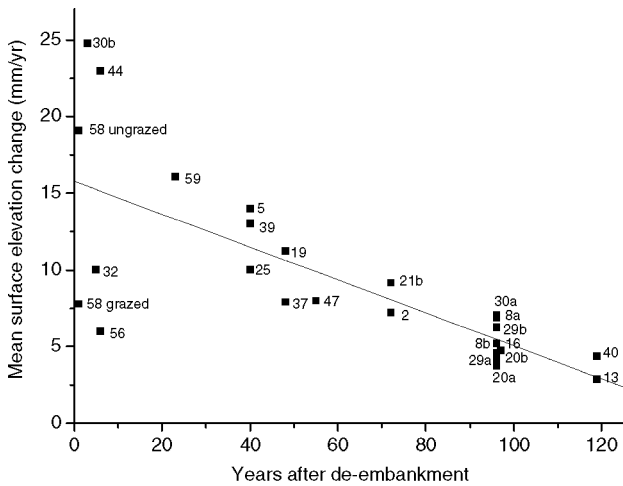
Fig. 8. Relationship between surface elevation change and restoration time ( $n = 26$ ,  $P < 0.0001$ ,  $R^2 = 0.55$ ).

(Nr. 11) were also excluded from the analysis as sedimentation–erosion measurements were taken recently, whereas the sites were 53 and 45 years old, respectively. The results suggest that the elevation of the sites, which are likely to have subsided considerably during the period of embankment due to soil shrinkage and a lack of fresh sediment input, can increase rapidly during the first years after de-embankment. Over time, when pre-reclamation levels or levels similar to existing marshes and suitable for vegetation establishment are gained, the rate of surface elevation change is likely to decrease. Morgan and Short (2002) also observed a higher amount of deposited sediment in the younger sites compared to older ones, in a comparison of six salt-marsh restoration sites in New Hampshire, and the same observation at 15 re-flooded sites in San Francisco Bay formed the bases for a conceptual model of salt-marsh plain evolution with time since breaching (Williams and Orr, 2002). The decrease in sedimentation rates over time after de-embankment may be explained by the fact that once the substrate has become high enough for vegetation to colonise, accretion rates will decline due to less frequent flooding (Brown et al., 1999; Bakker et al., 2002) and because much sediment is trapped by vegetation and is therefore unavailable for the interior marsh (Adam, 1990; Schröder et al., 2002). *Puccinellia maritima*, has been identified as a key species in the process of trapping and stabilising sediment on European marshes (Andresen et al., 1990; Langlois et al., 2003).

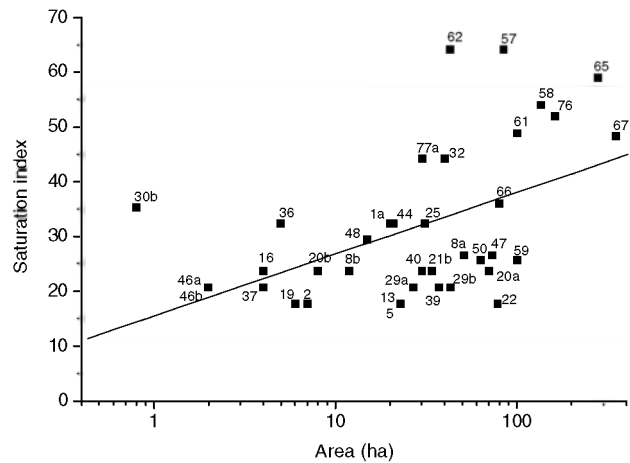
Fig. 9. Relationship between saturation index and size of restoration sites ( $n = 37$ ,  $P < 0.01$ ,  $R^2 = 0.25$ ).

It has been established that, for a variety of organisms and habitats, a linear relationship exists between the number of species and the size of the area (plotted on a log scale) (Begon et al., 1996). Therefore, the size of restoration sites may be an important determinant of success in restoration sites. Indeed, a significant relationship ( $P < 0.05$ ) between the percentage of regional target species and size of the restoration area is observed for our study sites (Fig. 9), although the regression coefficient is low ( $R^2 = 0.25$ ). The data in Fig. 9 suggest that restoration sites should be at least 30 ha in order to be able to harbour 50% or more of the target species. The best results are found for sites larger than 100 ha. It should be noted however, that the width of a site (i.e., the line perpendicular to the coastline) is likely to be more important than the length (i.e., the line parallel to the coastline), due to zonal processes leading to higher species diversity.

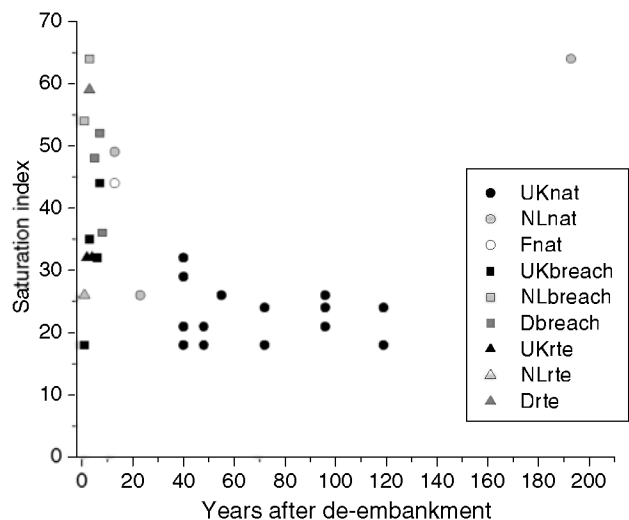
Fig. 10. Relationship between saturation index and restoration time. Nat, natural de-embankments; Breach, deliberate partial or complete removal of seawall; RTE, regulated tidal exchange by means of sluices or pipes.

Management may also be required to prevent successional processes from reducing species diversity over time. A comparison between restoration time and saturation index for 37 study sites showed that with the exception of a 197-year-old site, the highest saturation index was observed for the youngest sites, with a rapid decrease setting in after 15 years of restoration (Fig. 10). Highest species richness also occurred at around 15 years of restoration time in a comparison of six constructed restoration sites in New Hampshire (USA) (Morgan and Short, 2002). On the basis of their trajectory model, these authors
