## URGENT MEDICAL DEVICE RECALL NOTICE

RE: Western/Scott Fetzer OxyTOTE products which include the following models: OxyTOTE, OxyTOTE 3000, OxyTOTE NG, OxyTOTE 3000 NG, AirTOTE, and oxyQuik Series Valve Integrated Pressure Regulators (VIPR), as well as private label versions of these products.

**Western/Scott Fetzer is implementing a voluntary recall for OxyTOTE/oxyQuik/AirTOTE products**, including OxyTOTE, OxyTOTE 3000, OxyTOTE NG, OxyTOTE 3000 NG, AirTOTE, and oxyQuik Series Valve Integrated Pressure Regulators, and all private label versions of these products. Hereafter, they will be referred to as “OxyTOTE/oxyQuik/AirTOTE”. See *Attachments 1 and 2 for details and instructions for identification of affected product.*

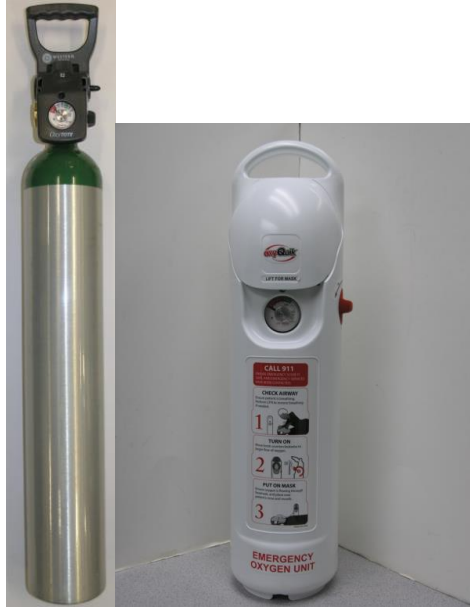
The OxyTOTE and oxyQuik products have the following general appearance:

OxyTOTE

oxyQuik

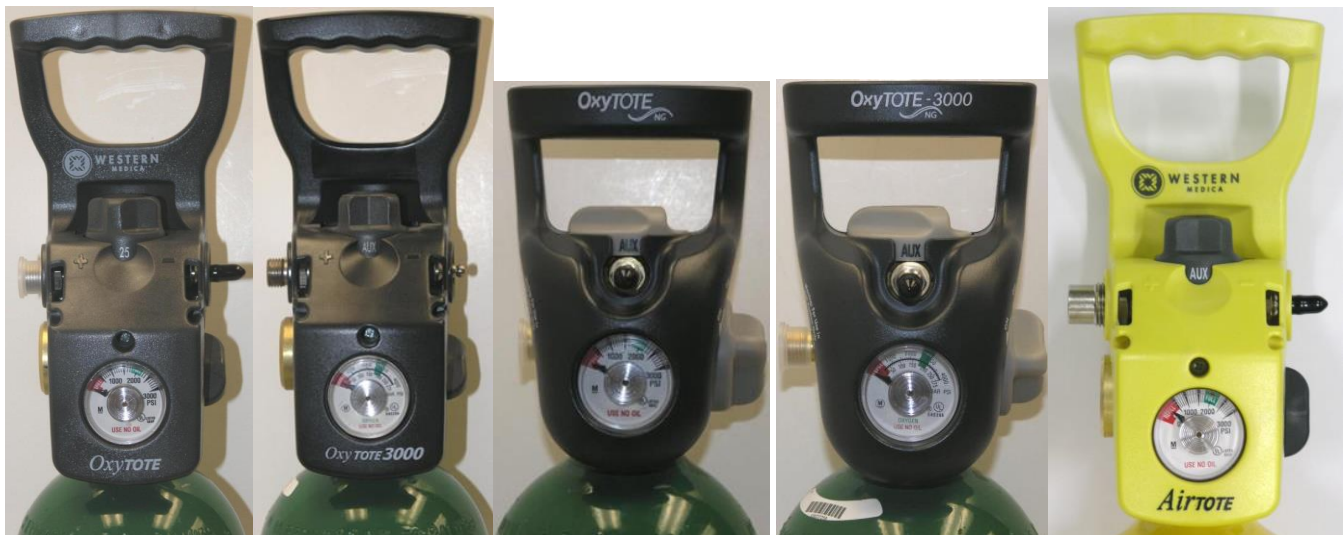
**OxyTOTE, OxyTOTE 3000, OxyTOTE NG, OxyTOTE 3000 NG, AirTOTE, and private label versions** of these products are similar in appearance, with variations in the regulator housing as indicated below. OxyTOTE brand products are readily identified by the name “OxyTOTE” on the regulator housing and/or handle.

OxyTOTE

OxyTOTE 3000

OxyTOTE NG

OxyTOTE 3000 NG

AirTOTE

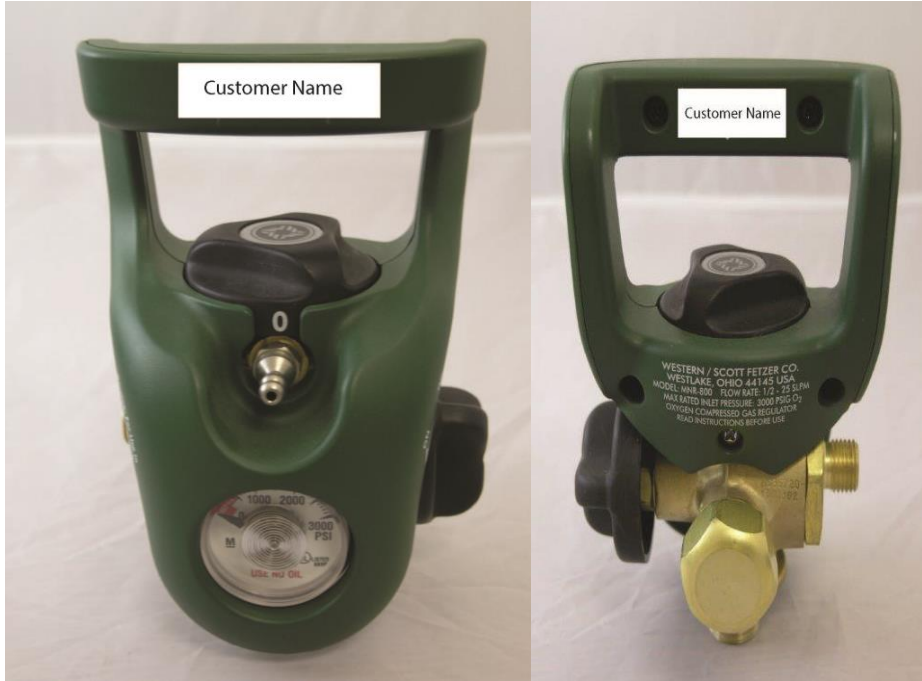
**Private Label versions of the affected OxyTOTE products** are identical in form/size/shape, but are readily identified as indicated in the pictures below.

- 1) Note that the specific “private label” name appears in the areas indicated below.
- 2) For ALL private label variants, the Western/Scott Fetzer identity can be confirmed on the back of the regulator housing as indicated.
- 3) The color of the regulator housing can vary (green, black, etc.).

Customer “private label” replaces “OxyTOTE”

Back indicates “Western /Scott Fetzer”

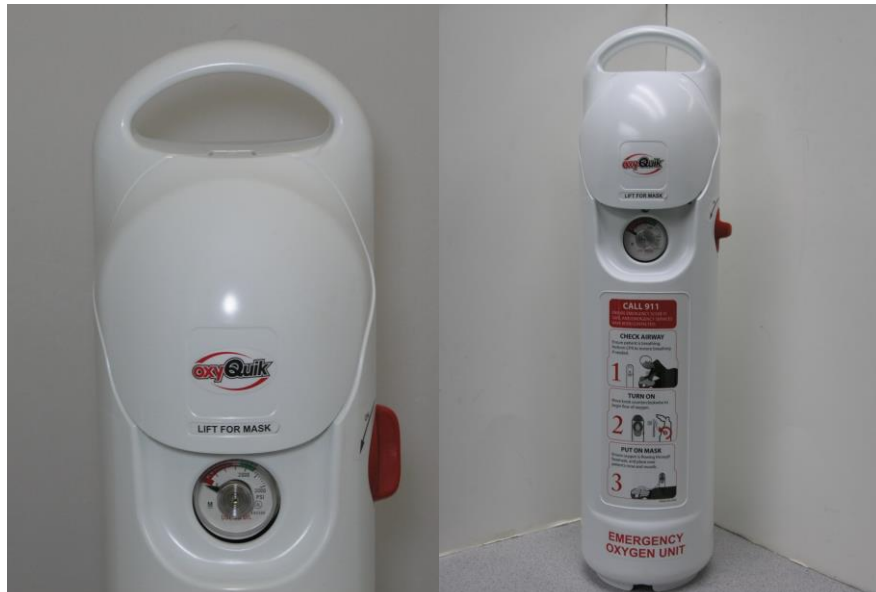
**The oxyQuik product** has a significantly different appearance:

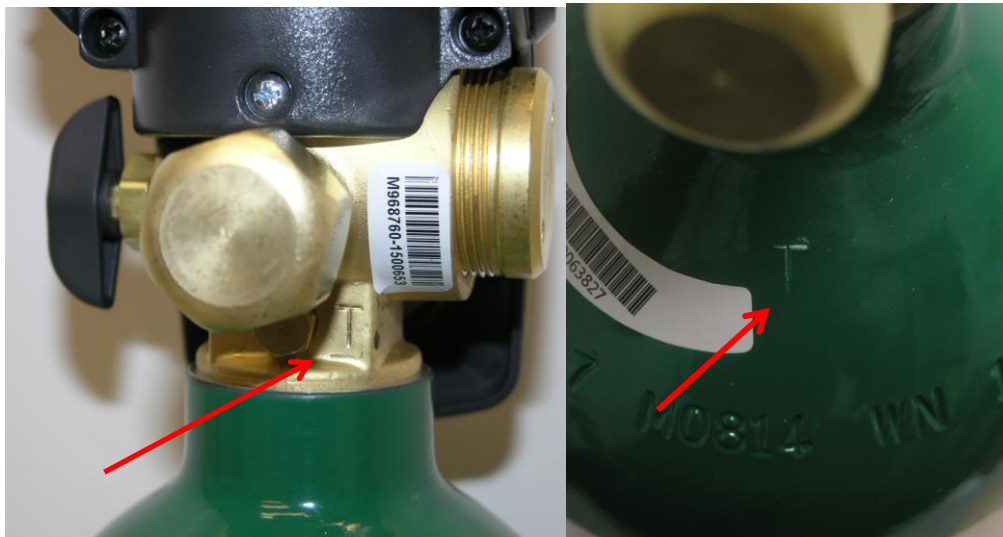
- 1) **ALL** OxyTOTE/oxyQuik/AirTOTE products are subject to this recall **EXCEPT** units that are marked with a hard stamped “T” on BOTH the Oxygen cylinder AND the brass portion of the regulator body. Refer to the following illustrations. **These OxyTOTE units were manufactured from October 2014 to date, and are NOT subject to this recall action.**

OxyTOTE with “T” stamp on regulator

Oxygen cylinder with “T” stamp on shoulder area

- 2) **Any OxyTOTE/oxyQuik/AirTOTE products that DO NOT include the hard stamped “T” on BOTH the Oxygen cylinder AND Valve Integrated Pressure Regulator (VIPR) body ARE INCLUDED IN THIS RECALL.**
  - a. If you cannot find a hard stamped “T” during an inspection of the shoulder area of the Oxygen cylinder, then BOTH the regulator AND cylinder assembly are subject to the recall.
  - b. If you cannot find a hard stamped “T” during an an inspection of the regulator body in the location indicated, then BOTH the regulator AND cylinder assembly are subject to the recall.
- 3) **ALL oxyQuik brand products are subject to the recall.**
- 4) **ALL AirTOTE brand products are subject to the recall.**

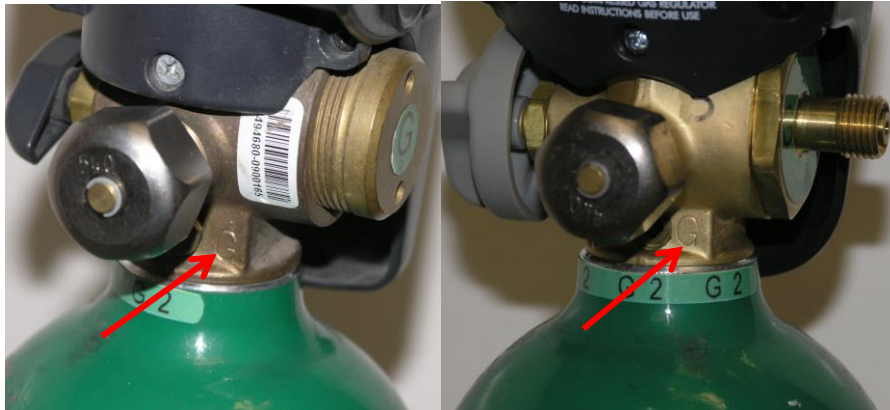
Upon completion of the remediation under this recall, all OxyTOTE product will be hard stamped with a “G” on BOTH the Oxygen cylinder shoulder AND the regulator body.

**OxyTOTE and OxyTOTE**

**OxyTOTE NG and 3000 NG**

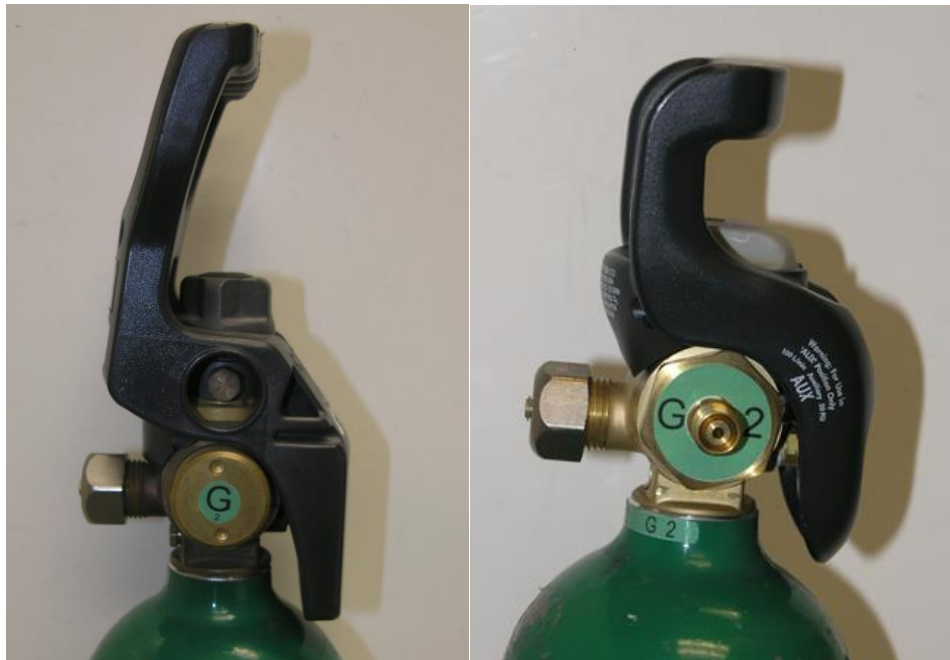
In addition, a green “G” label will be affixed to BOTH the Oxygen cylinder AND the regulator body to facilitate efficient identification of remediated product during and after the recall.

**OxyTOTE and OxyTOTE**

**OxyTOTE NG and 3000 NG**

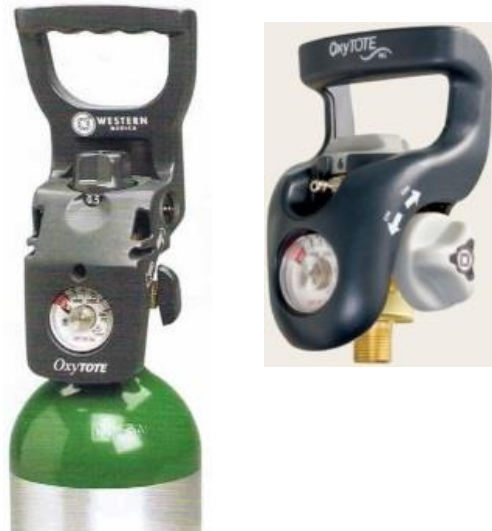
Depicted below, are illustrations of the OxyTOTE and OxyTOTE NG Models affected by this advisory.
