## Contingency Planning for Oil Spill Accidents in Brazil

### Synopsis

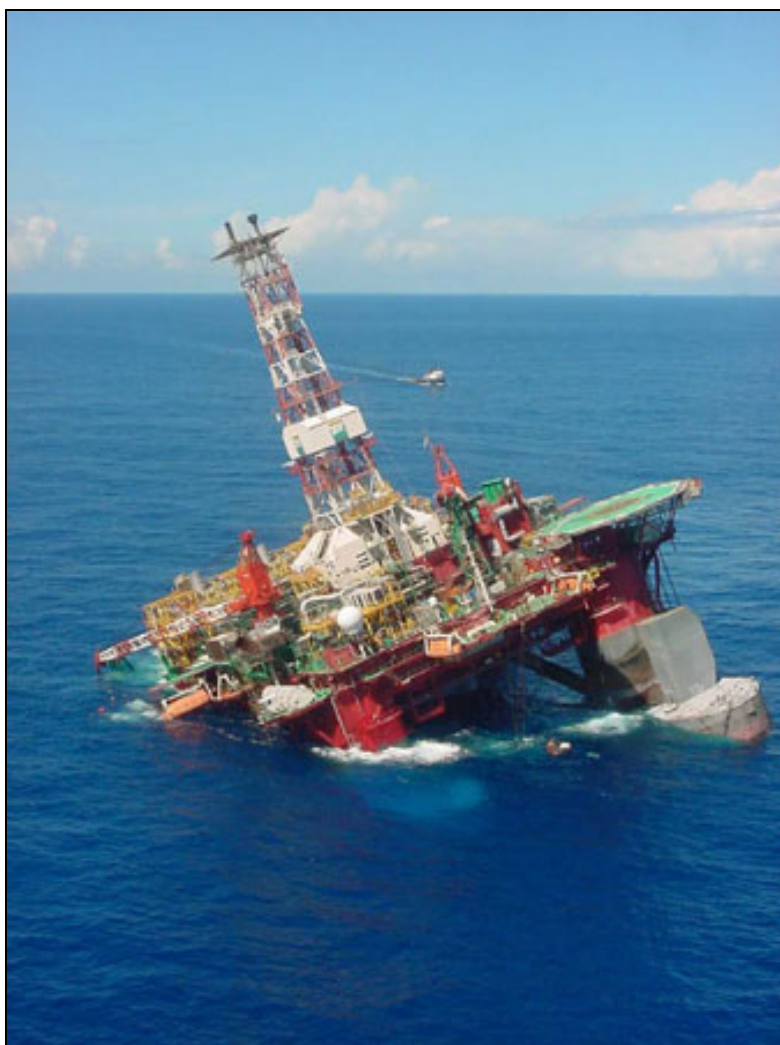
**Figure 1 – Platform P-36, Campos Basin, Rio de Janeiro, Brazil, 15 March 2001**

More recently, in May 2001, another severe accident involved a production unit in the Campos Basin, causing the death of 11 workers and the sinking of P-36 semi-submersible platform. P-36 was in operation since May 2000, at approximately 120 km from the coast, in the Roncador field, in a water depth of 1,360 meters. Worth about half a billion dollars, P-36 was the world's largest semi-submersible production platform, with a daily processing capacity of 180,000 barrels of oil and 7.2 million m<sup>3</sup> of natural gas. At the time of the accident, the unit was producing about 84,000 barrels of oil and 1.3 million m<sup>3</sup> of natural gas coming from six wells connected to the platform. There was 175 people on board.

The accident took place in the first hours of the morning of March 15, 2001, beginning with an explosion inside one of the platform columns, followed by a second explosion about 20 minutes later. This explosion caused the death of 11 members of the fire brigade, the flooding of the column and subsequent loss of stability of the unit. The incident investigation concluded that the cause of the first explosion was the overpressurization and rupture of a tank, causing the release of the fluids which originated the second explosion.

With the flooding, the platform progressively started to capsize. Some attempts were made in order to expel the water and regain the stability of the unit, such as the injection of nitrogen and compressed air into the flooded compartments. These attempts, however, did not succeed, not avoiding the sinking of the platform five days later.

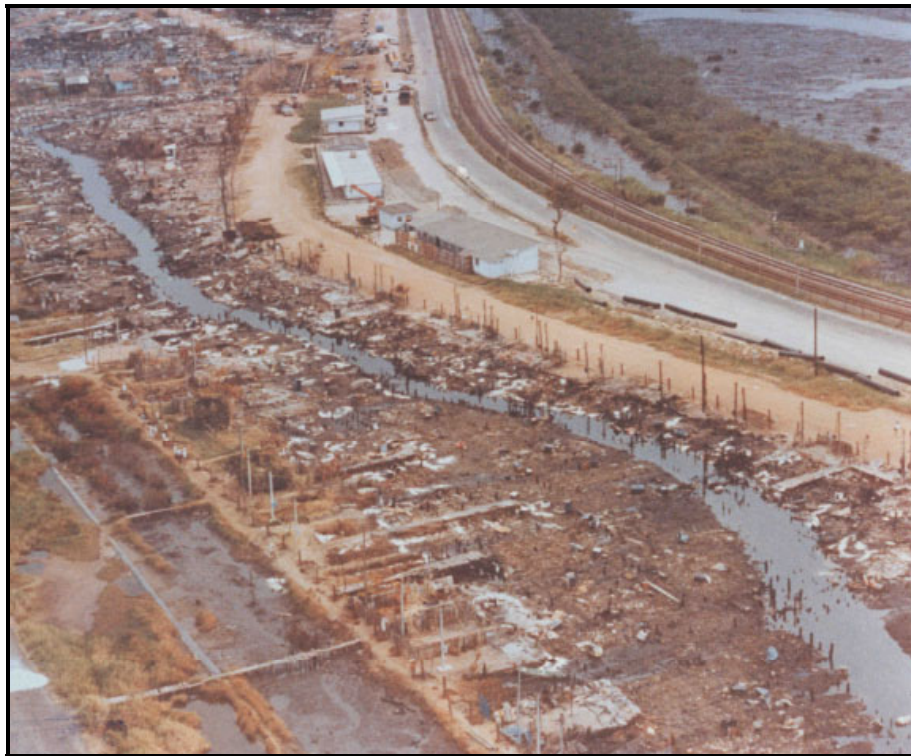
**Figure 2 – Vila Socó, Cubatão, São Paulo, Brazil, 25 February 1984**

One of the most serious accidents related to pipeline oil transportation occurred in 1984 when a major spill of some 700,000 liters (184,800 gallons) of gasoline caused a fire in Cubatão, São Paulo, Brazil. The leak occurred in an 18-in. pipeline located near the shantytown of Vila Socó, where approximately 8,000 people lived. The fire, which lasted almost 10 hours, started in the early morning, but the gasoline leak had been perceived by some of the residents at least two hours before the fire began. There are some reports that residents had begun to collect and stockpile the spilled gasoline in their homes. The fire resulted in the complete destruction of an area of 100,000 m<sup>2</sup>, nearly 75% of the shantytown. The bodies of 67 persons – almost all burned beyond recognition – were recovered from the ruins of their homes. Among the more than 200 seriously injured, many were unable to survive the severity of their burns and died. In any event, the number of fatalities commonly attributed to the fire (508) exceeds by a considerable margin the official number of fatalities.
