UTAH GEOLO a division of UTAH GEOLOGICAL SURVEY Utah Department of Natural Resources

Sources of information used to evaluate gypsiferous soil and rock in the State Route 9 Corridor Geologic-Hazard Study Area (SR-9 study are) include (1) 40 geotechnical reports on file with the National Park Service (NPS), the Utah Department of Transportation (UDOT), and the towns of Springdale and Virgin, (2) Natural Resources Conservation Service (NRCS) (formerly Soil Conservation Service) Soil Survey of Washington County Area, Utah (Mortensen and others, 1977), (3) the four Utah Geological Survey (UGS) 1:24,000-scale geologic quadrangle maps that cover the study area (Virgin [Hayden and Sable, 2008], Springdale West [Willis and others, 2002], Springdale East [Doelling and others, 2002], and Smithsonian Butte [Moore and Sable, 2001]), (4) Engineering Geology of the St. George Area, Washington County, Utah (Christenson and Shnabkaib Member of the Moenkopi Formation and the Harrisburg Member of the Deen, 1983), (5) "Geologic Hazards of the St. George Area, Washington County, Utah" (Christenson, 1992), (6) Engineering Geologic Map Folio, Springdale, Washington County, Utah (Solomon, 1996), (7) Geol

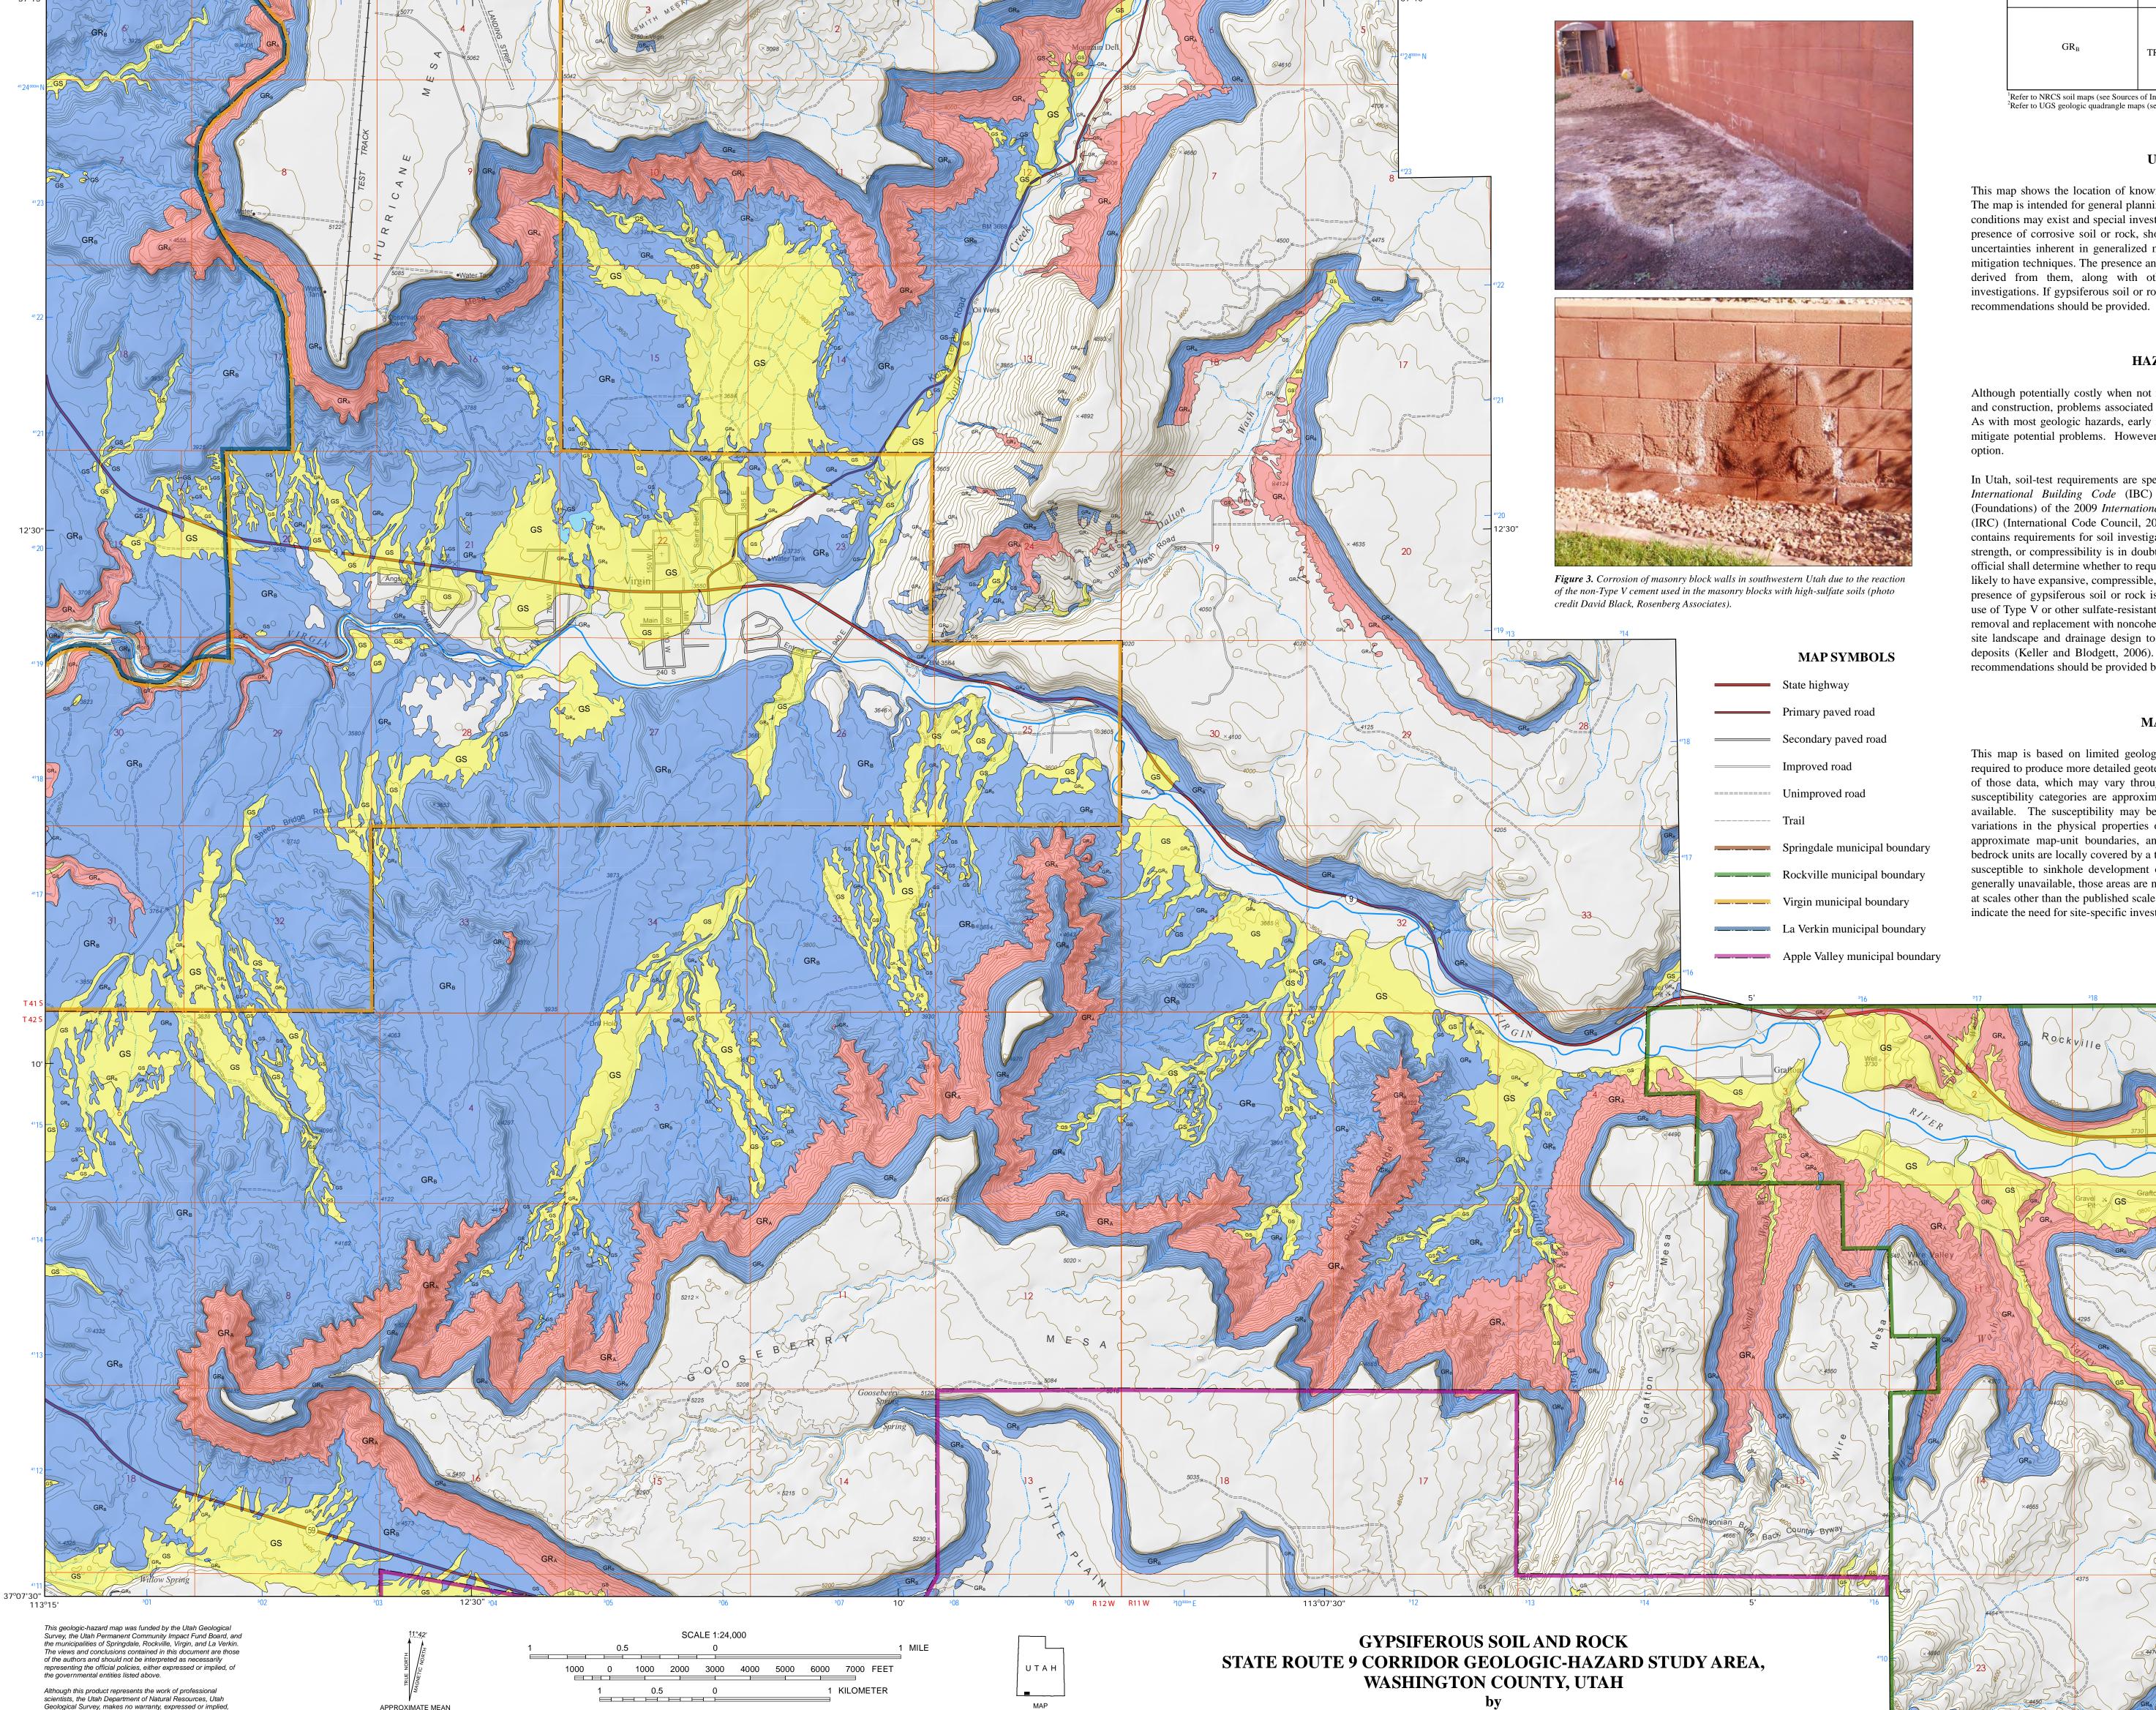
This map shows the location of known and suspected gypsiferous rock in the SR-9 study area. The map is intended for general planning and design purposes to indicate where gypsiferous rock conditions may exist and special investigations, including sodium sulfate testing to determine the presence of corrosive soil or rock, should be required. Site-specific investigations can resolve uncertainties inherent in generalized mapping and help identify the need for special design or mitigation techniques. The presence and severity of gypsiferous rock units and gypsum-rich soils derived from them, along with other geologic hazards, should be addressed in these investigations. If gypsiferous soil or rock is present at a site, appropriate design and construction

This map is based on limited geologic and geotechnical data; site-specific investigations are required to produce more detailed geotechnical information. The map also depends on the quality of those data, which may vary throughout the study area. The mapped boundaries between susceptibility categories are approximate and subject to change as new information becomes available. The susceptibility may be different than shown at any particular site because of variations in the physical properties of geologic deposits within a map unit, gradational and approximate map-unit boundaries, and the small map scale. Additionally, gypsum-bearing bedrock units are locally covered by a thin veneer of unconsolidated deposits. Such areas may be susceptible to sinkhole development or collapse; however, because subsurface information is generally unavailable, those areas are not identified on this map. The map is not intended for use at scales other than the published scale, and is designed for use in general planning and design to indicate the need for site-specific investigations.

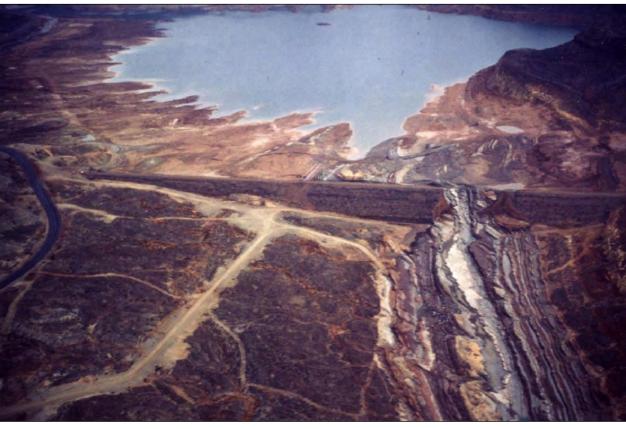
Figure 2. Quail Creek dike failure, January 1, 1989, in southwestern Utah was due in part to gypsum

dissolution in the underlying Shnabkaib Member of the Moenkopi Formation (photo credit Ben Everitt).

Gypsum dissolution in bedrock is common in southwestern Utah. Dissolution of gypsum (Shnabkaib Member of the Moenkopi Formation) was an important factor in the January 1, 1989, failure of the Quail Creek dike near Hurricane, Utah (figure 2; Gourley, 1992). Elsewhere in the region, gypsum solution caverns as much as several feet in diameter have formed in susceptible bedrock units. The entire flows of the Virgin River and La Verkin Creek have been captured by sinkholes that opened in their streambeds (Harrisburg Member of the Kaibab Formation) (Everitt and Einert, 1994; Lund, 1997). In St. George, a bulldozer broke through the roof of a cavern and was suspended by its front blade and back ripper (J and J Construction Company, personal communication, 1995, as reported in Higgins and Willis, 1995). David Black (Black, Miller, and
