**SUPPLEMENTAL MARINE HABITAT SURVEY AND MAPPING
FOR THE BROAD BEACH RESTORATION PROJECT**

June 2014

The Broad Beach Restoration Project ("Project") proposes to place 600,000 cubic yards of beach-compatible sand material on the beach to create a wider and longer beach, and new dune habitat. The Project is currently in the permitting phase, and while biological surveys have been conducted, a greater level of information regarding biological habitats and species has been requested by resource and regulatory agencies. A summary of the biological effort completed to date includes:

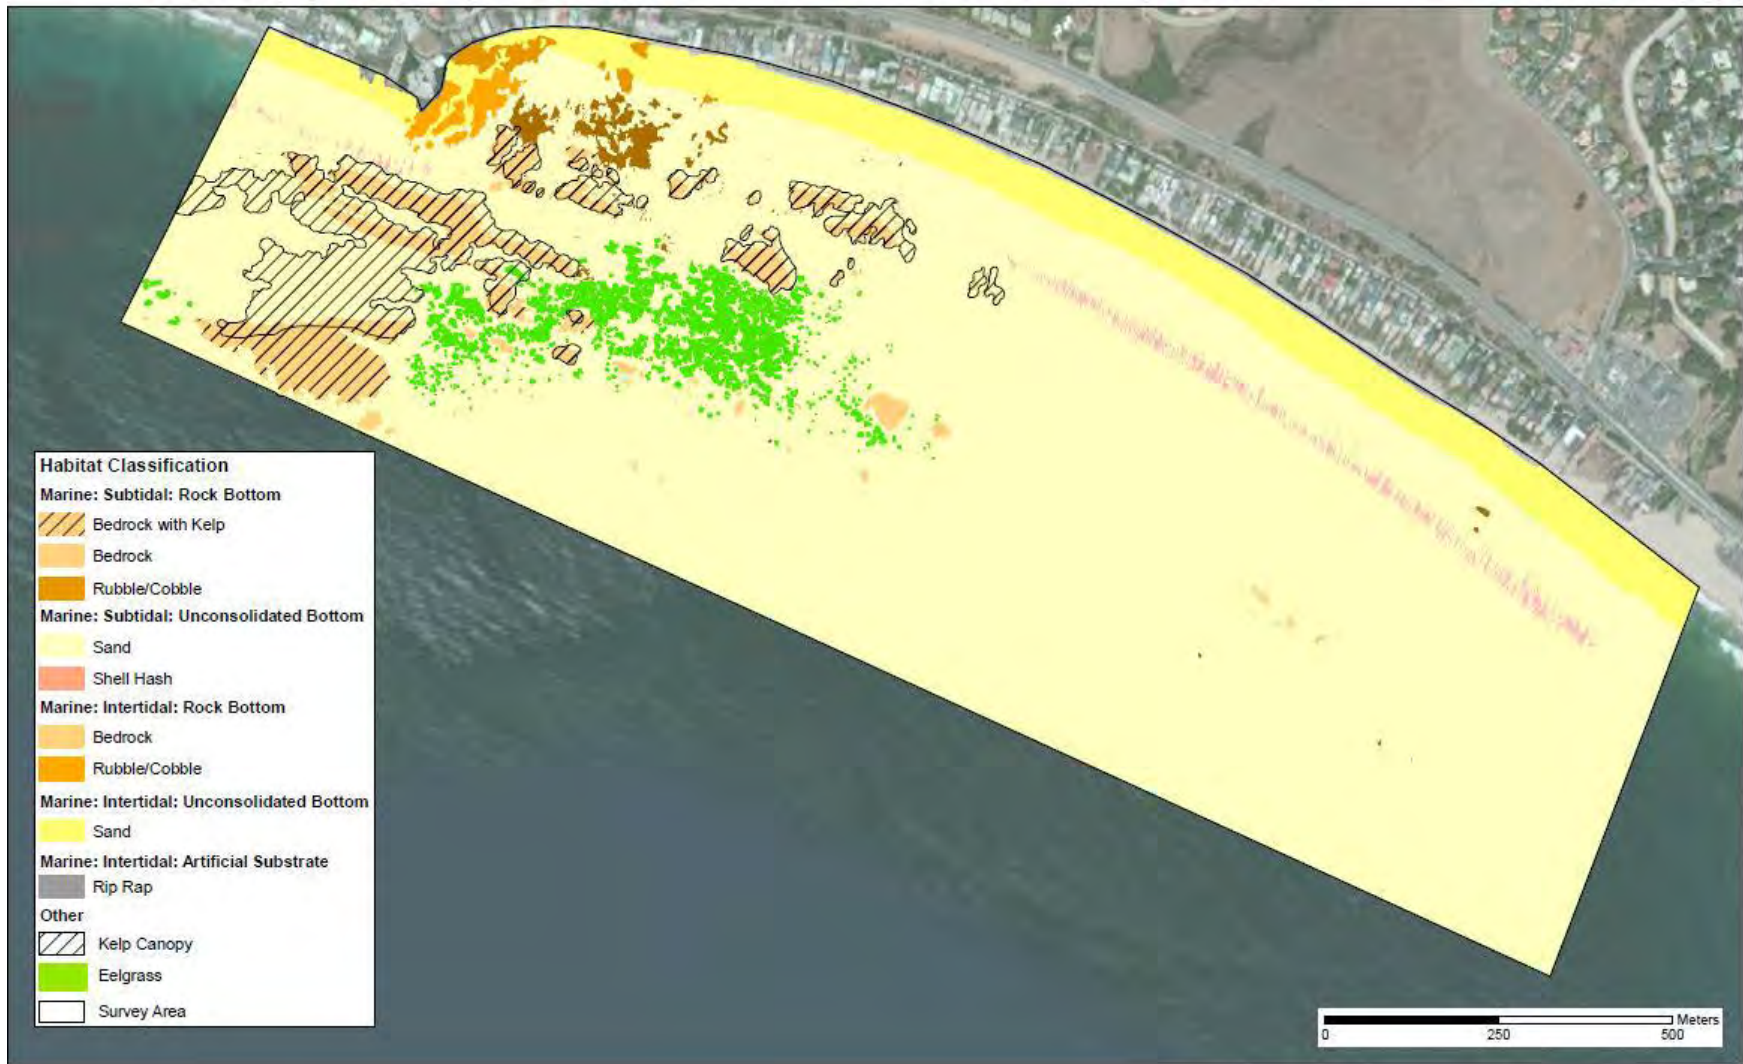
Figure 1. Benthic Habitat Map for Broad Beach Survey Area (May 2014).

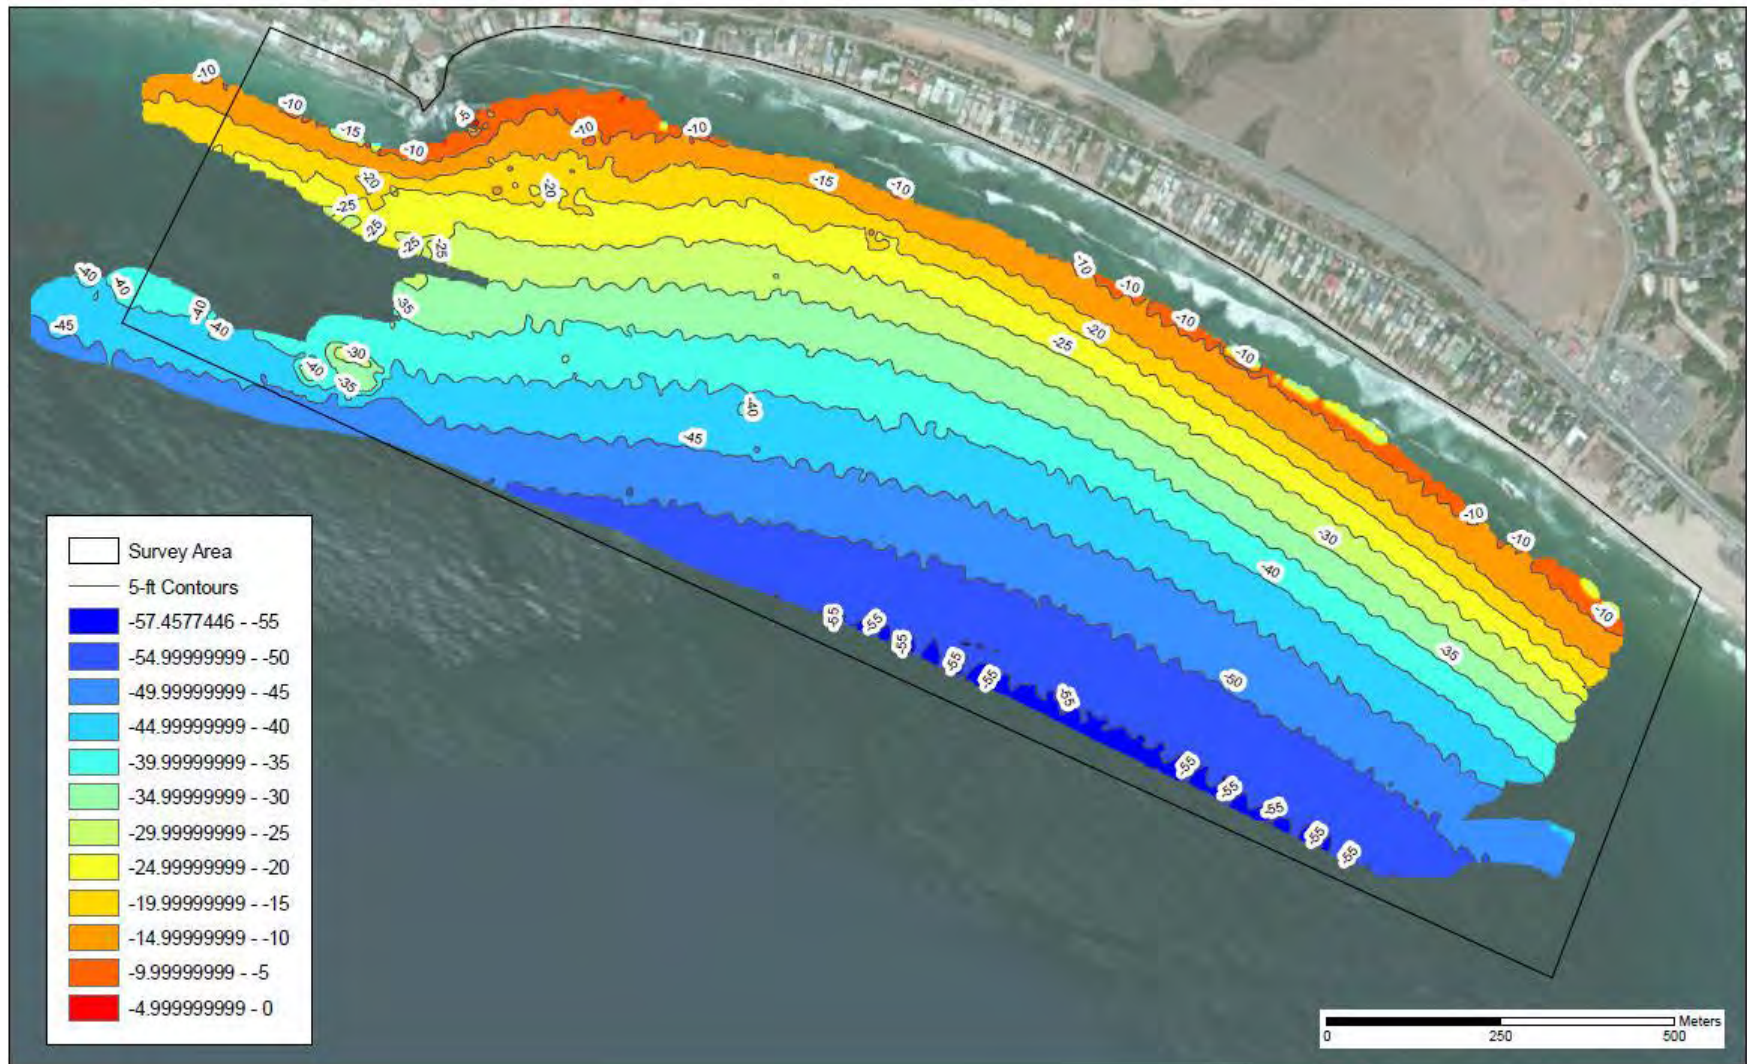
Figure 2. Bathymetry for Broad Beach Survey Area (May 2014).

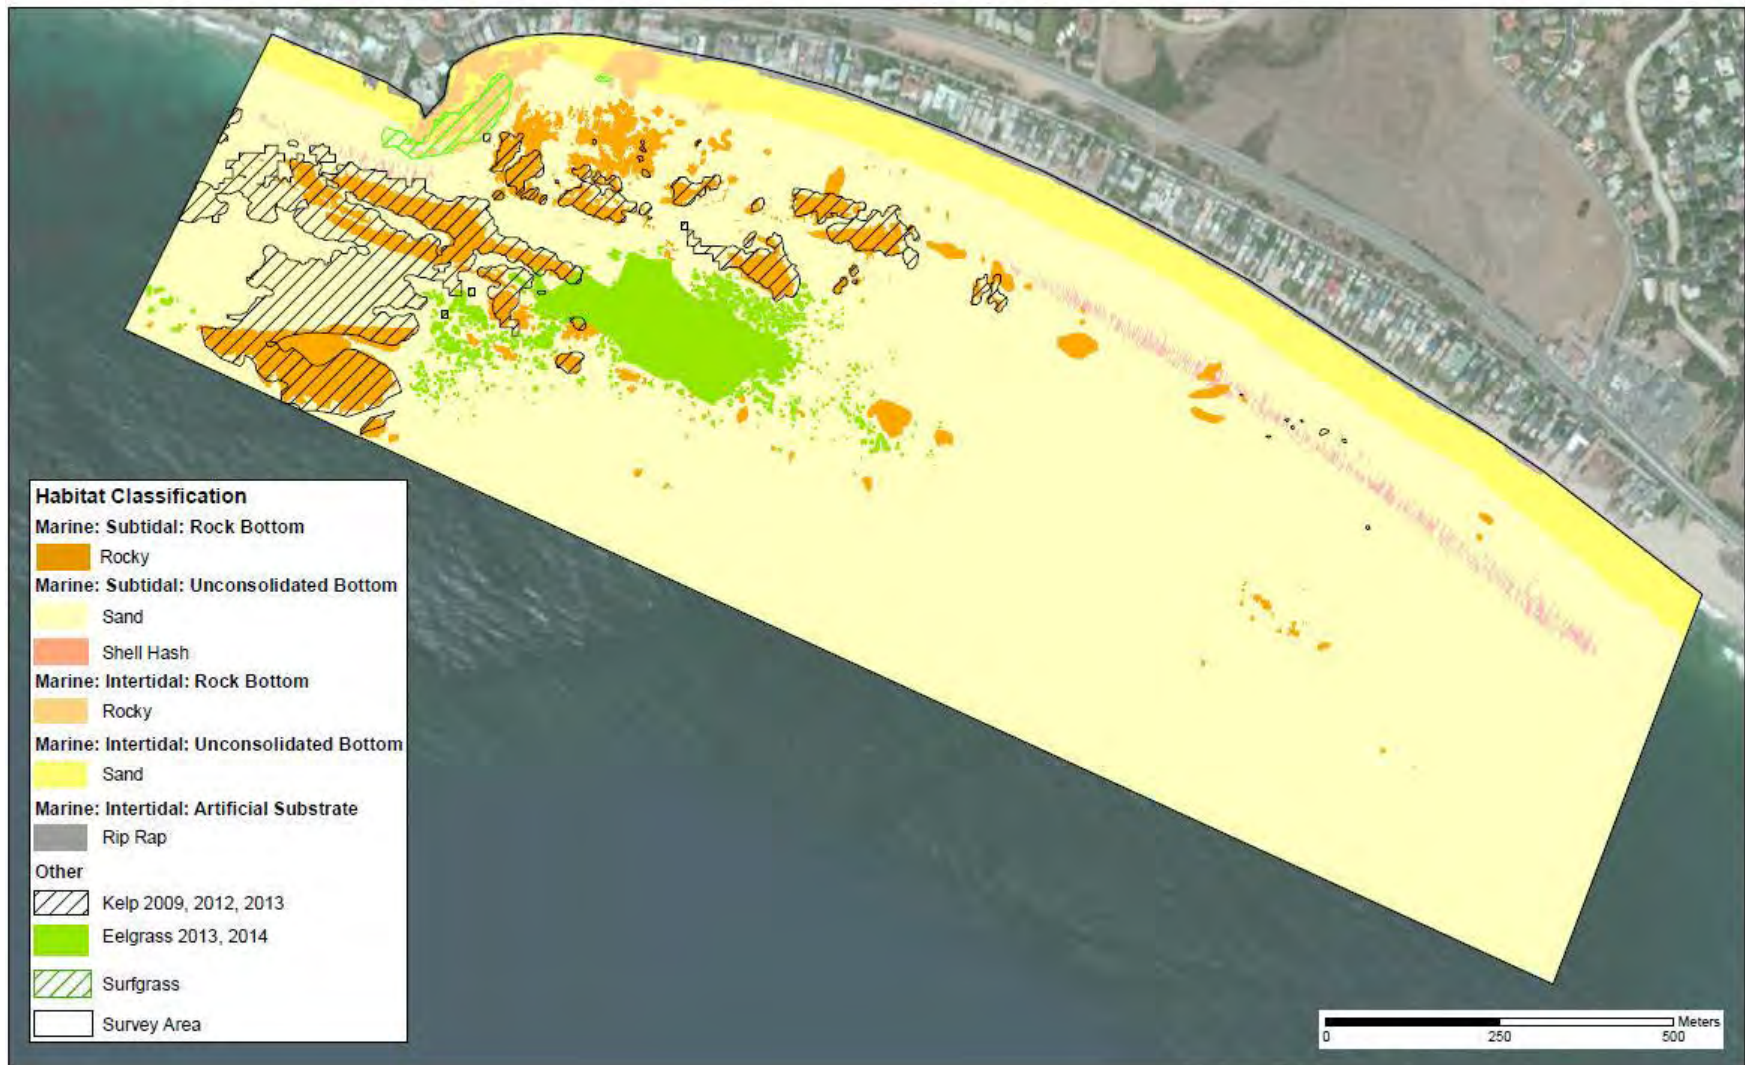
Figure 3. Benthic Habitat Map for Broad Beach Survey Area (Combined Data Sources).

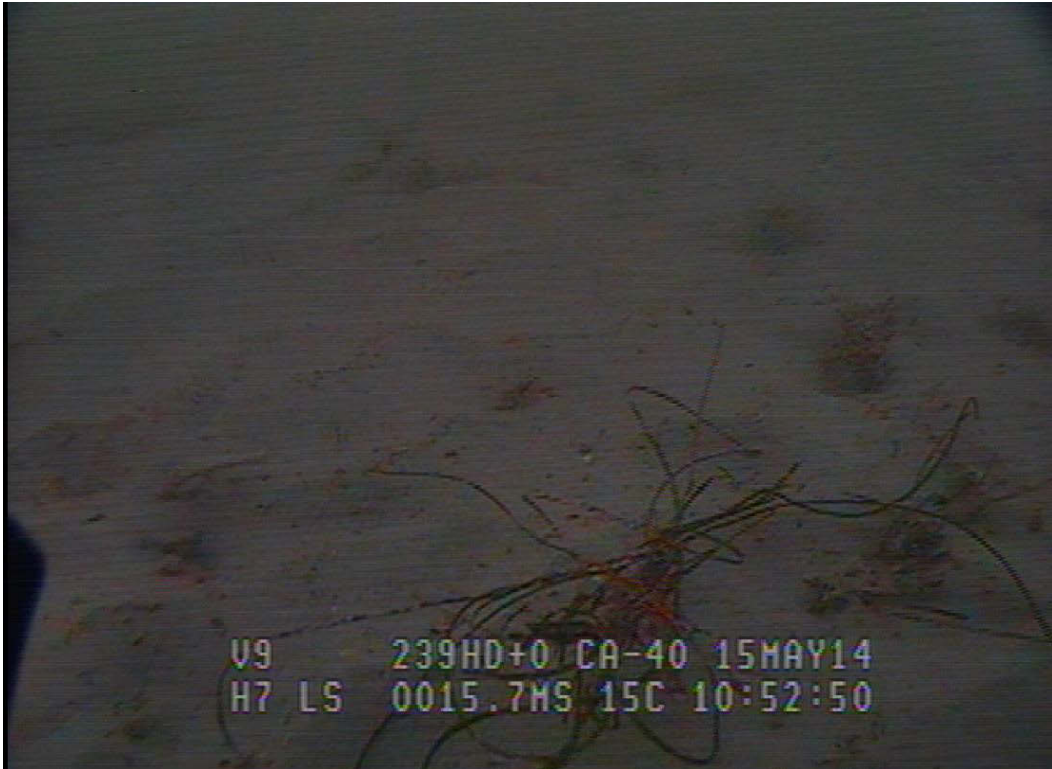
Figure 4. Sandy subtidal habitat.

The dominant habitat type detected both in the intertidal and subtidal zones was sand. Compacted medium and fine sands were generally observed in the deeper offshore waters (Figure 4). Moving inshore, areas with significant sand waves and coarser sand were often observed. Sand habitat was generally observed to be devoid of significant epifauna and observations of fish were rare (during ROV surveys). The mapped coarse sediments/shell hash comprised 3.7 acres of the mapped area. This habitat type can be classified as part of the sand habitat, but was mapped separately because the shell hash had a higher reflectance in the backscatter data. This made shell hash stand out, and in some cases, the shell hash appeared similar to cobble reef until the ground truth effort made it possible to distinguish the two habitats.

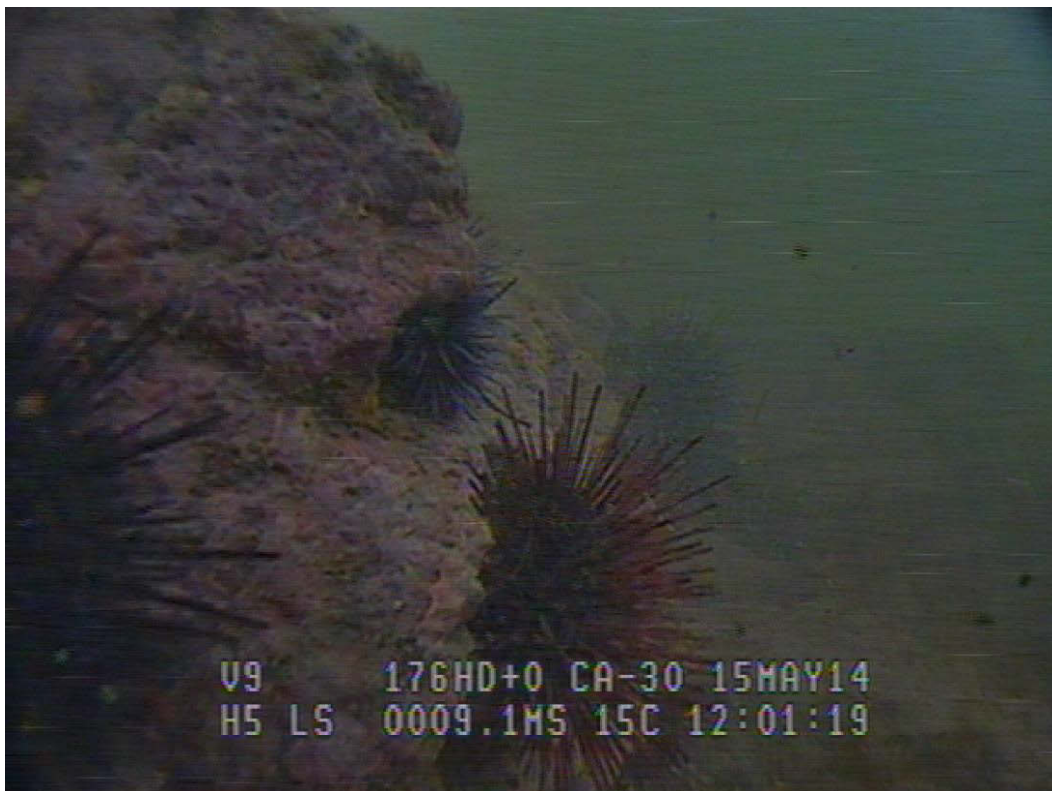
Figure 7. Rocky reef subtidal habitat with sea urchins.

The second most abundant benthic habitat type mapped in May 2014 was bedrock/boulder/cobble habitat (approximately 23.5 acres). The substrate generally consisted of areas with small and medium sized cobble, occasional boulders, as well as large rock outcroppings. Some of the lower-relief (< 1m high) boulder/cobble areas were generally characterized as having a low cover of foliose and sheet forms of red and brown algae (Figure 5), while areas with larger rock outcroppings and higher relief (> 1m high) were observed to support understory kelp species such as *Pterygophora californica* as well as canopy forming giant kelp, *Macrocystis pyrifera* (Figure 6). Some rocky areas also supported relatively high densities of purple and red sea urchins (*Strongylocentrotus purpuratus* and *S. francisanus*) (Figure 7).

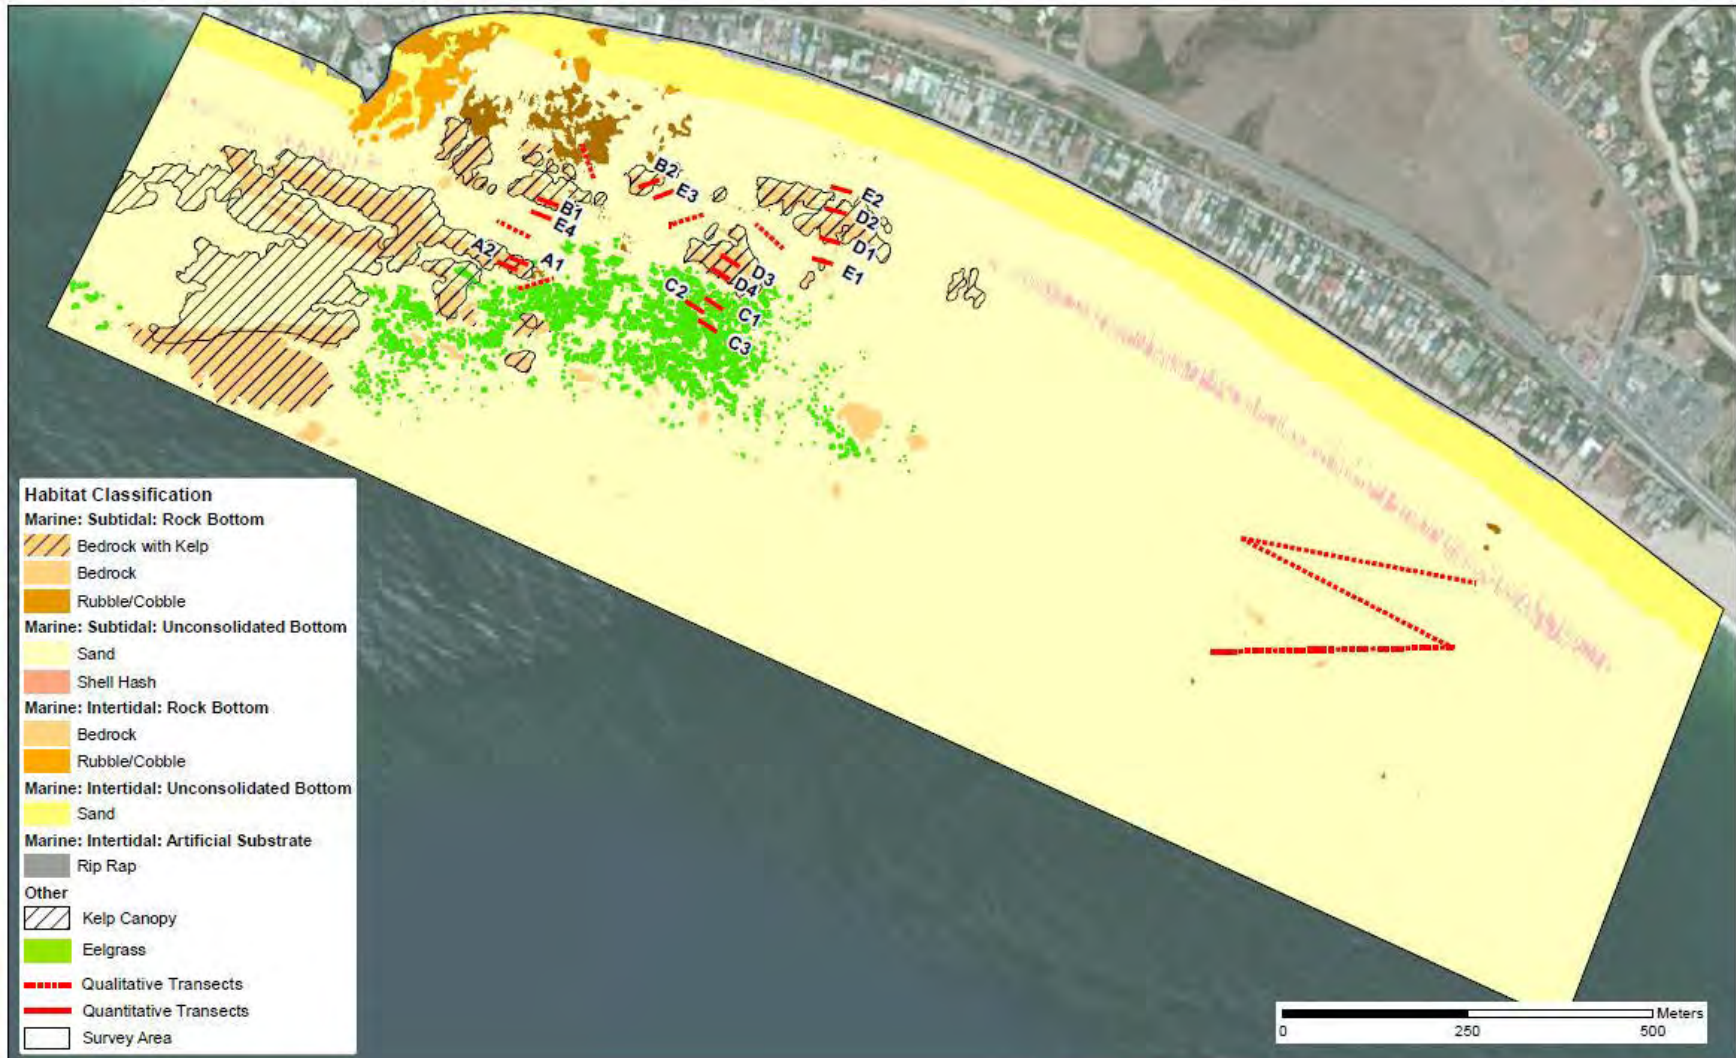
Figure 9. Transects sampled for subtidal community study.

As noted previously, the methodology was implemented based on habitat type and is summarized in Table 2 and depicted in Figure 9. In addition to the quantitative transects, additional qualitative transects were conducted to provide a more comprehensive species list (Figure 9).

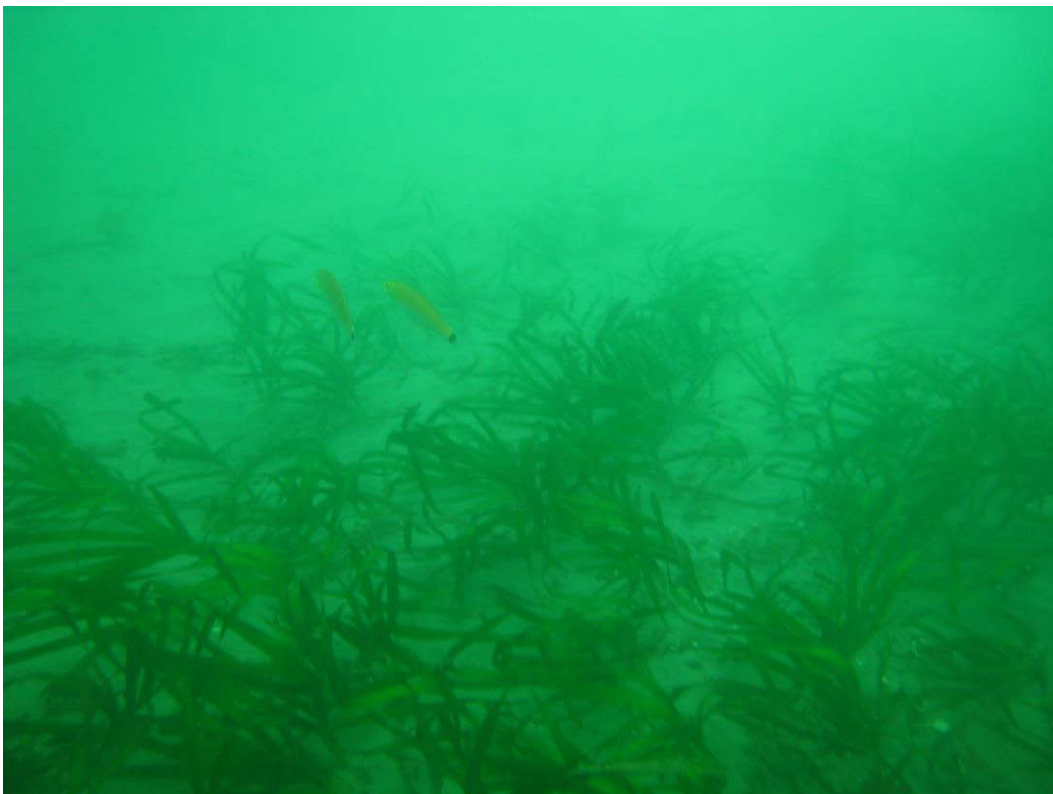
Figure 11. Eelgrass habitat located in approximately 30 ft of water.

One unique feature includes the presence of eelgrass beds downcoast of Lechuza Point which apparently has been present in this area since at least the 1970's (Chambers Group 2012; Figure 11). The May 2014 survey detected approximately 7.1 acres of eelgrass and the June 2014 dive survey indicated that the mean turion density was 4.5 per 0.0625m² (Table 7).

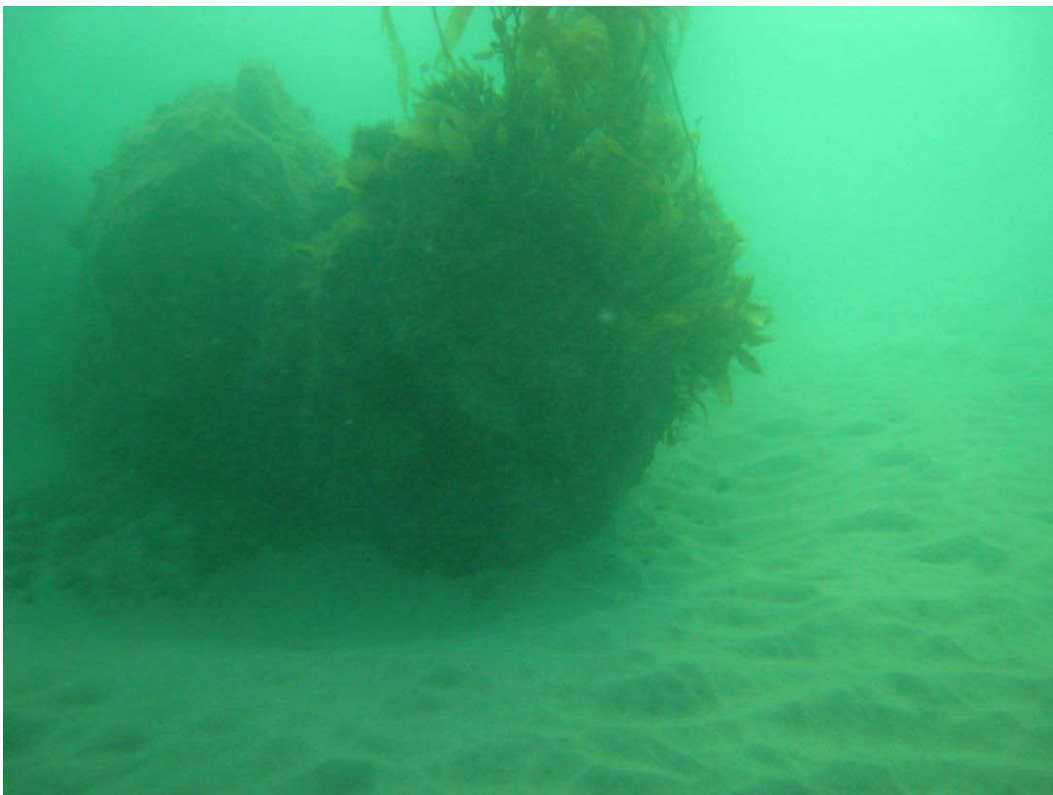
Figure 15. High-relief rocky substrate supporting giant kelp.

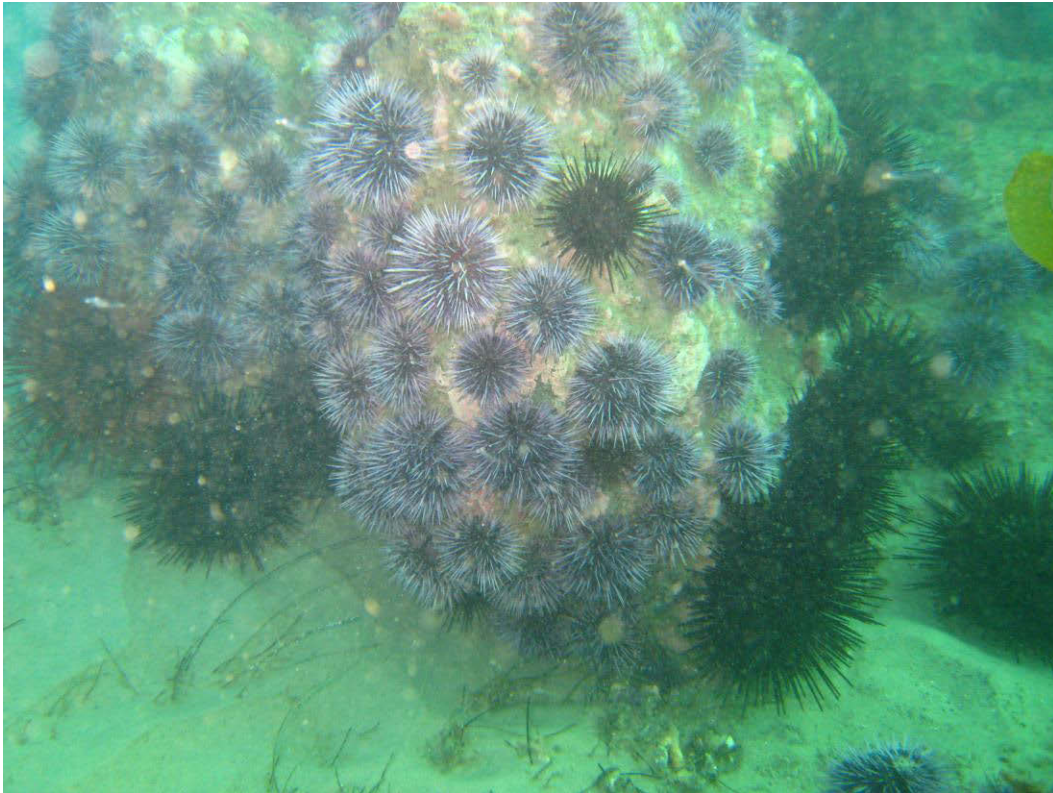
Figure 16. High-relief rocky substrate supporting purple and red sea urchins.

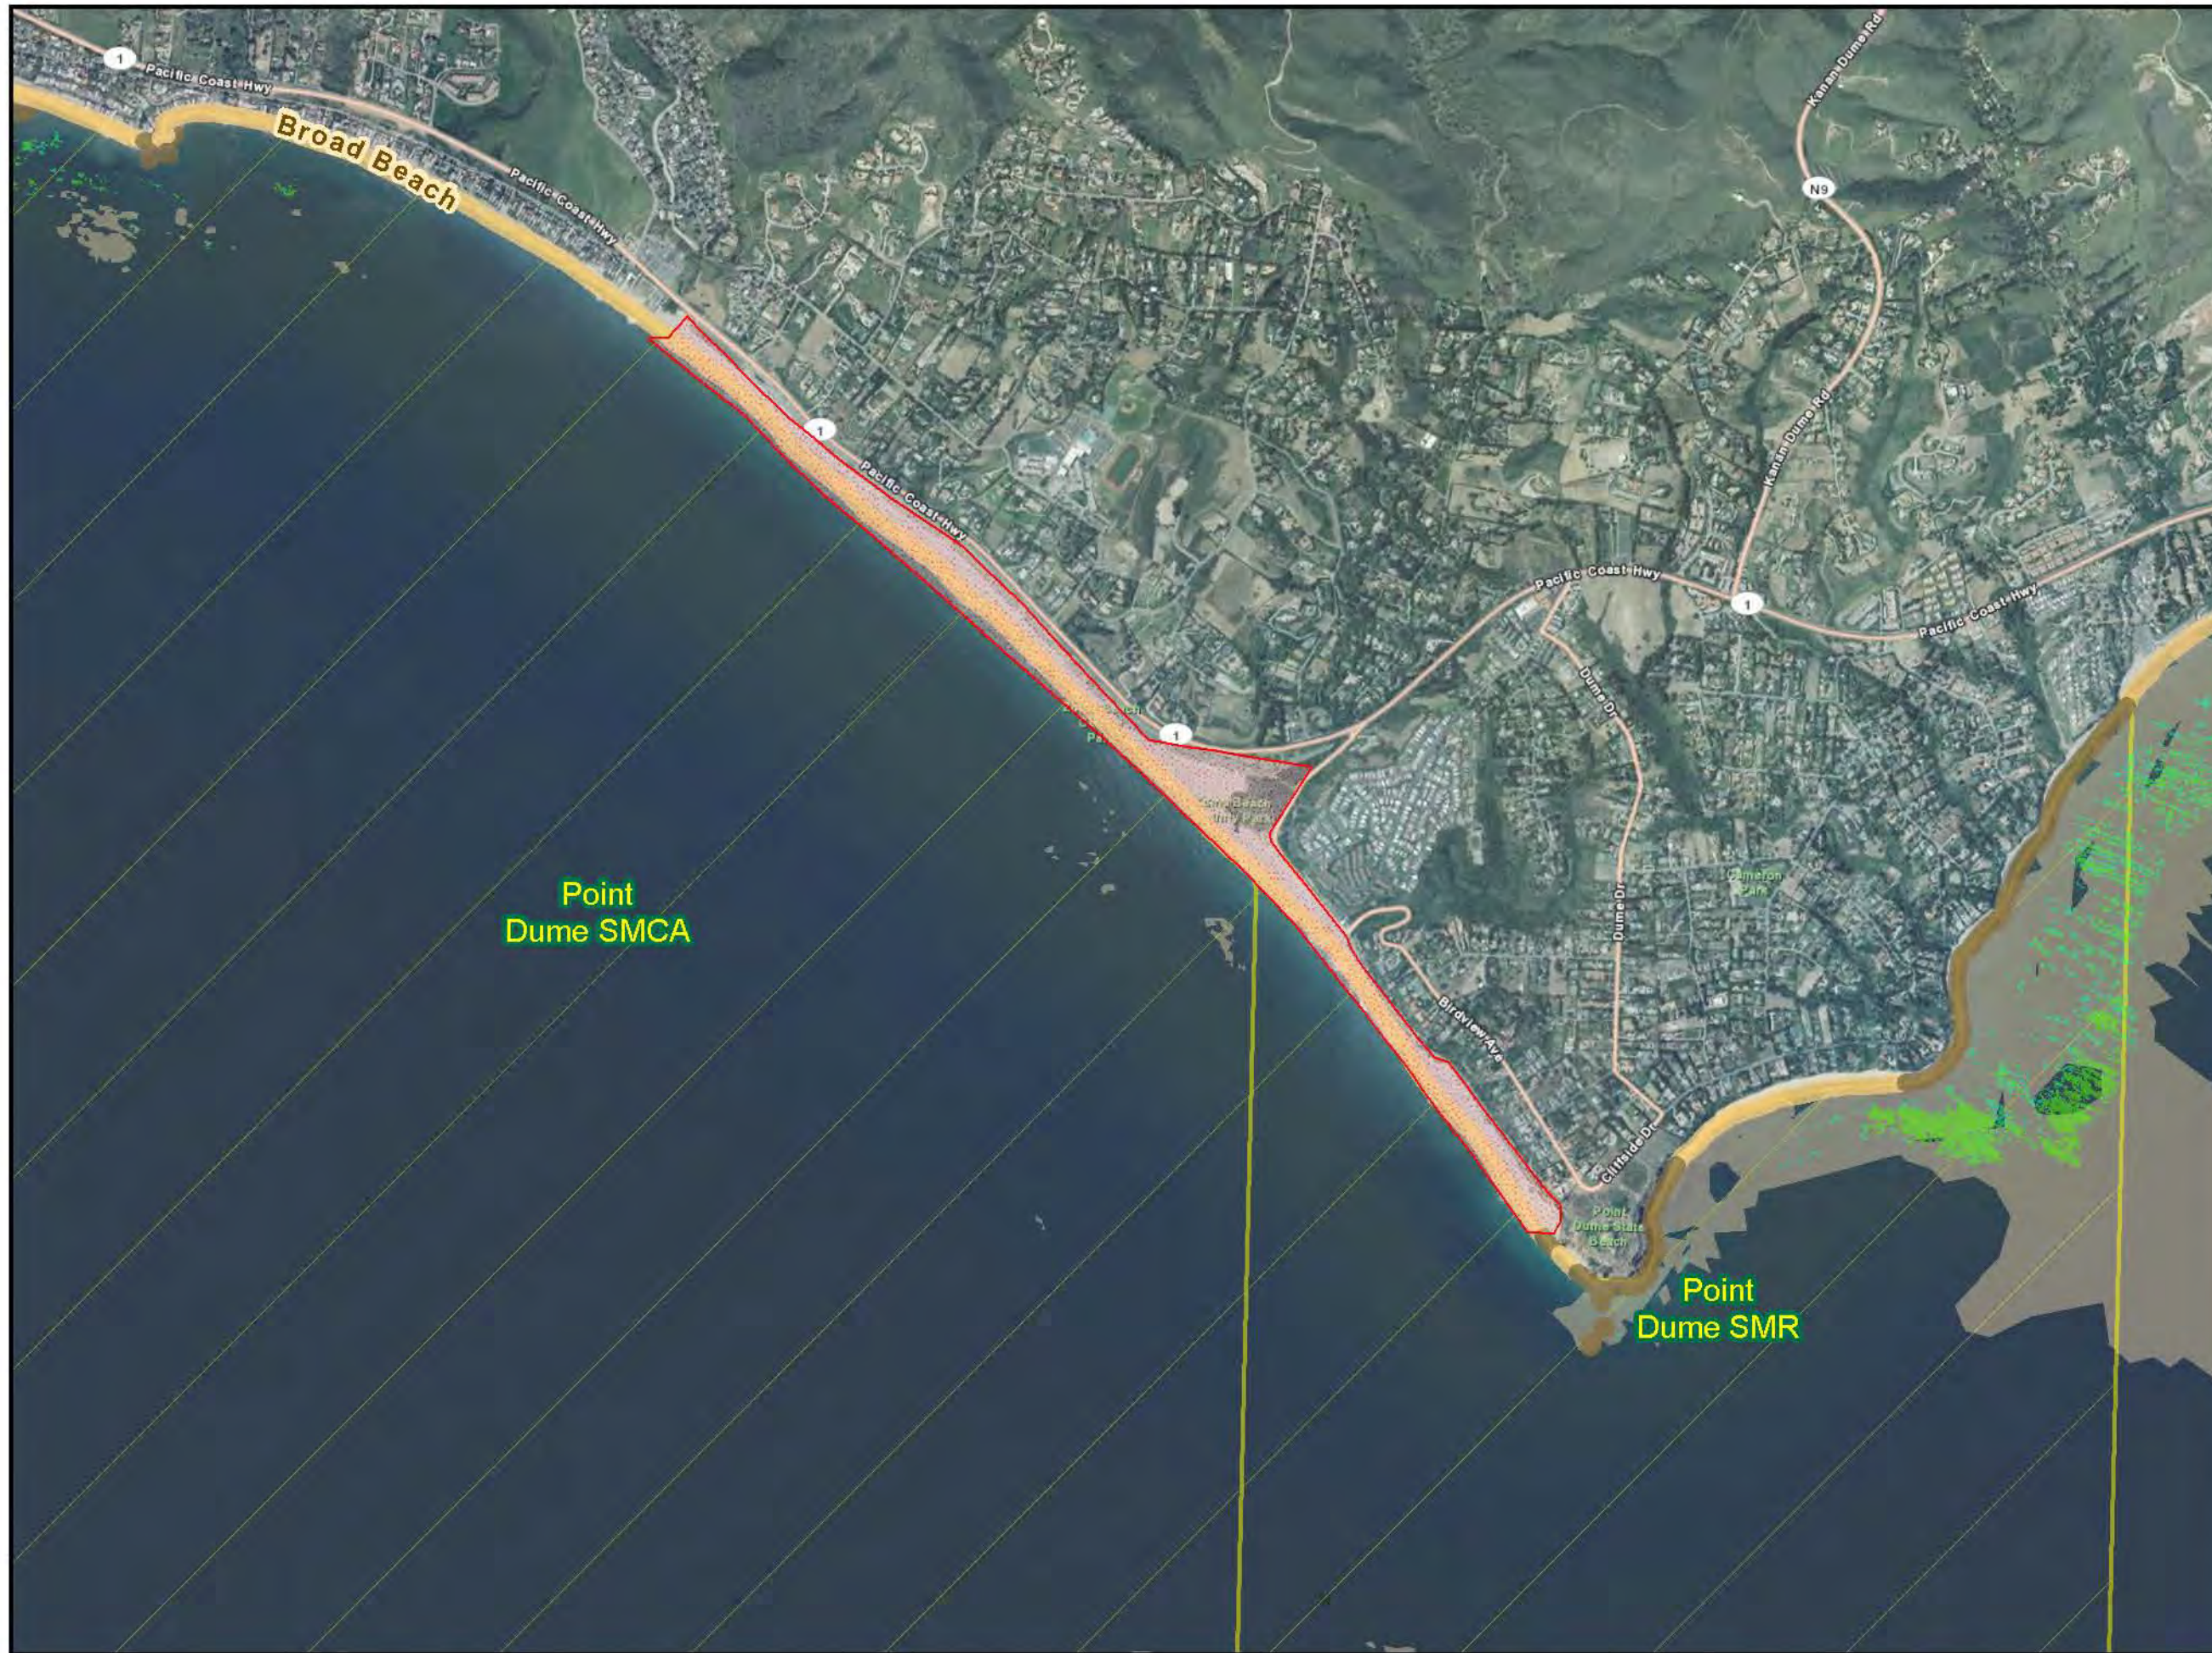
Figure 5
Habitat Types Between Lechuza Point and Point Dune

- Adopted Marine Protected Areas
 - Western Snowy Plover Critical Habitat
 - Predicted Substrate - Hard
- Shoreline Types**
- Beaches
 - Rocky Shores
- Kelp Beds**
- Kelp Canopy
 - Kelp Subsurface

Figure 5, based on California Department of Fish and Game GIS layers, is an overview of habitat types between Lechuza Point and Point Dune. Subtidal hard bottom, kelp beds and rocky shores are found at the western end of Broad Beach and from Point Dume to the east. Critical Habitat for the federal threatened western snowy plover is found between the extreme southeastern end of Broad Beach and Point Dume. The discussion below focuses on marine biological resources in the vicinity of the sand source and sand placement sites for the Broad Beach Restoration Project.

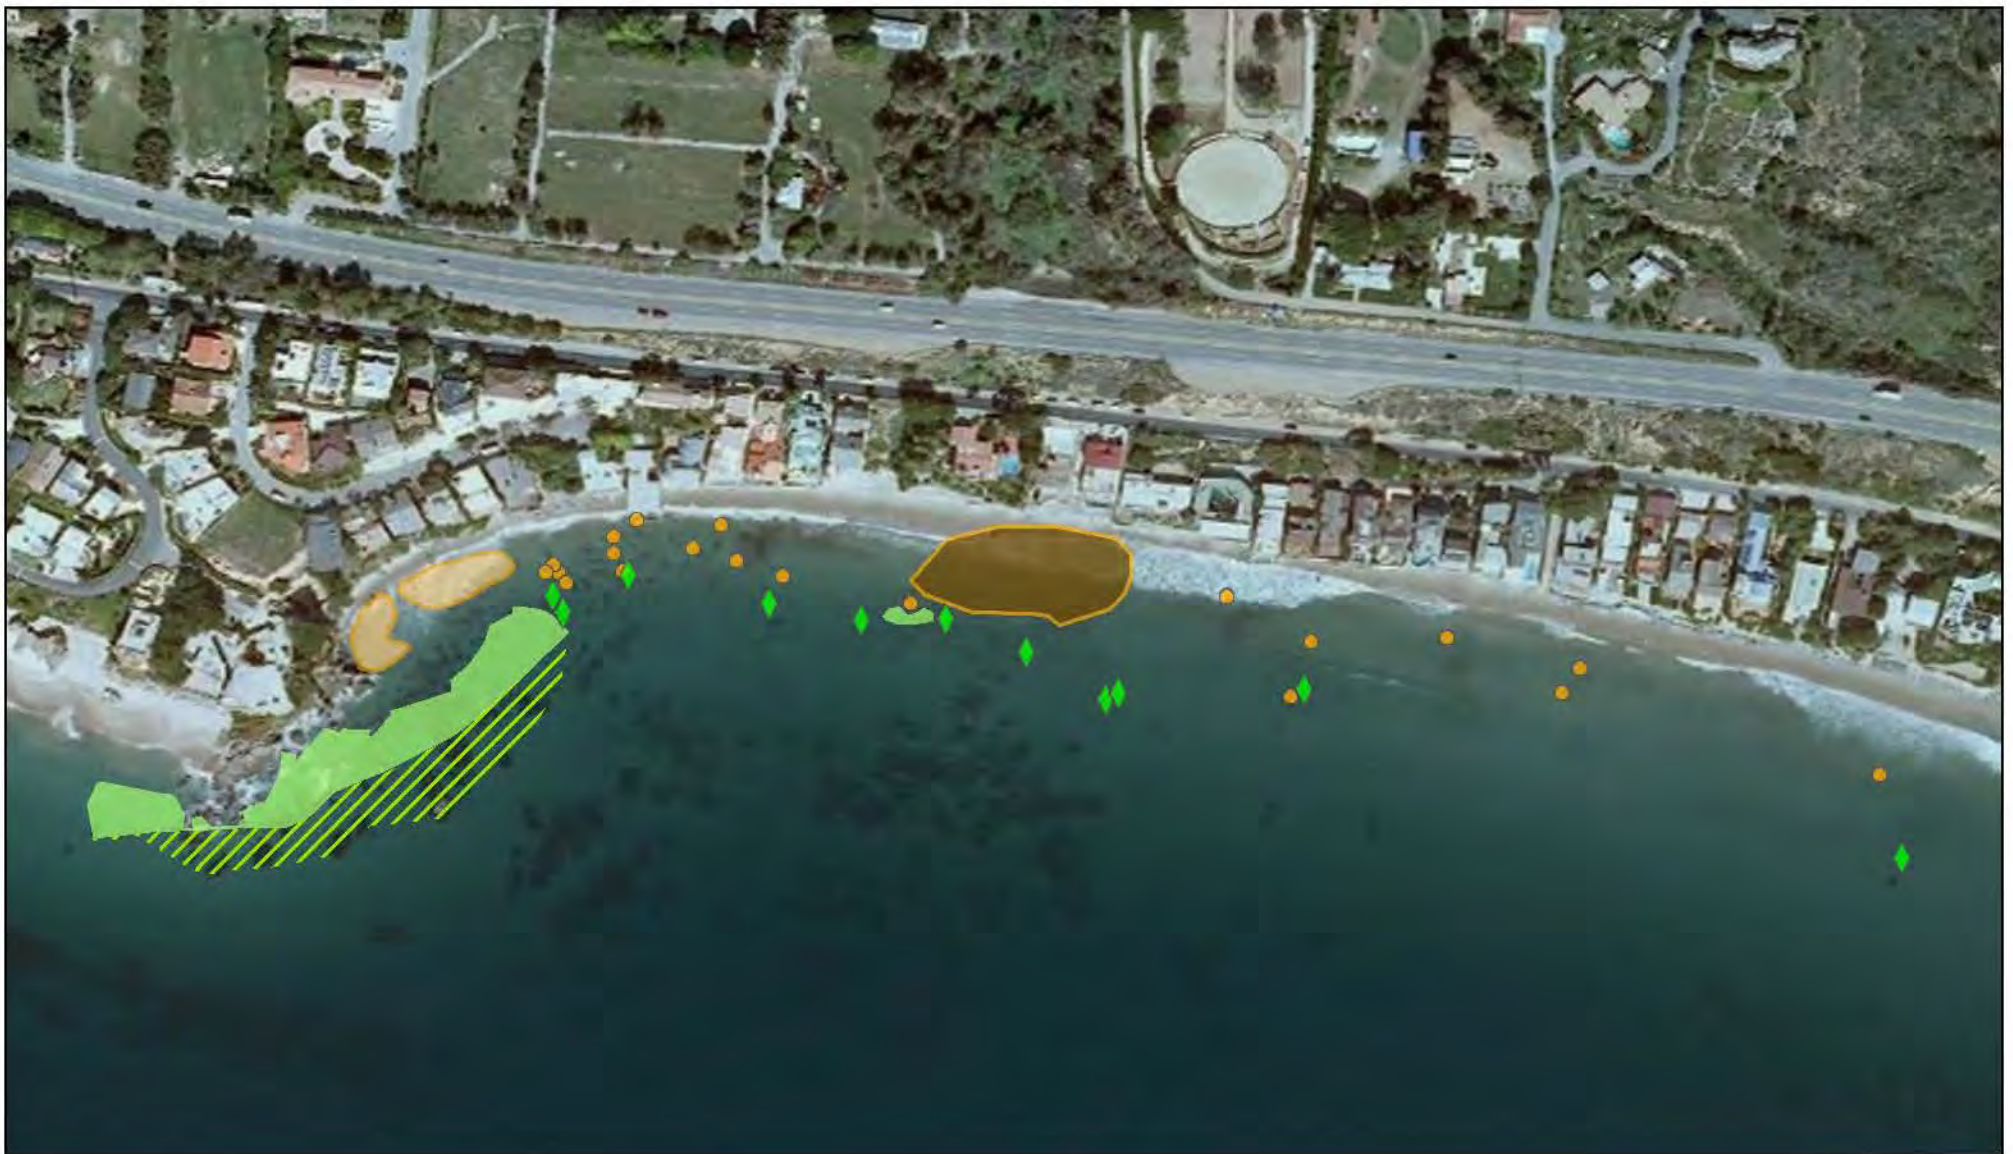
- ◆ Surfgrass
- Rocky Out Crops
- Observed Surfgrass
- Sanded in Rocky Area
- Extrapolated Surfgrass
- Boulder Field

Figure 9
Surfgrass Survey
Broad Beach

To obtain comparative information on seasonal sand movement, a second intertidal survey was done on April 10, 2012. Figure 9 shows the surfgrass and rocky intertidal mapped during this survey. The outer edge of the surfgrass, shown by green lines on the figure, was extrapolated based on the presence of rocky habitat and the occasional glimpse of surfgrass on the top of rocks when waves receded. Frequent patches of surfgrass were observed during the April, 2012 survey in the vicinity of Lechuza Point in approximately the same location they were observed in the October, 2010, survey. However, the rocky area near Lechuza Point observed in October, 2010, had experienced considerable sand inundation (Figure 10). The tidepools observed in October, 2010, were sanded in and the rocks were buried or partially buried (Figure 11). Some of the most inshore surfgrass observed in October, 2010, also may have been buried. Some surfgrass was observed with just blades sticking out of the sand. The list of species observed during the April 2012 survey are shown in Appendix B.

In April, 2010, scattered rocks and surfgrass southeast of Lechuza Point were similar to those observed in October, 2012 (Figure 9, Figure 12). The boulder field observed in October, 2010, was also observed in April, 2012, but the most landward portion of it was covered with more sand than in October, 2010 (Figure 13).

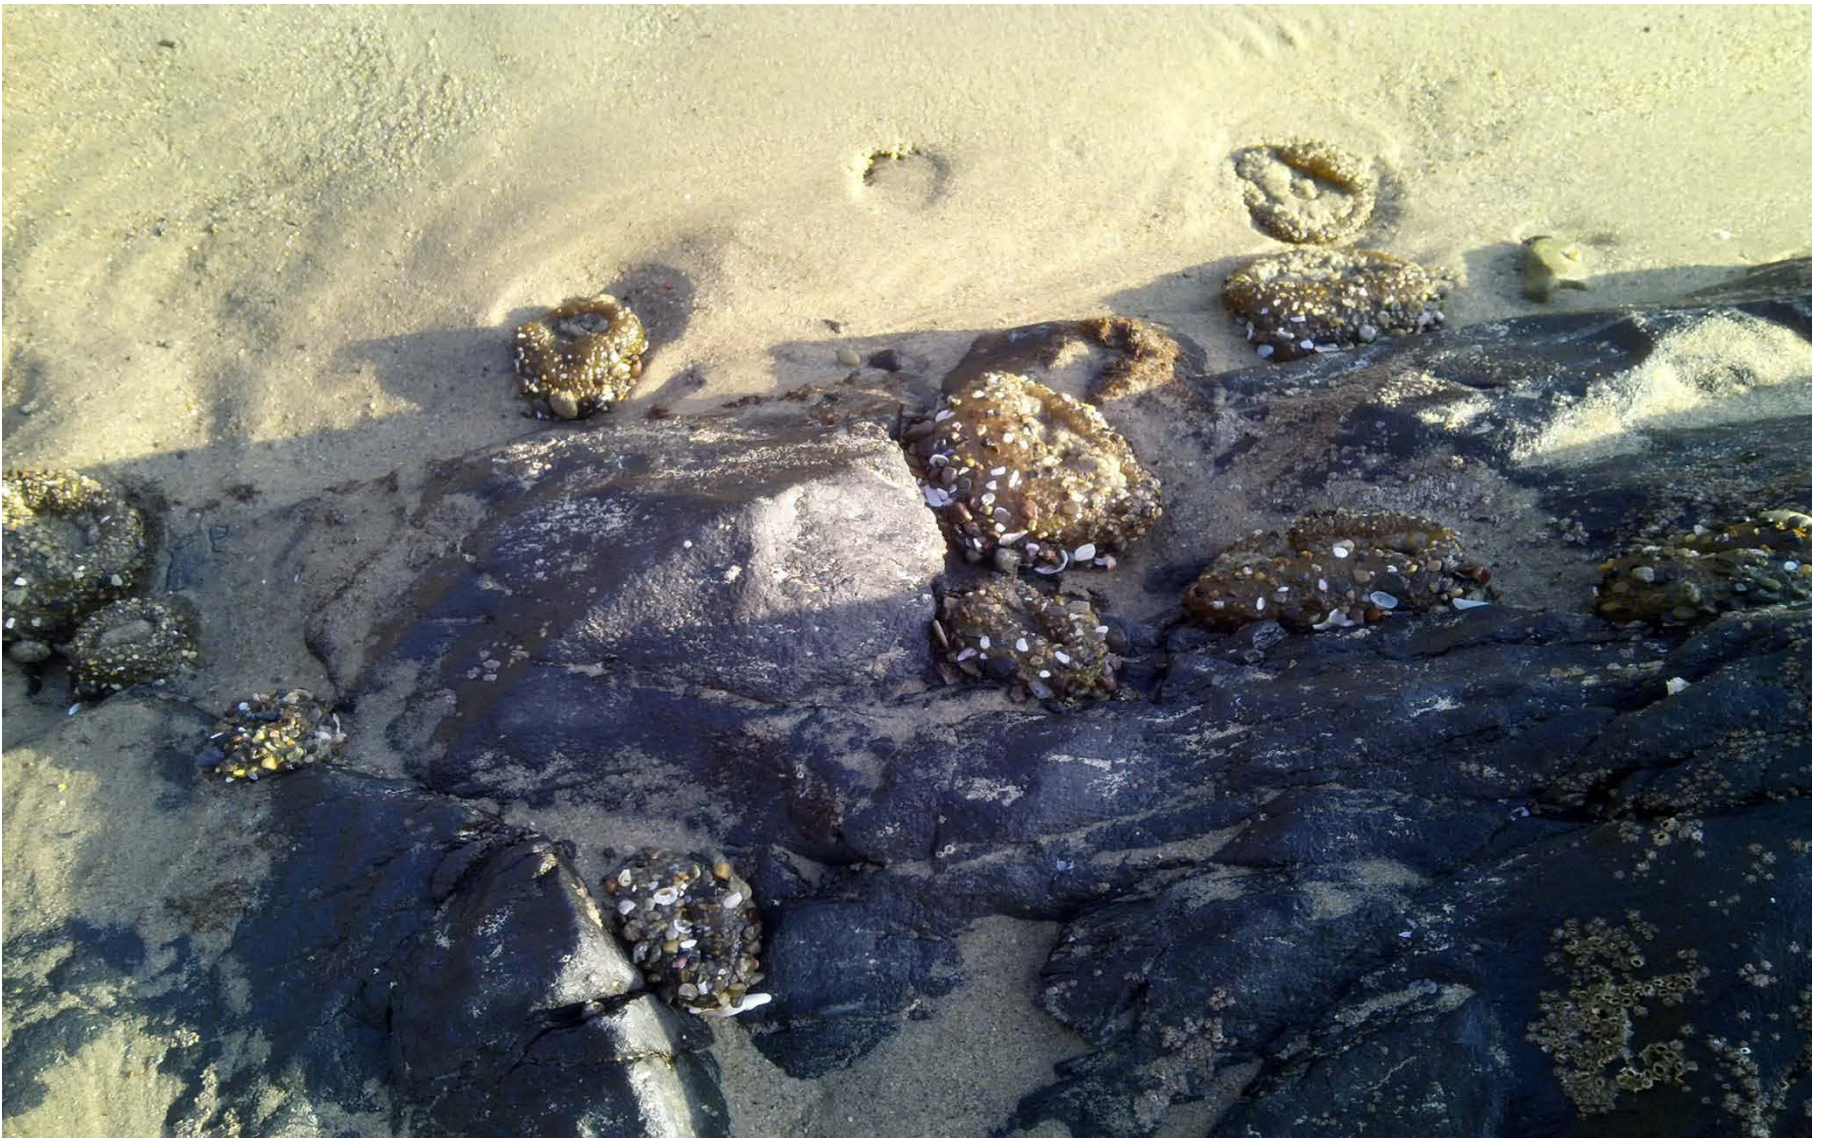
Figure 11 Partially Buried Rocks at Lechuza Point in April 2012
