**SUPPLEMENTAL MARINE HABITAT SURVEY AND MAPPING
FOR THE BROAD BEACH RESTORATION PROJECT**

June 2014

The Broad Beach Restoration Project ("Project") proposes to place 600,000 cubic yards of beach-compatible sand material on the beach to create a wider and longer beach, and new dune habitat. The Project is currently in the permitting phase, and while biological surveys have been conducted, a greater level of information regarding biological habitats and species has been requested by resource and regulatory agencies. A summary of the biological effort completed to date includes:

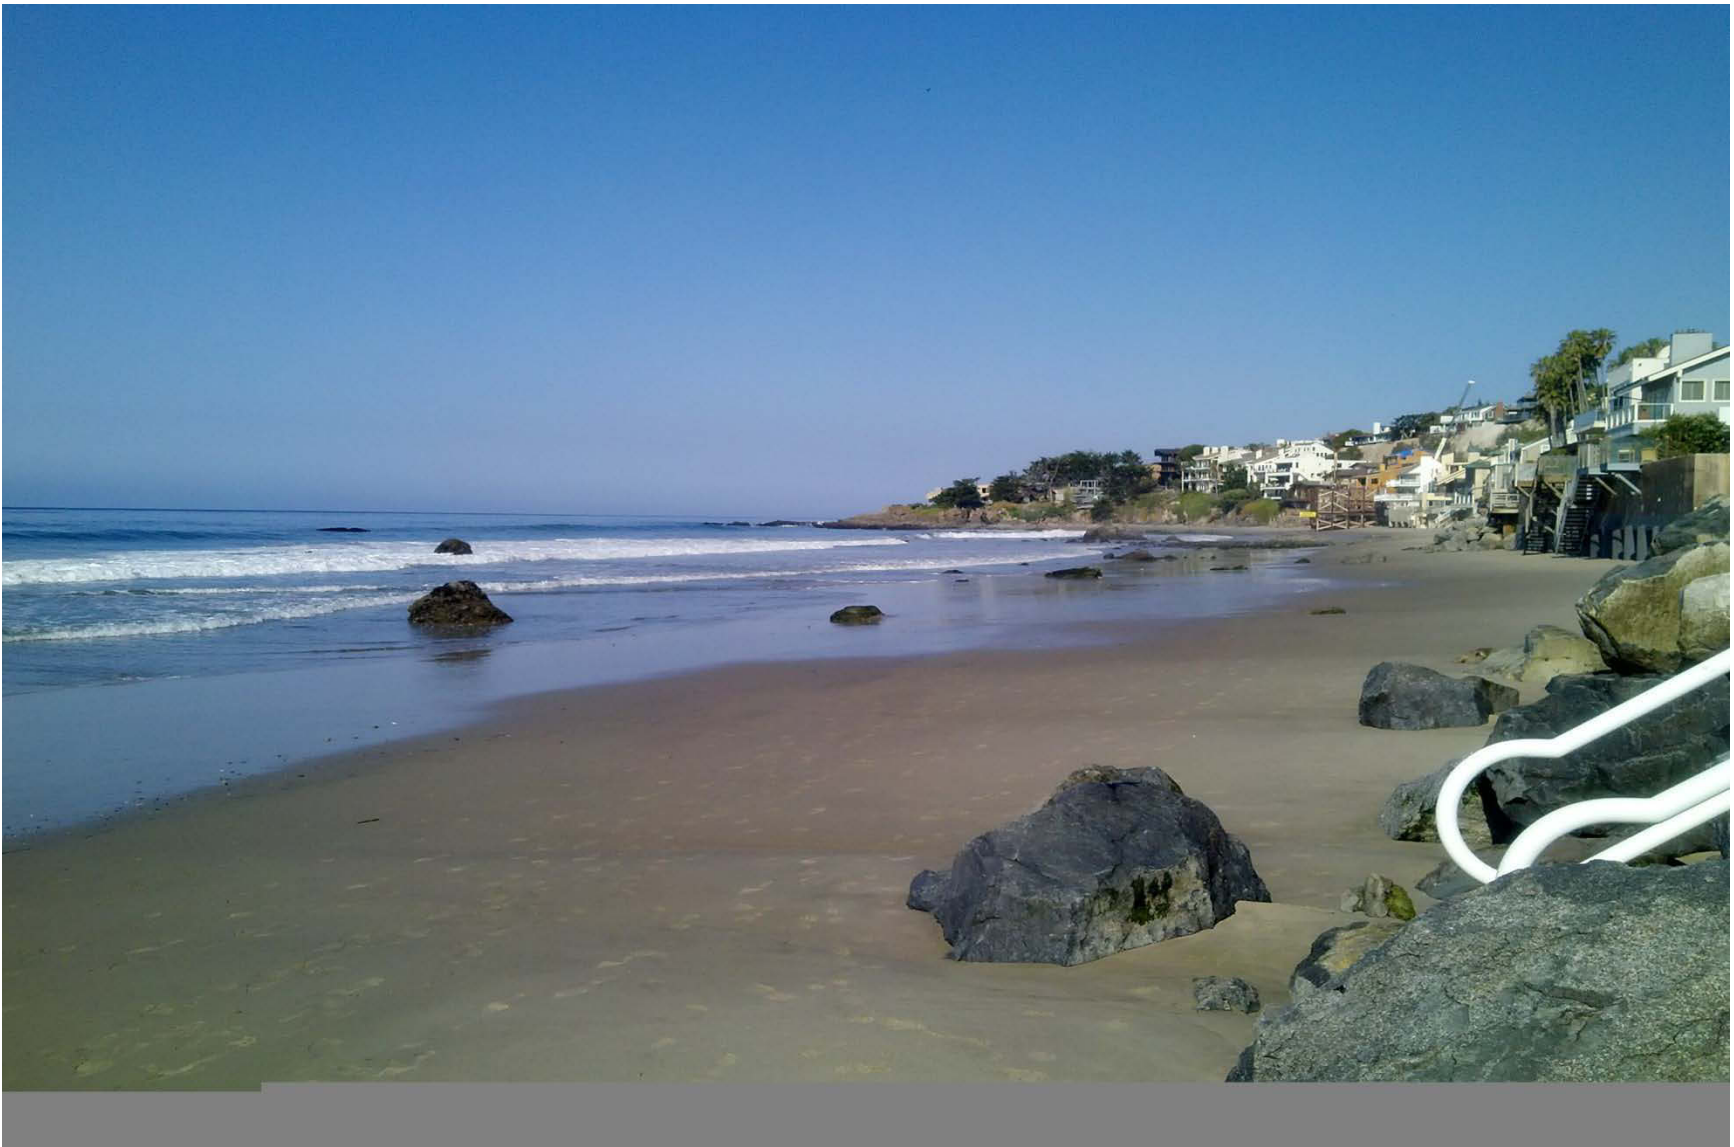
Figure 12 Scattered Rocks in April 2012

In April, 2010, scattered rocks and surfgrass southeast of Lechuza Point were similar to those observed in October, 2012 (Figure 9, Figure 12). The boulder field observed in October, 2010, was also observed in April, 2012, but the most landward portion of it was covered with more sand than in October, 2010 (Figure 13).

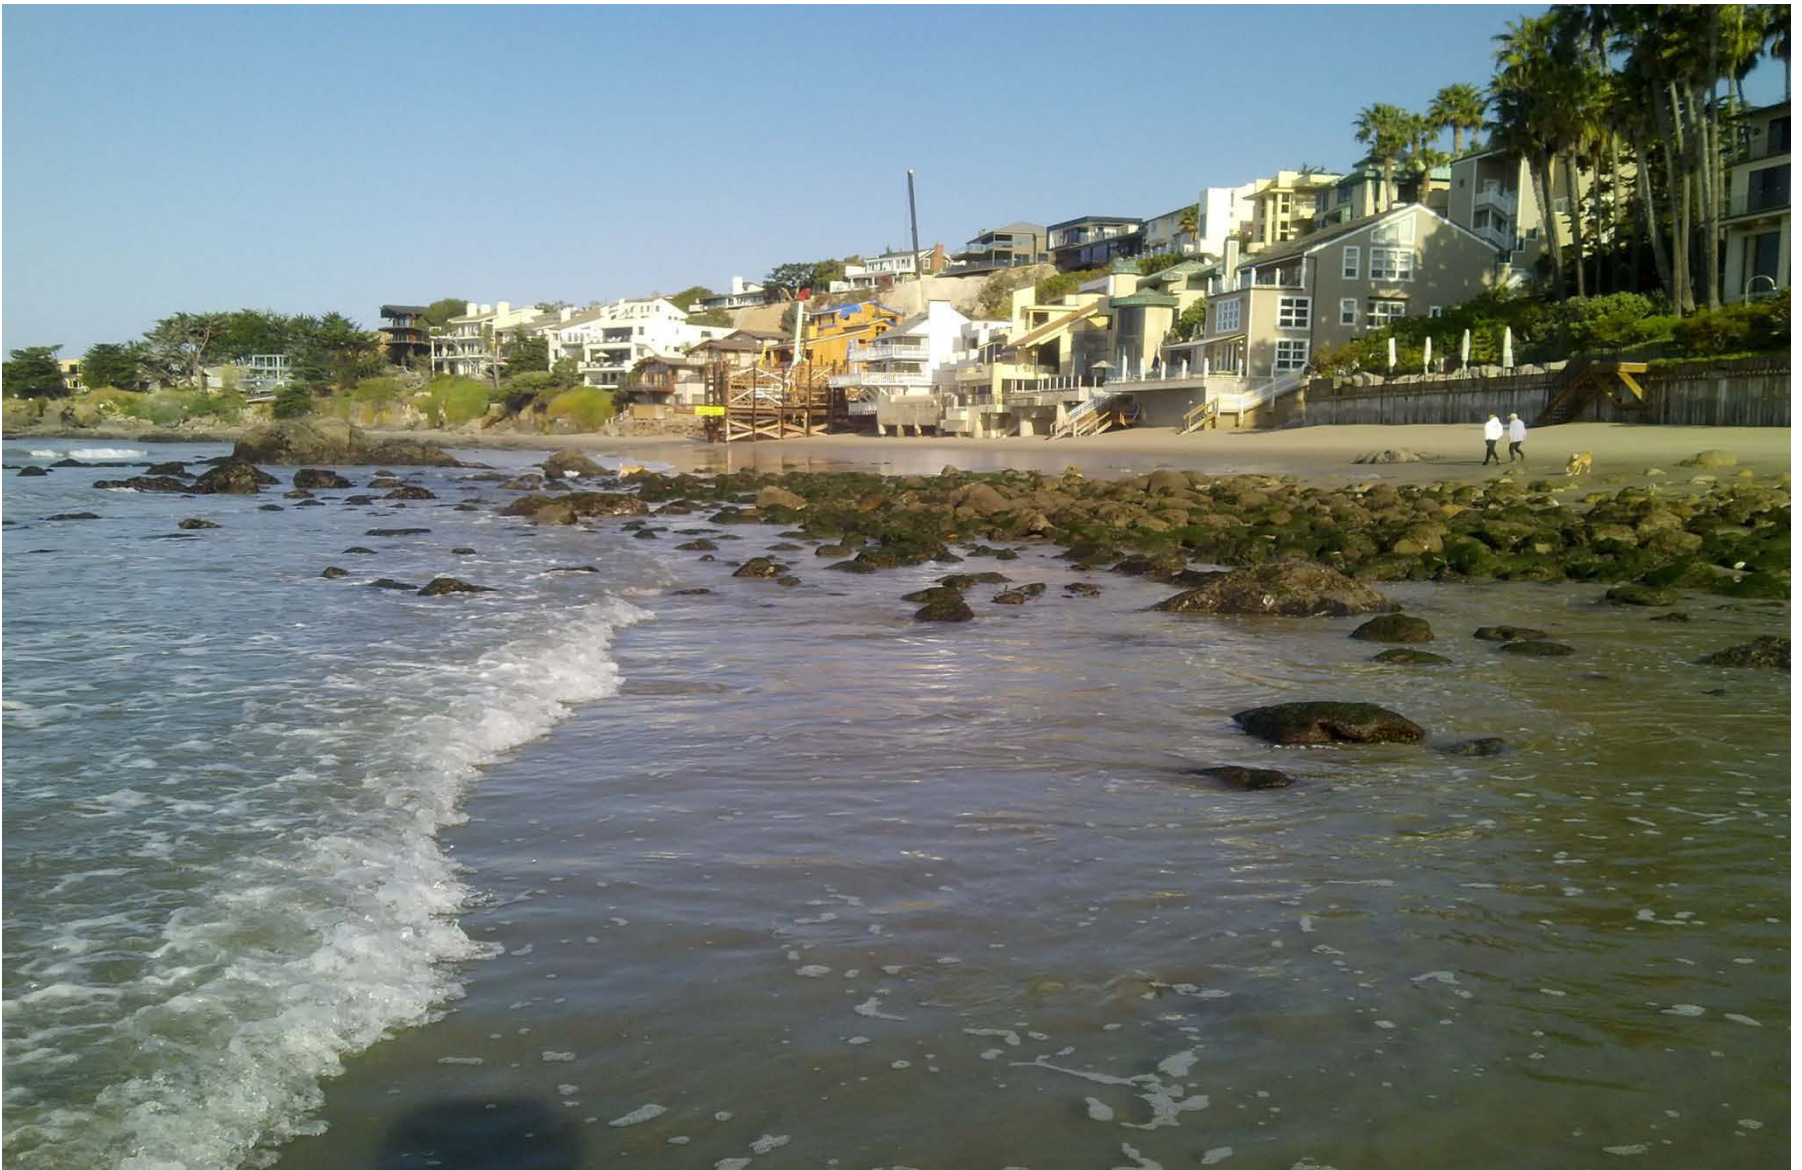
Figure 13 Broad Beach Boulder Field in April 2012

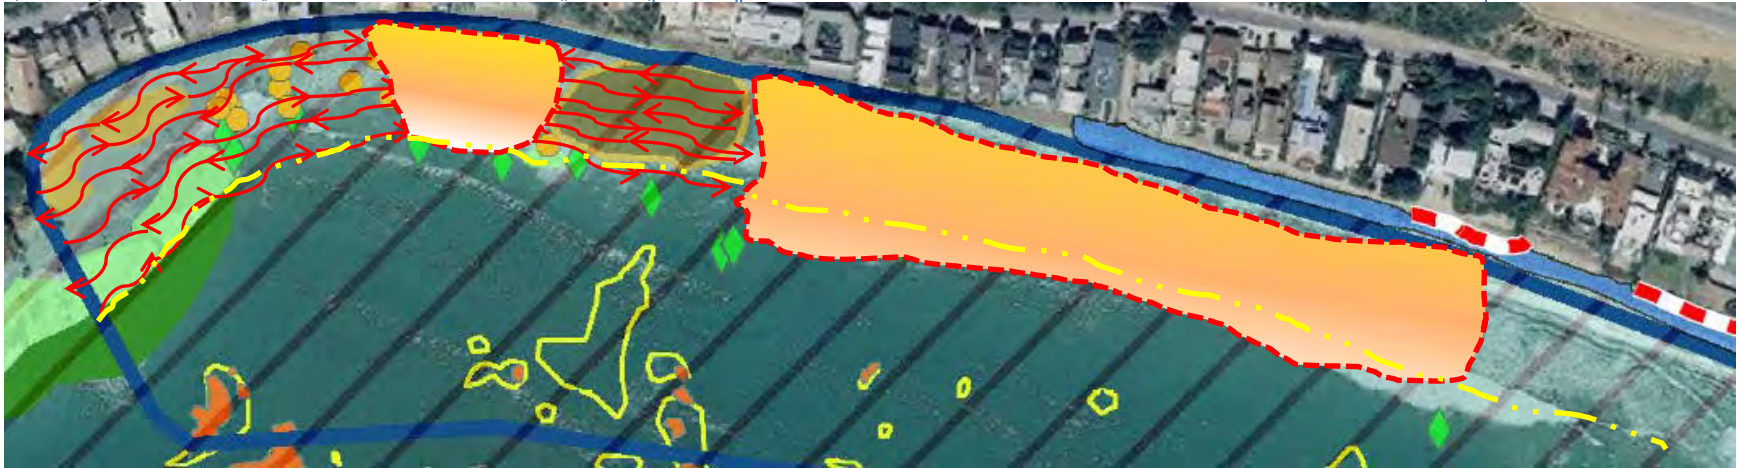
EST. 150 FT SWATH PATTERN IN
CONCENTRACTED ROCK AREA
TO BE SURVEYED BY SINGLE BIOLOGIST
