**Buildings at Risk
Register and Strategy**

March 2013

This document is the Vale of Glamorgan Council's Buildings at Risk Register and Strategy. It includes those listed buildings that are considered to be 'at risk'.

Survey work was carried out by the Handley Partnership, whilst the register and strategy was prepared by the Council's Conservation & Design team.

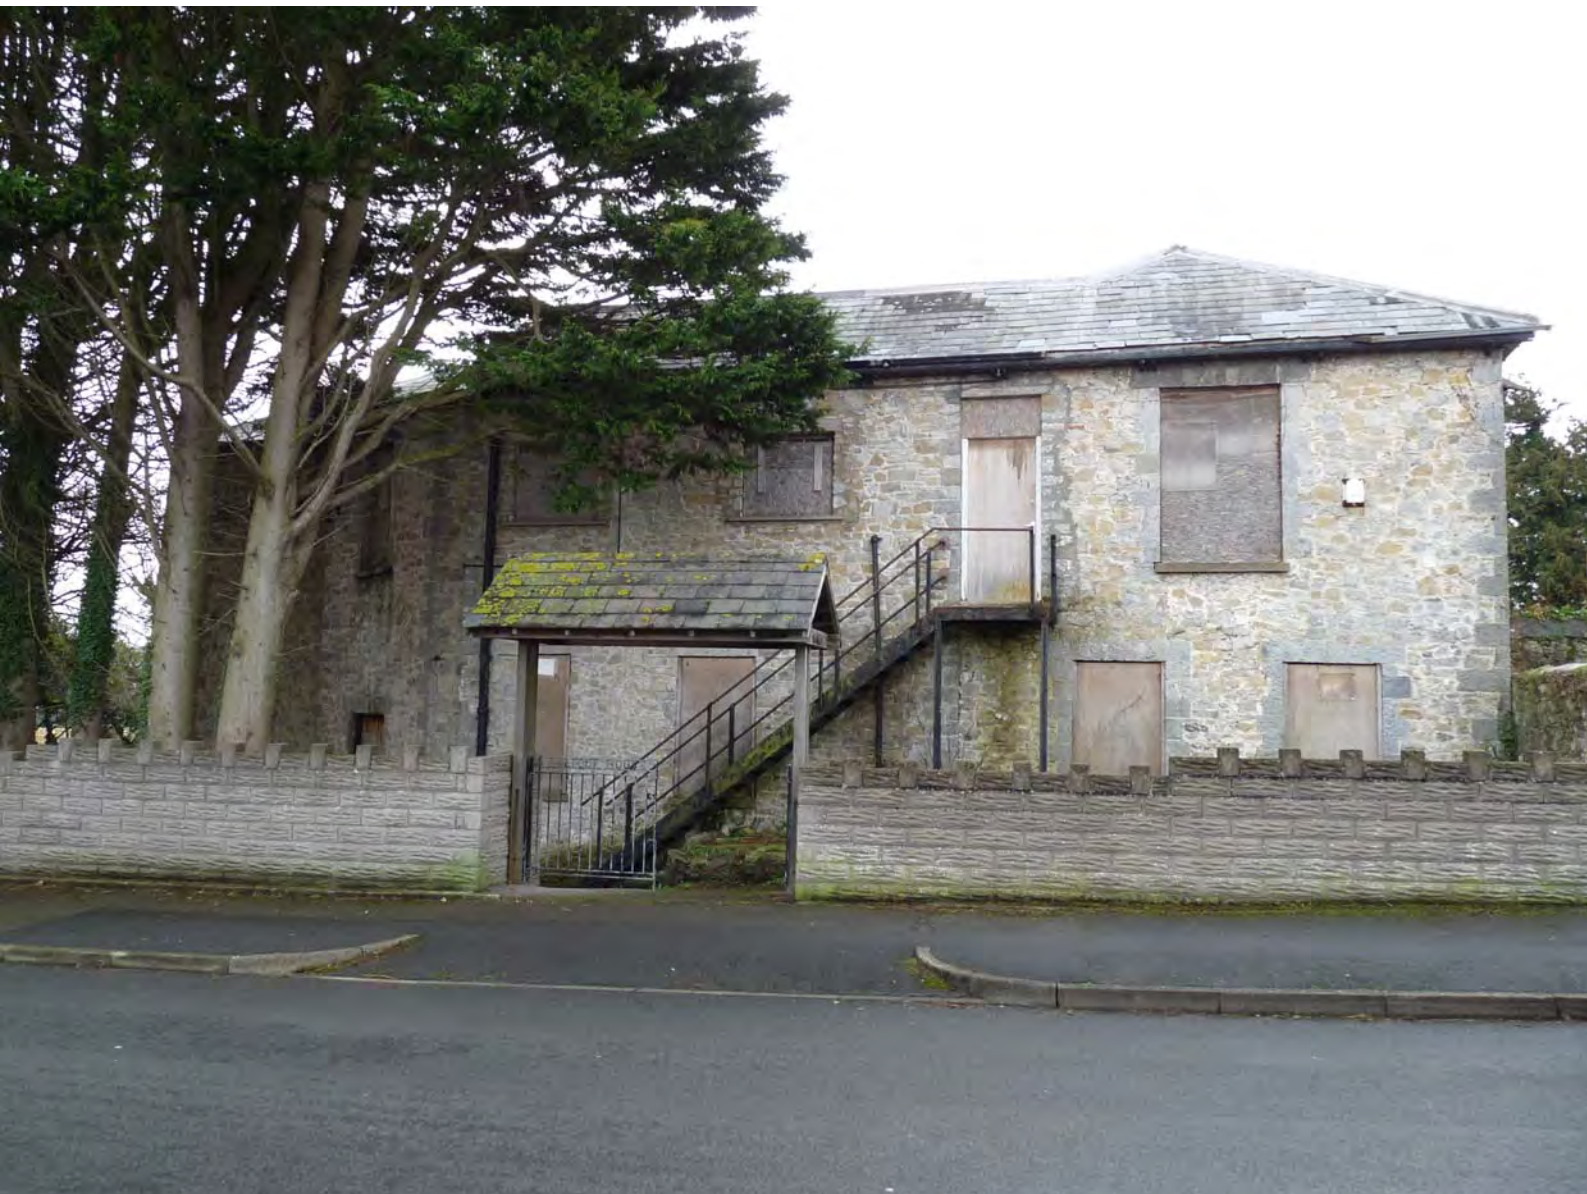
Balfour House, St Athan

Most recently used as flats, Balfour House is currently boarded up. It's reuse would also benefit the amenity of the wider area.

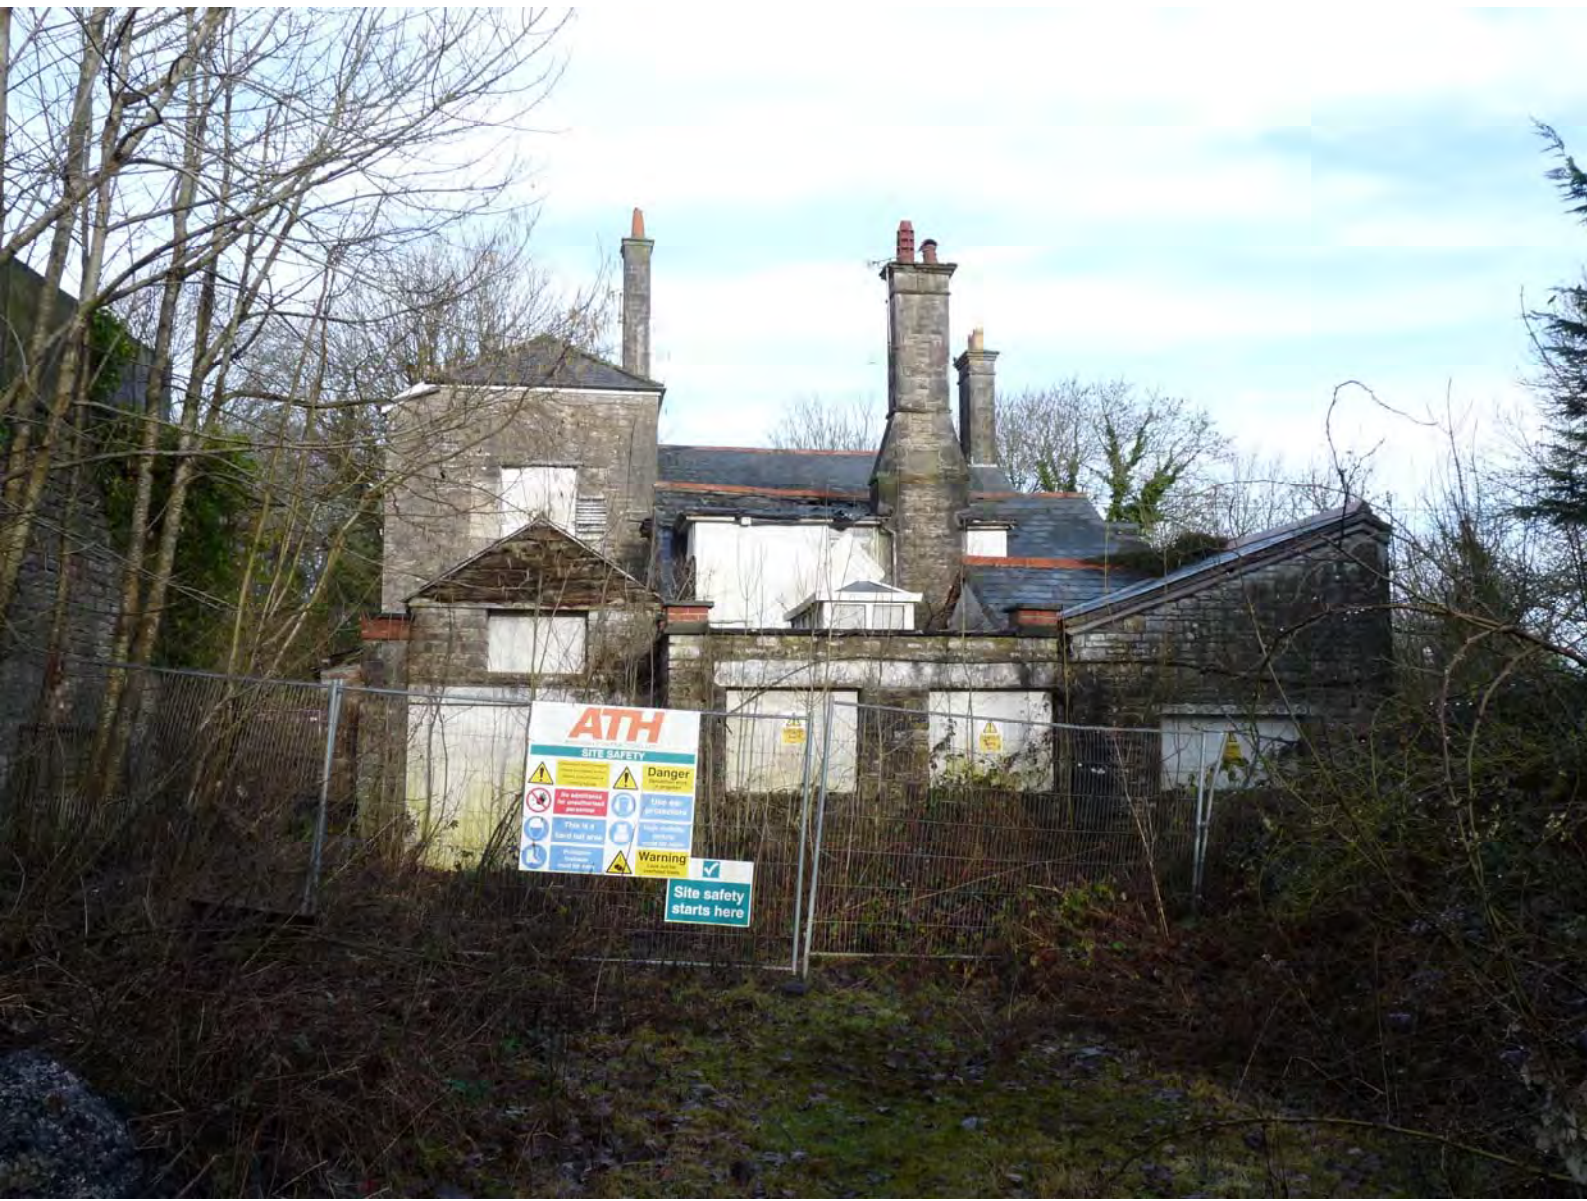
Llandough Castle Flats

Through working with the owners of the site it is hoped a satisfactory scheme to bring the building back in to use can be agreed.

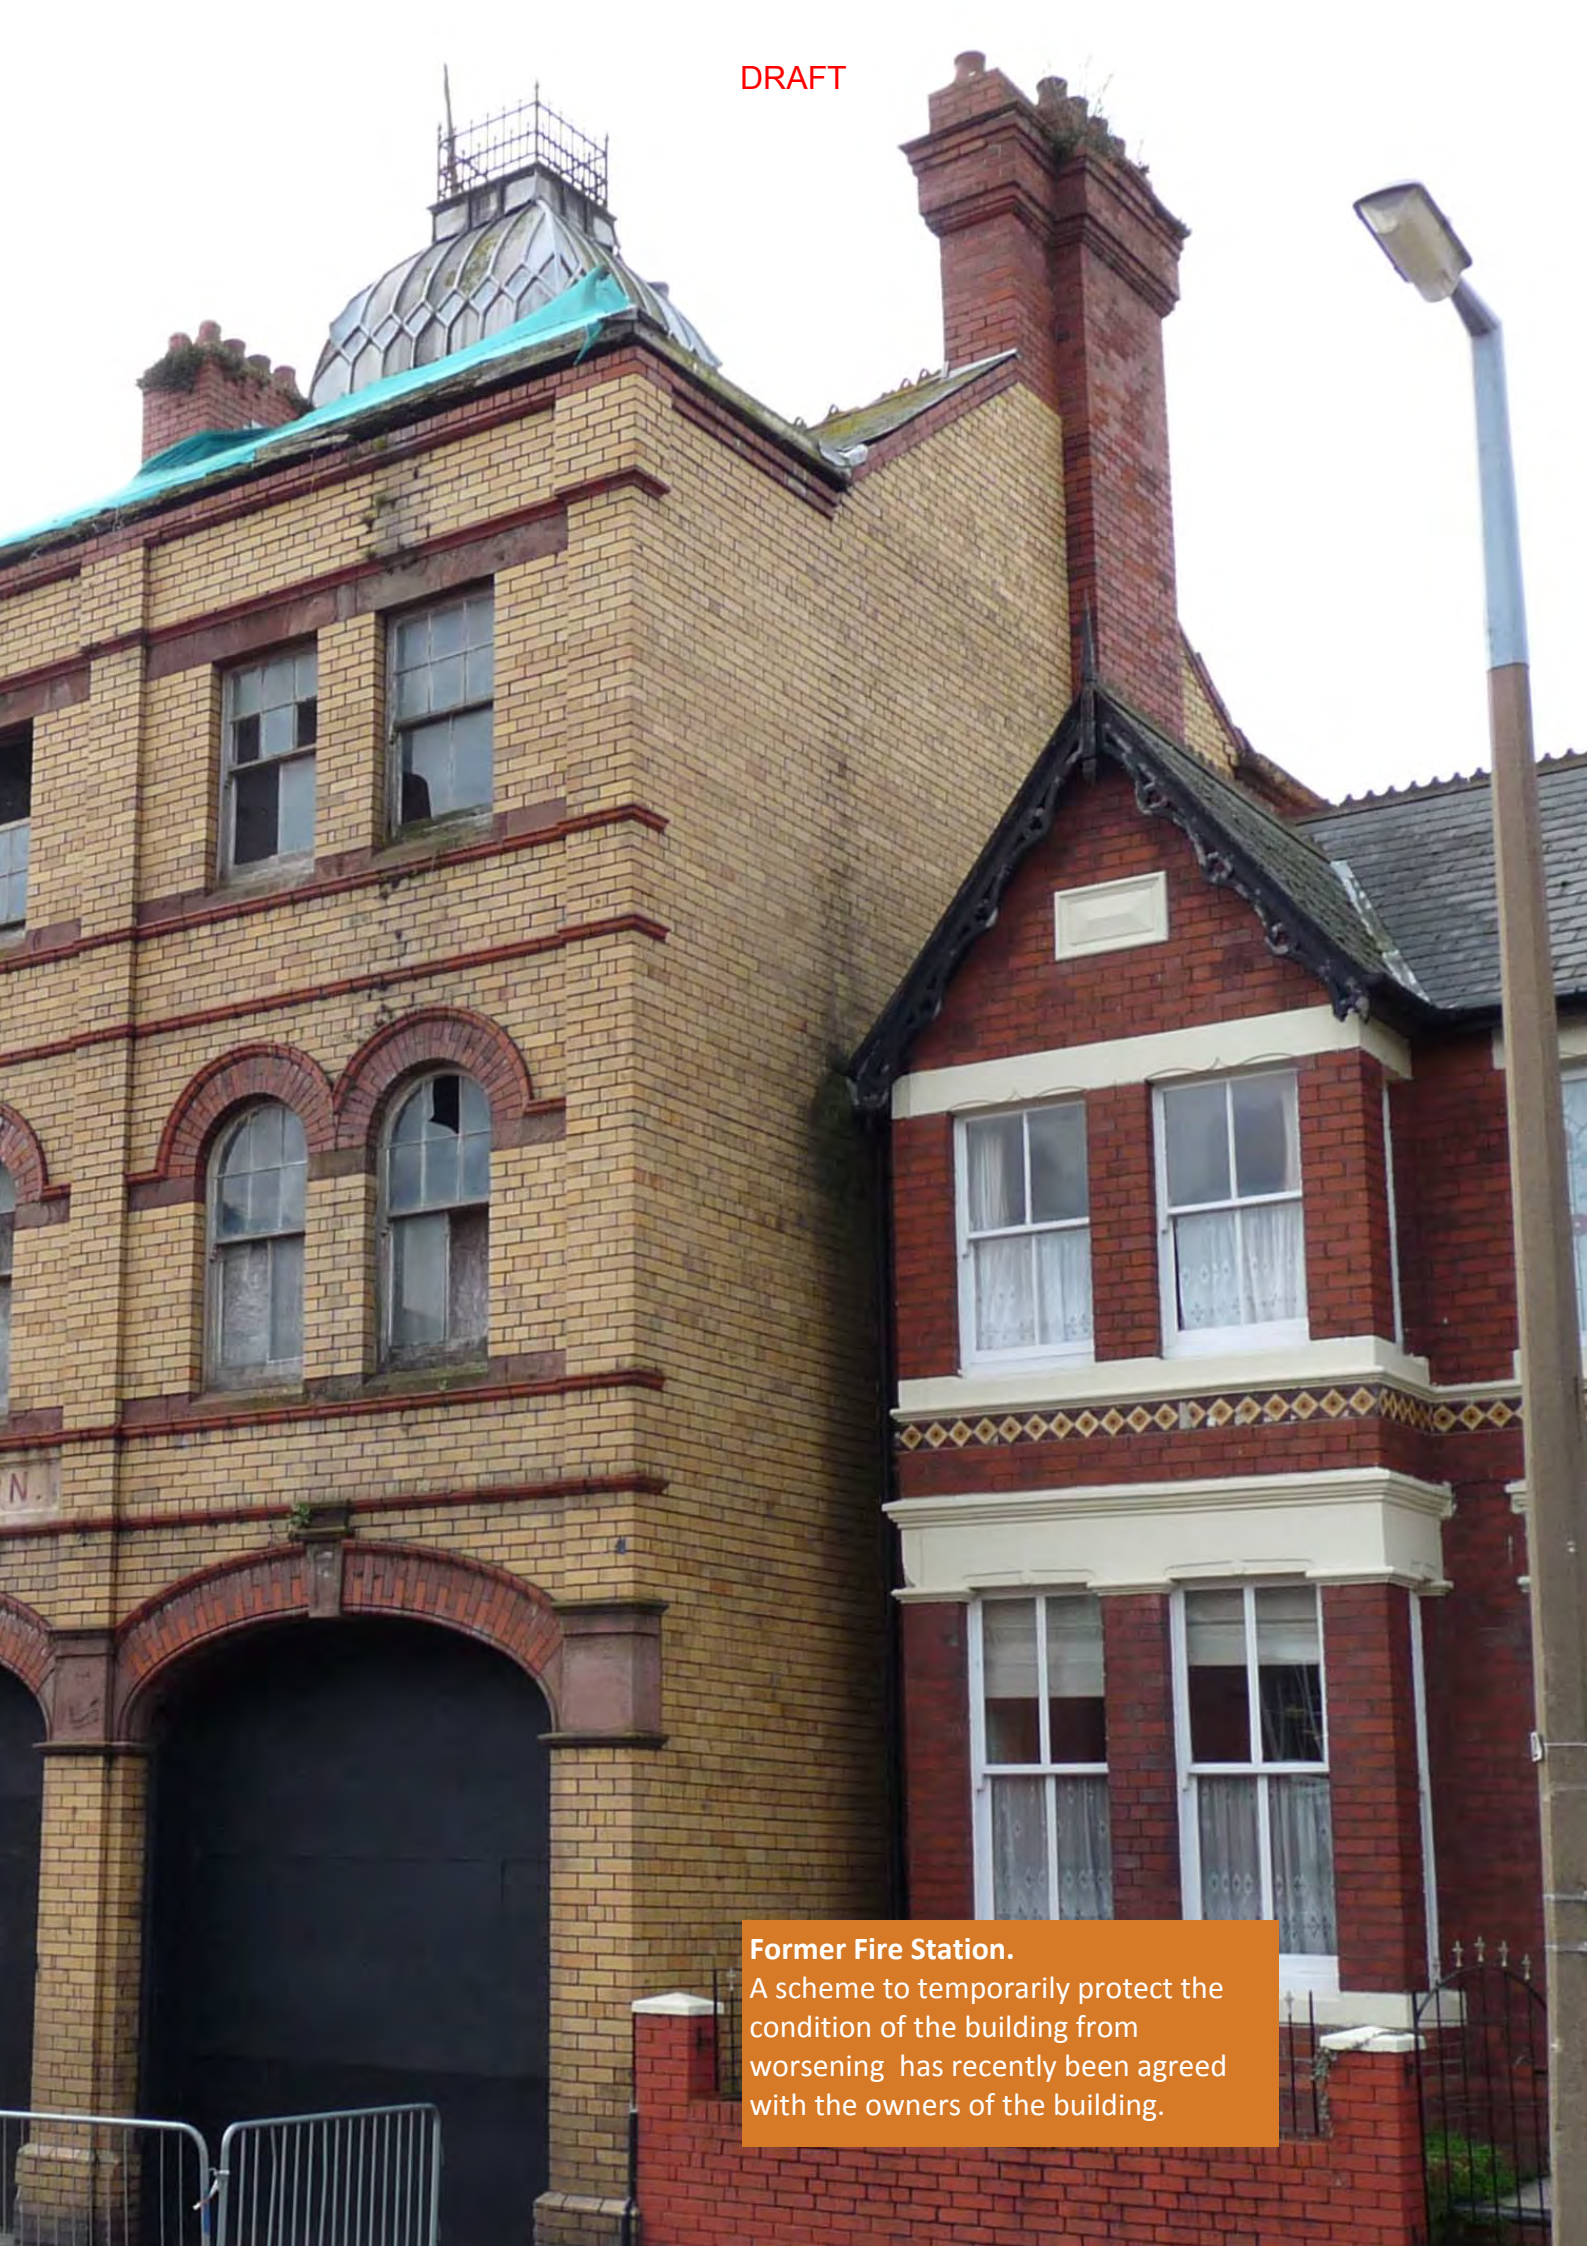
Former Fire Station.

A scheme to temporarily protect the condition of the building from worsening has recently been agreed with the owners of the building.

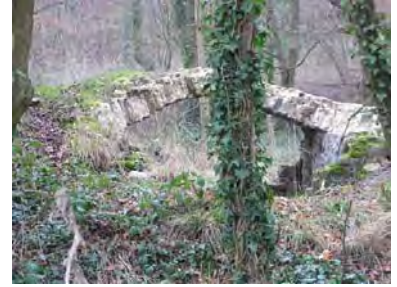
Community Barry
 Name/address **Operator's Cabin to Sliding Bridge**
 Rec No. / Survey Ref No 16837 / 90/86/196 / 1663
 Listed Building Grade II
 Risk Assessment **AT RISK**
 Comment Many items require replacement

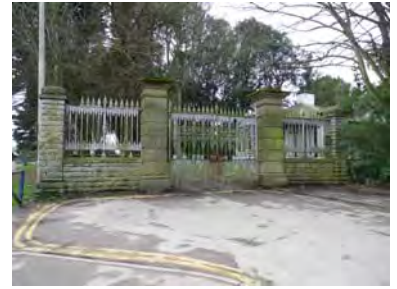
Community Barry
Name/address GATES AND GATEPIERS AT DRIVE ENTRANCE TO FRIARS POINT HOUSE, FRIARS ROAD (W END), BARRY ISLAND
Rec No. / Survey Ref No 13456 / 72/C/34 (3) / 1500
Listed Building Grade II
Risk Assessment **AT RISK**
Comment Reduced maintenance levels

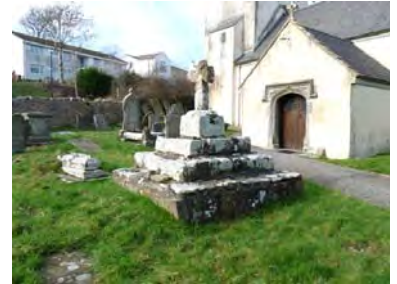
Community Colwinston
Name/address Churchyard Cross of Church of St. Michael and All Angels
Rec No. / Survey Ref No 81329 / AB / 1377
Listed Building Grade II
Risk Assessment **AT RISK**
Comment Serious lack of maintenance

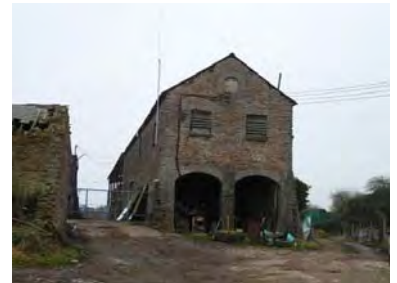
Community Ewenny
Name/address Barn on Ewenny Down
Rec No. / Survey Ref No 19456 / AA / 1214
Listed Building Grade II
Risk Assessment **AT RISK**
Comment Very poor condition

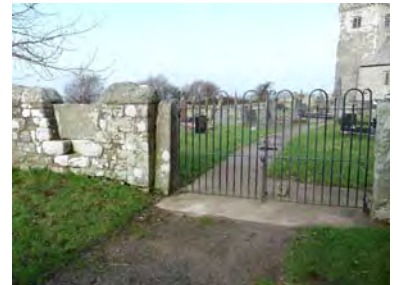
Community Llangan
Name/address **Chuchyard Wall of the Church of St Mary**
Rec No. / Survey Ref No 81312 / BC / 1258
Listed Building Grade II
Risk Assessment **AT RISK**
Comment Ongoing decline

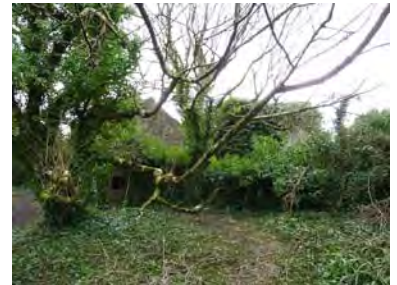
Community Llantwit Major
Name/address **Summerhouse Fort**
Rec No. / Survey Ref No 83401 / KD / 1273
Listed Building Grade II
Risk Assessment **AT RISK**
Comment Structurally unsound

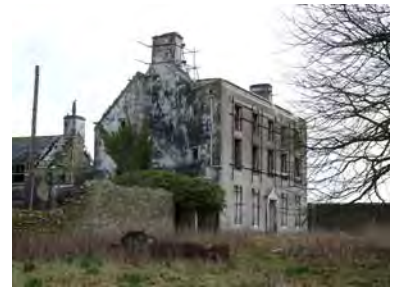
Community Llantwit Major
Name/address **Great Frampton**
Rec No. / Survey Ref No 13300 / IG / 1505
Listed Building Grade II
Risk Assessment **AT RISK**
Comment Structurally unsound

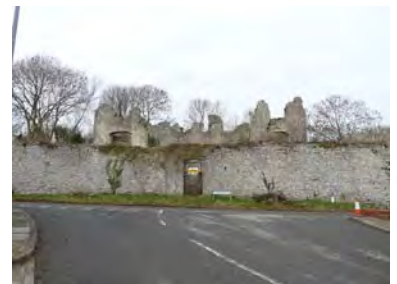
Community Llantwit Major
Name/address **Old Place (or Llantwit Major Castle)**
Rec No. / Survey Ref No 13286 / DA / 1657
Listed Building Grade II
Risk Assessment **AT RISK**
Comment Structurally unsound

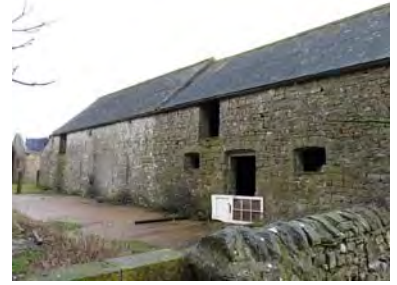
Community Llantwit Major
Name/address **Boverton Place including attached bee-boles**
Rec No. / Survey Ref No 13245 / AH / 1204
Listed Building Grade II*
Risk Assessment **AT RISK**
Comment Many items require replacement

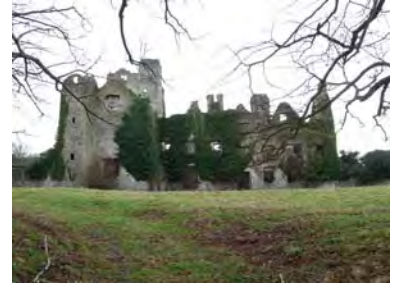
Community Llantwit Major
Name/address **Summerhouse Tower**
Rec No. / Survey Ref No 83402 / KE / 1274
Listed Building Grade II
Risk Assessment **AT RISK**
Comment Some critical items require replacement

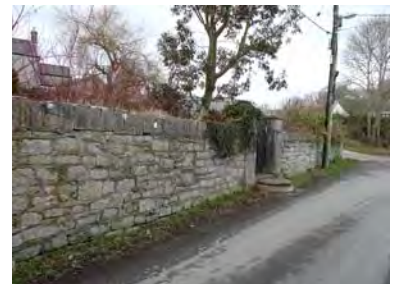
Community Llantwit Major
Name/address **Wall and Gateway opposite Boverton House**
Rec No. / Survey Ref No 83404 / BF / 1803
Listed Building Grade II
Risk Assessment **AT RISK**
Comment Maintenance backlog building up

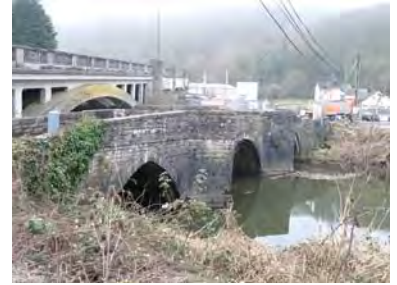
Community Penarth
Name/address MARINE BUILDINGS, DOCK ROAD
Rec No. / Survey Ref No 13351 / 72/B/17(3) / 1597
Listed Building Grade II
Risk Assessment **AT RISK**
Comment Major repairs required to many items

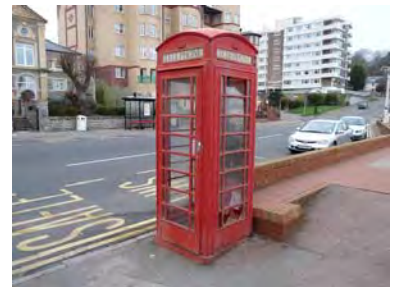
Community Penarth
Name/address TELEPHONE CALL-BOX IN FRONT OF THE PAVILION AND PIER, THE ESPLANADE
Rec No. / Survey Ref No 13354 / 72/B/20(4) / 1286
Listed Building Grade II
Risk Assessment **AT RISK**
Comment Secondary item maintenance required

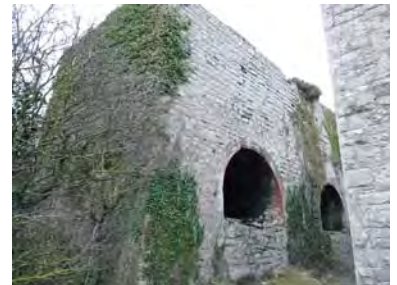
Community Rhoose
Name/address Aberthaw Lime and Cement Works
Rec No. / Survey Ref No 83144 / BA / 1166
Listed Building Grade II
Risk Assessment **AT RISK**
Comment Some critical items require replacement

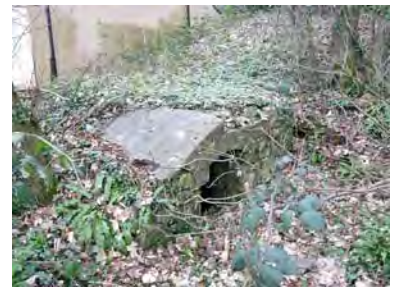
Community Rhoose
Name/address Retaining Walls of South Garden at Fonmon Castle
Rec No. / Survey Ref No 83159 / CE / 1722
Listed Building Grade II
Risk Assessment **AT RISK**
Comment Maintenance backlog building up

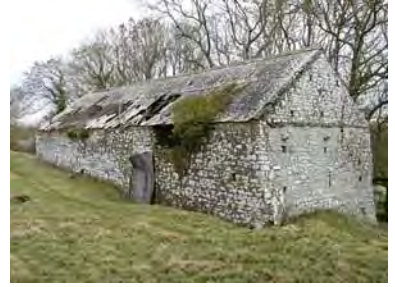
Community St Athan
 Name/address **Retainers' Hall at East Orchard**
 Rec No. / Survey Ref No 83125 / CA / 1721
 Listed Building Grade II
 Risk Assessment **AT RISK**
 Comment Structurally unsound

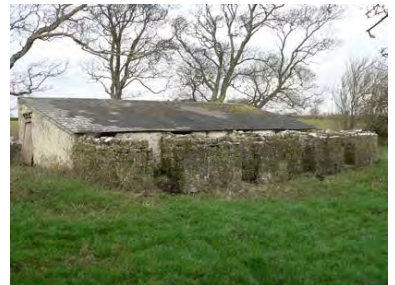
Community St Athan
 Name/address **Garden wall and House Ruins at Flemingston Manor**
 Rec No. / Survey Ref No 83119 / ED / 1518
 Listed Building Grade II
 Risk Assessment **AT RISK**
 Comment Major repairs required to many items

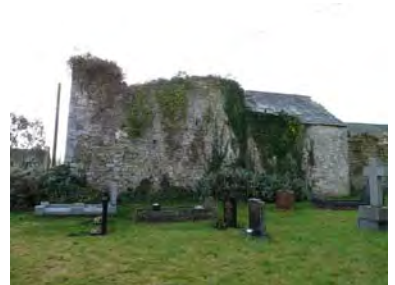
Community St Athan
 Name/address **Barn at West Aberthaw Farm**
 Rec No. / Survey Ref No 83111 / GC / 1213
 Listed Building Grade II
 Risk Assessment **AT RISK**
 Comment Major repairs required to many items

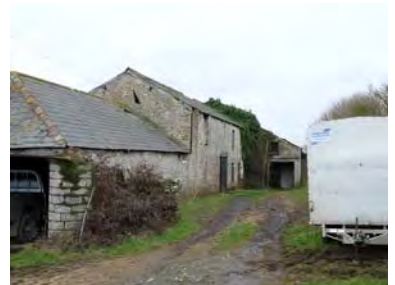
Community St Athan
 Name/address **West Aberthaw Farmhouse**
 Rec No. / Survey Ref No 83130 / GA / 1815
 Listed Building Grade II
 Risk Assessment **AT RISK**
 Comment Major repairs required to many items

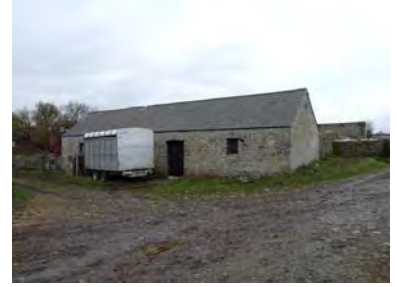
Community St Athan
Name/address Heavy Horse Stable at West Aberthaw Farm
Rec No. / Survey Ref No 83122 / GF / 1539
Listed Building Grade II
Risk Assessment **AT RISK**
Comment Full refurbishment required

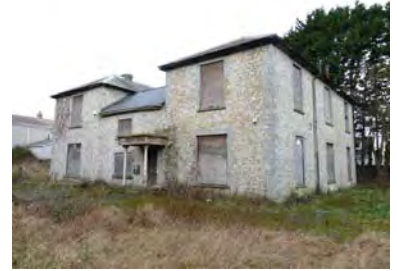
Community St Athan
Name/address The Old Rectory (aka Balfour House)
Rec No. / Survey Ref No 83128 / AD / 1324
Listed Building Grade II
Risk Assessment **AT RISK**
Comment Ongoing decline

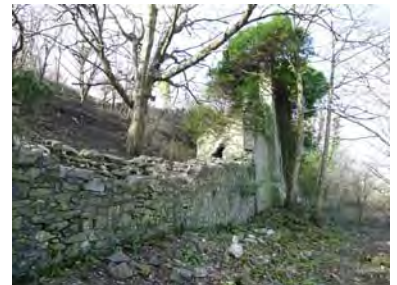
Community St Brides Major
Name/address Garden Building
Rec No. / Survey Ref No 21788 / DD / 1515
Listed Building Grade II
Risk Assessment **AT RISK**
Comment Structurally unsound

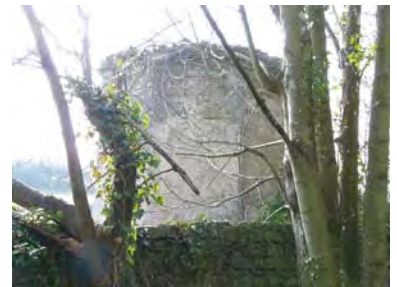
Community St Brides Major
Name/address Fynnon y Winch (Pump House)
Rec No. / Survey Ref No 21796 / EB / 1514
Listed Building Grade II
Risk Assessment **AT RISK**
Comment Very poor condition

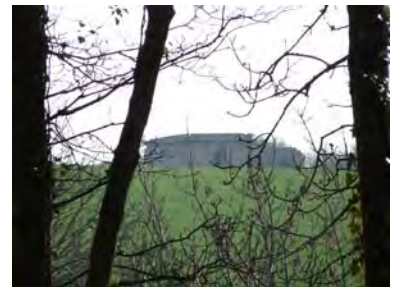
Community St Brides Major
Name/address Entrance gateway with flanking wall at Dunraven House
Rec No. / Survey Ref No 21797 / DE / 1419
Listed Building Grade II
Risk Assessment **AT RISK**
Comment Some critical items require replacement

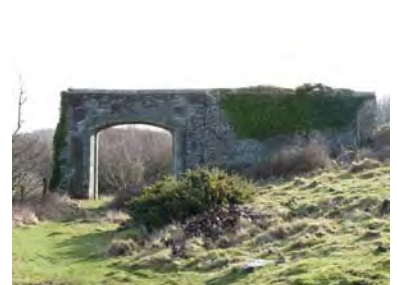
Community St Brides Major
 Name/address **Grand Lodge**
 Rec No. / Survey Ref No 21785 / DA / 1504
 Listed Building Grade II
 Risk Assessment **AT RISK**
 Comment Major repairs required to many items

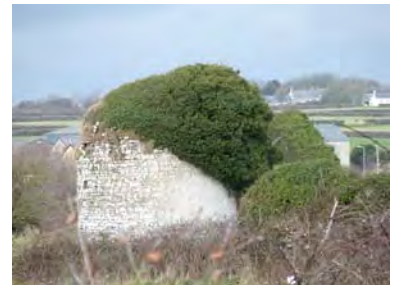
Community St Donats
 Name/address **Watch-tower to west of St Donats Castle**
 Rec No. / Survey Ref No 13332 / AS / 1840
 Listed Building Grade II
 Risk Assessment **AT RISK**
 Comment Very poor condition

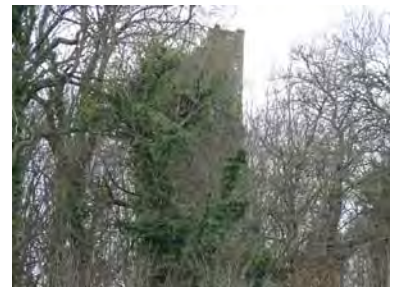
Community St Donats
 Name/address **High Wall, comprising remains of Marcross Castle, bounding part of SW Farmyard of Village Farm**
 Rec No. / Survey Ref No 13306 / BD / 1579
 Listed Building Grade II
 Risk Assessment **AT RISK**
 Comment Major repairs required to many items

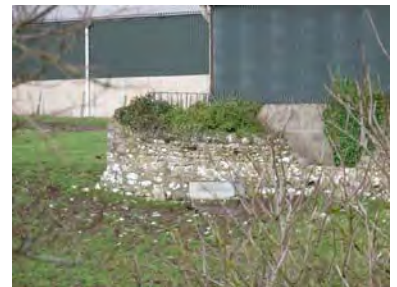
Community St Georges Super Ely
 Name/address **St-y-Nyll windmill tower and attached barn remains**
 Rec No. / Survey Ref No 13419 / BB / 1272
 Listed Building Grade II
 Risk Assessment **AT RISK**
 Comment Many items require replacement

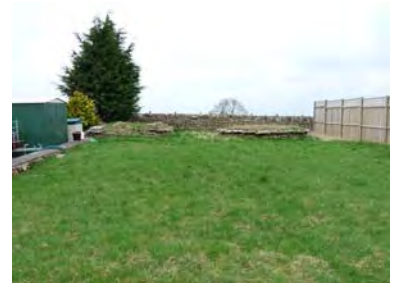
Community Sully
 Name/address Barn at Home Farm
 Rec No. / Survey Ref No 26972 / BD / 1210
 Listed Building Grade II
 Risk Assessment **AT RISK**
 Comment Major repairs required to many items

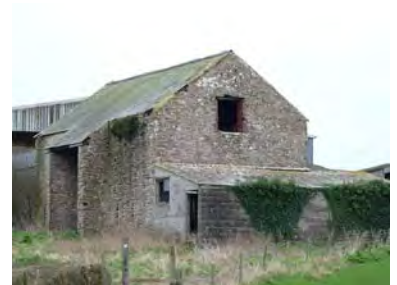
Community Wick
 Name/address Outbuilding at Church Farm
 Rec No. / Survey Ref No 20981 / EC / 1666
 Listed Building Grade II
 Risk Assessment **AT RISK**
 Comment Structurally unsound

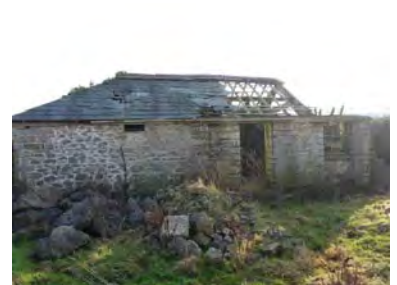
Community Wick
 Name/address Farm Range to NE of Brooks Farm
 Rec No. / Survey Ref No 20969 / AJ / 1457
 Listed Building Grade II
 Risk Assessment **AT RISK**
 Comment Very poor condition

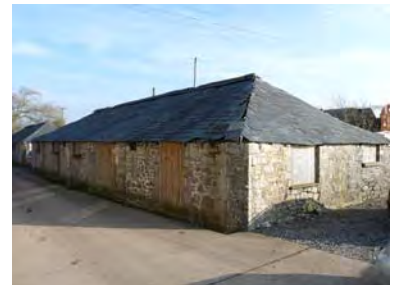
Community Wick
Name/address Outbuilding at Church Farm
Rec No. / Survey Ref No 20982 / ED / 1665
Listed Building Grade II
Risk Assessment **AT RISK**
Comment Major repairs required to many items

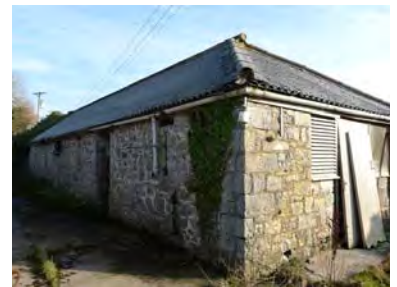
Community Wick
Name/address Cow-house and Stable Range to NE of Brooks Farm
Rec No. / Survey Ref No 20970 / AK / 1434
Listed Building Grade II
Risk Assessment **AT RISK**
Comment Full refurbishment required

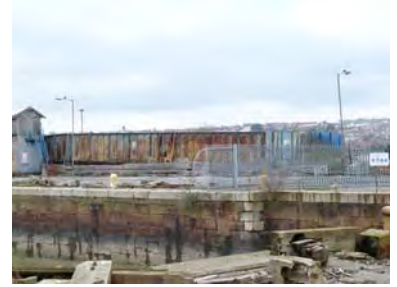
Community Barry
 Name/address Sliding Bridge at N entrance to Basin
 Rec No. / Survey Ref No 16562 / 90/86/195 / 1751
 Listed Building Grade II*
 Risk Assessment **VULNERABLE**
 Comment Full refurbishment required

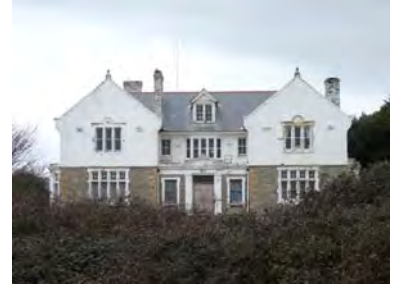
Community Barry
 Name/address **FRIARS POINT HOUSE,**
 Rec No. / Survey Ref No 13455 / 72/C/33 (2) / 1490
 Listed Building Grade II
 Risk Assessment **VULNERABLE**
 Comment Maintenance backlog building up

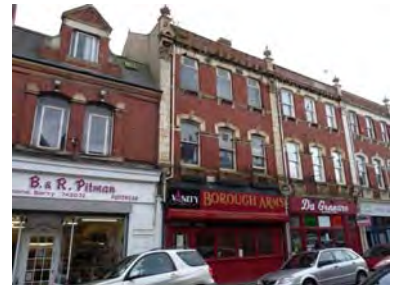
Community Barry
 Name/address **NO 72, HIGH STREET (S SIDE) BARRY**
 Rec No. / Survey Ref No 15891 / 72/C/12 (1) / 1612
 Listed Building Grade II
 Risk Assessment **VULNERABLE**
 Comment Maintenance backlog building up

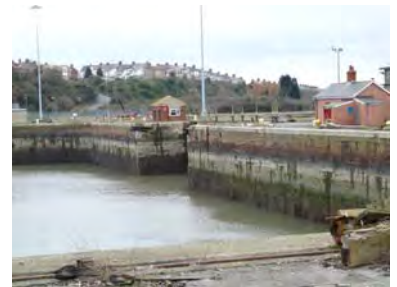
Community Barry
 Name/address **Walls of Dock Basin (Also known as No 3 Basin)**
 Rec No. / Survey Ref No 3212 / 90/86/194 / 1806
 Listed Building Grade II
 Risk Assessment **VULNERABLE**
 Comment Maintenance backlog building up

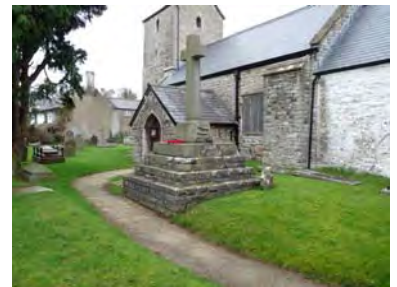
Community Barry
 Name/address **CROSS IN CHURCHYARD AT CHURCH OF ST CADOC,
 COLDBROOK ROAD WEST (W SIDE), CADOXTON**
 Rec No. / Survey Ref No 15901 / 72/C/38 (7) / 1395
 Listed Building Grade II
 Risk Assessment **VULNERABLE**
 Comment Maintenance backlog building up

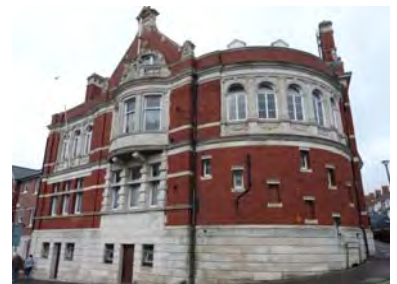
Community Barry
 Name/address **FORMER CUSTOMS HOUSE AND MERCANTILE MARINE
 OFFICE, STATION STREET (SW SIDE) BARRY**
 Rec No. / Survey Ref No 13446 / 72/C/21 (9) / 1509
 Listed Building Grade II
 Risk Assessment **VULNERABLE**
 Comment Reduced maintenance levels

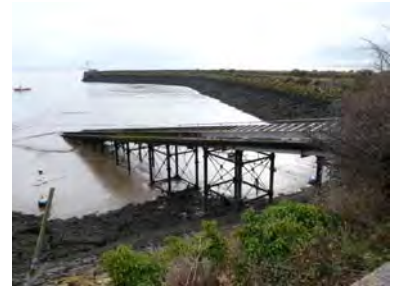
Community Barry
 Name/address **SLIPWAY, BARRY DOCKS**
 Rec No. / Survey Ref No 15895 / 72/C/24 (10) / 1752
 Listed Building Grade II
 Risk Assessment **VULNERABLE**
 Comment Reduced maintenance levels

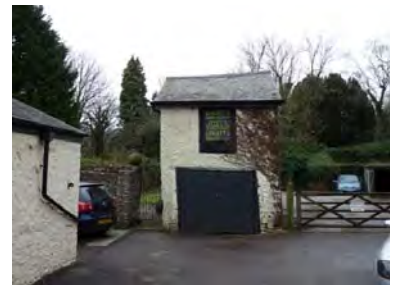
Community Cowbridge with Llanblethian
 Name/address **Former Coach House to rear of Nos 34 & 36**
 Rec No. / Survey Ref No 22311 / H34A / 1507
 Listed Building Grade II
 Risk Assessment **VULNERABLE**
 Comment Serious lack of maintenance

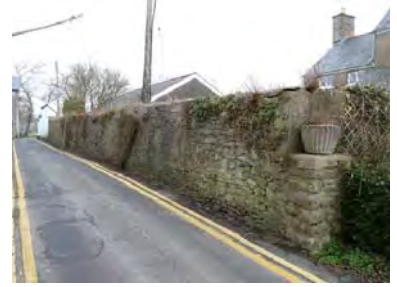
Community Cowbridge with Llanblethian
Name/address **NW Boundary Wall To No 83 High Street**
Rec No. / Survey Ref No 13214 / H83A / 1652
Listed Building Grade II
Risk Assessment **VULNERABLE**
Comment Maintenance backlog building up

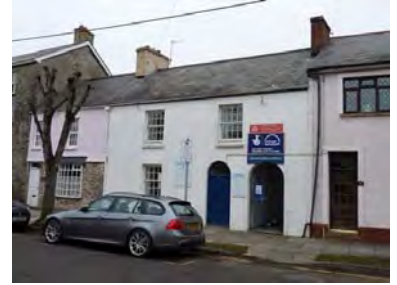
Community Cowbridge with Llanblethian
Name/address **No.21 Westgate**
Rec No. / Survey Ref No 13237 / W21 / 1134
Listed Building Grade II
Risk Assessment **VULNERABLE**
Comment Maintenance backlog building up

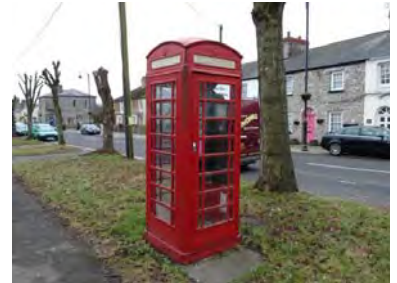
Community Cowbridge with Llanblethian
Name/address **Telephone Call-Box Outside Hill View & The Haven**
Rec No. / Survey Ref No 13477 / W / 1310
Listed Building Grade II
Risk Assessment **VULNERABLE**
Comment Maintenance backlog building up

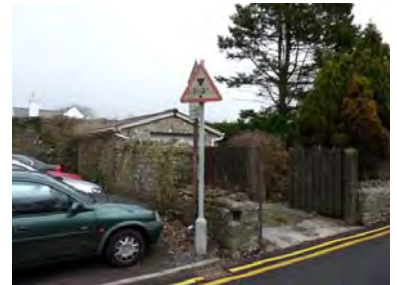
Community Cowbridge with Llanblethian
Name/address **NW Garden Wall to Rose Cottage and SW Garden Walls to Old Hall & Grammar School Garden at SE**
Rec No. / Survey Ref No 13233 / TM1 / 1653
Listed Building Grade II
Risk Assessment **VULNERABLE**
Comment Maintenance backlog building up

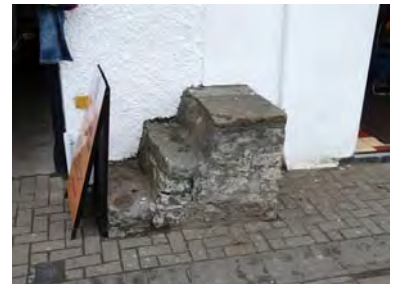
Community Cowbridge with Llanblethian
Name/address **Mounting Block attached to Nos 25 & 27 High Street**
Rec No. / Survey Ref No 13203 / H27A / 1605
Listed Building Grade II
Risk Assessment **VULNERABLE**
Comment Maintenance backlog building up

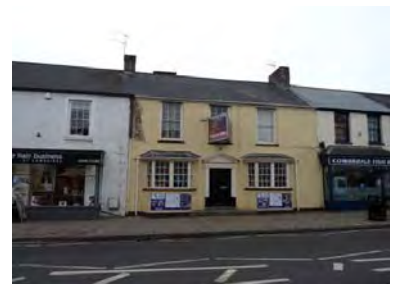
Community Cowbridge with Llanblethian
Name/address **No.20 High Street**
Rec No. / Survey Ref No 13217 / 1H20 / 1133
Listed Building Grade II
Risk Assessment **VULNERABLE**
Comment Maintenance backlog building up

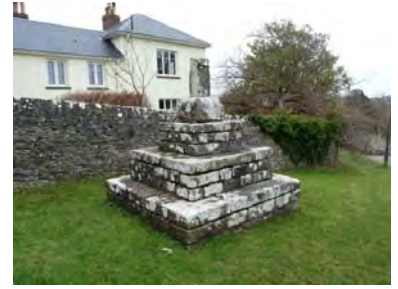
Community Cowbridge with Llanblethian
Name/address **Roadside Cross**
Rec No. / Survey Ref No 13145 / BLB / 1739
Listed Building Grade II
Risk Assessment **VULNERABLE**
Comment Maintenance backlog building up

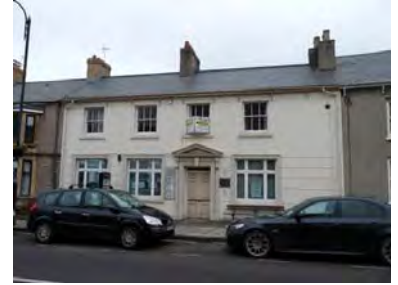
Community Cowbridge with Llanblethian
Name/address **Citizens' Advice Bureau**
Rec No. / Survey Ref No 22296 / E79 / 1382
Listed Building Grade II
Risk Assessment **VULNERABLE**
Comment Reduced maintenance levels

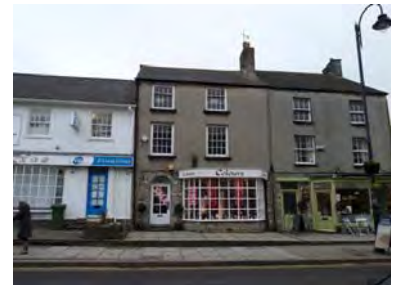
Community Cowbridge with Llanblethian
Name/address **Colours**
Rec No. / Survey Ref No 22286 / E66 / 1433
Listed Building Grade II
Risk Assessment **VULNERABLE**
Comment Reduced maintenance levels

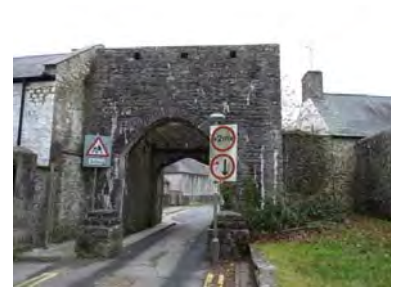
Community Cowbridge with Llanblethian
Name/address **South Gate (Porth y Felin)**
Rec No. / Survey Ref No 13183 / CHG / 1754
Listed Building Grade II*
Risk Assessment **VULNERABLE**
Comment Reduced maintenance levels

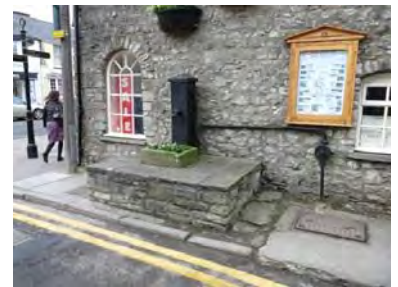
Community Cowbridge with Llanblethian
Name/address **Water Pump against SE Elevation of No 23 High Street**
Rec No. / Survey Ref No 13201 / H23A / 1843
Listed Building Grade II
Risk Assessment **VULNERABLE**
Comment Reduced maintenance levels

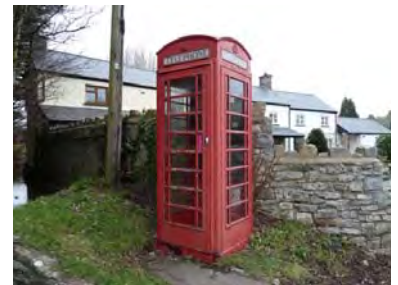
Community Cowbridge with Llanblethian
Name/address **Telephone Call-Box Near Brook Cottage**
Rec No. / Survey Ref No 13478 / BLTCB / 1287
Listed Building Grade II
Risk Assessment **VULNERABLE**
Comment Secondary item maintenance required

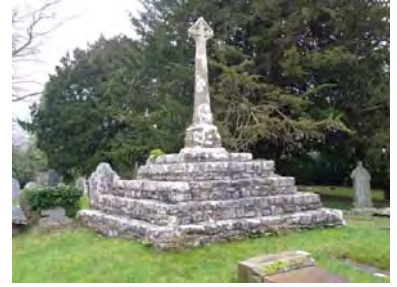
Community Dinas Powys
Name/address Churchyard cross in St Andrew's Churchyard
Rec No. / Survey Ref No 26501 / BB / 1376
Listed Building Grade II
Risk Assessment **VULNERABLE**
Comment Maintenance backlog building up

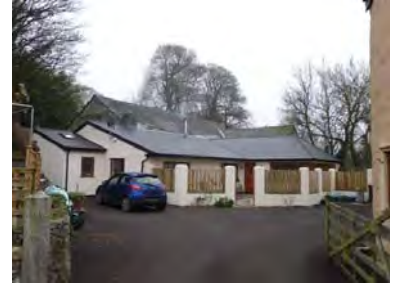
Community Dinas Powys
Name/address The Old Rectory
Rec No. / Survey Ref No 13626 / BD / 1329
Listed Building Grade II*
Risk Assessment **VULNERABLE**
Comment Reduced maintenance levels

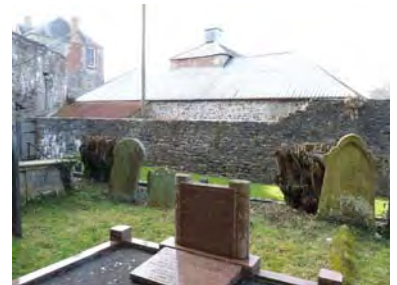
Community Ewenny
Name/address NE Precinct Wall at Ewenny Priory (house)
Rec No. / Survey Ref No 19461 / BK / 1570
Listed Building Grade II
Risk Assessment **VULNERABLE**
Comment Maintenance backlog building up

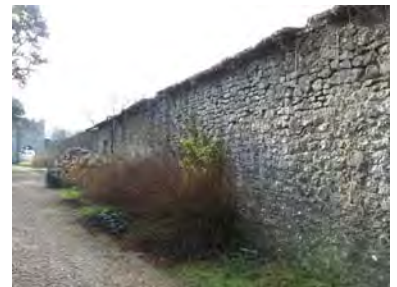
Community Ewenny
Name/address Garden wall linking N and S Gatehouses at Ewenny Priory (house)
Rec No. / Survey Ref No 19464 / BG / 1519
Listed Building Grade II
Risk Assessment **VULNERABLE**
Comment Maintenance backlog building up

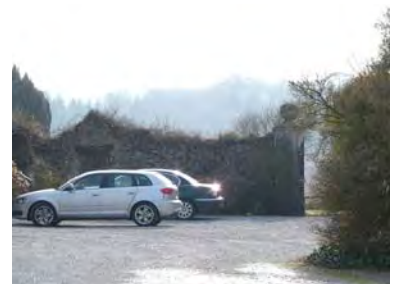
Community Ewenny
Name/address Garden gateway with gates and attached wall at Ewenny Priory (house)
Rec No. / Survey Ref No 19468 / BF / 1516
Listed Building Grade II
Risk Assessment **VULNERABLE**
Comment Maintenance backlog building up

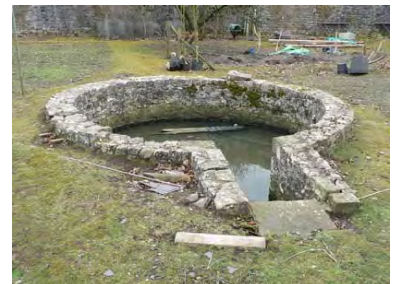
Community Ewenny
Name/address Medieval fishpool in W part of Ewenny Priory (house) gardens
Rec No. / Survey Ref No 19469 / BE / 1338
Listed Building Grade II*
Risk Assessment **VULNERABLE**
Comment Secondary item maintenance required

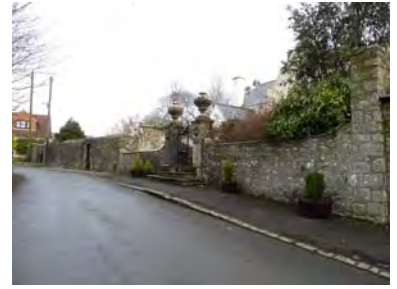
Community Llan Maes
 Name/address **Walls, Gatepiers and Gates of Llanmaes House**
 Rec No. / Survey Ref No 81305 / AF / 1811
 Listed Building Grade II*
 Risk Assessment **VULNERABLE**
 Comment Maintenance backlog building up

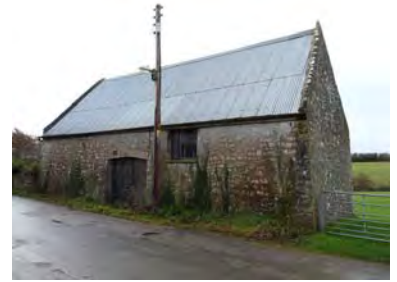
Community Llan Maes
 Name/address **Barn at Great House Farm**
 Rec No. / Survey Ref No 81299 / AD / 1209
 Listed Building Grade II
 Risk Assessment **VULNERABLE**
 Comment Reduced maintenance levels

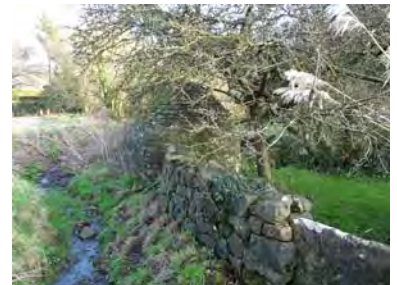
Community Llancarfan
 Name/address **CIRCULAR PIGSTY AT THE MEADOWS**
 Rec No. / Survey Ref No 16412 / 72/E/13(3) / 1380
 Listed Building Grade II
 Risk Assessment **VULNERABLE**
 Comment Secondary item maintenance required

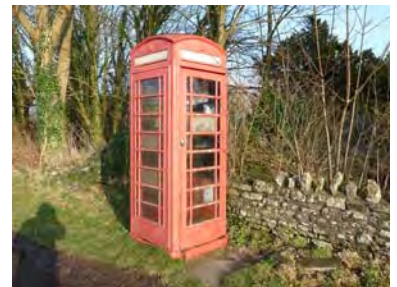
Community Llancarfan
 Name/address **TELEPHONE CALL-BOX TO N OF PARISH CHURCH, LLANTRITHYD**
 Rec No. / Survey Ref No 13440 / 72/E/11(3) / 1315
 Listed Building Grade II
 Risk Assessment **VULNERABLE**
 Comment Secondary item maintenance required

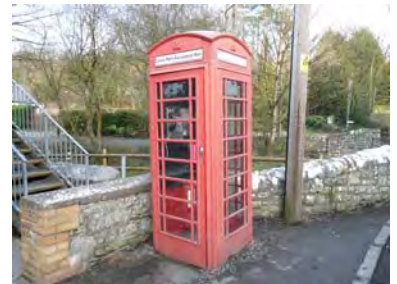
Community Llancarfan
 Name/address **TELEPHONE CALL-BOX BETWEEN THE PARISH HALL AND THE BRIDGE**
 Rec No. / Survey Ref No 13438 / 72/E/2(1) / 1283
 Listed Building Grade II
 Risk Assessment **VULNERABLE**
 Comment Secondary item maintenance required

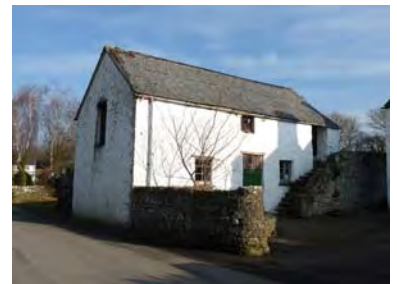
Community Llandow
 Name/address **BARN TO THE E OF THE GREAT HOUSE, TY DRAW (S SIDE)**
 Rec No. / Survey Ref No 16458 / 72/G/04 (1) / 1188
 Listed Building Grade II
 Risk Assessment **VULNERABLE**
 Comment Ongoing decline

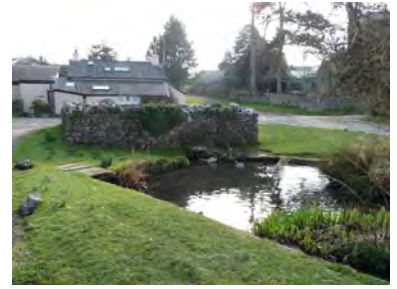
Community Llandow
Name/address THE OLD SHEEP WASHERY, LLYSWORNEY
Rec No. / Survey Ref No 13403 / 72/G/17 (2) / 1778
Listed Building Grade II
Risk Assessment **VULNERABLE**
Comment Maintenance backlog building up

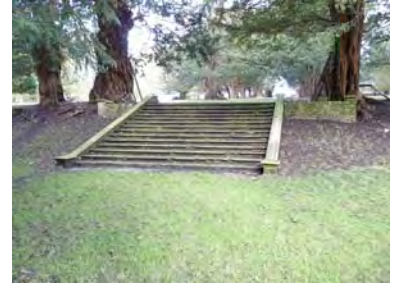
Community Llandow
Name/address TWO FLIGHTS OF STEPS UP TO TERRACE AND YEW TREE PLEASANCE AT LLANMIHANGEL PLACE, LLANMIHANGEL
Rec No. / Survey Ref No 16461 / 72/G/08 (INDEX) / 1796
Listed Building Grade II
Risk Assessment **VULNERABLE**
Comment Reduced maintenance levels

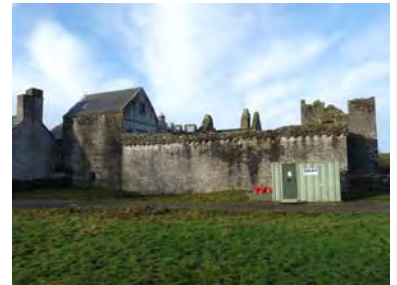
Community Llanfair
Name/address OLD BEAUPRE CASTLE, OLD BEAUPRE
Rec No. / Survey Ref No 13171 / 72/H/12 (3) / 1645
Listed Building Grade I
Risk Assessment **VULNERABLE**
Comment Maintenance backlog building up

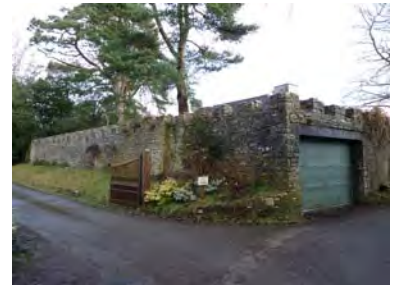
Community Llanfair
Name/address NE, SE AND SW WALLS, GATEPIERS AND RAILINGS ENCLOSING LLANDOUGH CASTLE AND GATEHOUSE
Rec No. / Survey Ref No 15764 / 72/H/09 (2) / 1571
Listed Building Grade II
Risk Assessment **VULNERABLE**
Comment Maintenance backlog building up

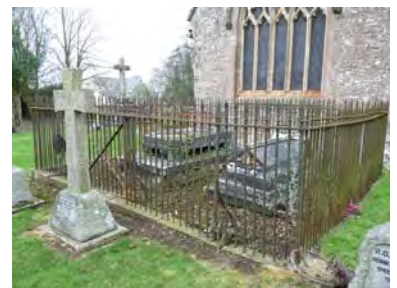
Community Llanfair
Name/address BASSETT FAMILY TOMB ENCLOSURE IN CHURCHYARD OF PARISH CHURCH OF ST HILARY, ST HILARY
Rec No. / Survey Ref No 16419 / 72/H/18 (5) / 1195
Listed Building Grade II
Risk Assessment **VULNERABLE**
Comment Reduced maintenance levels

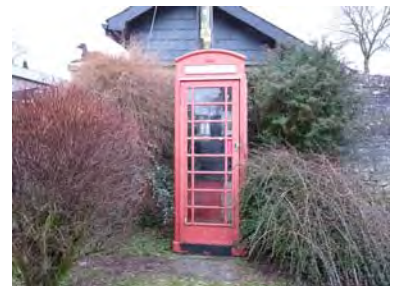
Community Llanfair
Name/address TELEPHONE CALL-BOX OPPOSITE VILLAGE FARM, LLANTRITHYD ROAD (NE SIDE), ST HILARY
Rec No. / Survey Ref No 13442 / 72/H/25 (5) / 1293
Listed Building Grade II
Risk Assessment **VULNERABLE**
Comment Secondary item maintenance required

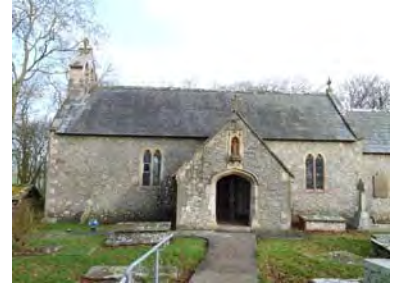
Community Llangan
Name/address **Church of St Canna**
Rec No. / Survey Ref No 13155 / AA / 1363
Listed Building Grade II
Risk Assessment **VULNERABLE**
Comment Serious lack of maintenance

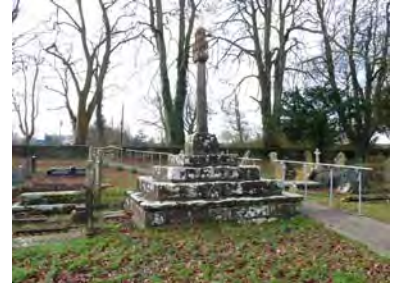
Community Llangan
Name/address **Churchyard Cross at Church of St Canna**
Rec No. / Survey Ref No 81314 / AB / 1372
Listed Building Grade I
Risk Assessment **VULNERABLE**
Comment Maintenance backlog building up

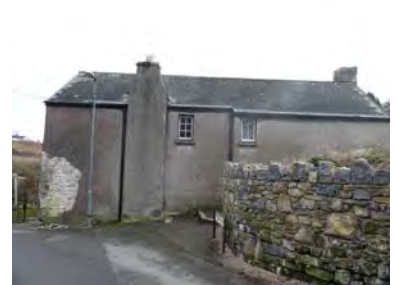
Community Llantwit Major
Name/address **Former Chantry Priest's House**
Rec No. / Survey Ref No 13251 / CB / 1476
Listed Building Grade II
Risk Assessment **VULNERABLE**
Comment Major repairs required to many items

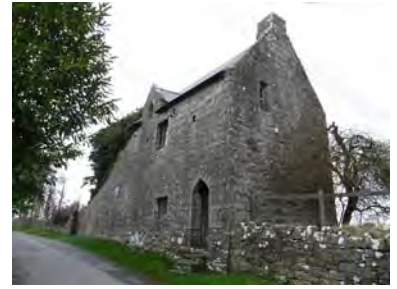
Community Llantwit Major
 Name/address **The Gatehouse (Porter's Room)**
 Rec No. / Survey Ref No 13254 / EB / 1319
 Listed Building Grade II*
 Risk Assessment **VULNERABLE**
 Comment Serious lack of maintenance

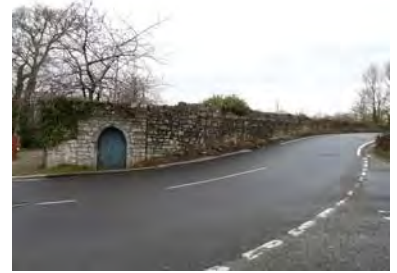
Community Llantwit Major
 Name/address **Walls surrounding Garden to west of Boverton House**
 Rec No. / Survey Ref No 13240 / BC / 1407
 Listed Building Grade II
 Risk Assessment **VULNERABLE**
 Comment Maintenance backlog building up

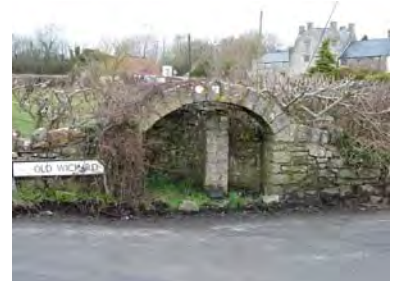
Community Llantwit Major
 Name/address **Well opposite Downcross Farm**
 Rec No. / Survey Ref No 13284 / DD / 1846
 Listed Building Grade II
 Risk Assessment **VULNERABLE**
 Comment Maintenance backlog building up

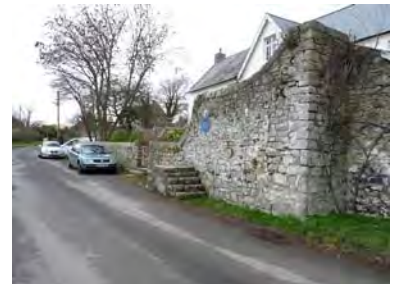
Community Llantwit Major
 Name/address **Garden Wall, Gate and Mounting Block and Stables at Plymouth House**
 Rec No. / Survey Ref No 83392 / HD / 1495
 Listed Building Grade II
 Risk Assessment **VULNERABLE**
 Comment Maintenance backlog building up

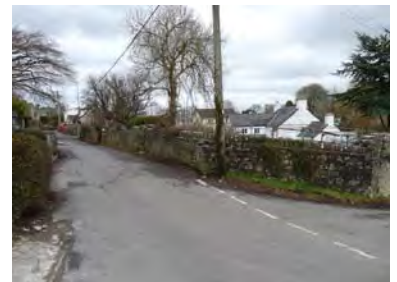
Community Llantwit Major
 Name/address **Walls to Garden to West Farmhouse on south-east side of West Street**
 Rec No. / Survey Ref No 13291 / MC / 1809
 Listed Building Grade II
 Risk Assessment **VULNERABLE**
 Comment Maintenance backlog building up

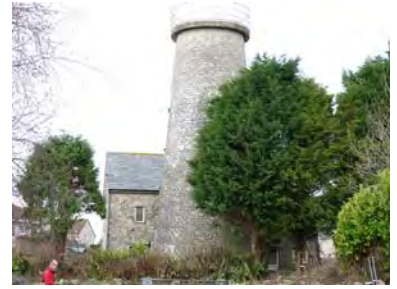
Community Llantwit Major
 Name/address **Windmill House**
 Rec No. / Survey Ref No 13292 / NC / 1488
 Listed Building Grade II
 Risk Assessment **VULNERABLE**
 Comment Reduced maintenance levels

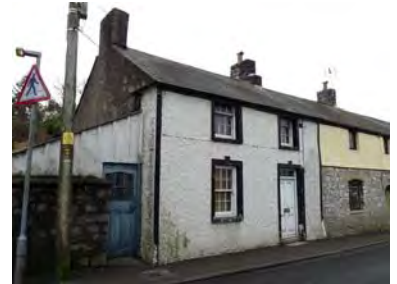
Community Llantwit Major
 Name/address **Navron**
 Rec No. / Survey Ref No 83395 / BB / 1569
 Listed Building Grade II
 Risk Assessment **VULNERABLE**
 Comment Reduced maintenance levels

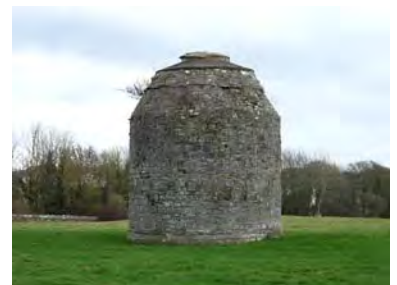
Community Llantwit Major
 Name/address **Dovecote**
 Rec No. / Survey Ref No 13253 / EC / 1444
 Listed Building Grade II*
 Risk Assessment **VULNERABLE**
 Comment Reduced maintenance levels

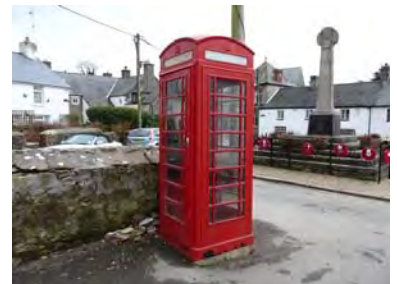
Community Llantwit Major
 Name/address **Telephone Call-Box outside Old White Hart P.H.**
 Rec No. / Survey Ref No 13453 / LB / 1265
 Listed Building Grade II
 Risk Assessment **VULNERABLE**
 Comment Secondary item maintenance required

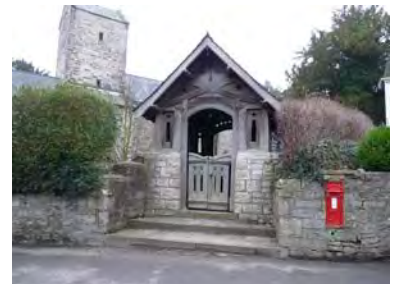
Community Michaelston
 Name/address **Lychgate at Church of St Michael**
 Rec No. / Survey Ref No 26488 / AB / 1595
 Listed Building Grade II
 Risk Assessment **VULNERABLE**
 Comment Maintenance backlog building up

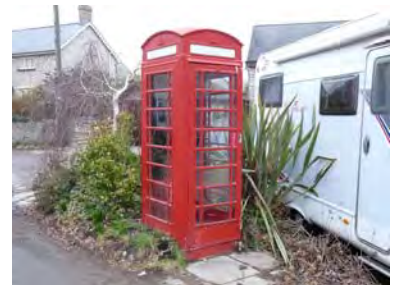
Community Michaelston
 Name/address **Telephone Call-box**
 Rec No. / Survey Ref No 13449 / AD / 1296
 Listed Building Grade II
 Risk Assessment **VULNERABLE**
 Comment Secondary item maintenance required

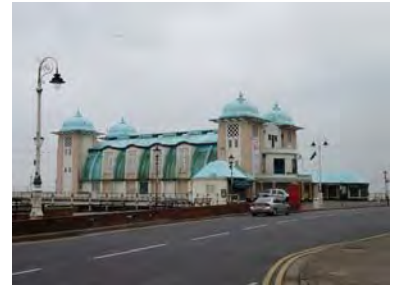
Community Penarth
 Name/address **PENARTH PIER (INCLUDING PAVILION & SHOPS) THE ESPLANADE**
 Rec No. / Survey Ref No 13355 / 72/B/21(4) / 1693
 Listed Building Grade II
 Risk Assessment **VULNERABLE**
 Comment Ongoing decline

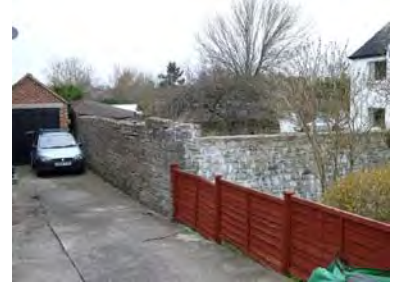
Community Penarth
 Name/address **REMAINS OF CWRT-Y-VIL GRANGE (GENERALLY KNOWN AS CWRT-Y-VIL CASTLE) CASTLE AVENUE**
 Rec No. / Survey Ref No 13346 / 72/B/12(1) / 1717
 Listed Building Grade II
 Risk Assessment **VULNERABLE**
 Comment Maintenance backlog building up
