**Buildings at Risk
Register and Strategy**

March 2013

This document is the Vale of Glamorgan Council's Buildings at Risk Register and Strategy. It includes those listed buildings that are considered to be 'at risk'.

Survey work was carried out by the Handley Partnership, whilst the register and strategy was prepared by the Council's Conservation & Design team.

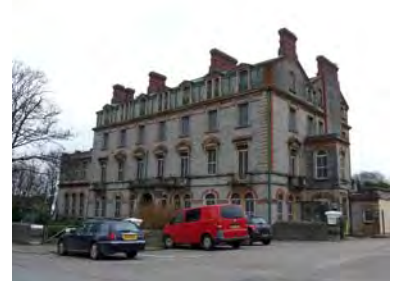
Community Penarth
 Name/address **HEADLANDS SCHOOL, PAGET PLACE**
 Rec No. / Survey Ref No 13358 / 72/B/24(3) / 1537
 Listed Building Grade II
 Risk Assessment **VULNERABLE**
 Comment Maintenance backlog building up

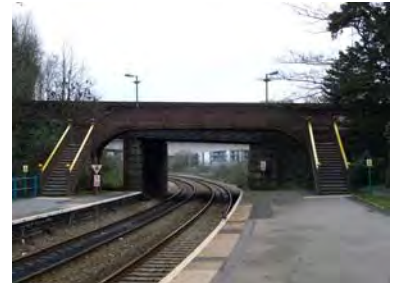
Community Penarth
 Name/address **FOOTBRIDGE AT COGAN STATION, COGAN HILL**
 Rec No. / Survey Ref No 13349 / 72/B/15(1) / 1467
 Listed Building Grade II
 Risk Assessment **VULNERABLE**
 Comment Reduced maintenance levels

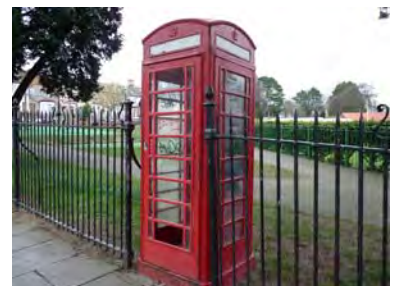
Community Penarth
 Name/address **TELEPHONE CALL-BOX ON THE EDGE OF ALBERT ROAD GARDENS, ALBERT ROAD**
 Rec No. / Survey Ref No 13339 / 72/B/5(3) / 1289
 Listed Building Grade II
 Risk Assessment **VULNERABLE**
 Comment Secondary item maintenance required

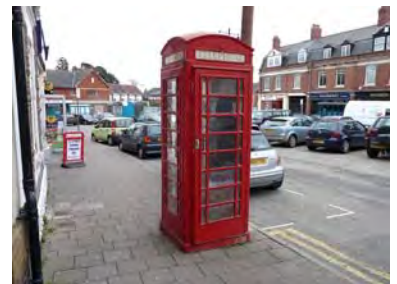
Community Penarth
 Name/address **TELEPHONE CALL-BOX OUTSIDE NOS.5 & 5A ROYAL BUILDINGS, STATION APPROACH**
 Rec No. / Survey Ref No 13369 / 72/B/35(2) / 1312
 Listed Building Grade II
 Risk Assessment **VULNERABLE**
 Comment Secondary item maintenance required

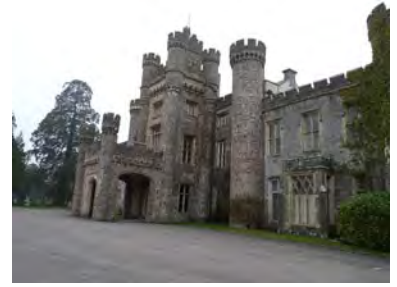
Community Pendoylan
Name/address HENSOL CASTLE (INCLUDING ATTACHED COURTYARD RANGES TO N.) HENSOL
Rec No. / Survey Ref No 13482 / 72/D/7 (2) / 1577
Listed Building Grade I
Risk Assessment **VULNERABLE**
Comment Reduced maintenance levels

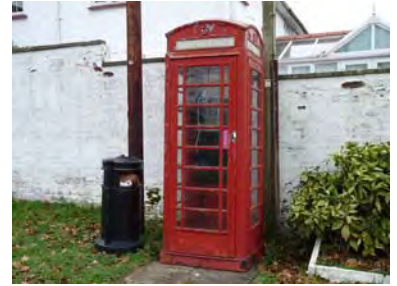
Community Pendoylan
Name/address TELEPHONE CALL-BOX, HEOL ST CATTWG (N SIDE), PENDOYLAN
Rec No. / Survey Ref No 13454 / 72/D/3 (1) / 1295
Listed Building Grade II
Risk Assessment **VULNERABLE**
Comment Reduced maintenance levels

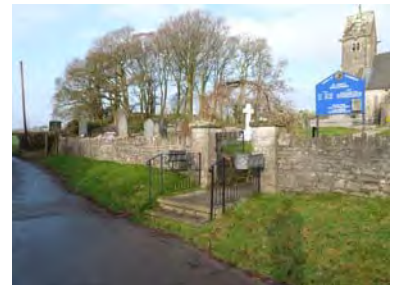
Community Penllyn
Name/address Churchyard Wall and Gates of Church of St. Owain
Rec No. / Survey Ref No 82685 / FB / 1422
Listed Building Grade II
Risk Assessment **VULNERABLE**
Comment Maintenance backlog building up

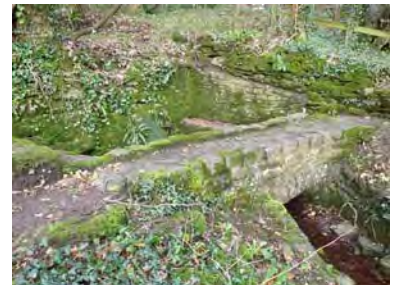
Community Penllyn
Name/address Westernmost Salmon Well
Rec No. / Survey Ref No 19655 / EJ / 1821
Listed Building Grade II
Risk Assessment **VULNERABLE**
Comment Maintenance backlog building up

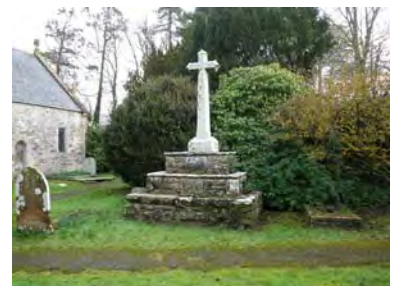
Community Penllyn
Name/address Cross in Churchyard of Church of St. Senwyr
Rec No. / Survey Ref No 82687 / CB / 1399
Listed Building Grade II
Risk Assessment **VULNERABLE**
Comment Maintenance backlog building up

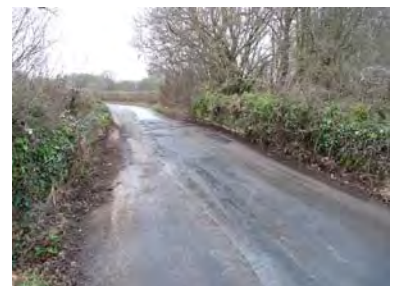
Community Peterston Super Ely
Name/address Road Bridge over Nant Criafol
Rec No. / Survey Ref No 26947 / AG / 1738
Listed Building Grade II
Risk Assessment **VULNERABLE**
Comment Maintenance backlog building up

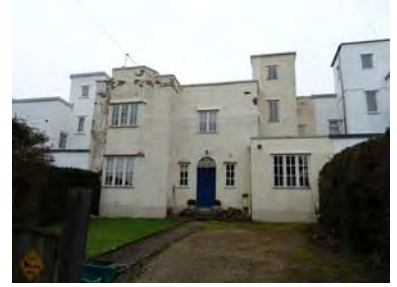
Community Peterston Super Ely
Name/address **No.2 Pwll y Min Crescent**
Rec No. / Survey Ref No 26949 / BA1 / 1132
Listed Building Grade II
Risk Assessment **VULNERABLE**
Comment Maintenance backlog building up

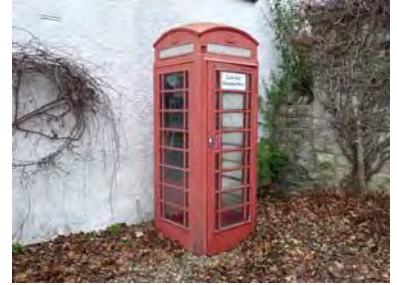
Community Peterston Super Ely
Name/address **Telephone Call-box outside Fircot**
Rec No. / Survey Ref No 13441 / AC / 1309
Listed Building Grade II
Risk Assessment **VULNERABLE**
Comment Secondary item maintenance required

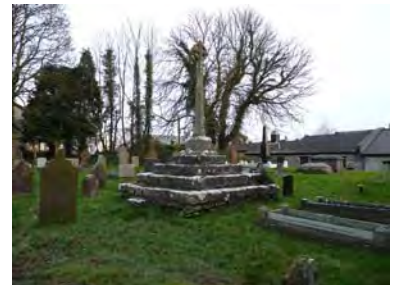
Community Rhoose
Name/address **Cross in Churchyard at Church of St Mary**
Rec No. / Survey Ref No 83148 / EB / 1396
Listed Building Grade II
Risk Assessment **VULNERABLE**
Comment Maintenance backlog building up

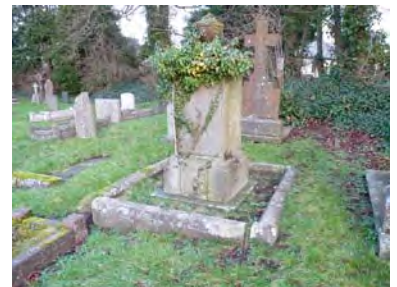
Community Rhoose
Name/address **Memorial to John and Mary Jenkins in Churchyard of Church of St Mary**
Rec No. / Survey Ref No 83156 / ED / 1339
Listed Building Grade II
Risk Assessment **VULNERABLE**
Comment Maintenance backlog building up

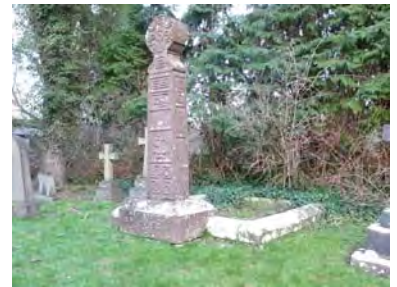
Community Rhoose
Name/address **Sarah Elizabeth Jones Memorial Cross in the Churchyard of the Church of St Mary**
Rec No. / Survey Ref No 83161 / EE / 1728
Listed Building Grade II
Risk Assessment **VULNERABLE**
Comment Maintenance backlog building up

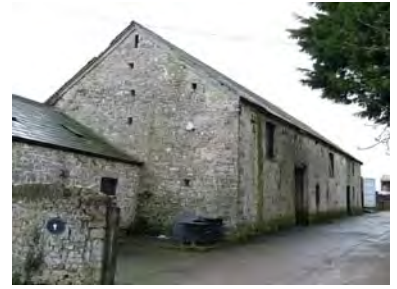
Community St Athan
 Name/address **Cart Shed at West Aberthaw Farm**
 Rec No. / Survey Ref No 83113 / GE / 1231
 Listed Building Grade II
 Risk Assessment **VULNERABLE**
 Comment Major repairs required to many items

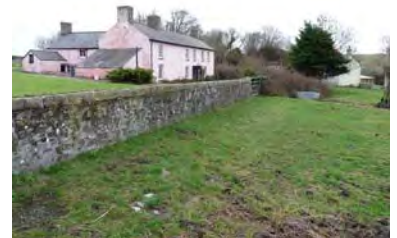
Community St Athan
 Name/address **Garden Wall of West Aberthaw Farmhouse**
 Rec No. / Survey Ref No 83120 / GB / 1494
 Listed Building Grade II
 Risk Assessment **VULNERABLE**
 Comment Major repairs required to many items

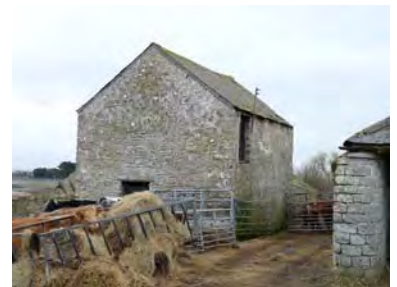
Community St Athan
 Name/address **Bullhouse (Old Chapel) at West Aberthaw Farm**
 Rec No. / Survey Ref No 83112 / GD / 1226
 Listed Building Grade II
 Risk Assessment **VULNERABLE**
 Comment Full refurbishment required

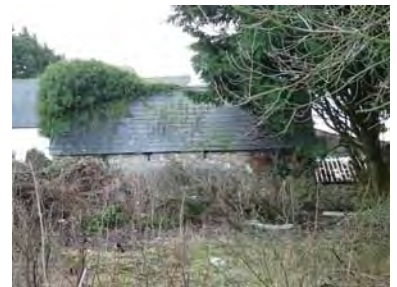
Community St Athan
 Name/address **Detached Kitchen at Flemingston Court**
 Rec No. / Survey Ref No 83117 / EC / 1405
 Listed Building Grade II
 Risk Assessment **VULNERABLE**
 Comment Ongoing decline

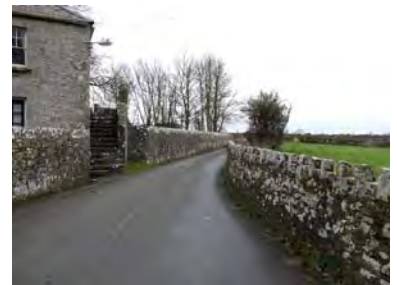
Community St Athan
 Name/address **Kitchen Garden Wall of Gileston Manor**
 Rec No. / Survey Ref No 83123 / FI / 1544
 Listed Building Grade II
 Risk Assessment **VULNERABLE**
 Comment Maintenance backlog building up

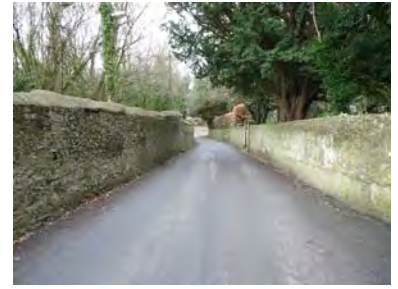
Community St Athan
 Name/address **Garden Walls along roadside at Gileston Manor**
 Rec No. / Survey Ref No 83121 / FH / 1496
 Listed Building Grade II
 Risk Assessment **VULNERABLE**
 Comment Maintenance backlog building up

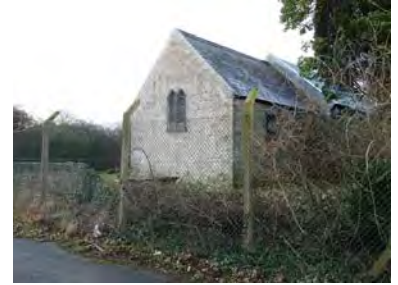
Community St Athan
 Name/address **Church of St Brise**
 Rec No. / Survey Ref No 13142 / D / 1361
 Listed Building Grade II
 Risk Assessment **VULNERABLE**
 Comment Secondary item maintenance required

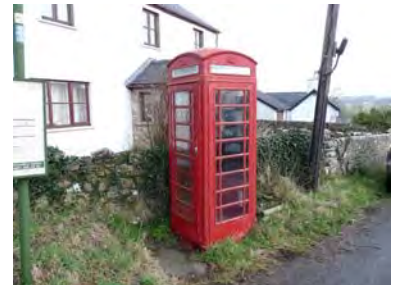
Community St Athan
 Name/address **Telephone Call-box on the road verge to the north of the Church of St Michael the Archangel**
 Rec No. / Survey Ref No 13439 / EF / 1290
 Listed Building Grade II
 Risk Assessment **VULNERABLE**
 Comment Secondary item maintenance required

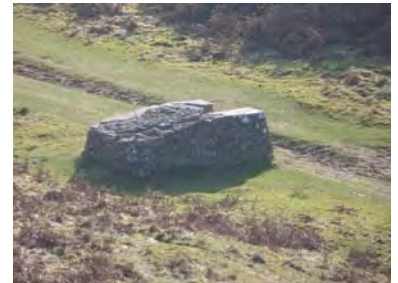
Community St Brides Major
 Name/address **Fynnon y Pant**
 Rec No. / Survey Ref No 21794 / FA / 1492
 Listed Building Grade II
 Risk Assessment **VULNERABLE**
 Comment Major repairs required to many items

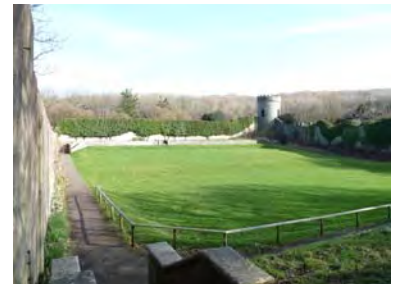
Community St Brides Major
 Name/address **Boundary and Dividing Walls to Walled Gardens**
 Rec No. / Survey Ref No 21787 / DC / 1218
 Listed Building Grade II
 Risk Assessment **VULNERABLE**
 Comment Full refurbishment required

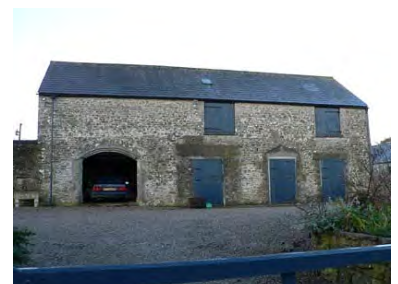
Community St Brides Major
 Name/address **Cart shed at Castle-upon-Alun House**
 Rec No. / Survey Ref No 21771 / BF / 1230
 Listed Building Grade II
 Risk Assessment **VULNERABLE**
 Comment Ongoing decline

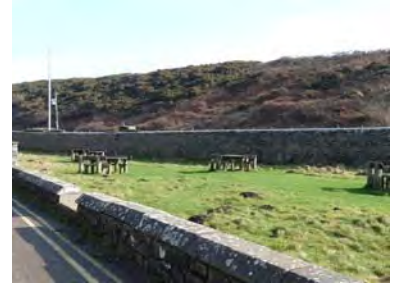
Community St Brides Major
Name/address **Boundary Wall N of Seamouth Lodge**
Rec No. / Survey Ref No 21792 / DH / 1201
Listed Building Grade II
Risk Assessment **VULNERABLE**
Comment Maintenance backlog building up

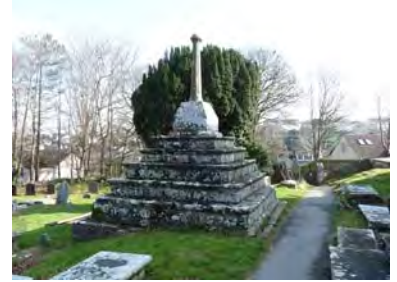
Community St Brides Major
Name/address **Churchyard Cross, Church of St Bridget**
Rec No. / Survey Ref No 21767 / AB / 1378
Listed Building Grade II
Risk Assessment **VULNERABLE**
Comment Maintenance backlog building up

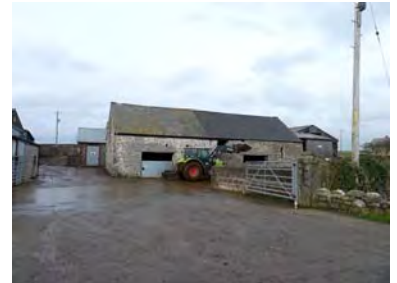
Community St Donats
Name/address **Free-standing Outbuilding at Village Farm incorporating remains of Marcross Castle and sited on SW**
Rec No. / Survey Ref No 13307 / BE / 1489
Listed Building Grade II
Risk Assessment **VULNERABLE**
Comment Major repairs required to many items

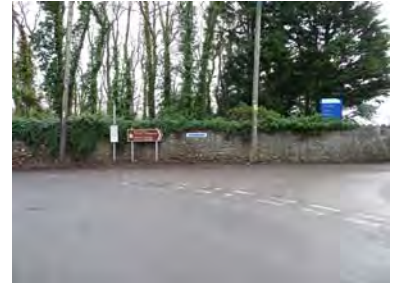
Community St Donats
Name/address **East Boundary Wall of St Donats Castle**
Rec No. / Survey Ref No 83480 / AV / 1414
Listed Building Grade II
Risk Assessment **VULNERABLE**
Comment Major repairs required to many items

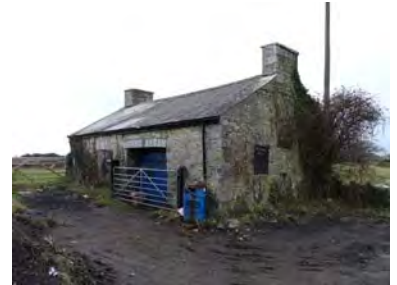
Community St Donats
Name/address **Monknash Forge**
Rec No. / Survey Ref No 13315 / CG / 1601
Listed Building Grade II
Risk Assessment **VULNERABLE**
Comment Full refurbishment required

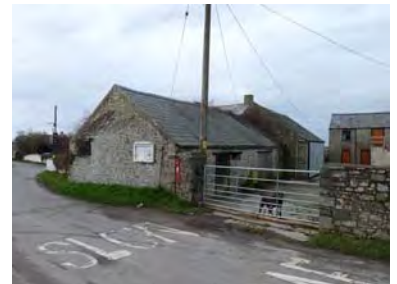
Community St Donats
Name/address **Outhouse Range to south of Church Farmhouse**
Rec No. / Survey Ref No 83483 / CE / 1669
Listed Building Grade II
Risk Assessment **VULNERABLE**
Comment Full refurbishment required

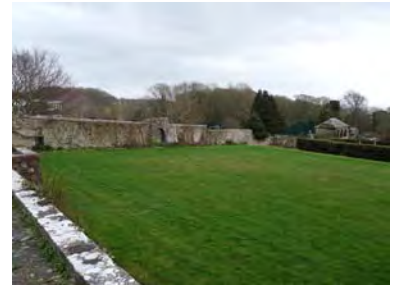
Community St Donats
Name/address Walls, Steps, Terraces, Pavilion, Summerhouses and Cottage attached to wall of the Hanging Gardens
Rec No. / Survey Ref No 13326 / AO / 1805
Listed Building Grade I
Risk Assessment **VULNERABLE**
Comment Serious lack of maintenance

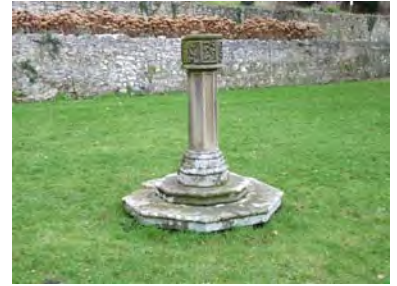
Community St Donats
Name/address Sundial at St Donat's Castle
Rec No. / Survey Ref No 83484 / AP / 1275
Listed Building Grade II
Risk Assessment **VULNERABLE**
Comment Maintenance backlog building up

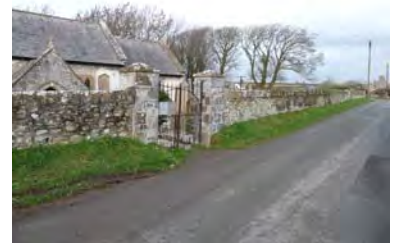
Community St Donats
Name/address Churchyard Wall, Gatepiers and Gates to the Church of the Holy Trinity running along the road
Rec No. / Survey Ref No 13305 / BB / 1746
Listed Building Grade II
Risk Assessment **VULNERABLE**
Comment Maintenance backlog building up

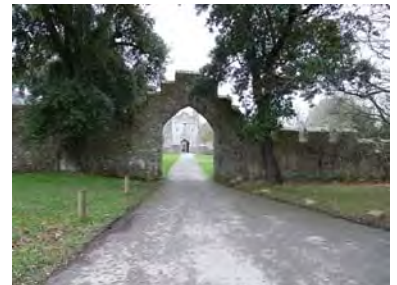
Community St Donats
Name/address Wall of Entrance Forecourt at St Donats Castle and part of North-west Boundary Wall
Rec No. / Survey Ref No 13318 / AH / 1682
Listed Building Grade II
Risk Assessment **VULNERABLE**
Comment Maintenance backlog building up

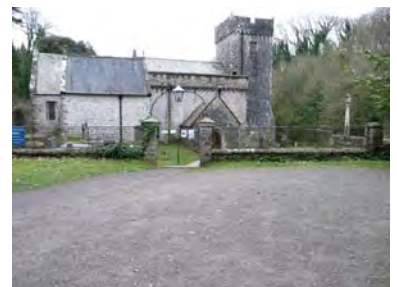
Community St Donats
Name/address Churchyard Wall of Church of St Donat, including Railings and Gates
Rec No. / Survey Ref No 83479 / AB / 1425
Listed Building Grade II
Risk Assessment **VULNERABLE**
Comment Maintenance backlog building up

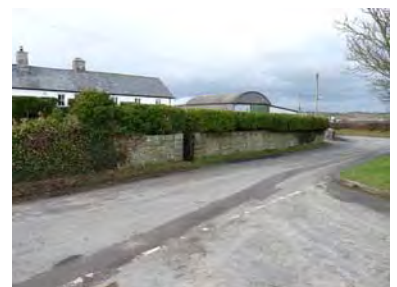
Community St Donats
Name/address Garden Wall of Church Farmhouse
Rec No. / Survey Ref No 83481 / CD / 1493
Listed Building Grade II
Risk Assessment **VULNERABLE**
Comment Maintenance backlog building up

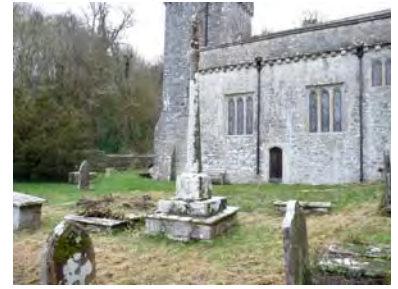
Community St Donats
 Name/address **Medieval Cross and associated Slab in the Churchyard of the Church of St Donat**
 Rec No. / Survey Ref No 13330 / AC / 1337
 Listed Building Grade I
 Risk Assessment **VULNERABLE**
 Comment Maintenance backlog building up

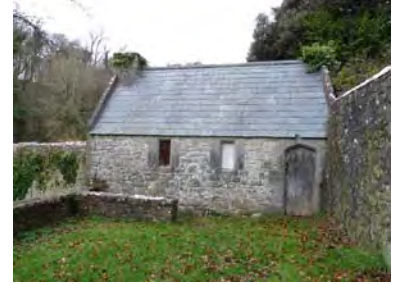
Community St Donats
 Name/address **Cottage against the south-east wall of the Churchyard of the Church of St Donat**
 Rec No. / Survey Ref No 13331 / AE / 1391
 Listed Building Grade II
 Risk Assessment **VULNERABLE**
 Comment Maintenance backlog building up

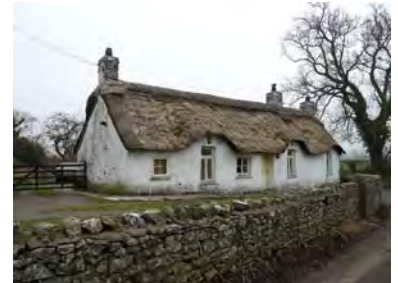
Community St Georges Super Ely
 Name/address **Ty Ffynnon**
 Rec No. / Survey Ref No 26823 / AD / 1770
 Listed Building Grade II
 Risk Assessment **VULNERABLE**
 Comment Serious lack of maintenance

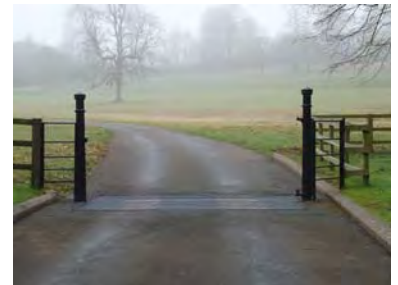
Community St Georges Super Ely
 Name/address **Gate and gatepiers midway along S drive at Coedarhydyglyn**
 Rec No. / Survey Ref No 14866 / CC / 1521
 Listed Building Grade II
 Risk Assessment **VULNERABLE**
 Comment Secondary item maintenance required

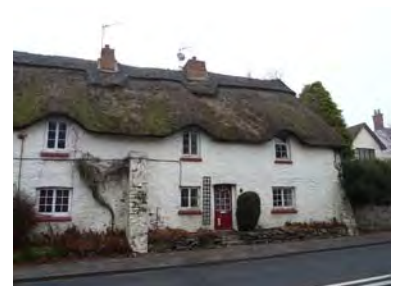
Community St Nicholas and Bonvilston
 Name/address **NO 5 SMITHS ROW (ALSO KNOWN AS BLACKSMITHS COTTAGES), A48 (N SIDE), ST. NICHOLAS**
 Rec No. / Survey Ref No 16325 / 72/F/14(4) / 1608
 Listed Building Grade II
 Risk Assessment **VULNERABLE**
 Comment Serious lack of maintenance

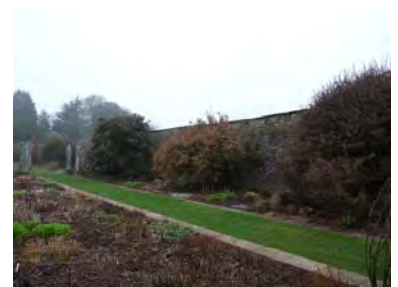
Community St Nicholas and Bonvilston
 Name/address **Walled Garden at Dyffryn House**
 Rec No. / Survey Ref No 13472 / 72/F/9(3) / 1804
 Listed Building Grade II
 Risk Assessment **VULNERABLE**
 Comment Maintenance backlog building up

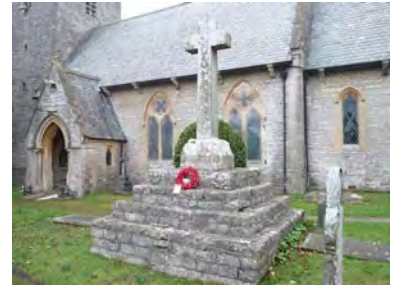
Community St Nicholas and Bonvilston
 Name/address **CHURCHYARD CROSS AT PARISH CHURCH OF ST MARY, A 48 (N SIDE), BONVILSTON**
 Rec No. / Survey Ref No 16320 / 72/F/3(1) / 1375
 Listed Building Grade II
 Risk Assessment **VULNERABLE**
 Comment Maintenance backlog building up

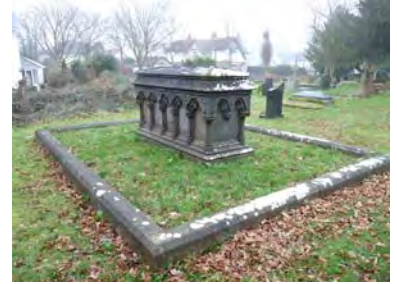
Community St Nicholas and Bonvilston
 Name/address **CORY FAMILY CHEST-TOMB AT PARISH CHURCH OF ST NICHOLAS, ST NICHOLAS**
 Rec No. / Survey Ref No 16322 / 72/F/11(4) / 1390
 Listed Building Grade II
 Risk Assessment **VULNERABLE**
 Comment Maintenance backlog building up

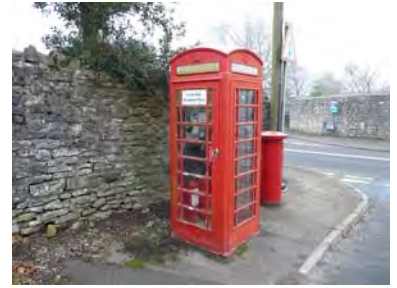
Community St Nicholas and Bonvilston
 Name/address **TELEPHONE CALL-BOX ON CORNER WITH ROAD TO ST.NICHOLAS' CHURCH, A48 (N SIDE), ST.NICHOLAS**
 Rec No. / Survey Ref No 13425 / 72/F/16(4) / 1288
 Listed Building Grade II
 Risk Assessment **VULNERABLE**
 Comment Secondary item maintenance required

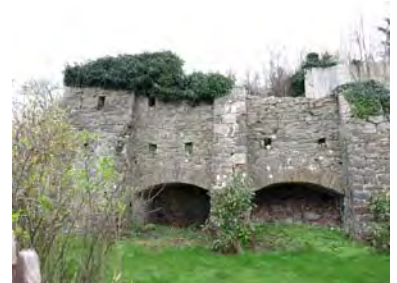
Community Sully
 Name/address **Limekiln**
 Rec No. / Survey Ref No 26973 / AE / 1548
 Listed Building Grade II
 Risk Assessment **VULNERABLE**
 Comment Maintenance backlog building up

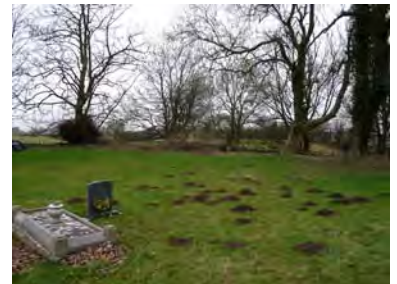
Community Welsh St Donats
 Name/address **Churchyard Wall of Church of St Donat**
 Rec No. / Survey Ref No 83405 / AB / 1423
 Listed Building Grade II
 Risk Assessment **VULNERABLE**
 Comment Maintenance backlog building up

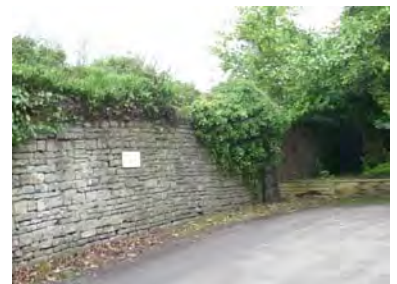
Community Wenvoe
 Name/address **Former walled kitchen garden wall at Wenvoe Castle- W range**
 Rec No. / Survey Ref No 26994 / AF / 1485
 Listed Building Grade II
 Risk Assessment **VULNERABLE**
 Comment Maintenance backlog building up

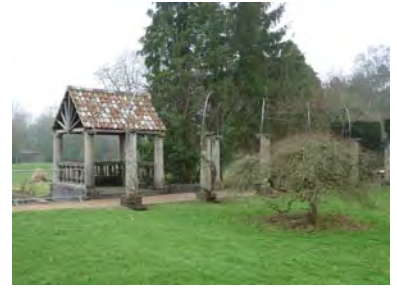
Community Wenvoe
Name/address Vine Walk and Kiosks
Rec No. / Survey Ref No 26990 / CD / 1839
Listed Building Grade II
Risk Assessment **VULNERABLE**
Comment Reduced maintenance levels

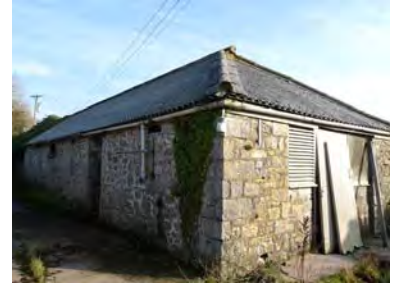
Community Wick
Name/address Outbuilding at Church farm
Rec No. / Survey Ref No 20983 / EE / 1677
Listed Building Grade II
Risk Assessment **VULNERABLE**
Comment Ongoing decline

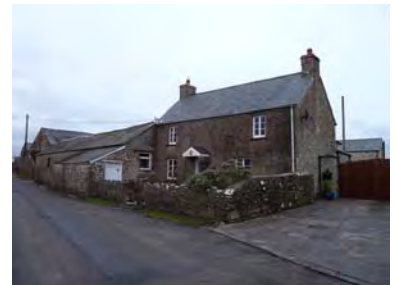
Community Wick
Name/address Brooks Farm and adjoining range aka Brook Farm
Rec No. / Survey Ref No 20968 / AI / 1222
Listed Building Grade II
Risk Assessment **VULNERABLE**
Comment Serious lack of maintenance

14	Farm Range to NE of Brooks Farm Wick	17.99	Repairable for viable use	Encourage maintenance. Consider further action.
15	Barn on Ewenny Down Ewenny	19.28	General Repairs Req'd.	Encourage maintenance

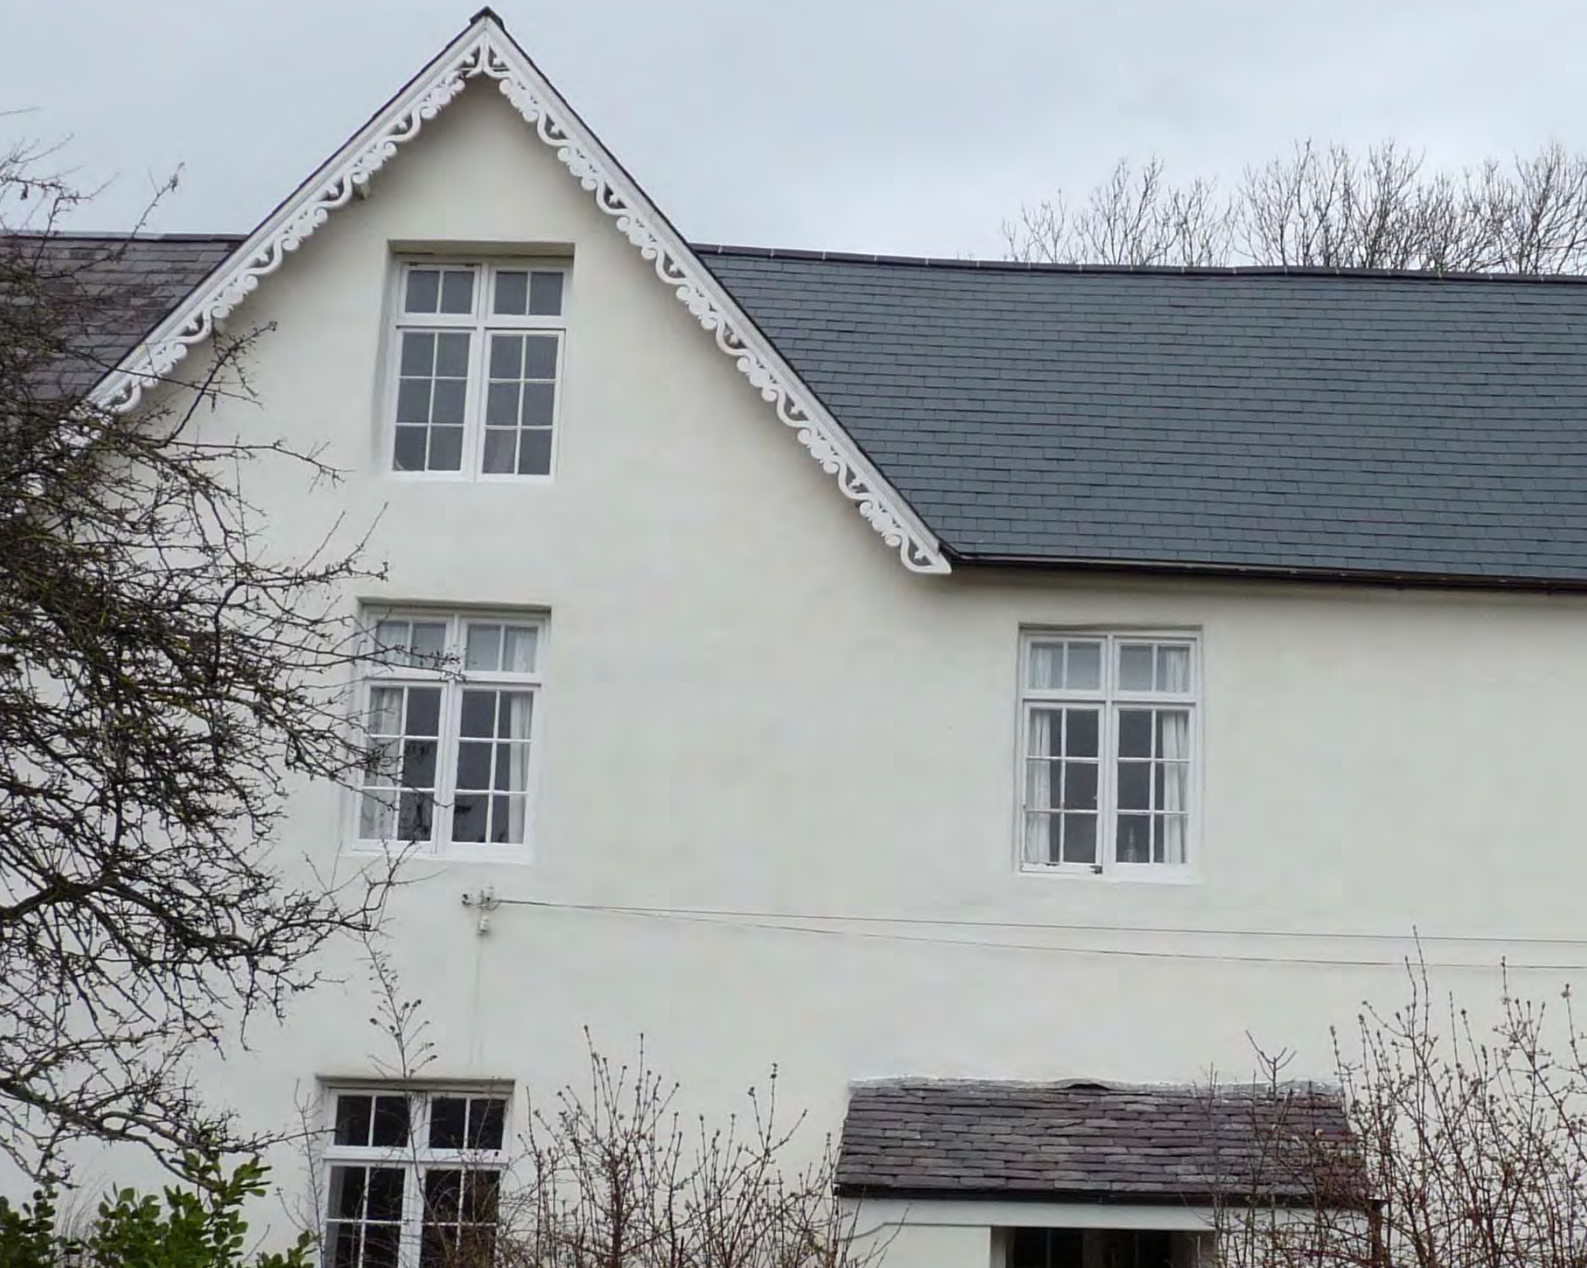
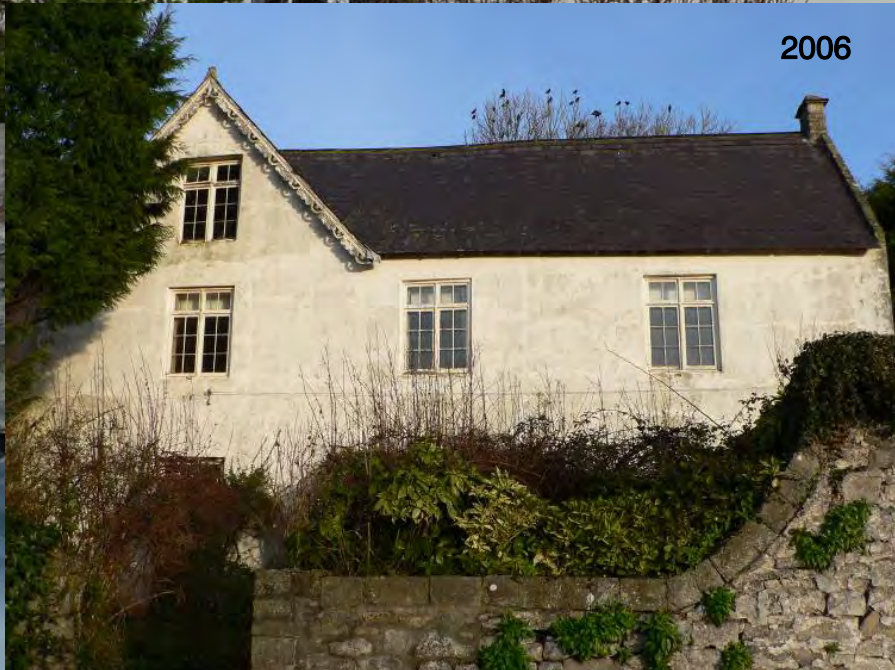
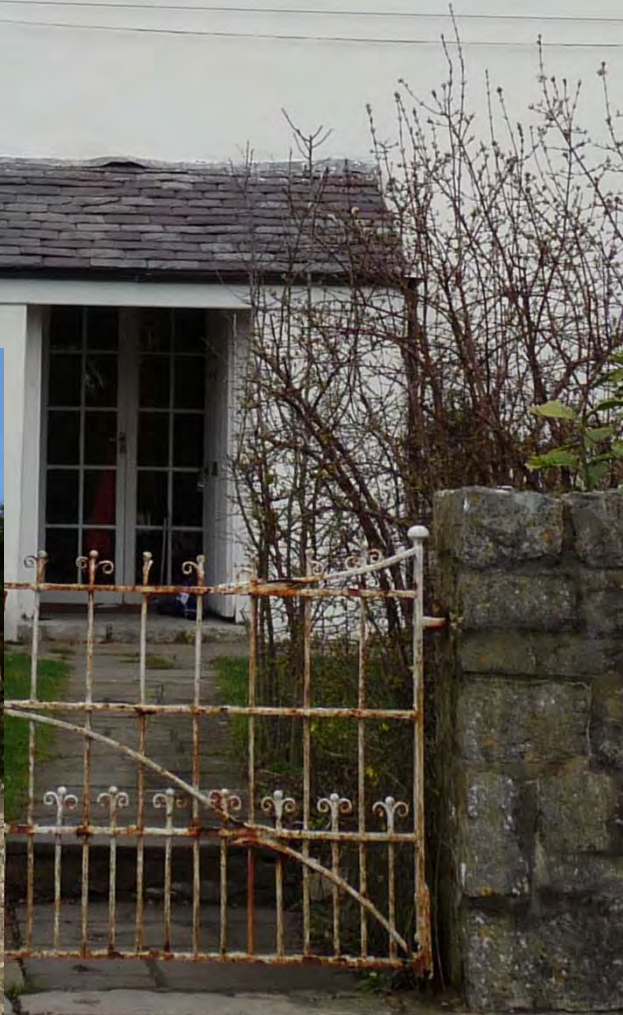
Plymouth House

Consent was granted in 2007 for the complete refurbishment of the building and its subdivision to create two residential units. These works have subsequently been completed.

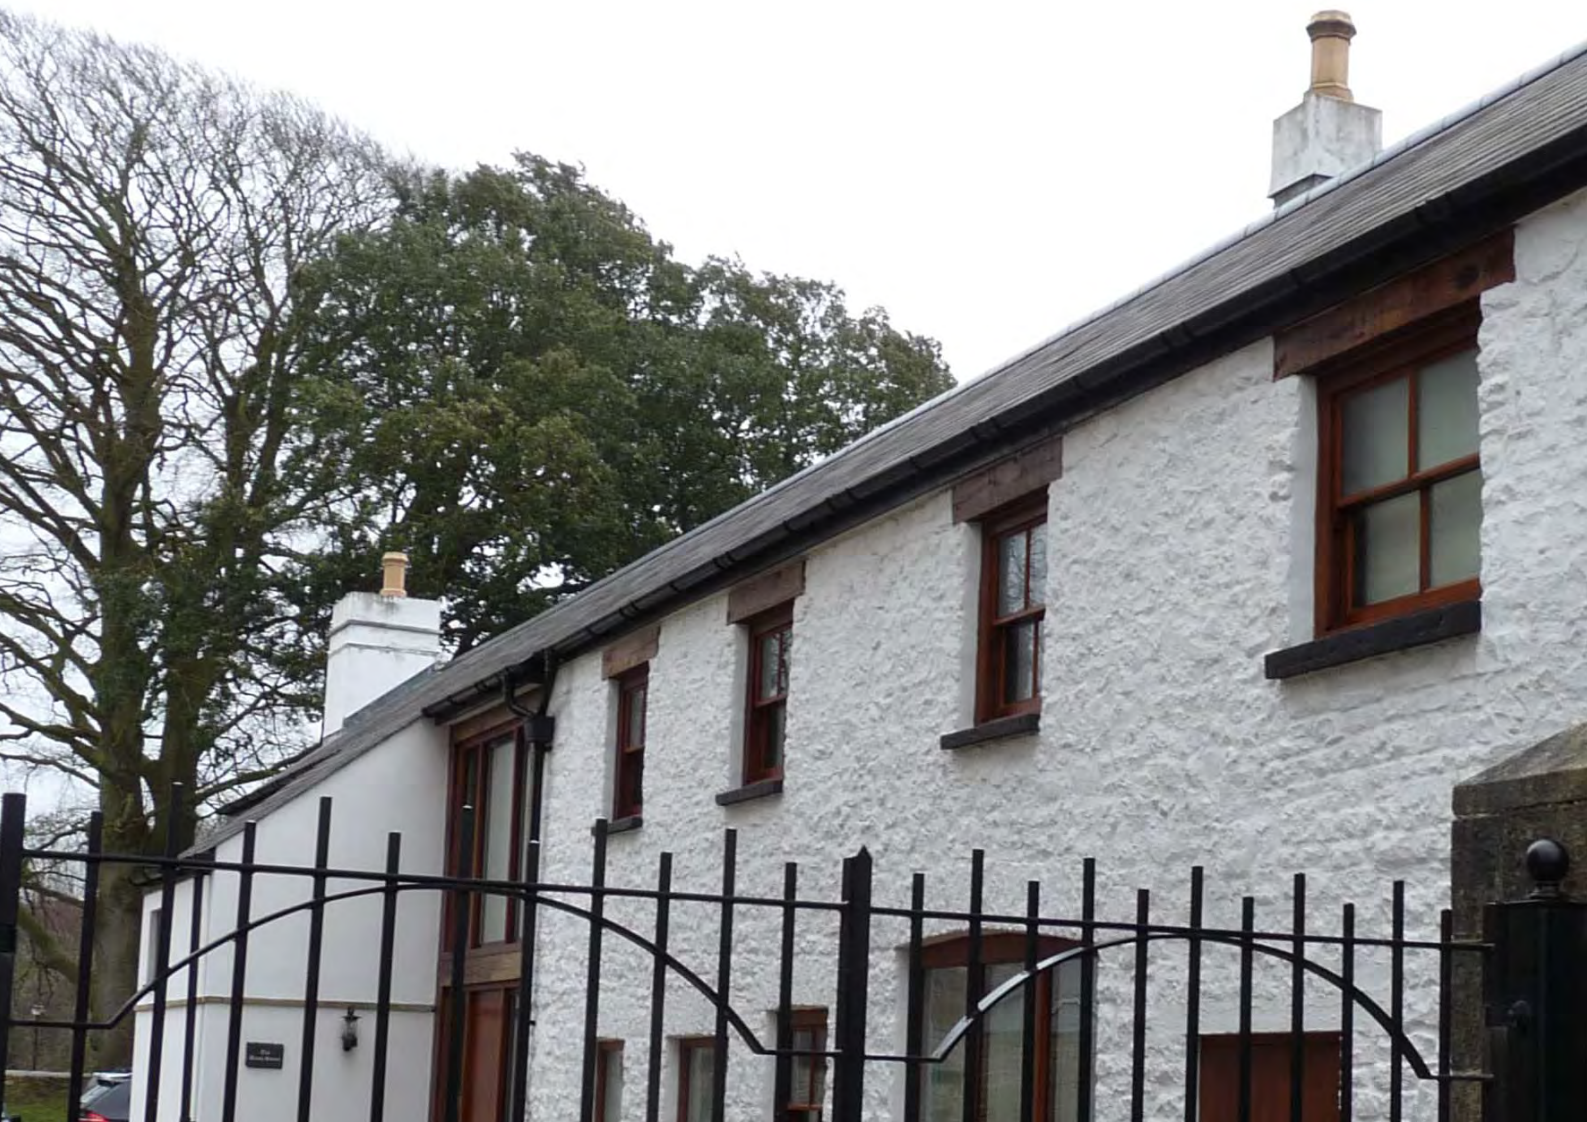
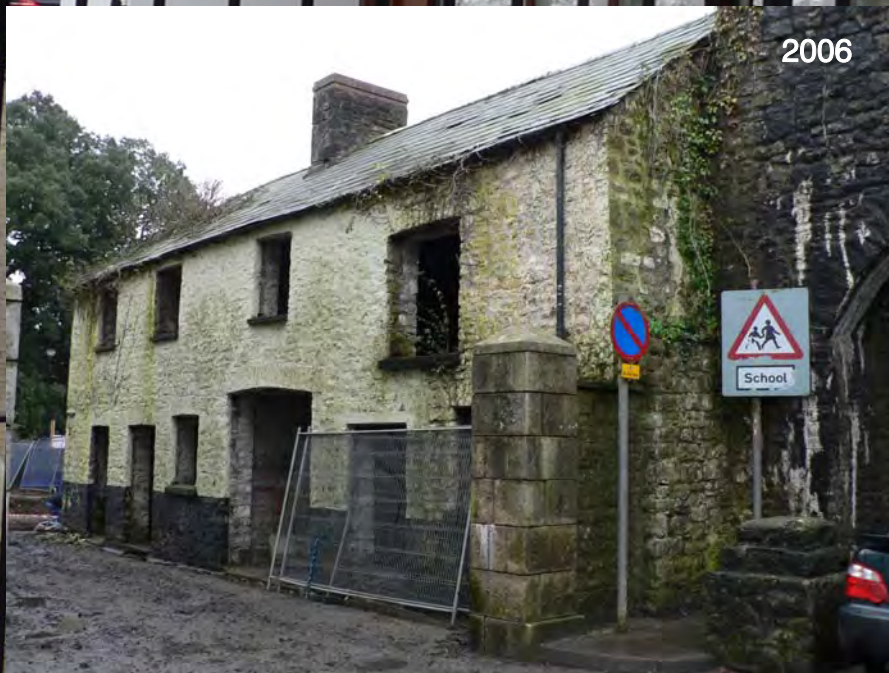
The Boot House

Consent was granted in 2007 for the complete refurbishment of the building, along with the former Grammar School and its subdivision to create residential units. These works have subsequently been completed.

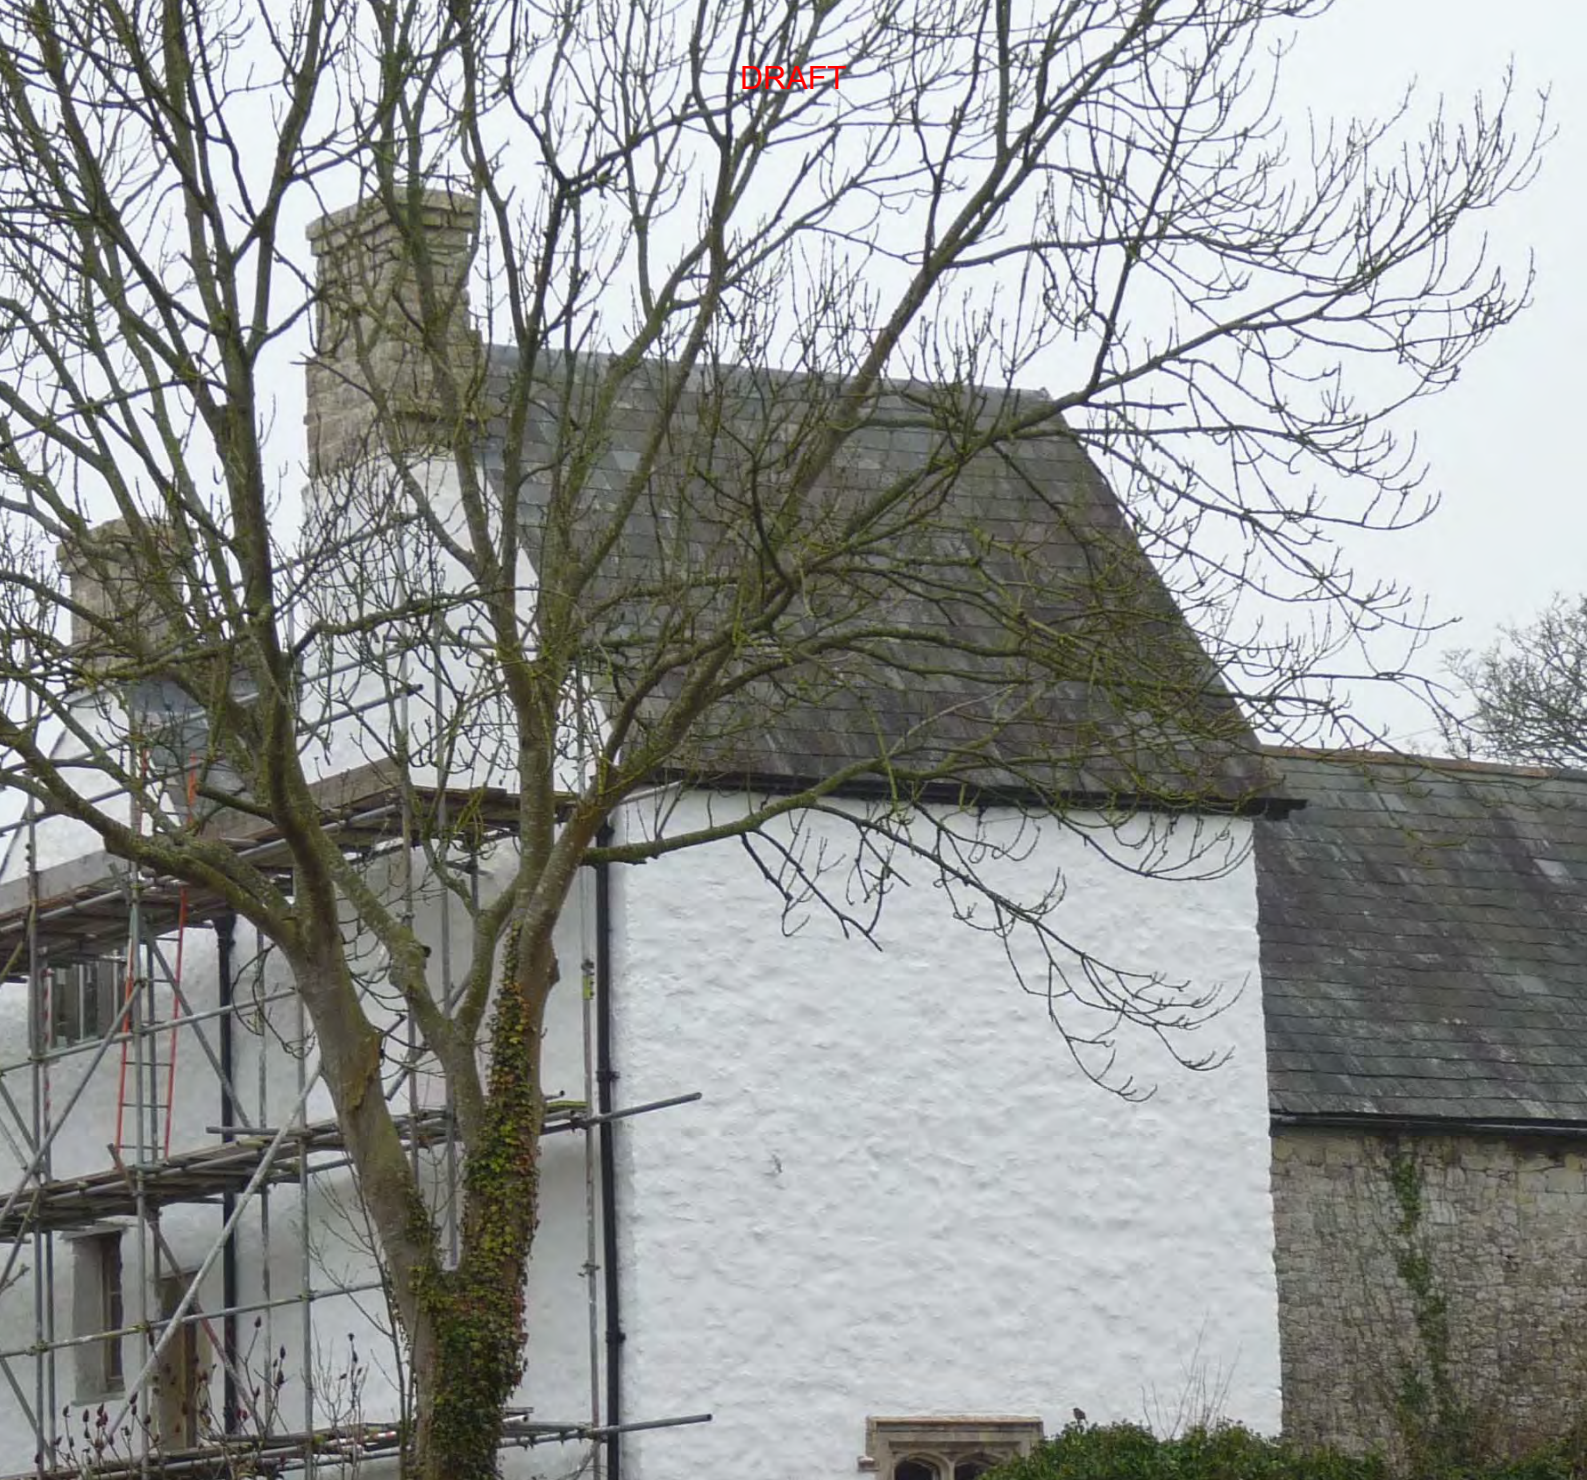
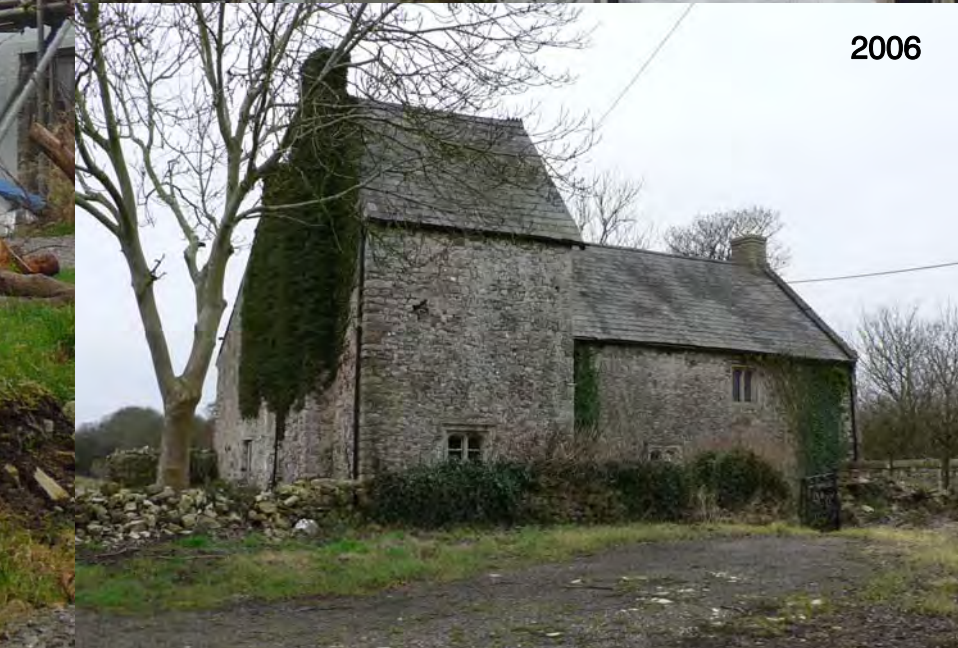
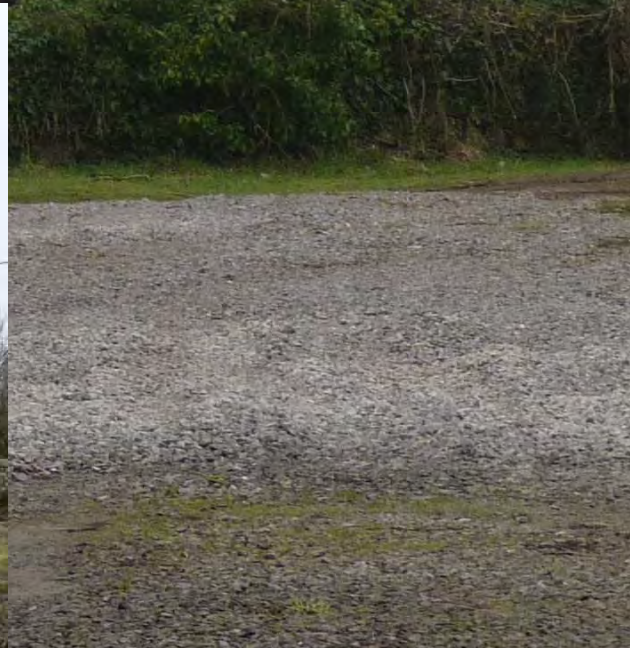
Castle Farm House

Consent was granted in 2010 for the refurbishment of the building. The works are currently ongoing.
