# Frugal Rehabilitation Demonstration (FRD) in Mongolia

## FRD Case Studies Handbook

**Frugal rehabilitation of lands degraded by artisanal and small-scale mining at seventeen sites within nine aimags and fourteen soums across Mongolia.**

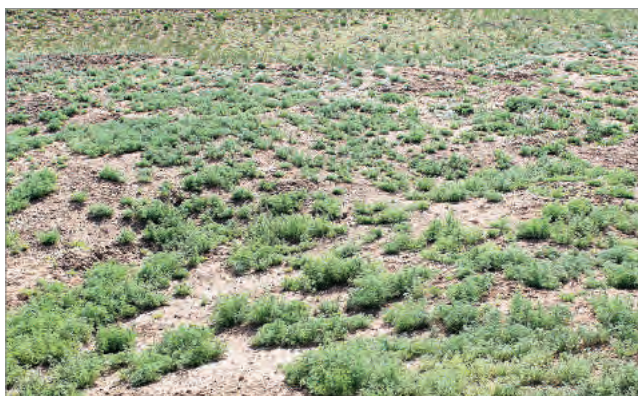
*Rapid regeneration of successional colonizer species*

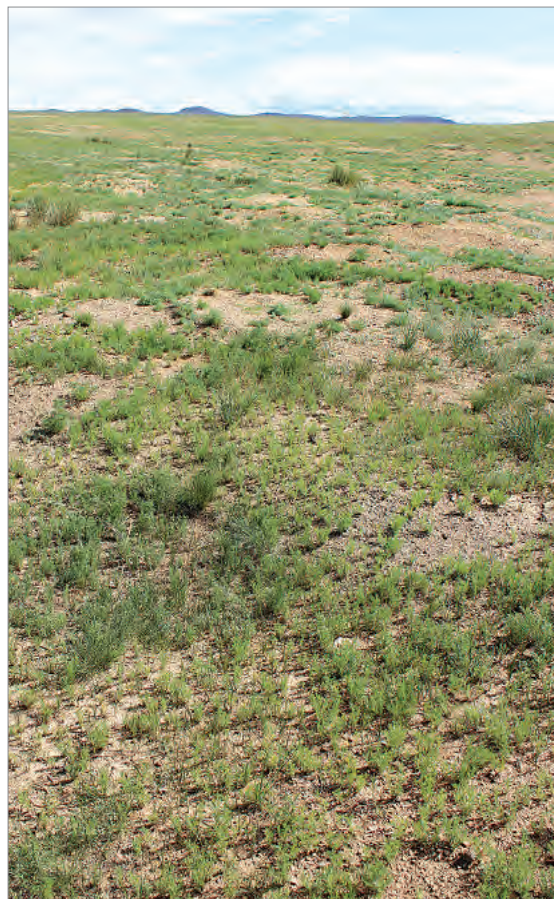
*Regeneration over final rehabilitation surface in 2015*

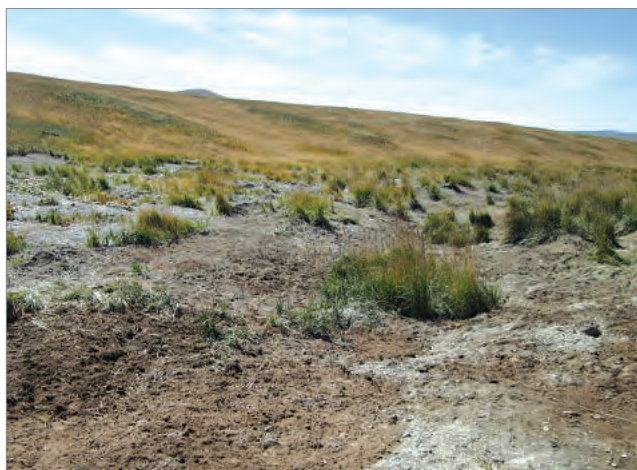
Hay and manure were collected and used on site to add organic matter to the soil and provide protection to the rehabilitation surface. However, initially the manure was unevenly distributed over the site, being spread mainly on fertile topsoil areas. Further instruction resulted in a more general mixing of manure and topsoil, with poorer areas also receiving such treatment.

*Distributed topsoils enriched with manure*

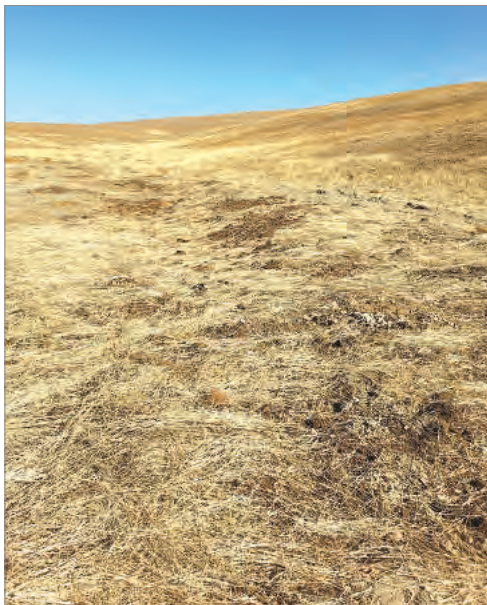
*Hay spread into topsoils*

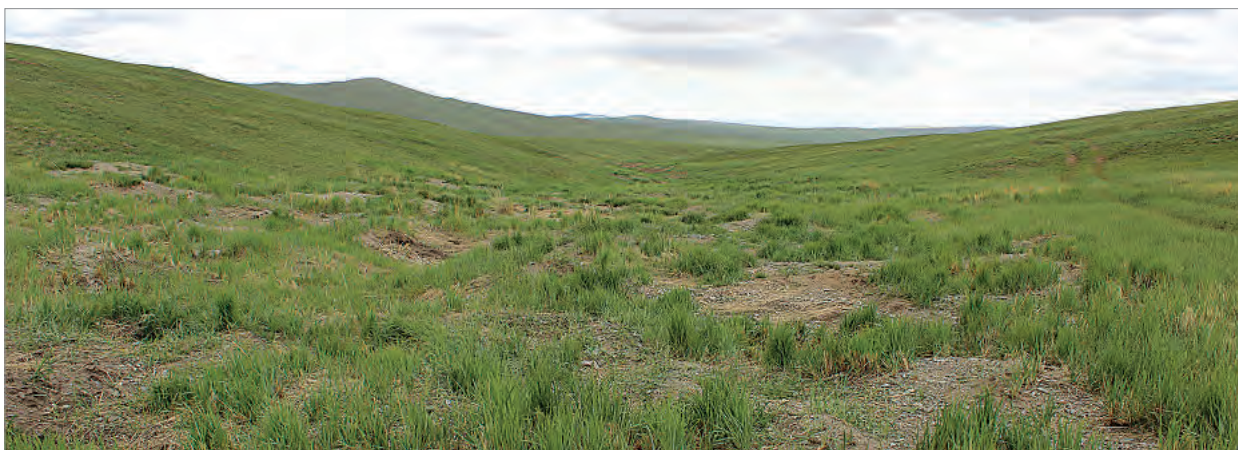
*Biological recovery at Shar Khuruu during summer of 2015 after good rains*

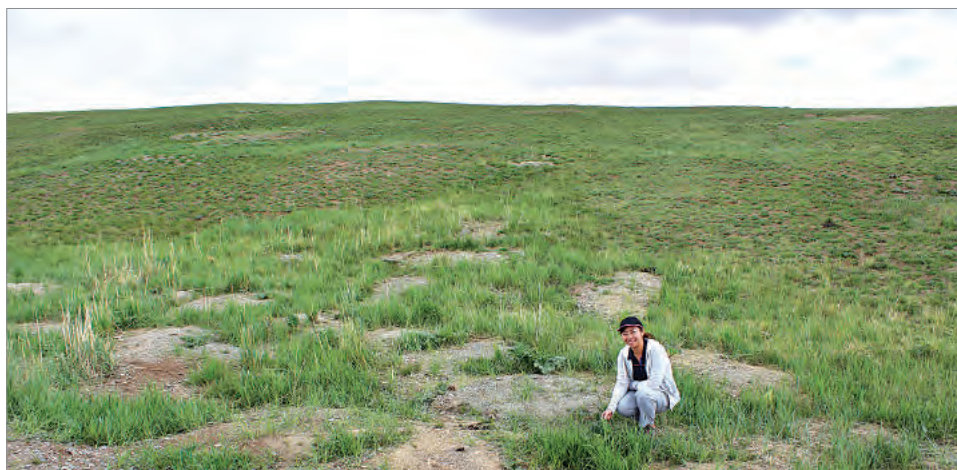
*Successful biological rehabilitation during summer monitoring 2015*

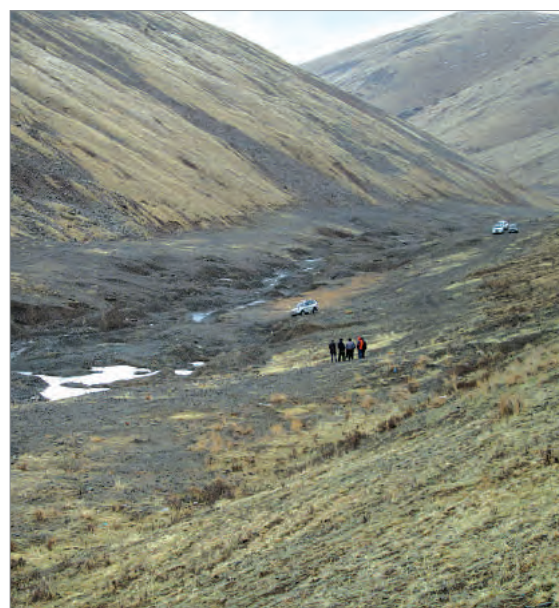
There was a total of 36 pits and 52 waste piles. The average depth of the pits was 2m and there was a high volume of piles to be moved, both as infill and for regrading. Given that much of the material had previously been re-worked by a mining company, there was sufficient heavy material for infilling on site in the form of gravel and rocks. It is important to understand that the ASM rehabilitation was working with a previously compromised site (previous mining history), so access to original topsoil was not a possibility. Across much of the site, vegetation had been stripped by earlier mining with only minor regeneration evident. Most critically the hydrology of the river had been destroyed by large-scale mining, and reinstatement of hydrology was a priority for the rehabilitation.

Overall, the site posed a low safety risk as pits were not very deep or in high density compared to other first generation alluvial FRD sites. However, some pits were located on steep hill slopes and demolishing high stockpiles exposed some risk to rehabilitation workers.

ASM workings on previously mined technical rehabilitation

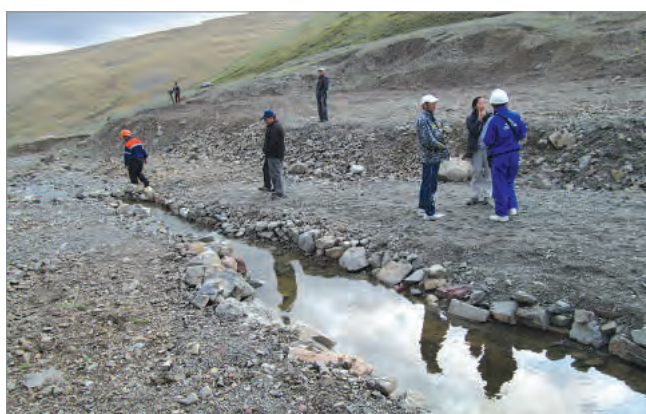
The hydrology issue for this site was critical as the site has an active seasonally fluctuating watercourse which posed a risk to the rehabilitation outcome. Relevant techniques were delivered through onsite instructions by the project team. The river bed was cleaned of garbage, and channels designed with meanders with outside bends strengthened with large heavy rocks. The prescriptions were designed to reduce erosive energy and protect vulnerable bends by rock placements. Some pools and water retention features were designed and implemented. As a result, surface river flow has resumed and will be monitored and managed by the ASM NGO.

*Watercourses strengthened with larger rocks*

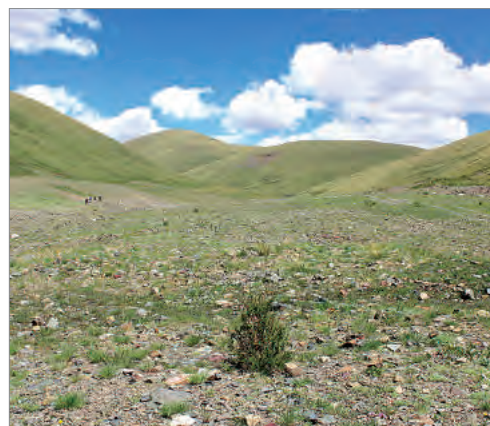
In 2015 biological recovery is underway

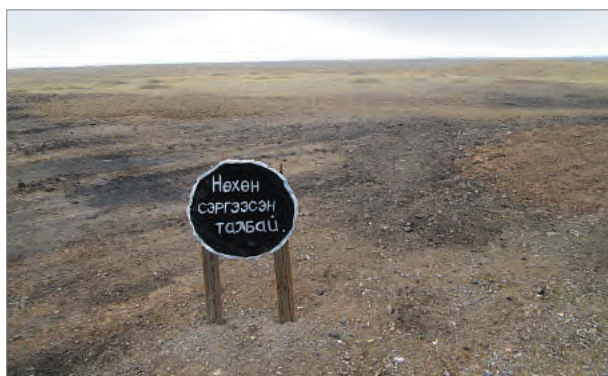
*Successful technical rehabilitation*

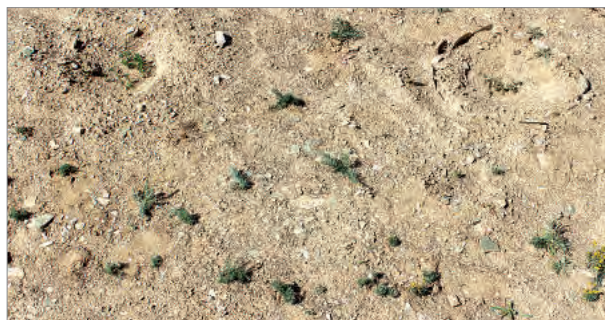
*Germination of planted and successional species after summer rains*

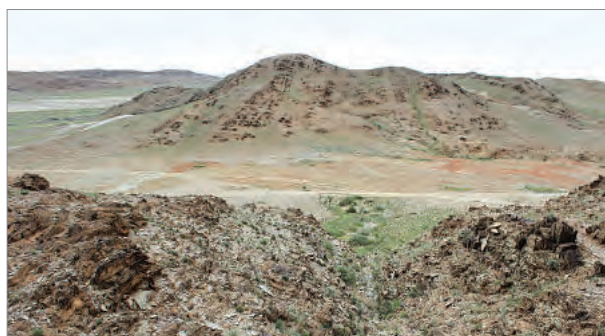
*Overview of rehabilitated site at Khutul*

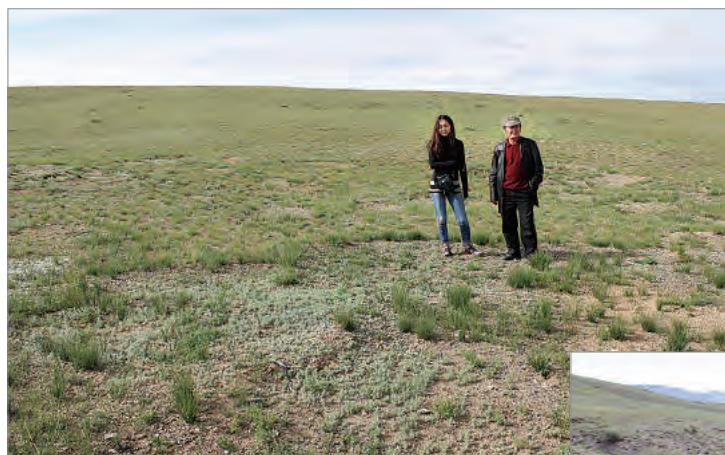
*2015 monitoring visit showing vegetation recovery*

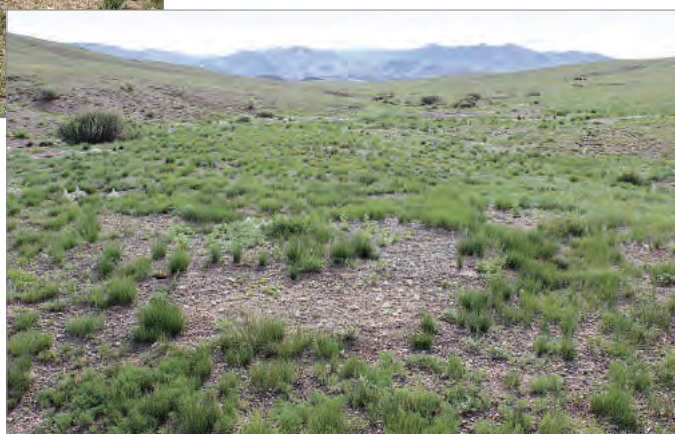
*Biological recovery was a success due to methodology and good rains*

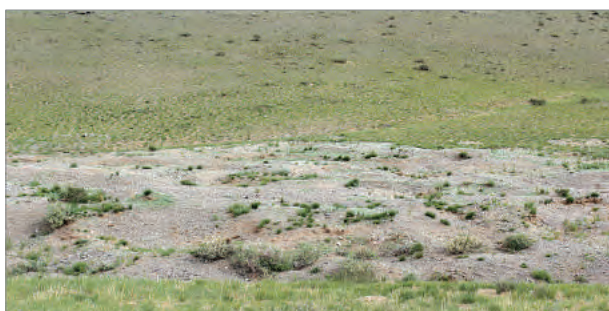
*Alluvial floodplains showing biological recovery*

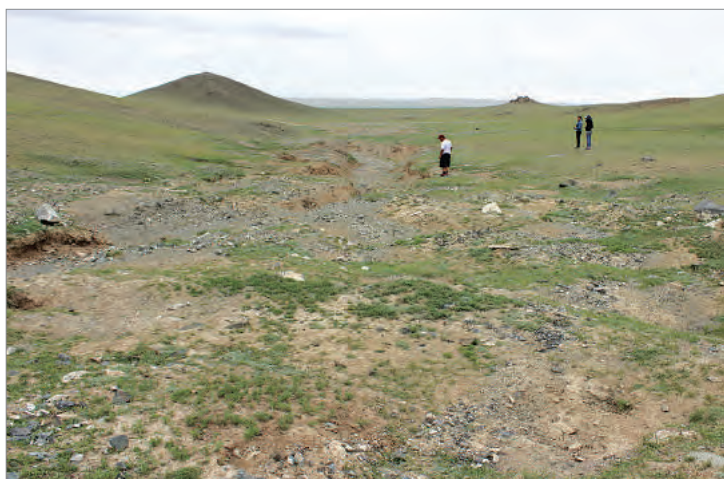
*Technical and biological recovery was evident*

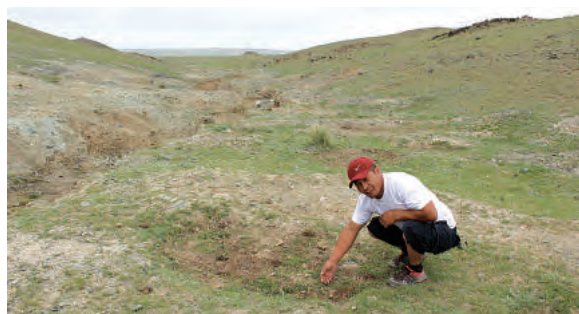
*Specific topsoil and biological rehabilitation showed success*

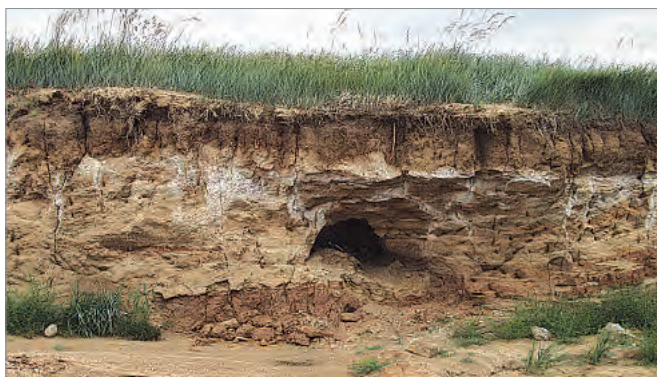
*Castellated areas held much dark topsoil which could be redistributed*

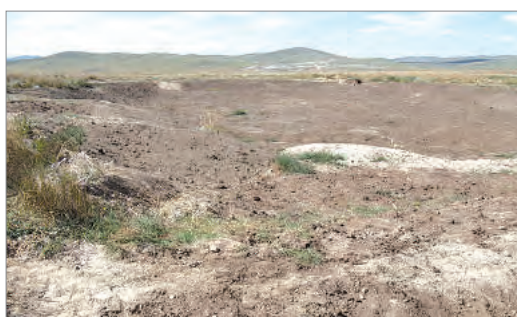
*Redistributed topsoils ready for biological rehabilitation*

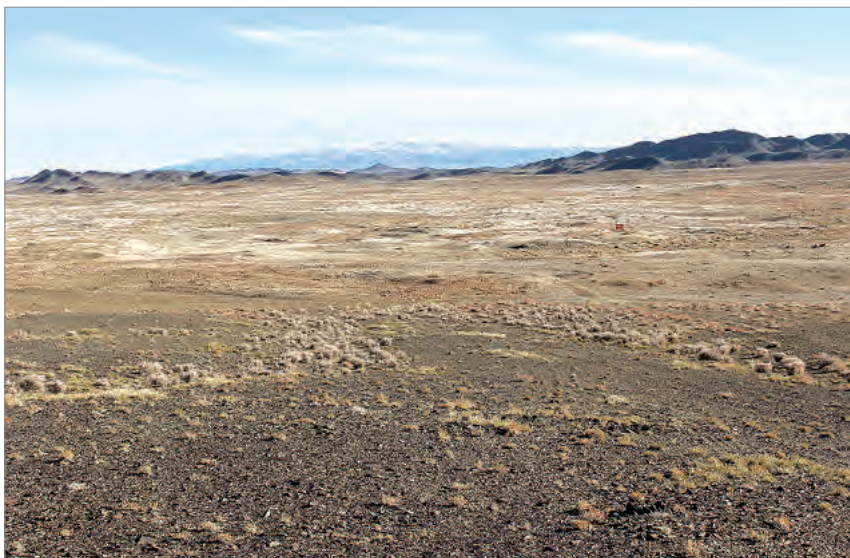
*Frugal rehabilitation completed at Khaltar Uul*

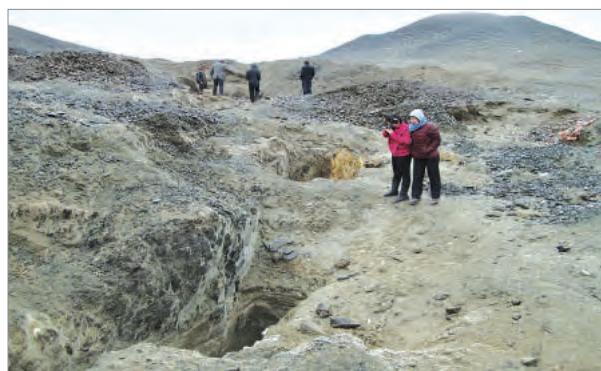
Environmental hazards were associated with high density deep shafts located near a winter herding area, with significant risks for livestock.

*Deep shafts from hard-rock gold mining*

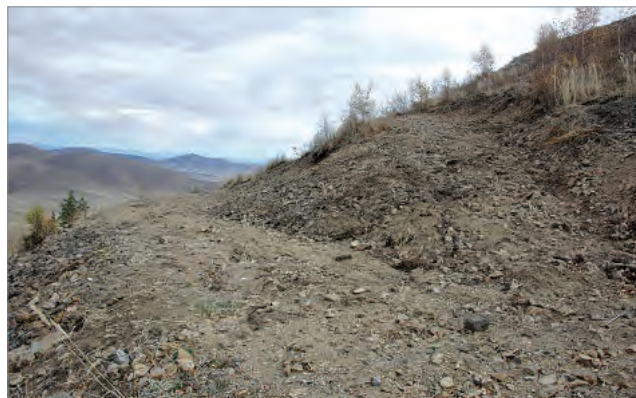
*Technical rehabilitation completed*

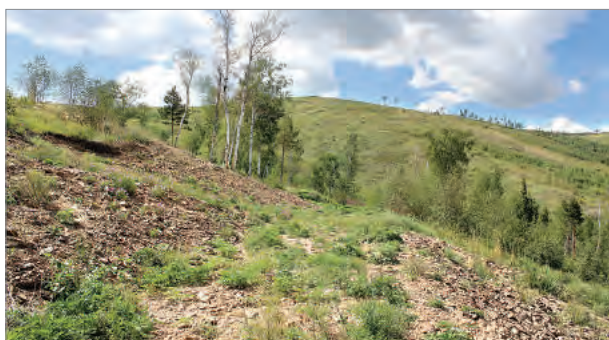
*Monitoring in 2015 showed recovery of forest steppe vegetation*

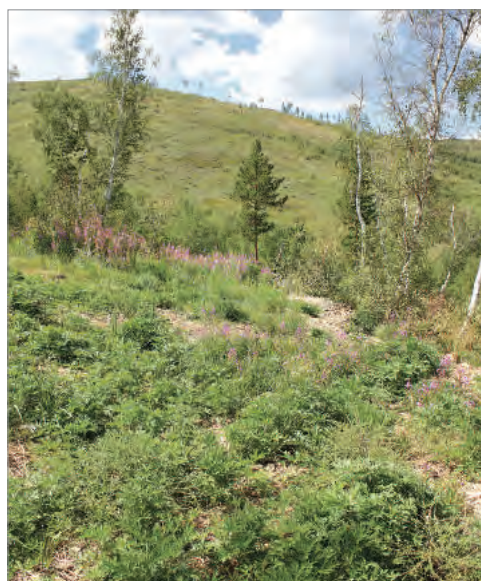
*Strong biological recovery after summer rain 2015*

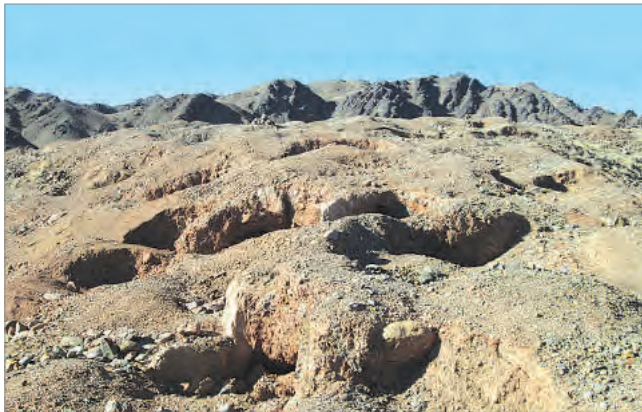
*Hard rock ridge mining - a rehabilitation challenge*

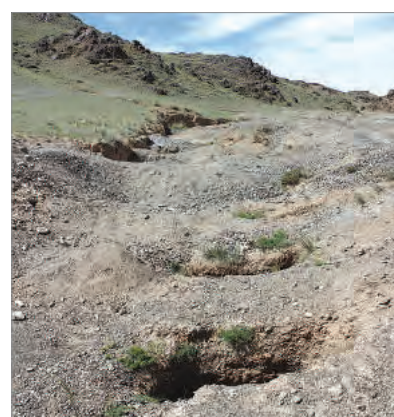
*Alluvial ASM shafts before frugal rehabilitation*

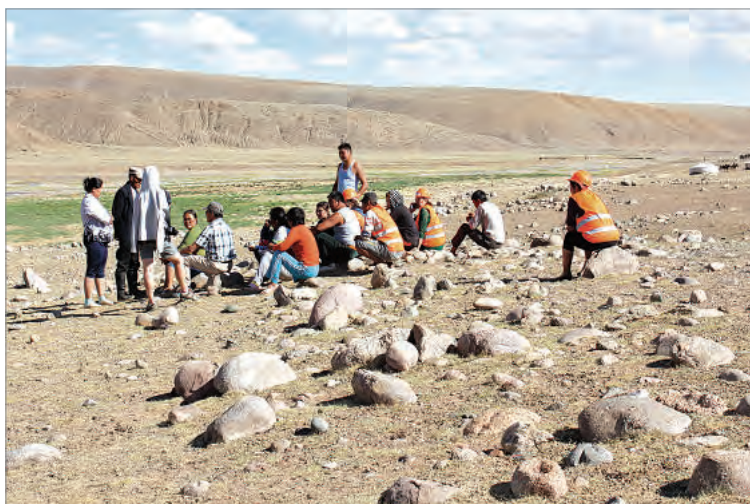
*Training in biological rehabilitation*

After technical rehabilitation, biological rehabilitation was continued until 3 September 2015. Seeds of target plant species for rehabilitation were collected in late August and early September. An onsite training on species recognition and seed collection were conducted amongst members. At the end of the season, ripened seeds of *Stipa gobica* and *Caragana* were collected by hand-stripping, seeds head of *Achnatherum splendens*, *Elymus angustes* and *E. chinensis* were clipped with scissors and allowed to dry in mesh or cotton bags. The collected seeds were mixed with manure

and were raked into the topsoil surface and hay spread over these areas to provide rehabilitation support (moisture retention) and protection (wind erosion). The site with its seedbanks in topsoil were responsive to limited summer rainfall and natural colonizer species. Technical assistance at the site was provided by the ESEC II project on three monitoring visits during the rehabilitation effort to ensure successful implementation of technical, topsoil management and biological rehabilitation processes.

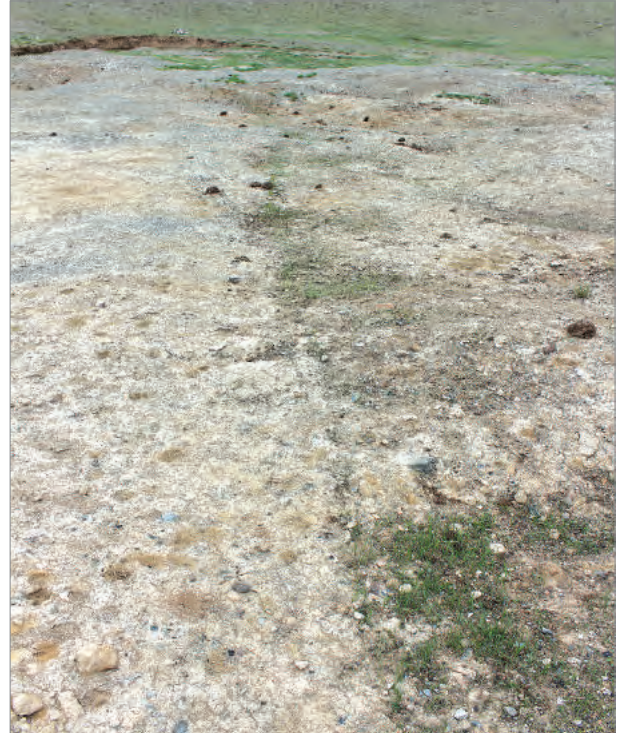
8. Boundary between FRD (right) and mechanized company rehabilitation, Zurkh Tolgoi 2015
