US Army Corps
of Engineers
Seattle District

Construction Foundation Report

Mud Mountain Dam Seepage Control Cutoff Wall

CONSTRUCTION FOUNDATION REPORT
 SEEPAGE CONTROL WALL
 CONTRACT NO. DACW67-83-C-0047

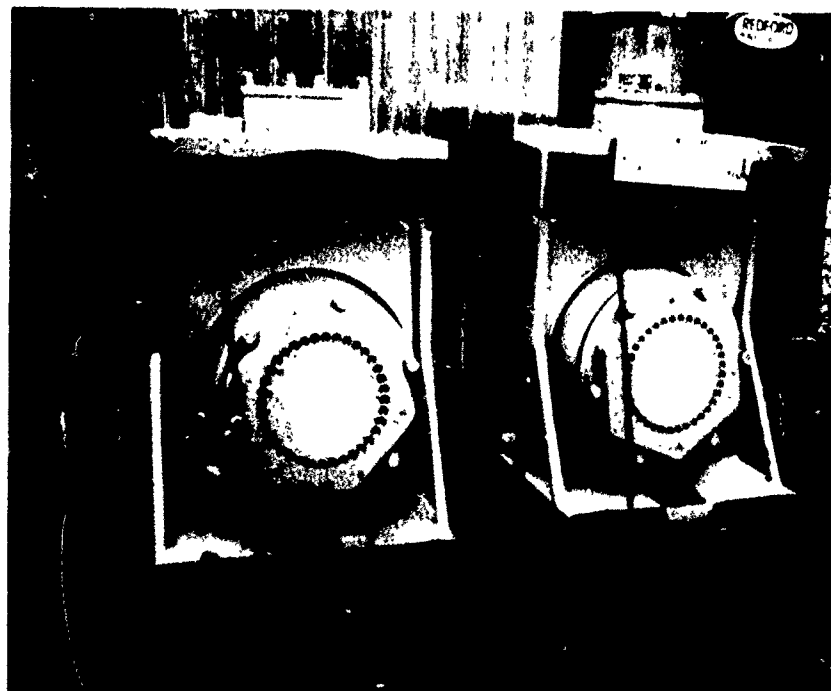
Spare hydrofraise motors.

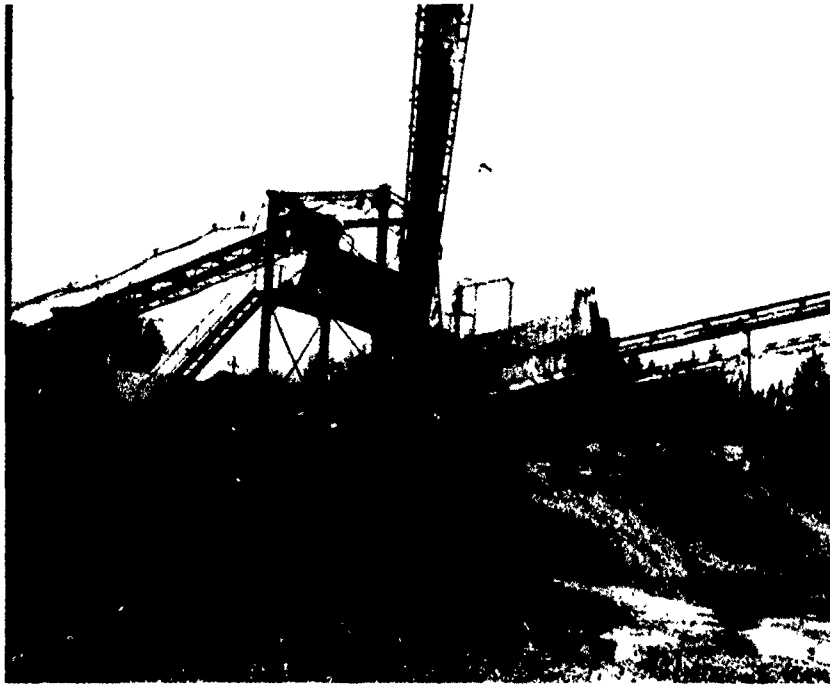
Cadman wash plant arranged to produce 1 1/2-inch, 7/8-inch, 3/8-inch nominal maximum sized aggregates and sand.

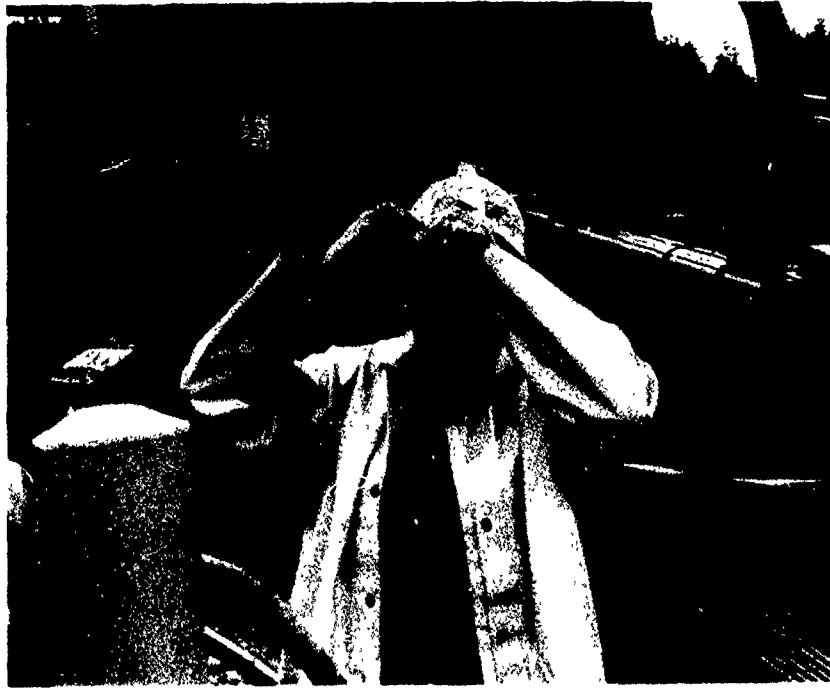
Driller checking "picture" taken with Navidrill to determine core hole orientation.
