APPENDIX C
Aerial and Site Photos

Supplemental Environmental Baseline Survey – Republic of Palau

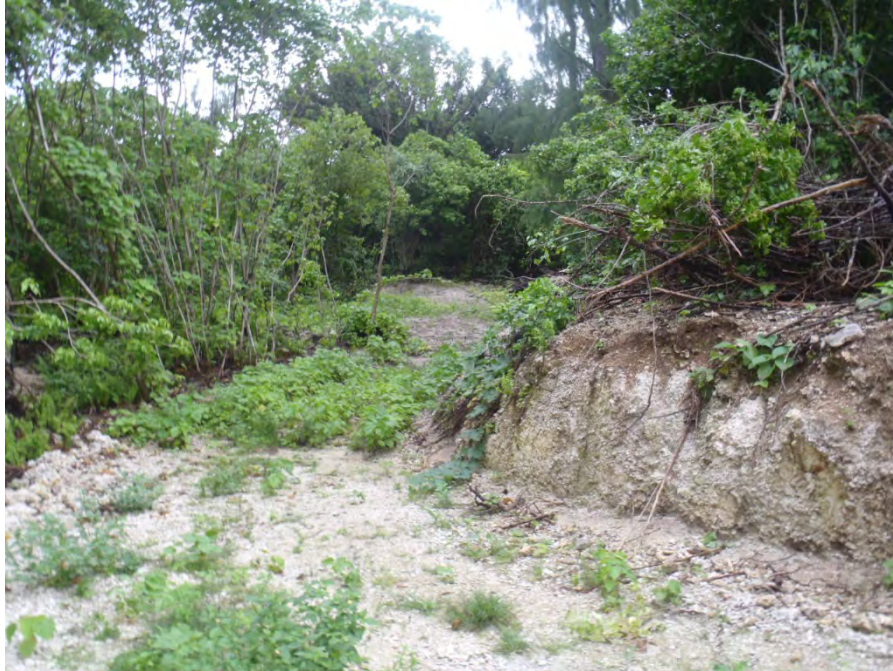
Location of sample 18PA-ANG-010 and -011 adjacent to a deteriorated tar drum and spilled bitumen at the Angaur Rx Site. Looking south.

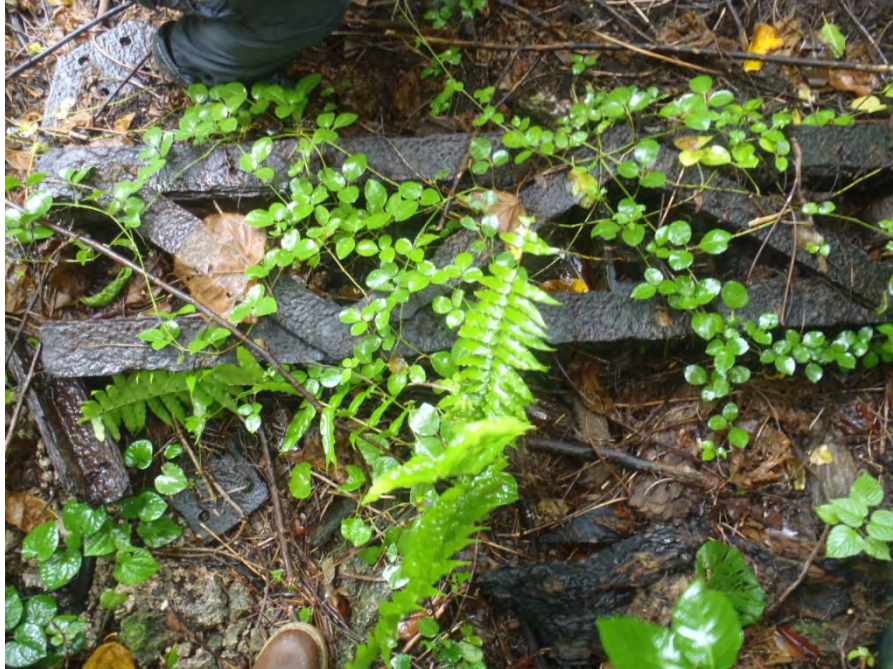
Photo No. 48 – 12 July 2018

Large piece of frag identified during MEC avoidance activities at the Angaur Rx Site.

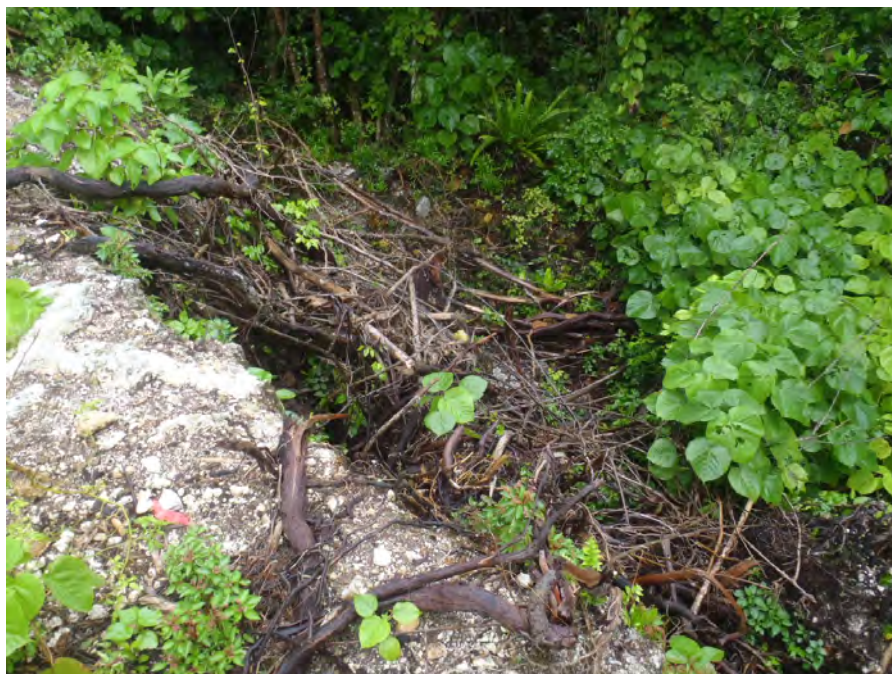
Photo No. 49 – 12 July 2018

Abandoned mining equipment adjacent to soil sample 18PA-ANG-004 at the Angaur Rx Site.
