Dysartgallen Church & Graveyard

Ballinakill, County Laois.

CONSERVATION MANAGEMENT PLAN

November 2020

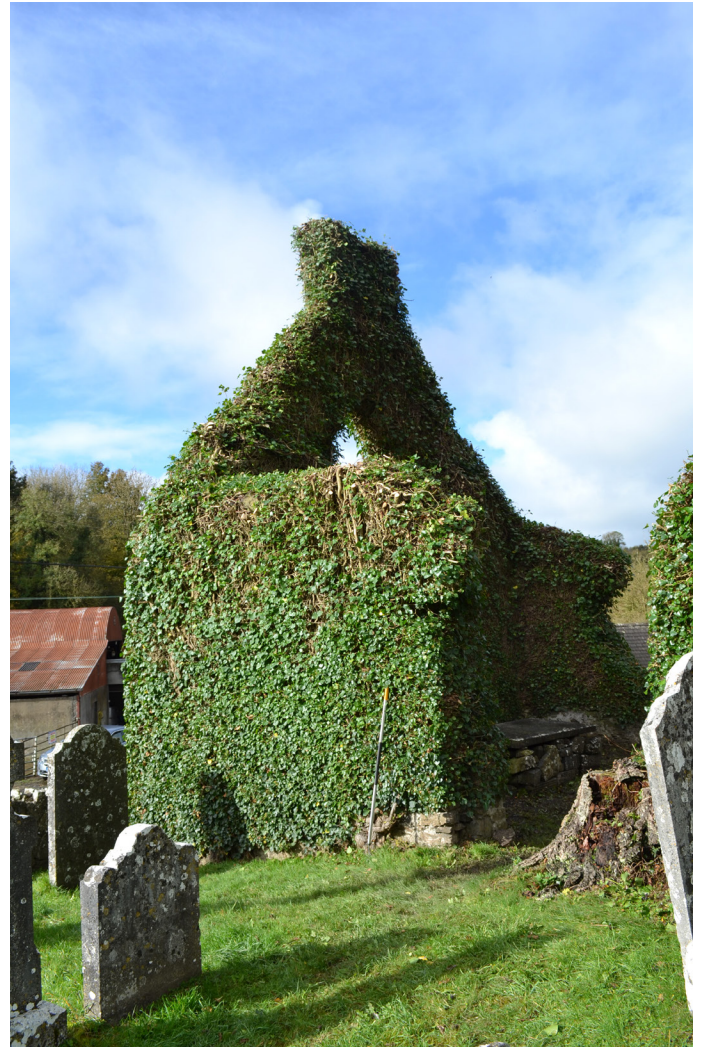
Detail of south west corner.

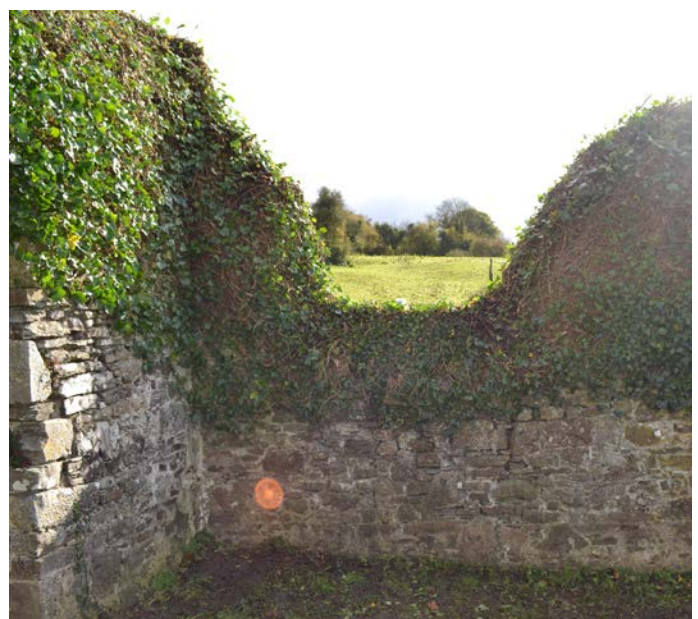
View of possible south window.

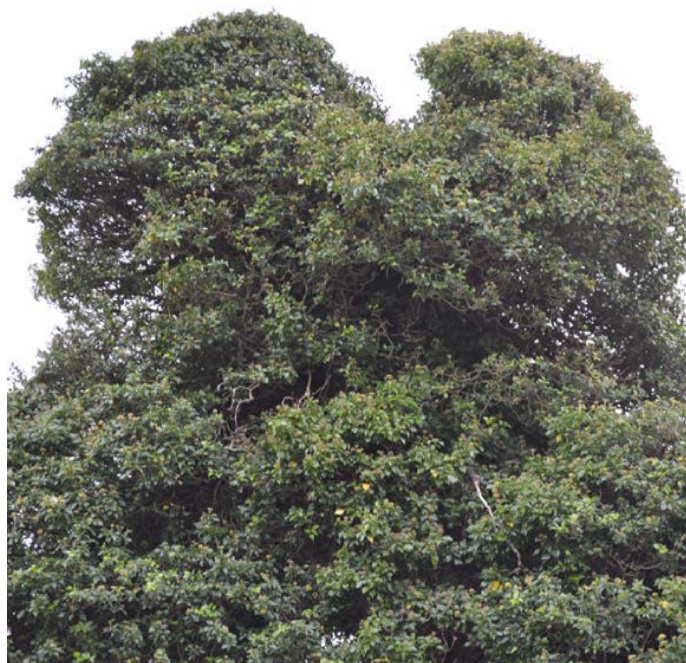
Detail of bellcote prior to trimming.

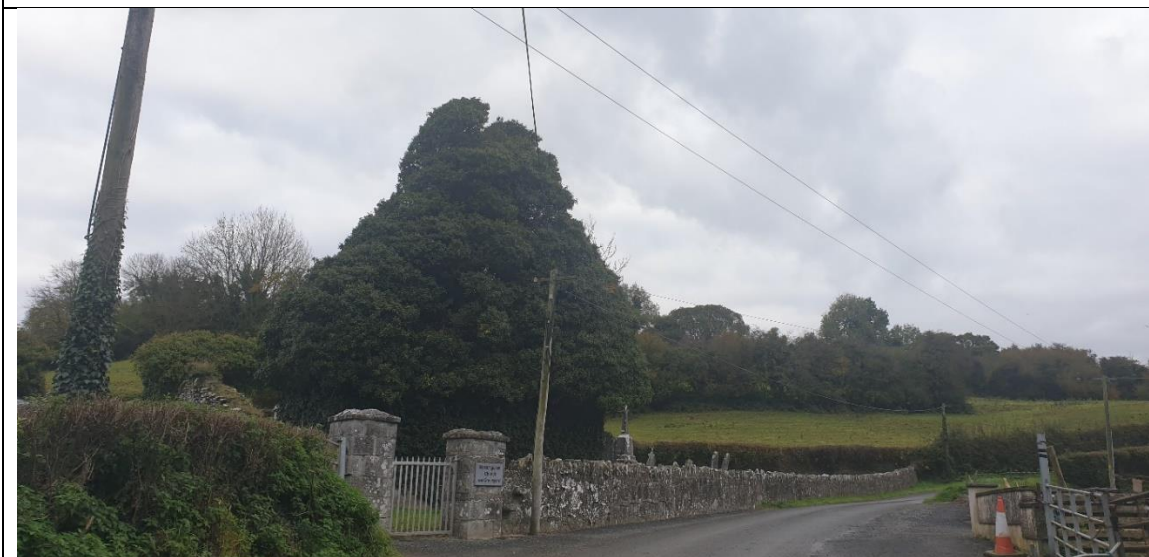
Fig. 1: Prolific ivy growth on Dysartgallen Church in early October 2020

local biodiversity has thrived as it has been left to its own devices in many ways. The primary example being the Ivy (*Hedera helix*) which had grown so prolifically on the church ruins that it threatened the building's future (Fig. 1).

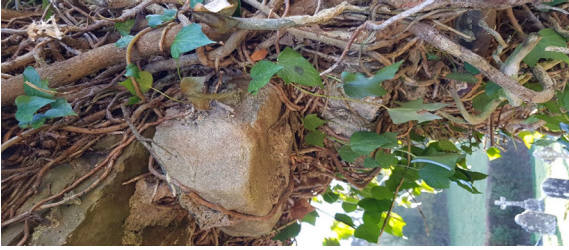
Rendered Masonry stepped plinth at external base of West gable

External plinth to outer face of west gable helps stabilise wall against overturning from retaining effect of built up ground internally. The condition of this masonry and its over render appear reasonable but should be further checked when all ivy removed

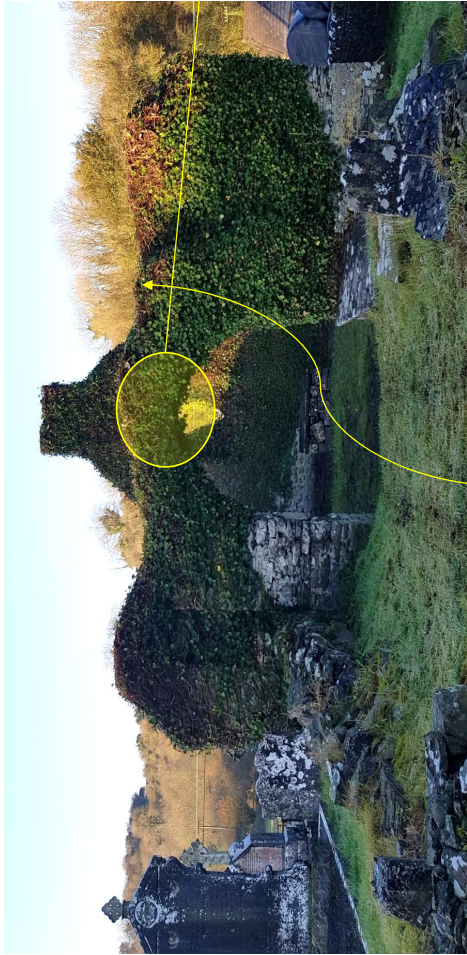
East gable wall - external

Hawthorn stems at top of arch require EcoPlug 2020.
To be checked again as part of masonry works.
Note it may not be possible to fully remove tree root. Any remaining root to be drilled and plugged again

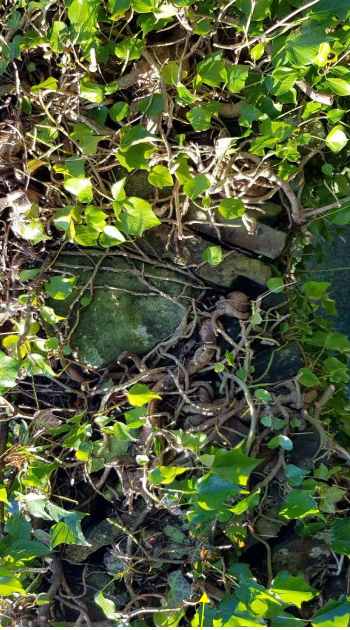
Arch voussoirs up to 400mm long generally of thin flat stone.
Unusual key stone formation that doesn't reach to underside of arch.

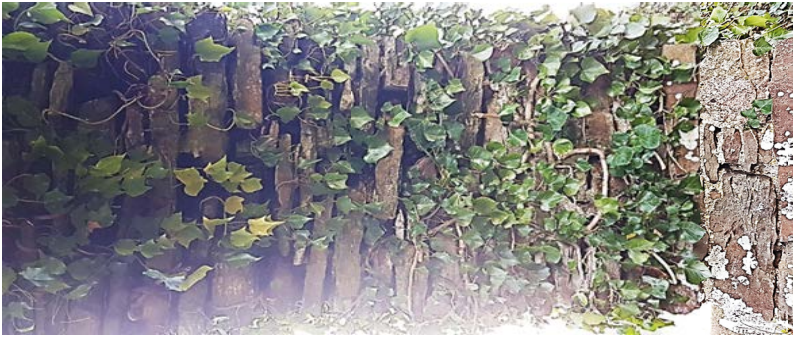
Mortar washed out to underside of arch with significant ivy growth around arch

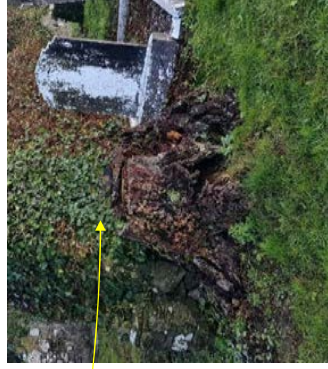
Corners where Quoins robbed out to be rebuilt to match other corners as closely as possible with squared off rubble work
