NIST Special Publication 901

The January 17, 1995 Hyogoken-Nanbu (Kobe) Earthquake

*Performance of Structures, Lifelines, and Fire
Protection Systems*

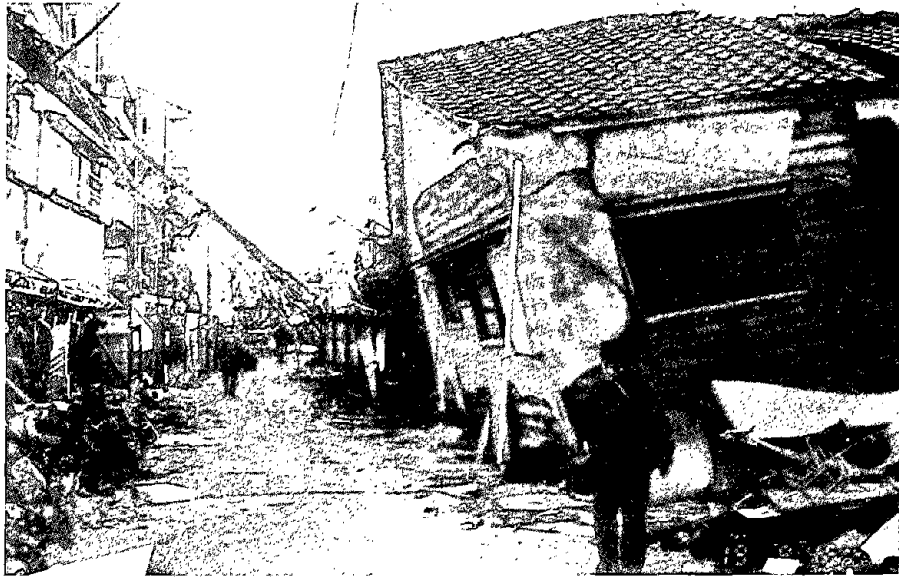
The number of collapsed houses constituted about 10 percent of the houses in the Kobe area. It was reported [3] that nearly 55000 houses collapsed and over 35000 houses were partially destroyed. These included both Shinkabe and Ohkabe houses. Typical damaged houses are shown in Figures 3.3.1 and 3.3.2.

Figure 3.3.1 A collapsed Ohkabe construction-type house.

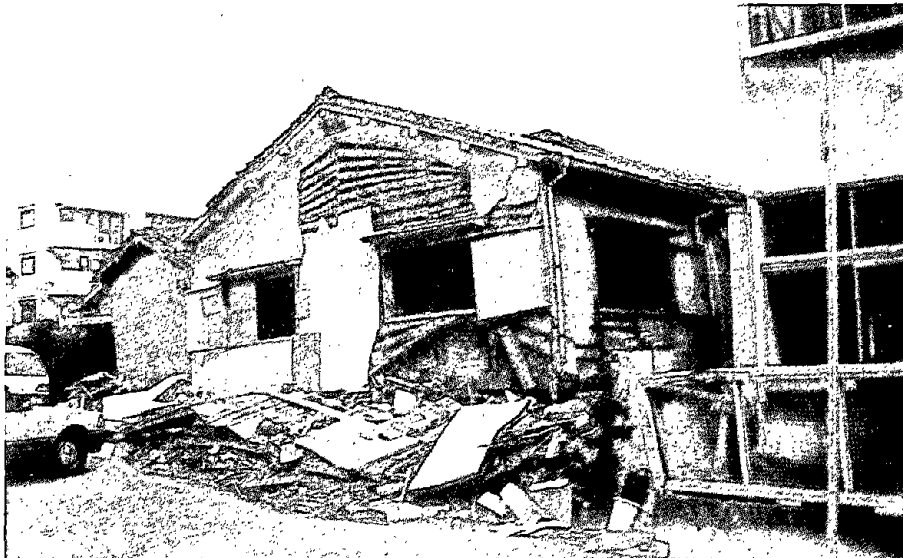
Figure 3.3.2 Same as Figure 3.3.1.

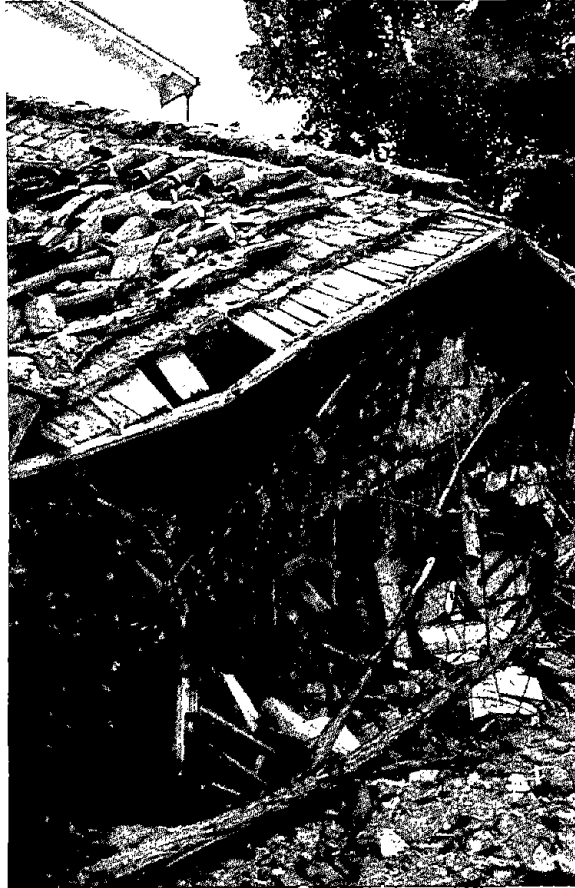
Figure 3.3.4 A completed collapsed Shinkabe construction-type house.

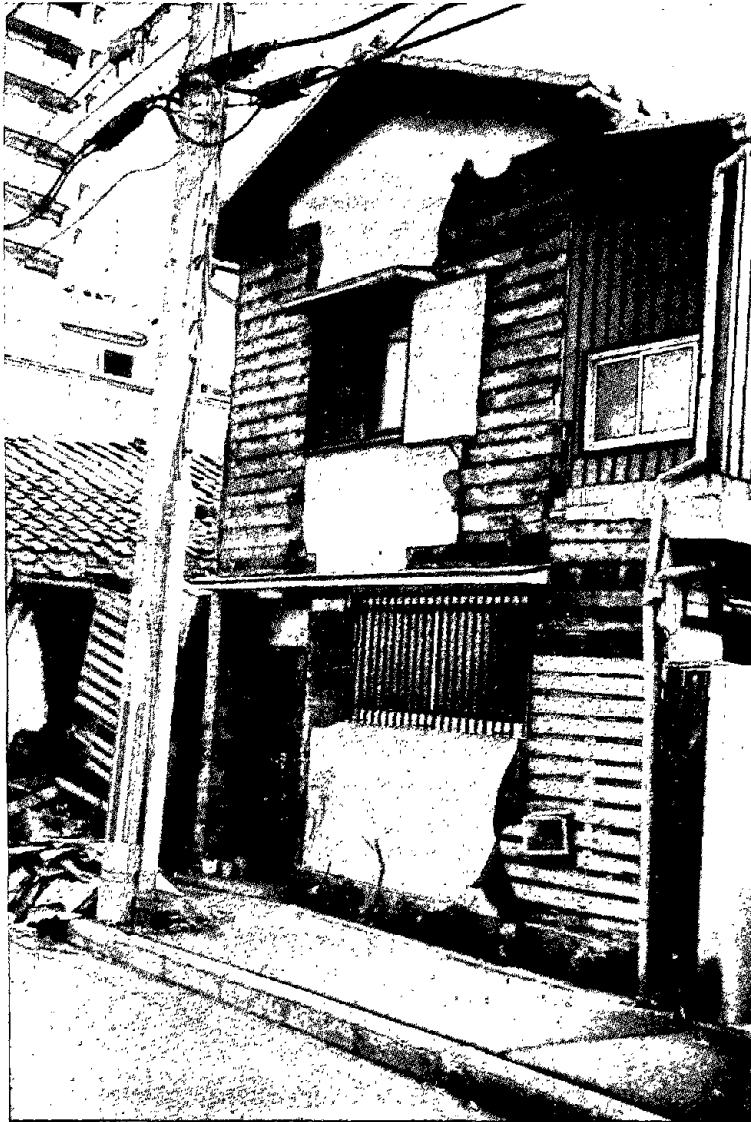
Figure 3.3.5 An Ohkabe house with only architectural design. Note a shadow of diagonal bracing on the left side of second story.

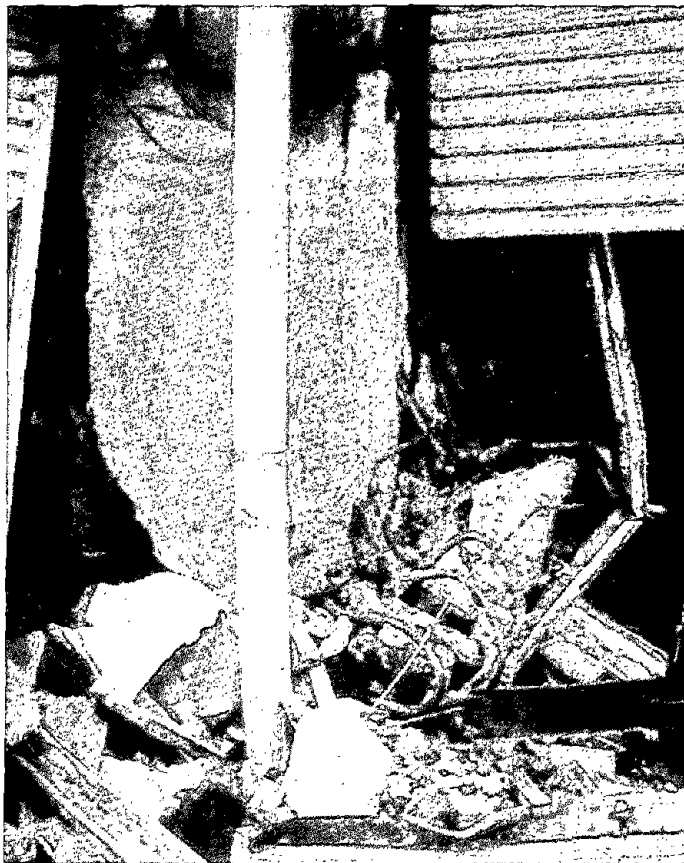
Figure 3.4.6 Failure of older column - local bar buckling.

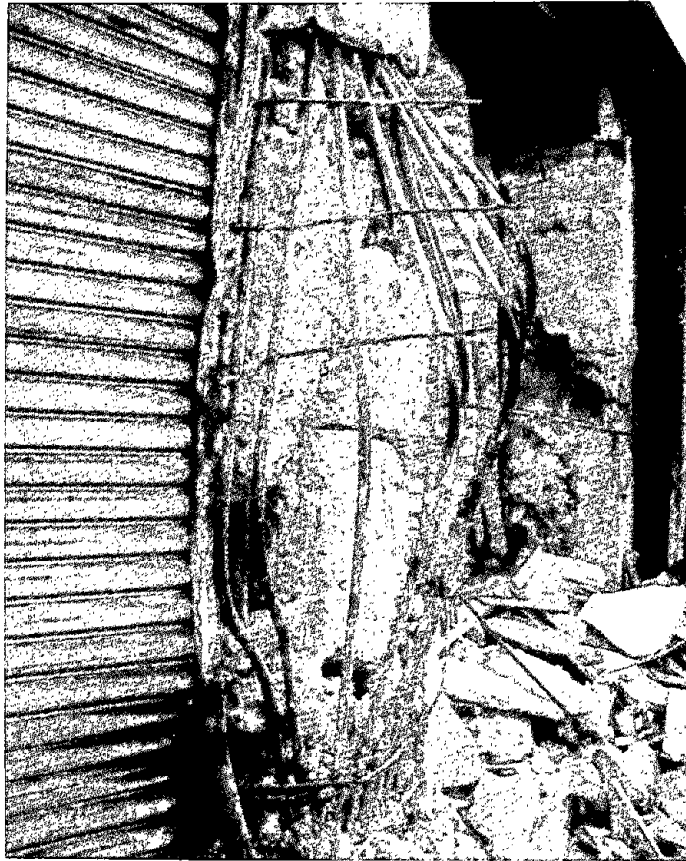
Figure 3.4.7 Failure of older column - general bar buckling.

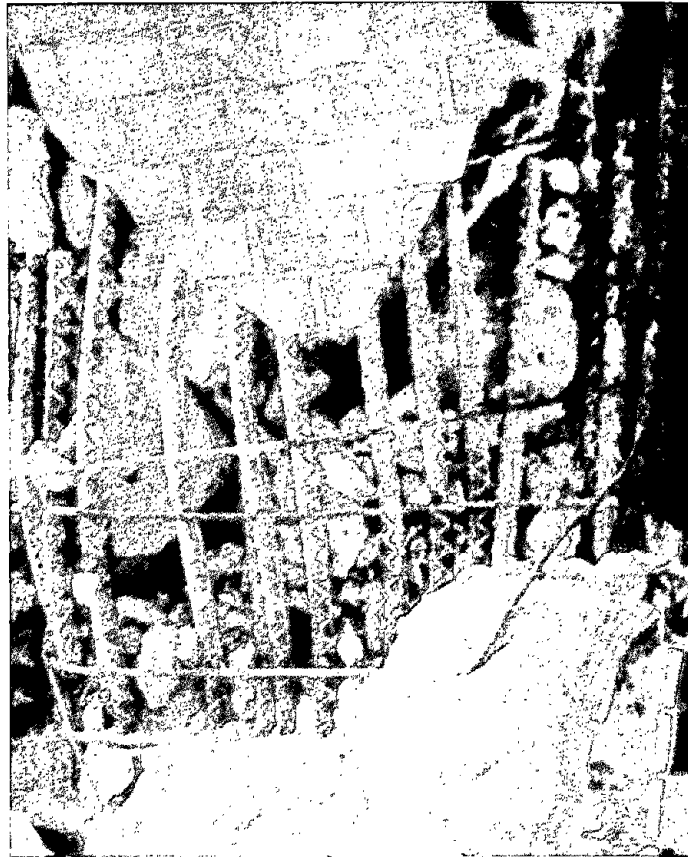
Figure 3.4.8 Failed column in commercial structure.

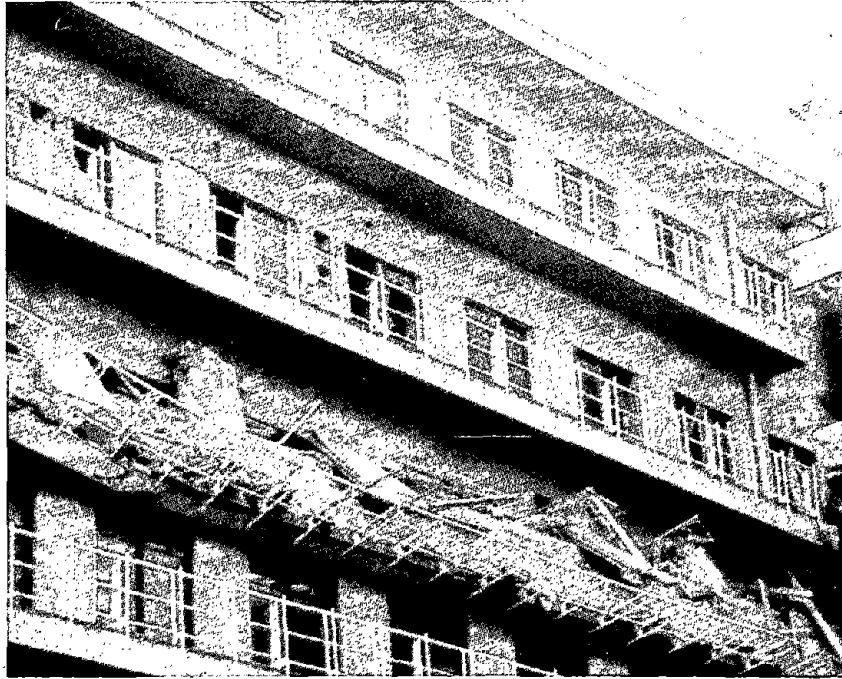
Figure 3.4.25 Collapsed upper story, northeast corner - West Kobe Citizens' Hospital.

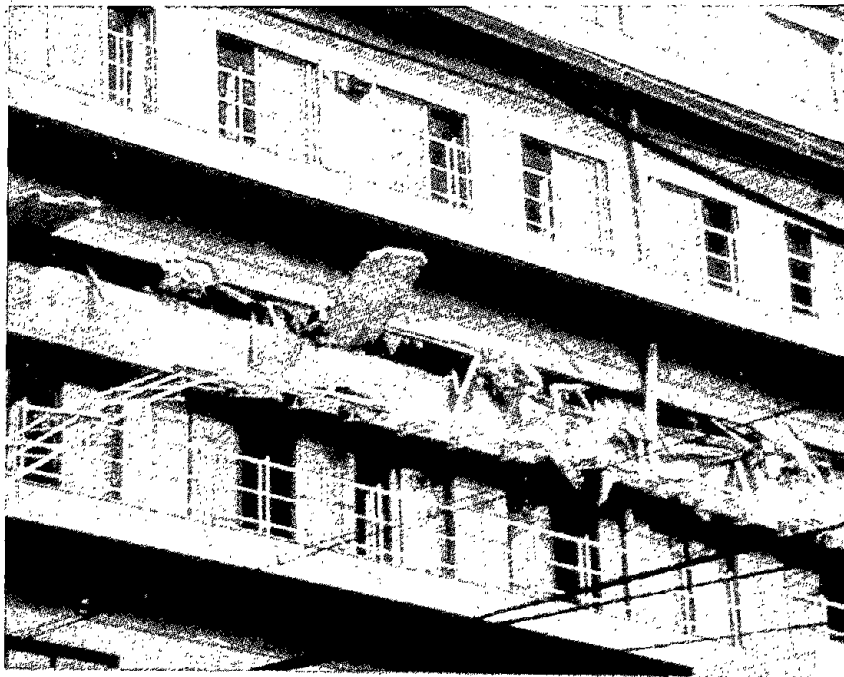
Figure 3.4.26 Collapsed upper story, northwest corner - West Kobe Citizens' Hospital.

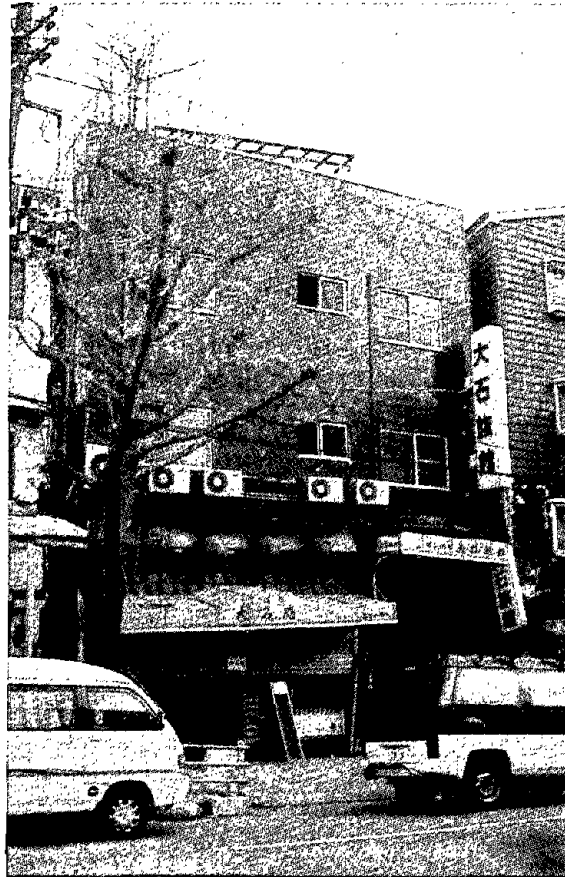
Figure 3.5.6 Three-story brick-faced light gage steel apartment. Has roll up door. Closeups (Fig 3.5.7) show that there is a great deal of rust at the connections at the second floor which connect 8 inch light gage wide flange columns. Rust clearly was at fault in the failure, not the steel frame itself... this is a common type of failure that seems peculiar to this form of light gage steel frame construction... perhaps it is the salt atmosphere of a port city that leads to such extensive corrosion.

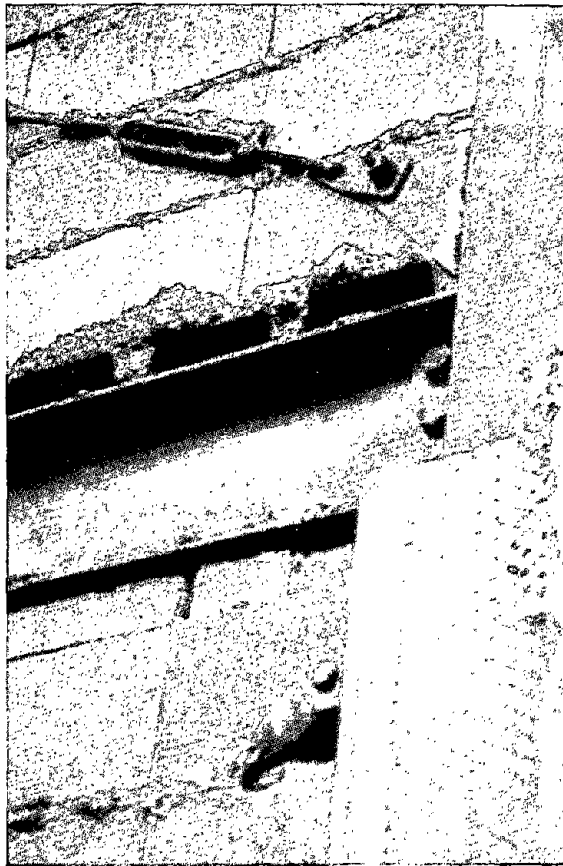
Figure 3.5.9 Many braced frame structures had failures of the diagonal braces at the welded connections. This photo shows a weld fracture between the turnbuckle rod and the gusset plate.

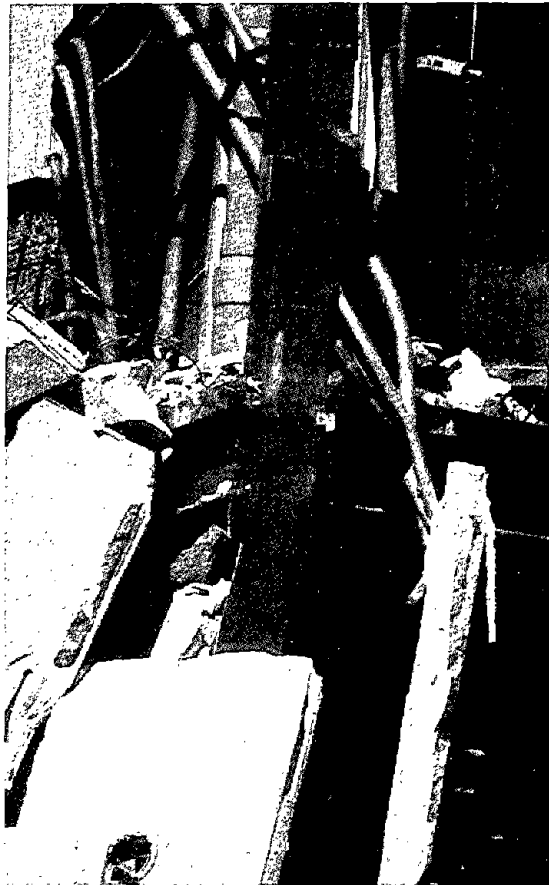
Figure 3.5.18 Closeup photo of the southwest column, second story junction in the Nairo Hiro building showing lateral buckling of the column.

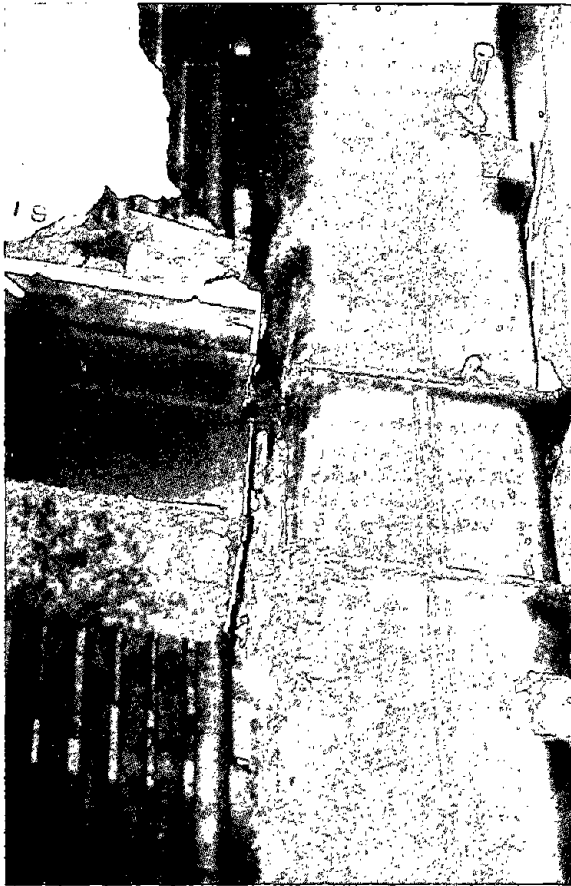
Figures 3.5.19 show details of a beam stub-to-column connection failure on the east face of the same building. Figures 3.5.20 and 3.5.21 show first floor column to second story column joint fillet weld failure.

Figure 3.5.19 Beam Stub-to-Column weld failure on the east face of the Nairo Hiro building.

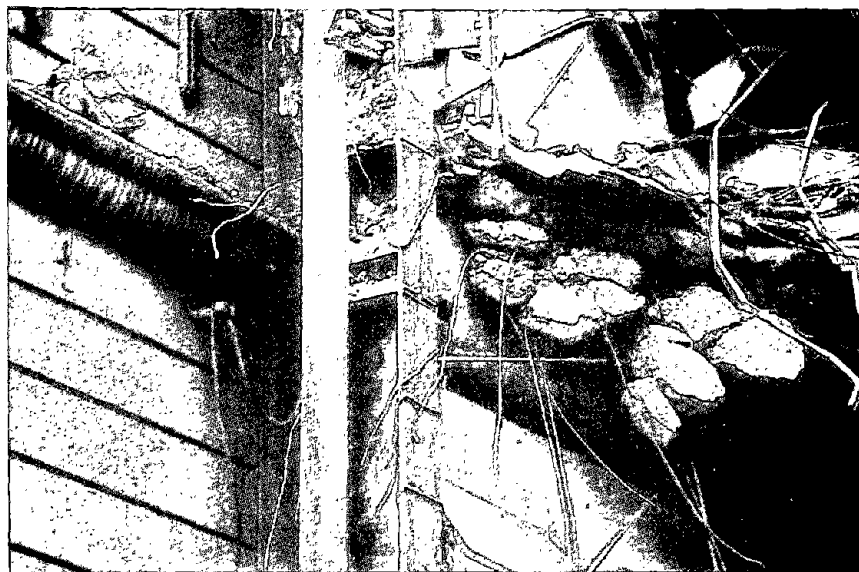
Figure 3.5.23 Close up of welded beam-column connection of Tanigawa building.

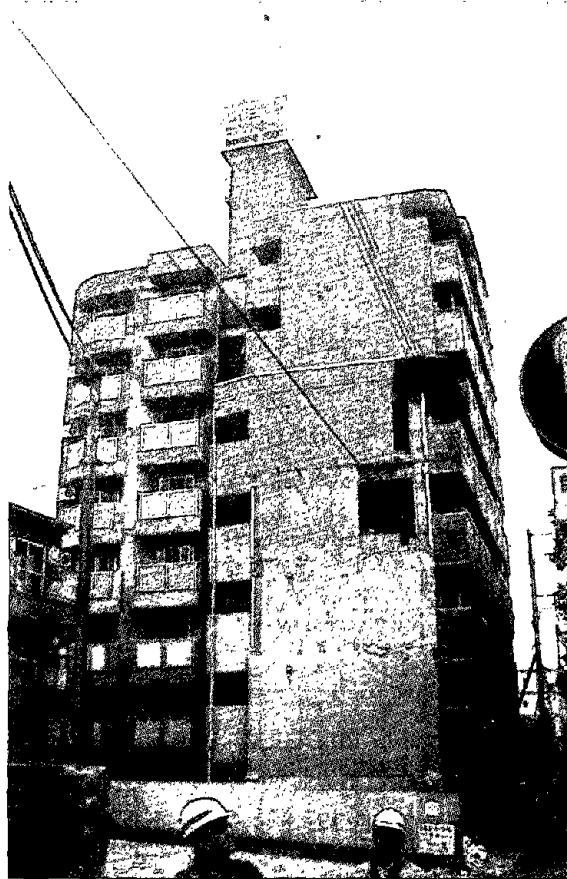
Figure 3.5.24 West face of the Liberty apartment complex in Higashi Nada-ku. This eight-story steel moment frame was typical of the performance of mid-rise steel structures designed according to post-1981 procedures.

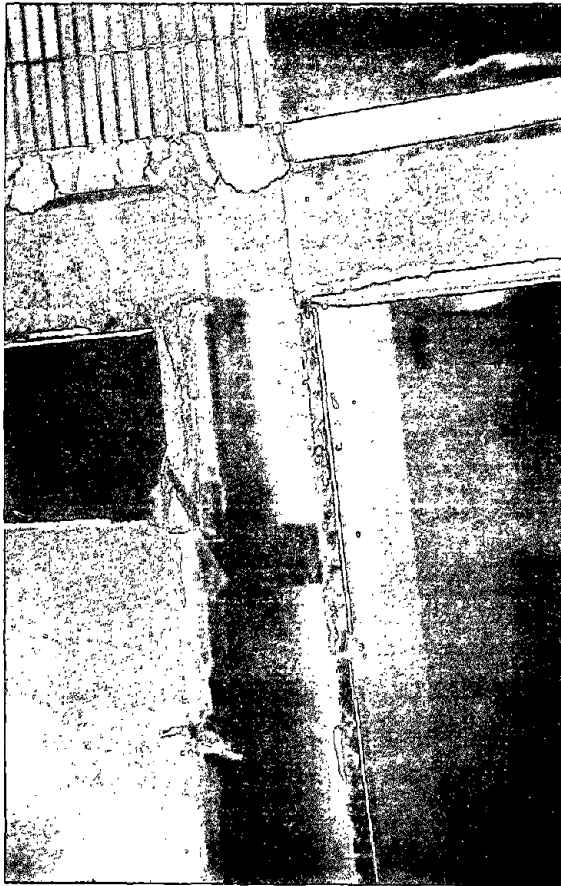
Figure 3.5.25 is a closeup view of west face steel moment frame of the Liberty apartments. The shop welded frame shows no damage but autoclaved lightweight concrete cladding suffered brittle failures along panel edges. Figures 3.5.26 and 3.5.27 show details of the east face of this same building. In this case one beam-column joint showed flaked paint indicative of local yielding.

Figure 3.5.25 Closeup photo of west face steel moment frame of the Liberty apartments. Shop welded frame shows no damage but autoclaved lightweight concrete cladding suffered brittle failures along panel edges.

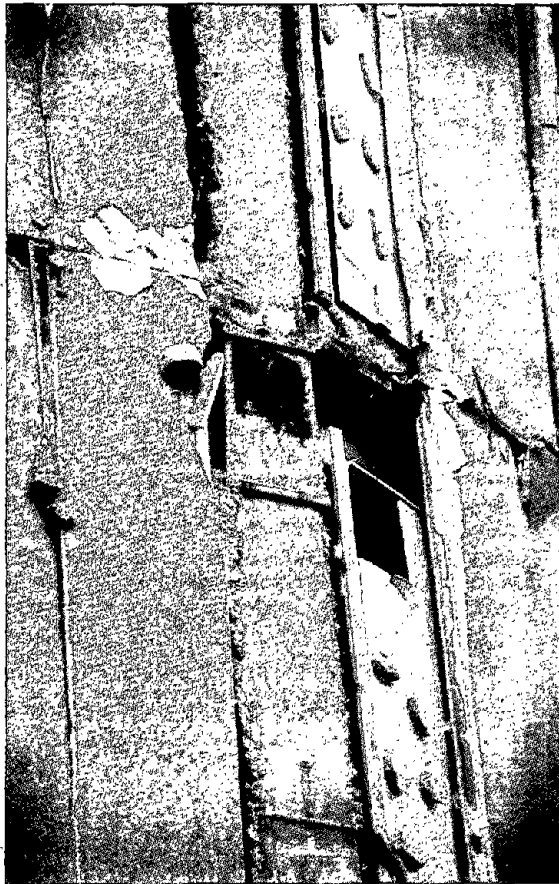
Figure 3.5.27 Closeup photo showing locally yielded third floor column joint in the Liberty apartment complex.

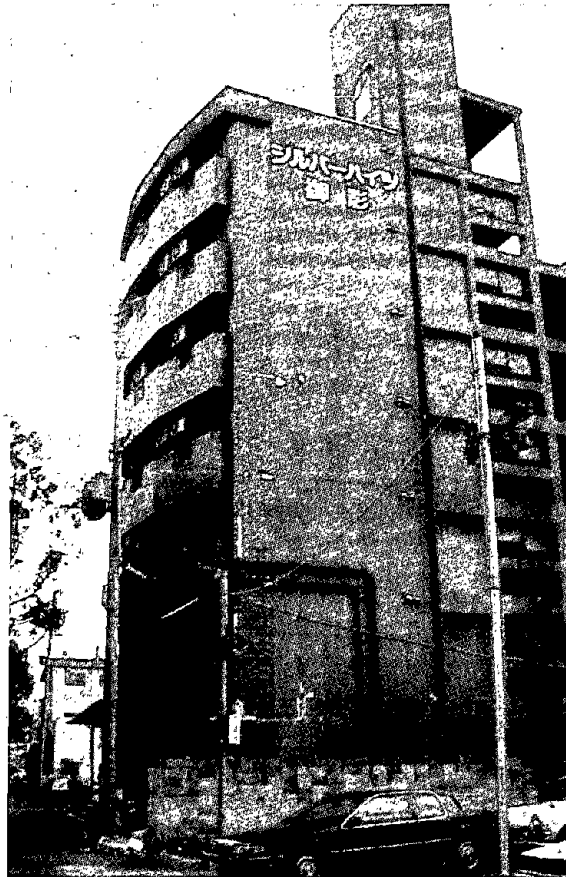
Figure 3.5.28 Seven-story Silver Heights Hotel in Higashi Nada-ku. This was another steel moment frame mid-rise building with cracking in the precast lightweight cladding.

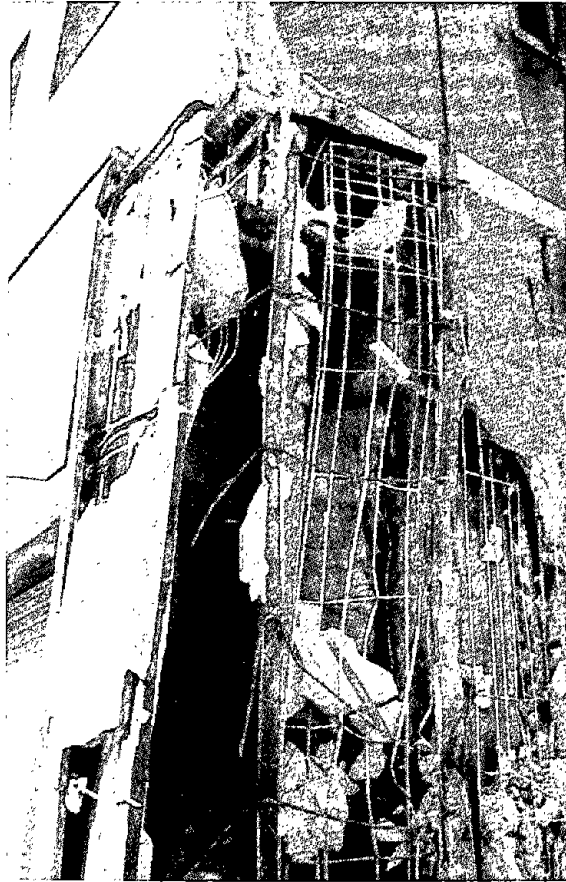
Figure 3.5.32 Closeup photo revealing steel moment frame beneath failed cladding of the Pacific Power Corporation building.

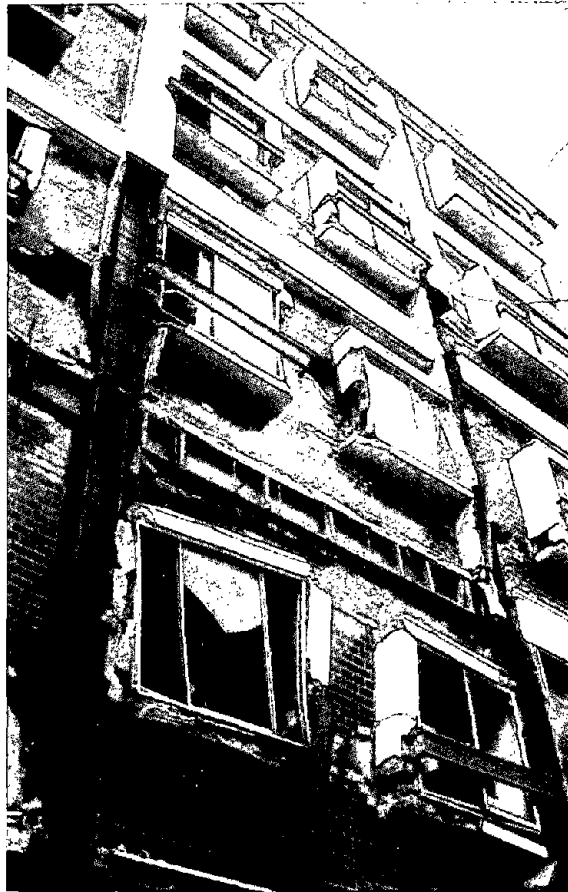
Figure 3.5.33 Older 5-story steel moment frame building showing extensive cladding damage to brittle cladding in Nada-ku near the Mikage metro station.

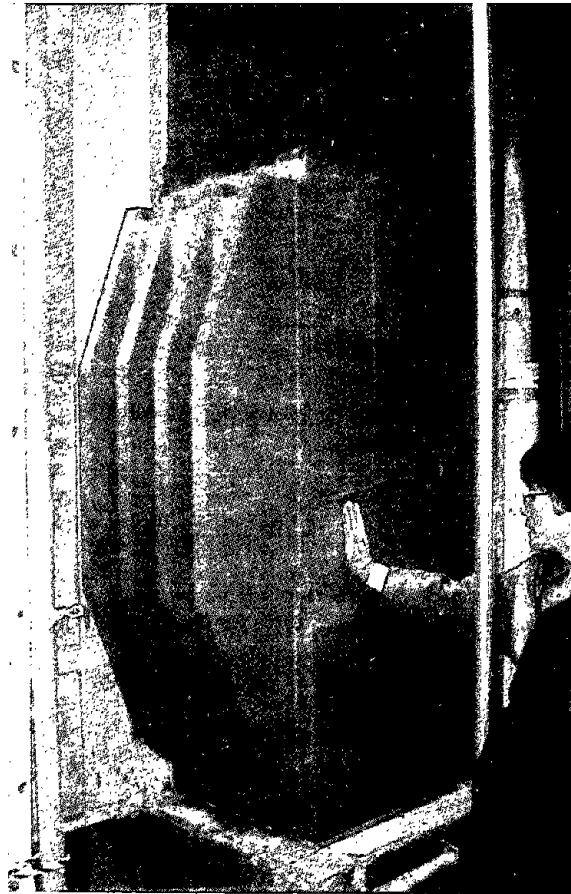
Figure 3.5.43 A column repaired not only with full-penetration weld, but also with stiffeners added.

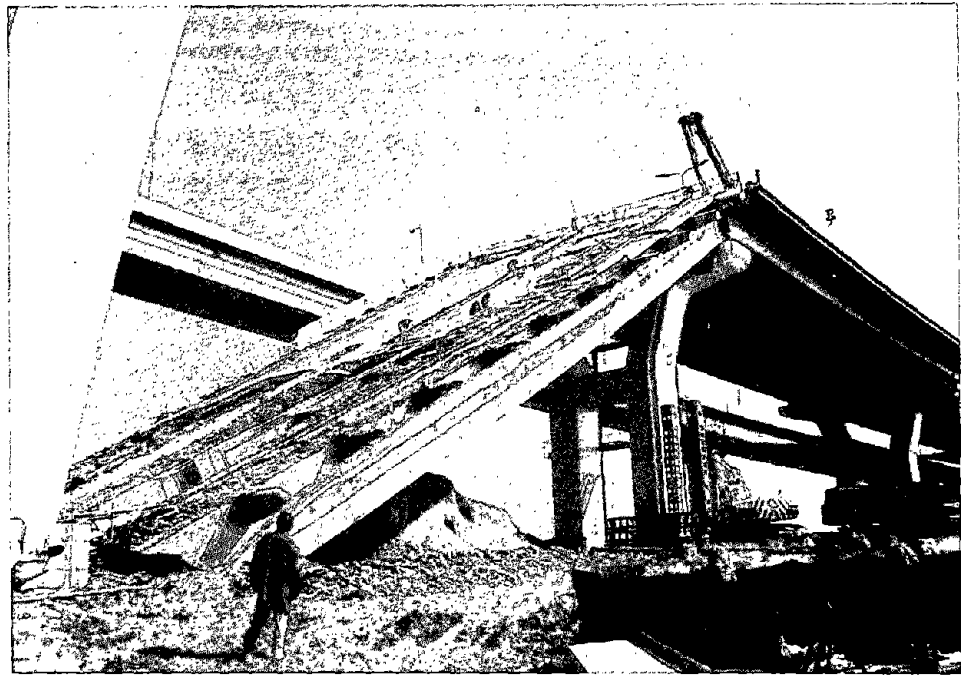
To illustrate in more detail the typical bay side soil conditions near Kobe, a soil boring log from the site of the Nishinomiya Ko bridge, located on the Bay Shore Route to the east of Rokko Island, is shown in Figure 4.1.4. The eastern approach span of this bridge collapsed during the earthquake. A major cause of the collapse was probably

liquefaction of the 10 m to 15 m of granular artificial fill soil at the site. When the fill on both banks of the river channel liquefied each bank moved towards the center of the channel. This lateral movement caused the two end piers of the main span to move towards one another, pushing the approach span off its support.

Figure 4.2.2b Collapsed approach span between Piers 111 and 112, Nishinomiya-ko Bridge.

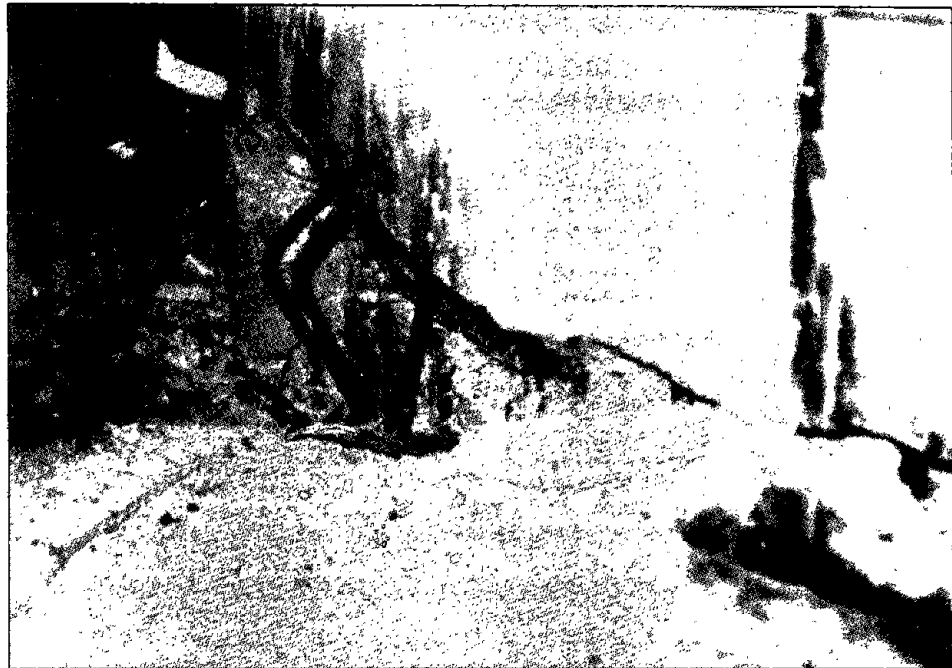
Figure 4.2.12 Failure at top of buried column, Pier P1, Mukogawa Bridge.

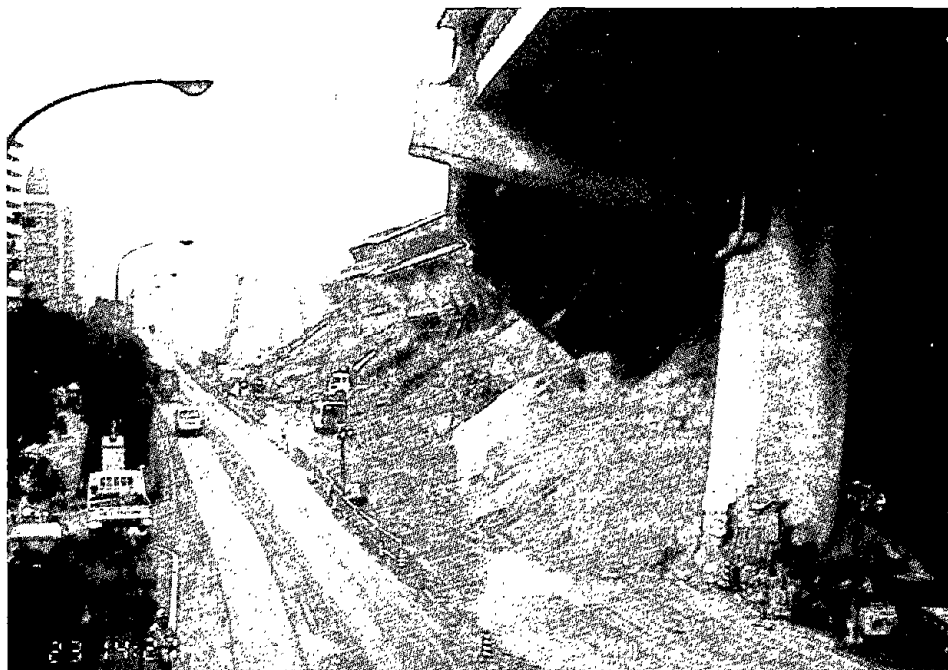
Figure 4.2.14 View of the collapsed Higashi-Nada Viaduct looking west from Pier 125.

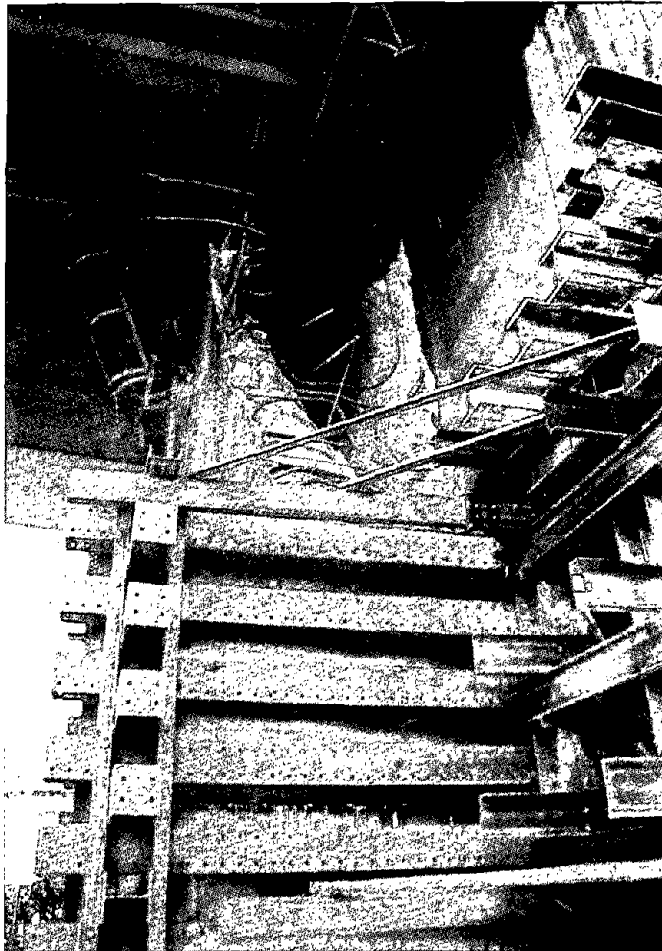
Figure 4.2.19

Shear failure in Pier 240 of Hanshin Expressway showing temporary repair to column to prevent total collapse.

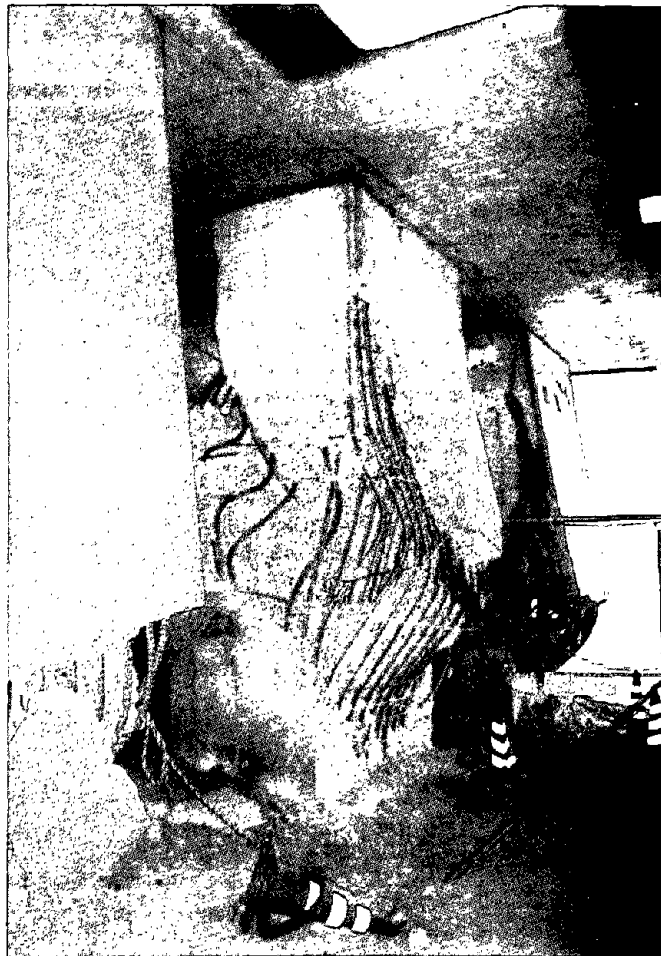
Figure 4.2.22 Shear failures in 3-column bent at Pier 3, Takarazuka Viaduct.

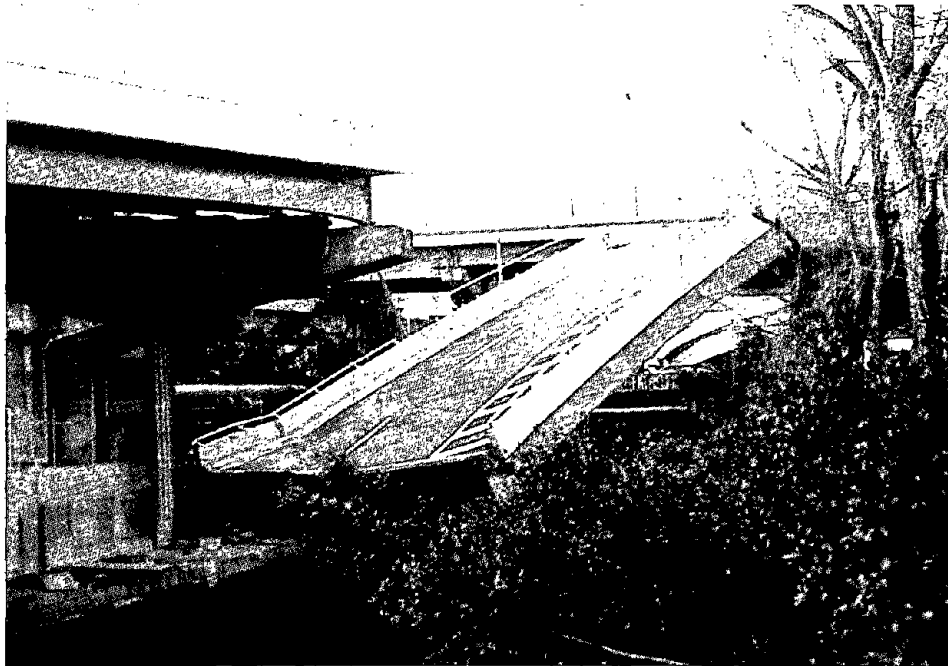
Figure 4.2.27 Collapse of Southeast Ramp at the Minatogawa Interchange.

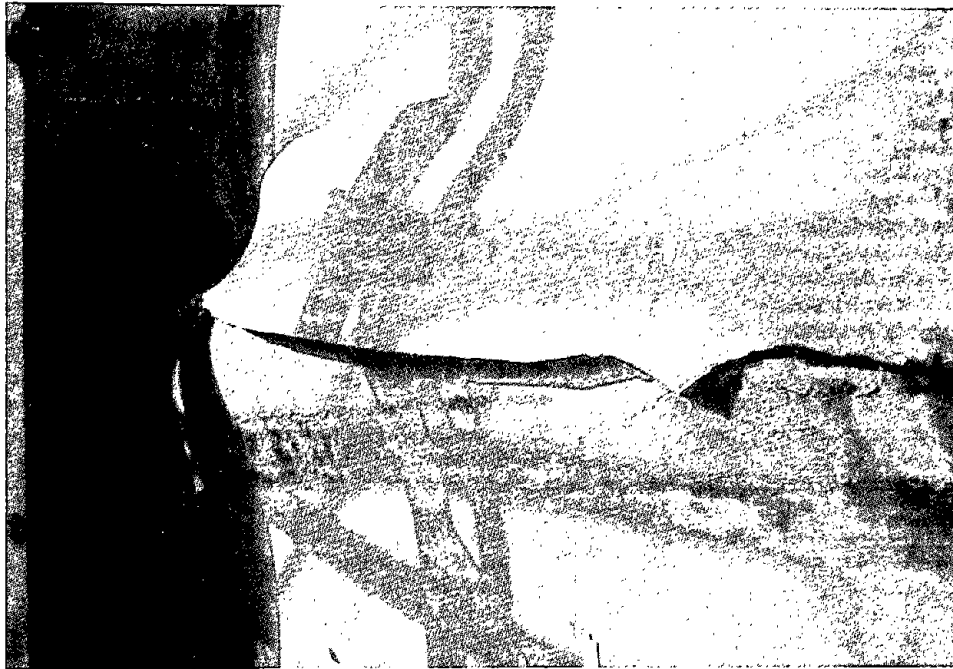
Figure 4.2.37 Fracture at mid-height of Pier 584 of westbound Route 3.

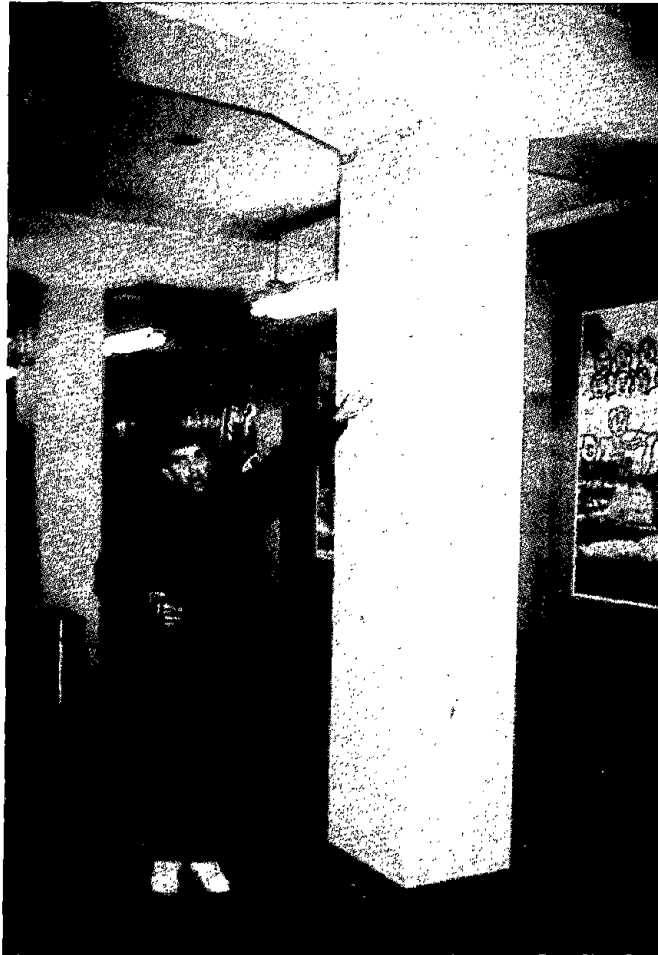
underground shopping mall adjacent to the KRTR near Shin Kaichi Station. Figures 4.3.14 and 4.3.15 show typical damage within the shopping mall. There was severe damage of the elevated rail structure near Sannomiya Station.

Figure 4.3.14 Cracked reinforced concrete column at underground shopping mall near Shin Kaichi Station.

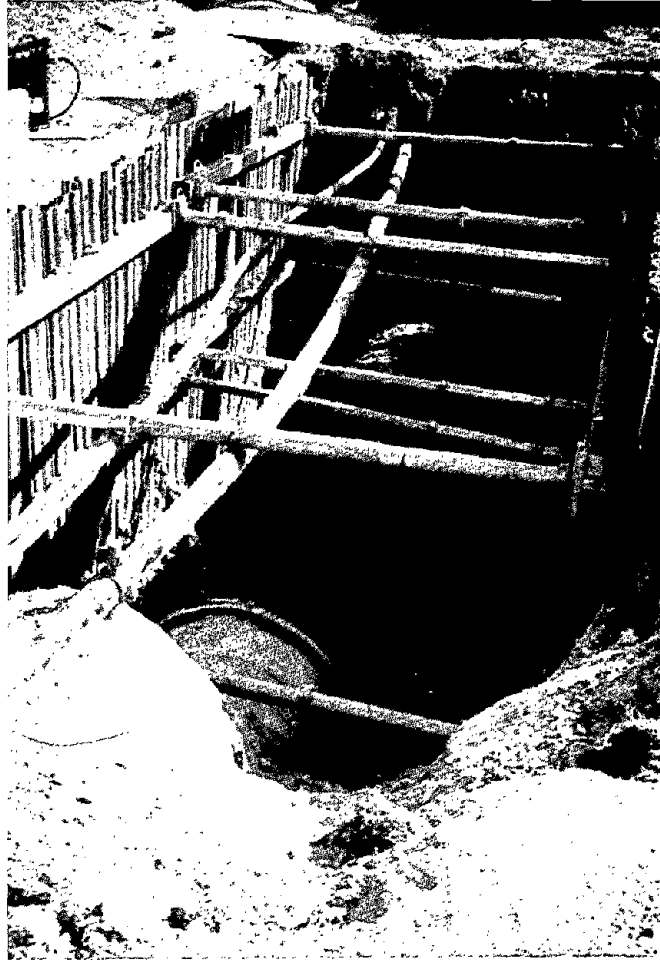
Photo 10 Repair of one of the three 1.2 m treated water lines leaving the Uegahara/Hanshin Plants site.

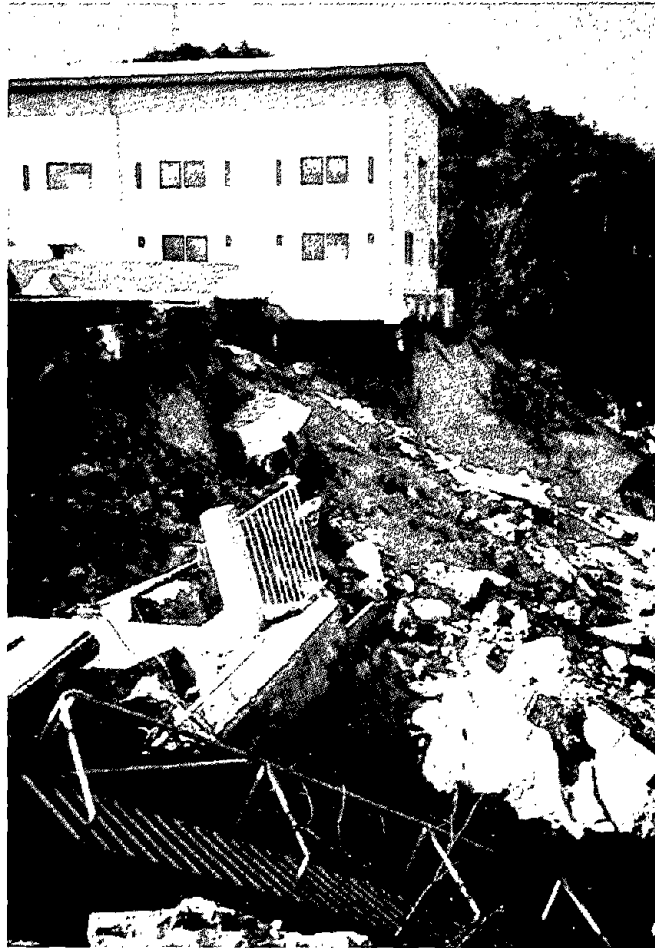
Photo 12 Landslide undermined solids handling building at the Hanshin (Kabutoyama) Plant.

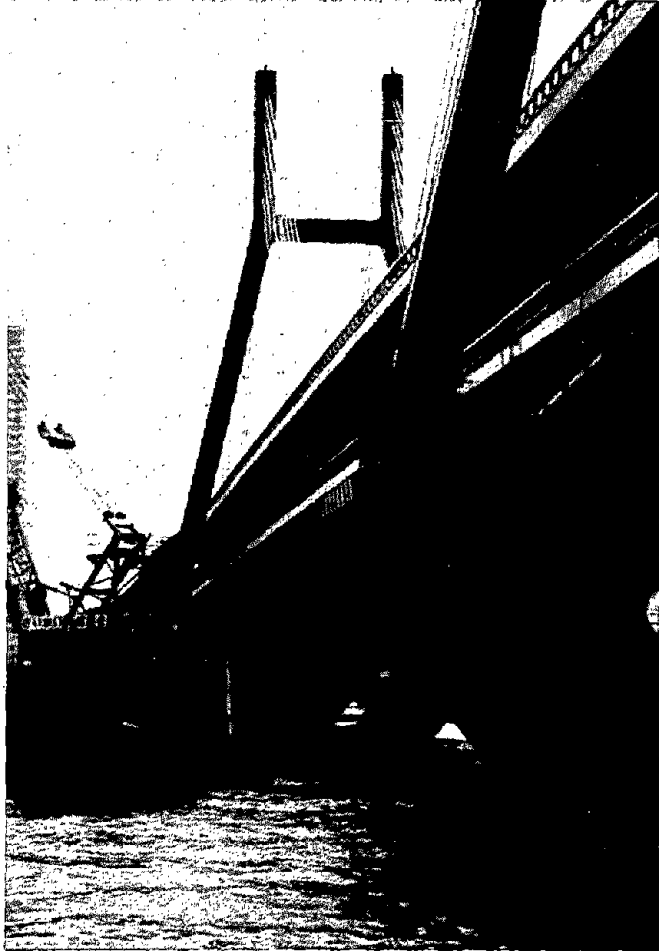
Photo 15 Pipe hanging from bridge to Rokko Island (just to the right of crane cab).

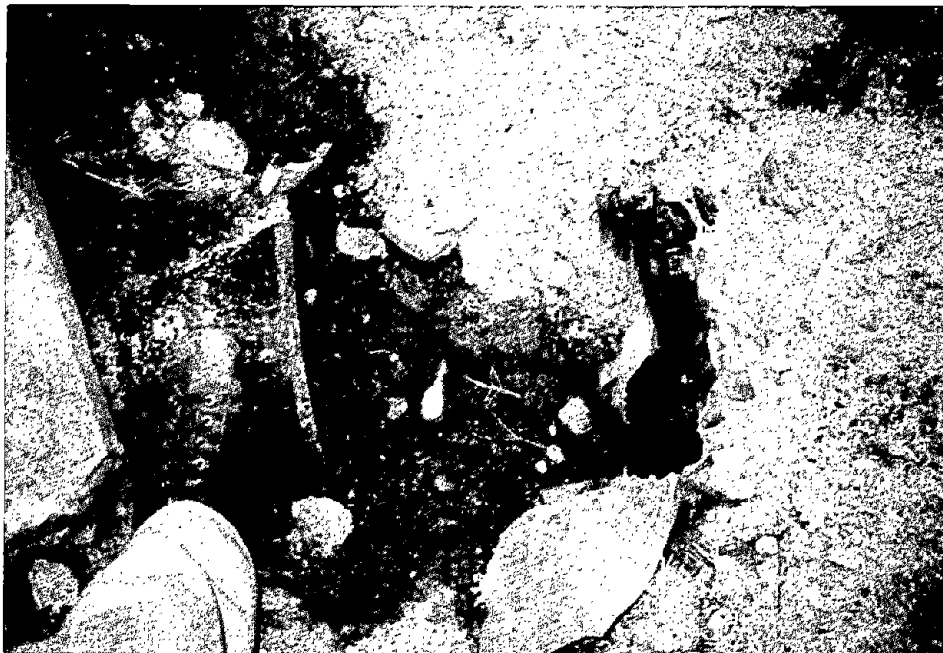
Photo 18 Shows a 300 mm diameter pipe joint in the bottom of the crack (Photo 17), where the bell (to the right) was separated from the spigot (under foot).

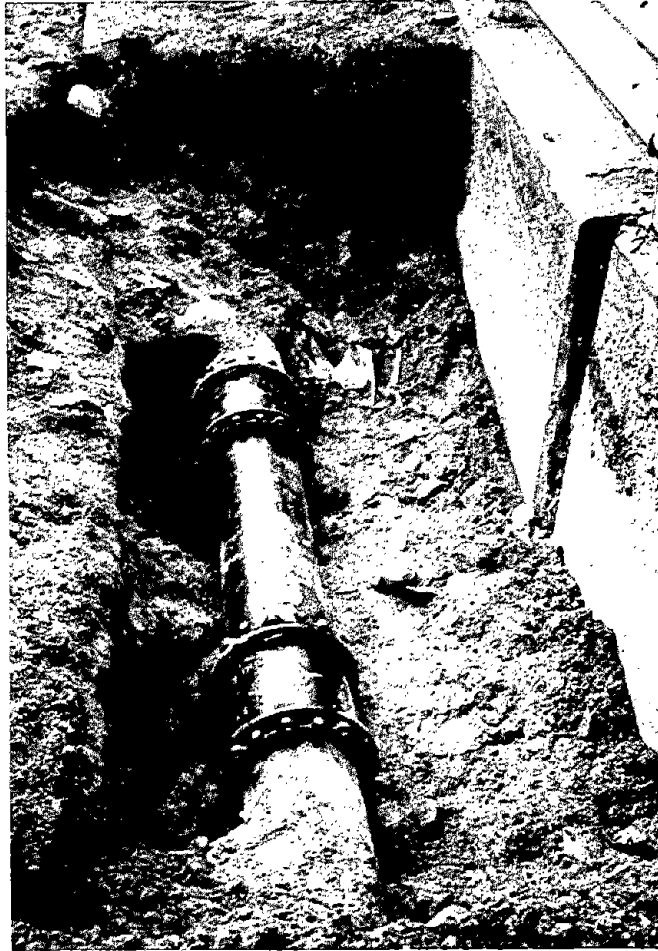
Photo 19 Pipe repair on approach to bridge to island where the wastewater plant was located. Settlement and slight lateral movement (see concrete wall on right) likely caused the pipe failure.

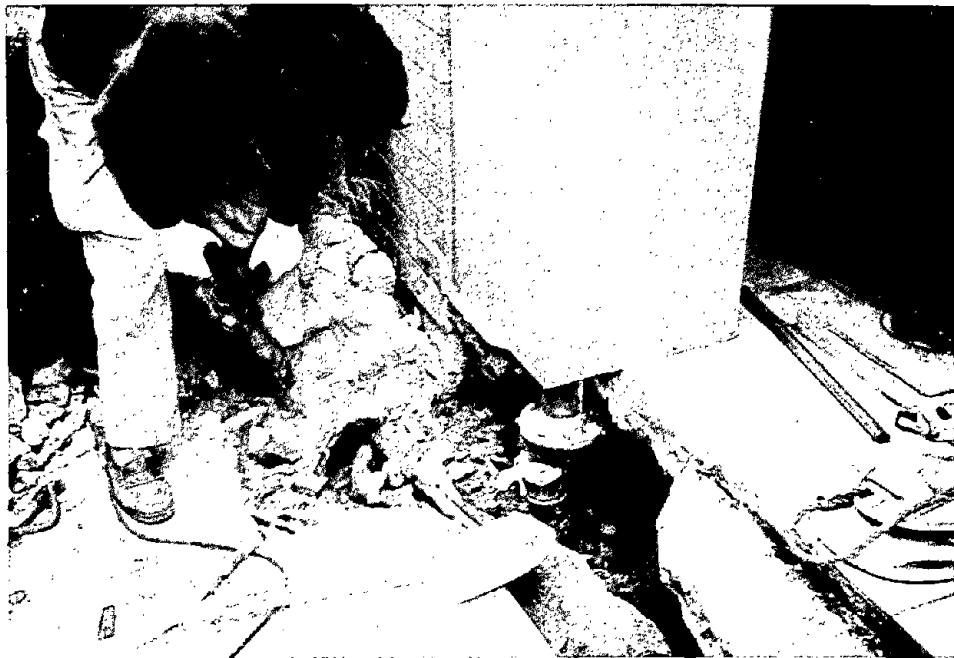
Photo 22 Repair of utility connections in mid-Rokko Island.

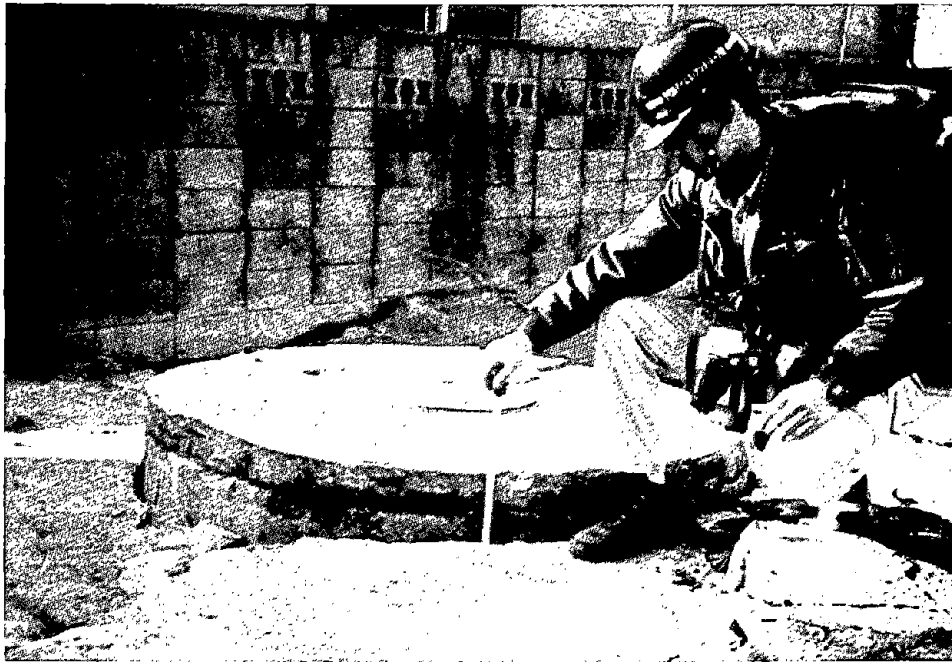
Photo 25 Manhole floated as a result of liquefaction near the wastewater treatment plant.

Photo 26 Same as Photo 25.

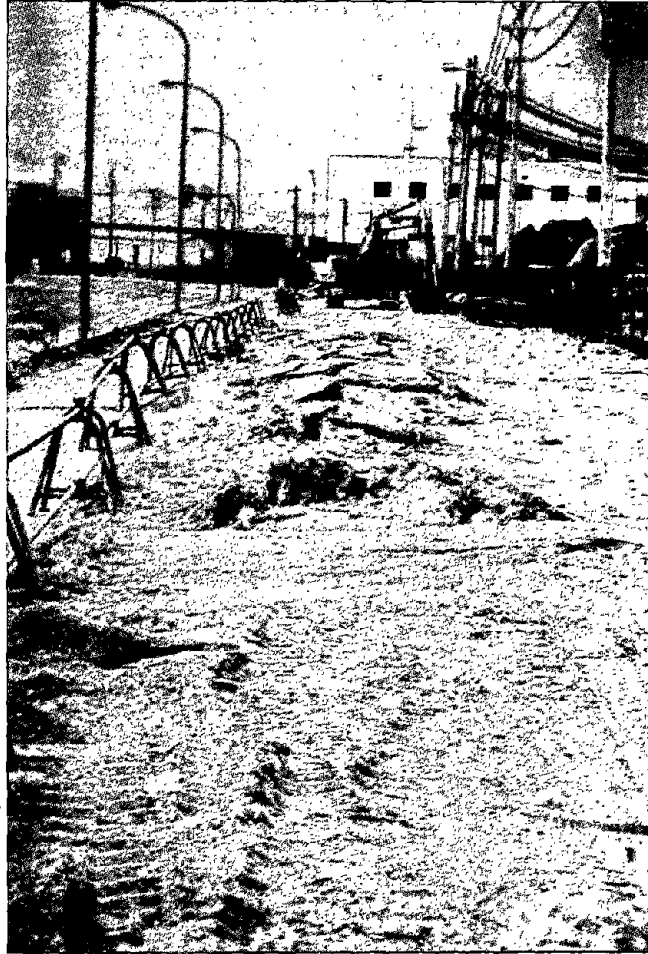
Photo 27 A 500 mm diameter sewer floated upward on Port Island, resulting in the upheaval of ground.
