NIST Special Publication 901

The January 17, 1995 Hyogoken-Nanbu (Kobe) Earthquake

*Performance of Structures, Lifelines, and Fire
Protection Systems*

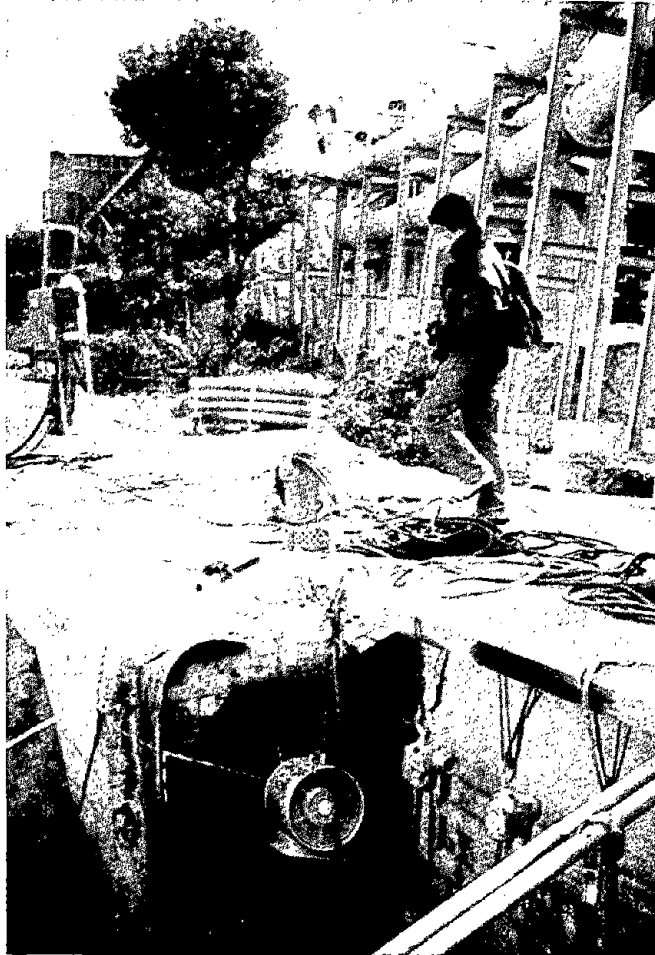
Lateral deformation caused severe damage to underground structures and facilities founded on spread footings. The effluent channel separated in 4 places (Photo 31). The pipe rack distorted from foundation settlement (Photo 32).

Photo 31 Effluent channel, approximately 2 m², offset nearly one meter from lateral spreading.

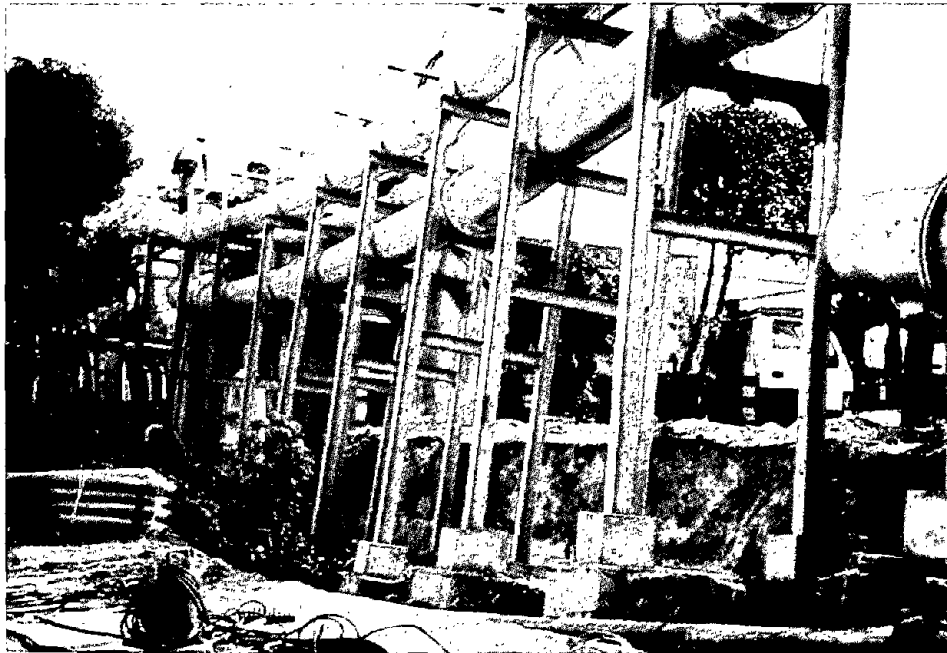
Photo 32 Pipe rack foundations adjacent to channel settled approximately one meter, distorting piping.

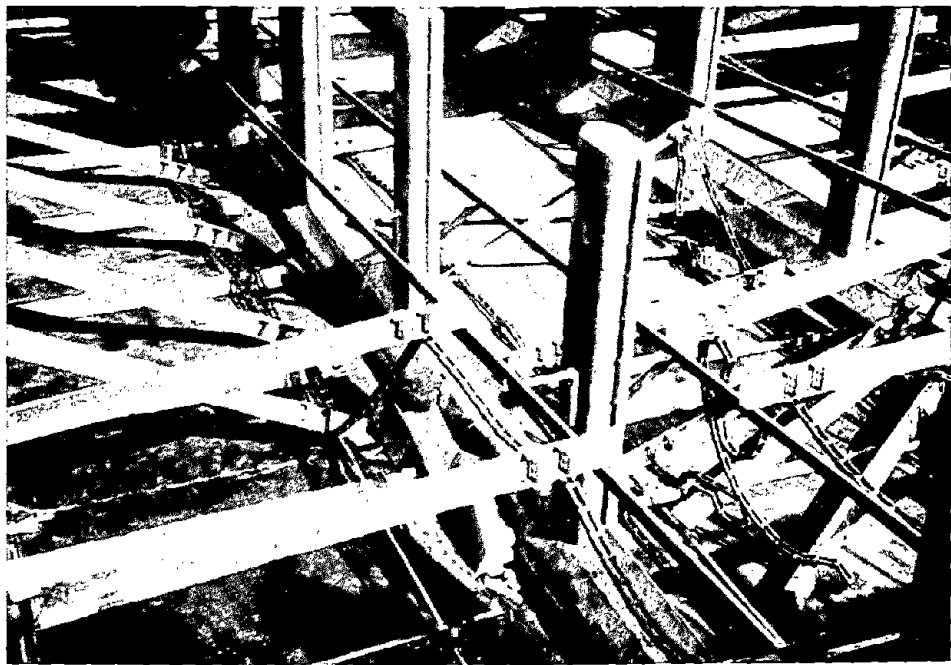
Photo 35 Sludge scraper chain came off sprockets in sedimentation tanks.

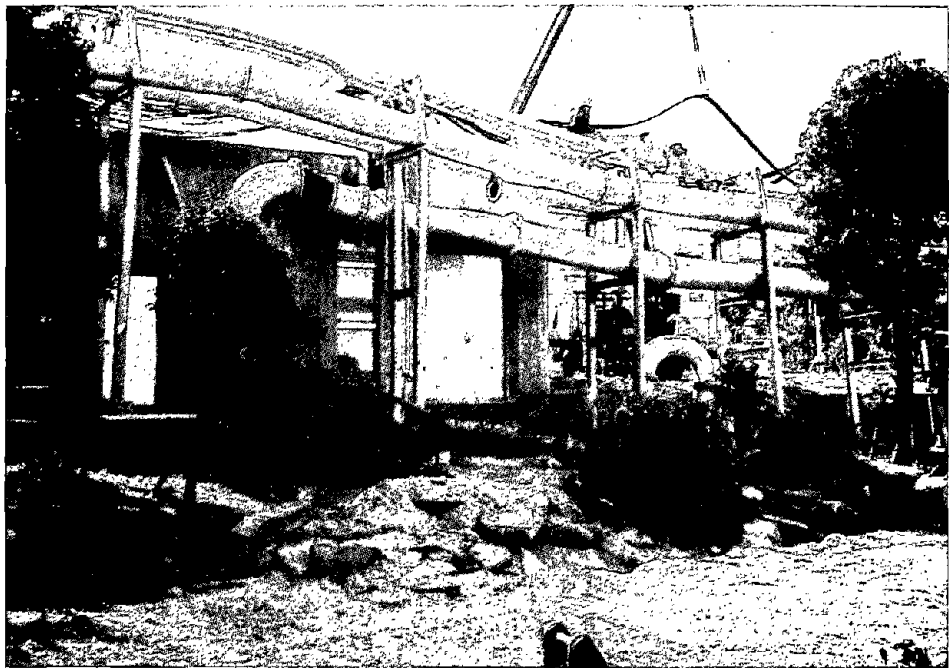
Differential settlement and lateral spreading of approximately 600 mm occurred at the filter building, as shown in Photos 38 and 39 resulting in some pile damage. The control building and the sludge thickener room moved north 60 cm (Photos 40, 41). The

Photo 38 Filter building support pipes failed allowing the building to move and settle differentially.

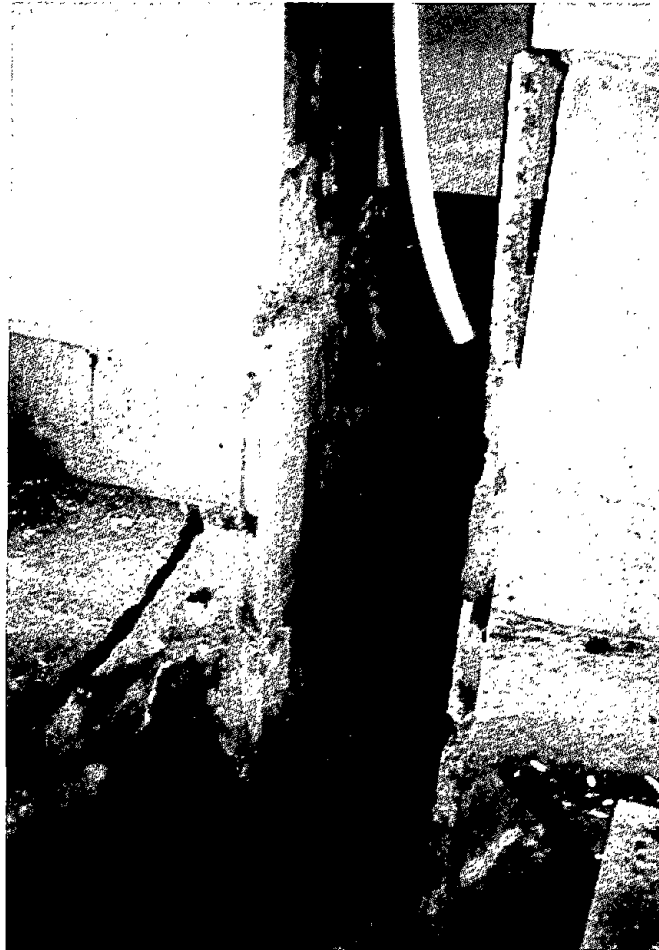
Photo 41 Shows the gap between the two buildings in Photo 40.

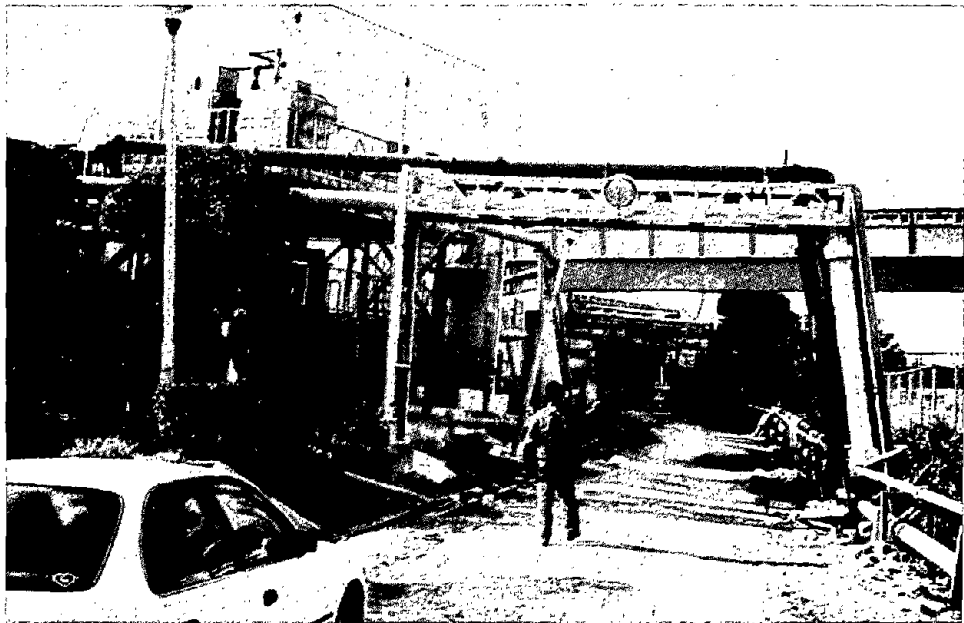
Photo 42 Piping distorted as a result of the movement.

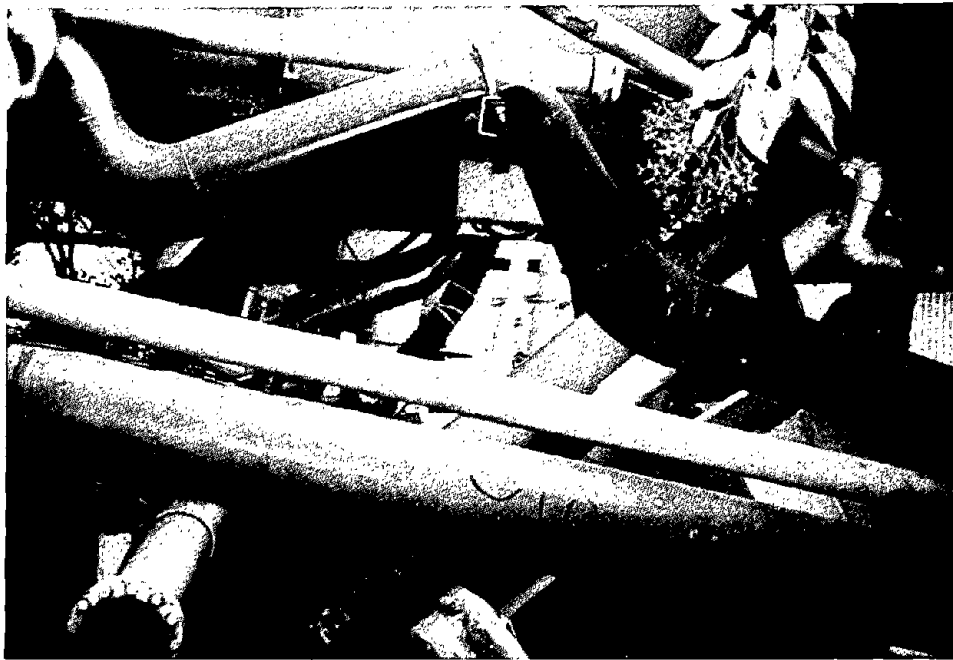
Photo 46 Welded steel pipe, approximately 200 mm in diameter folded when the foot/pipe bridge support was distorted from lateral spread.

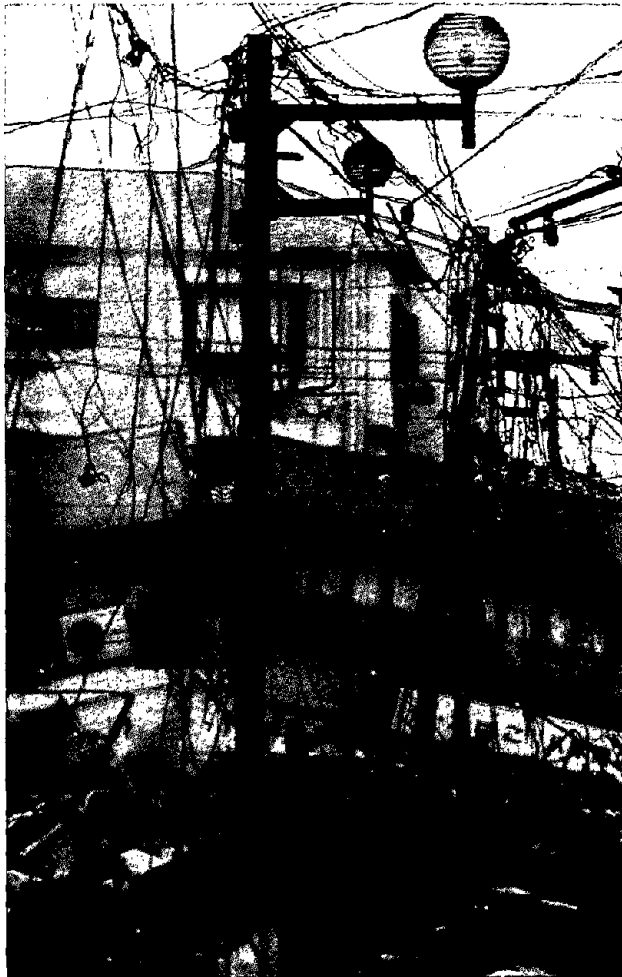
Figure 5.4.18

Damage to the distribution system was massive, but a traffic light in the background is the result of special restoration of the traffic control system.

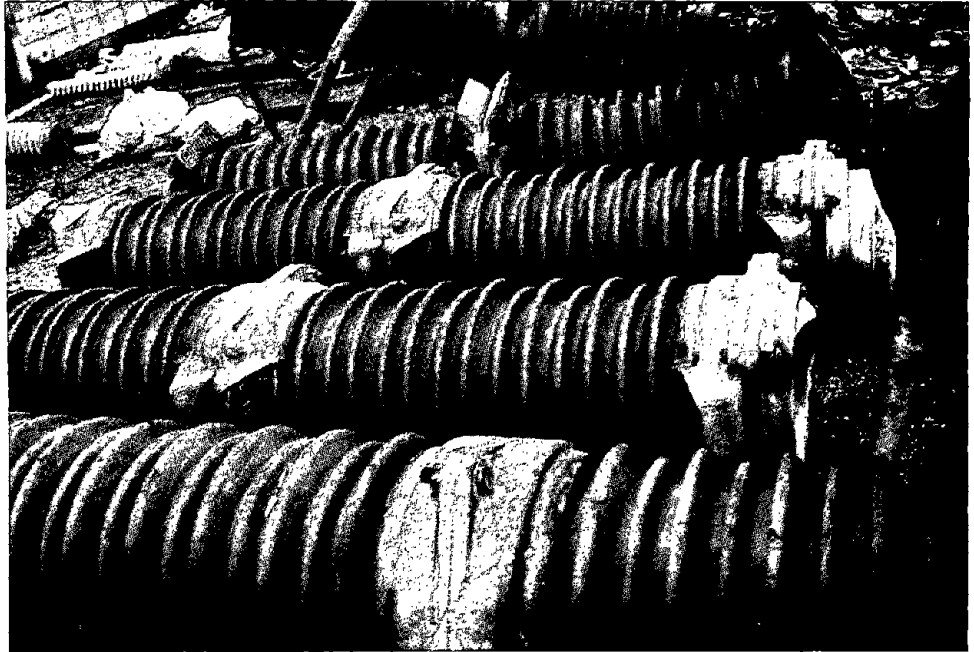
Figure 5.4.31 Damaged 275 kV lightning arrester in the grave yard.

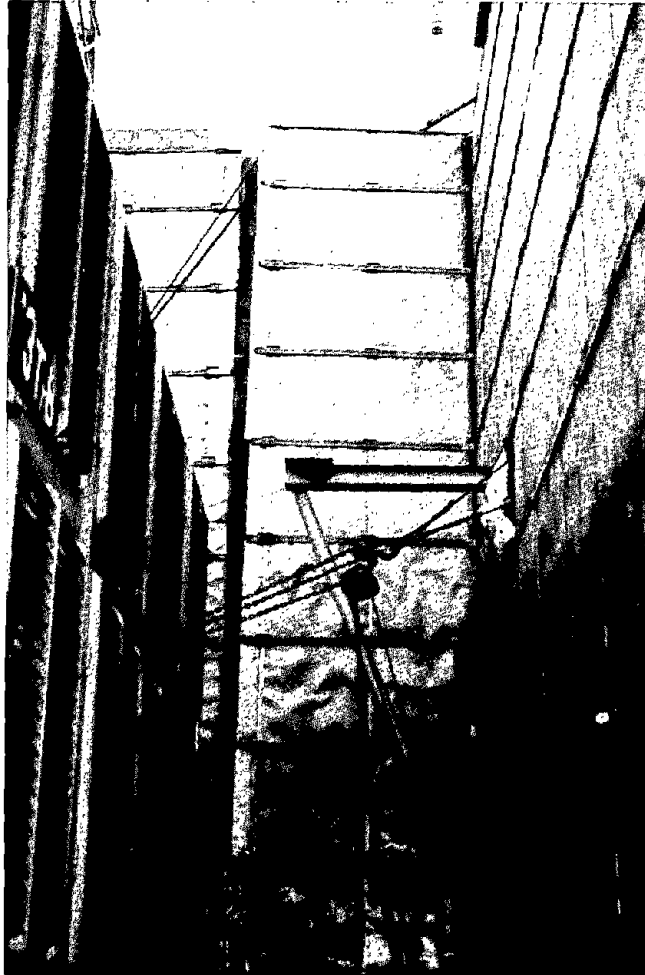
Figure 5.4.37

Transformer acoustical enclosure support was damaged and the enclosure shifted.

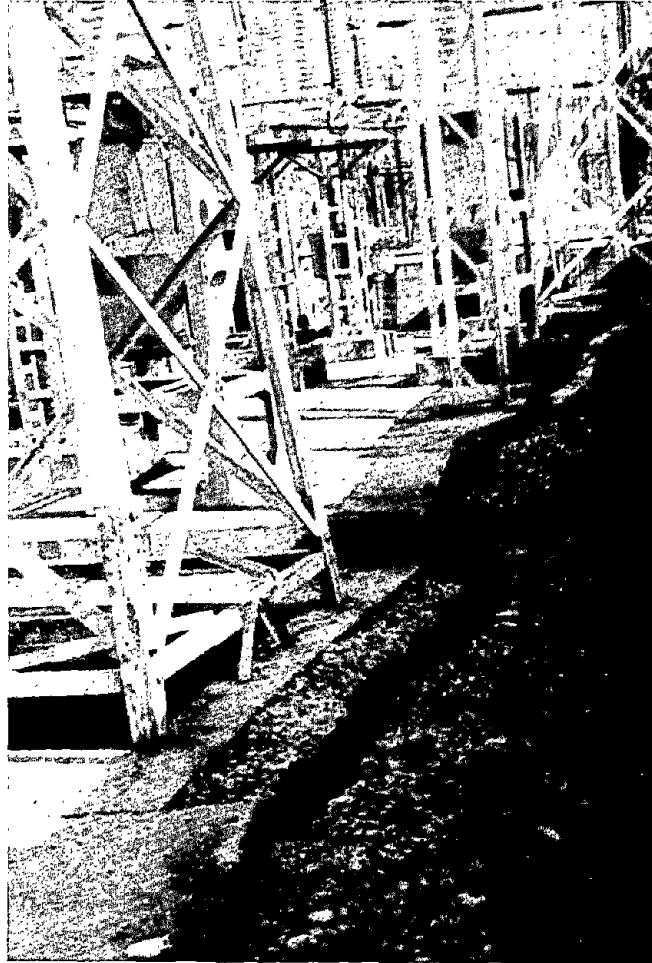
Figure 5.4.43

A long crack in the ground surface opened about 25 cm and damaged cable trenches.

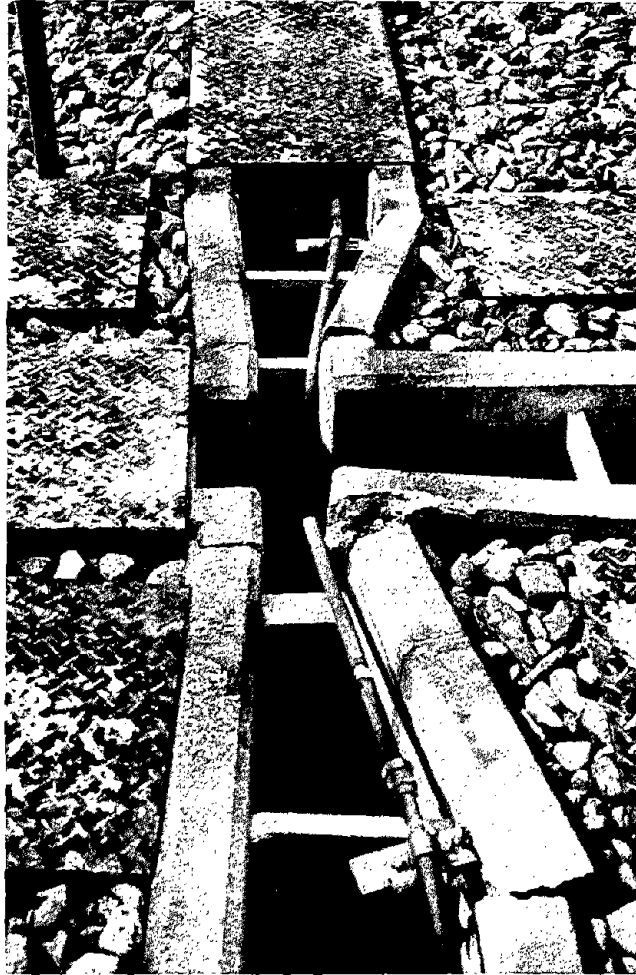
Figure 5.4.44 Cable trenches were deformed with the ground fracturing an air line be leaving control cables undamaged.

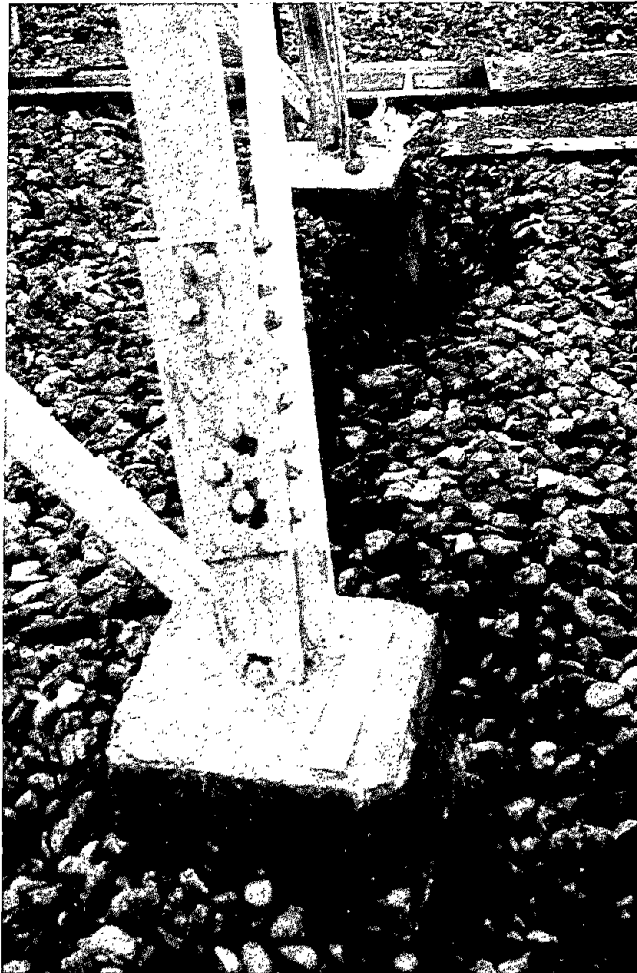
Figure 5.4.46

Foundations of conductor support structures were disturbed and individual footings rotated as much as 25 degrees.

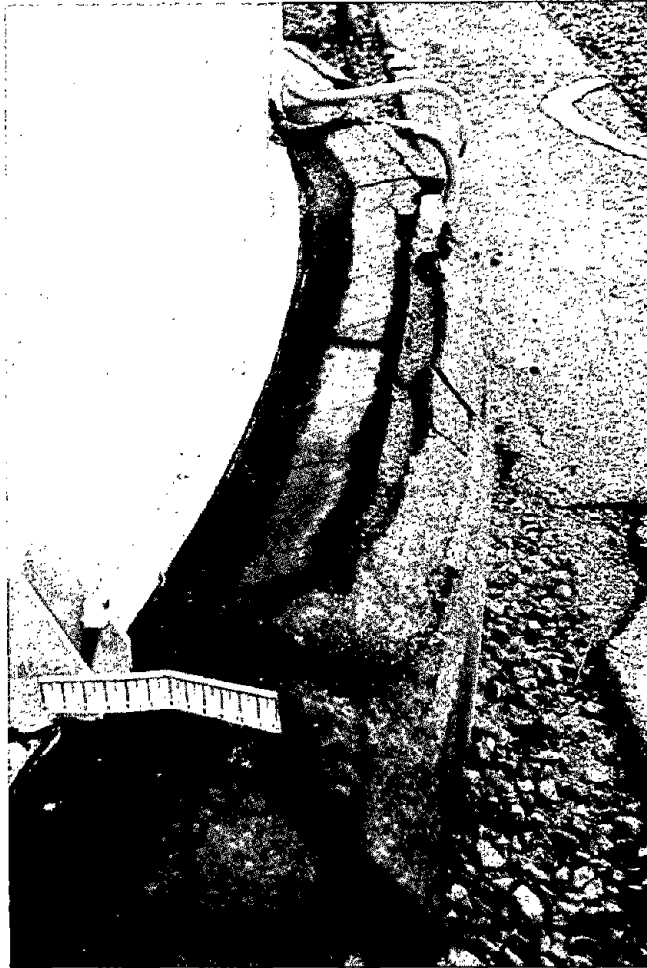
Figure 5.4.49

The asphalt surface between the tank and the concrete ring was broken and the bolts stretched or were pulled out due to rocking of the tank.

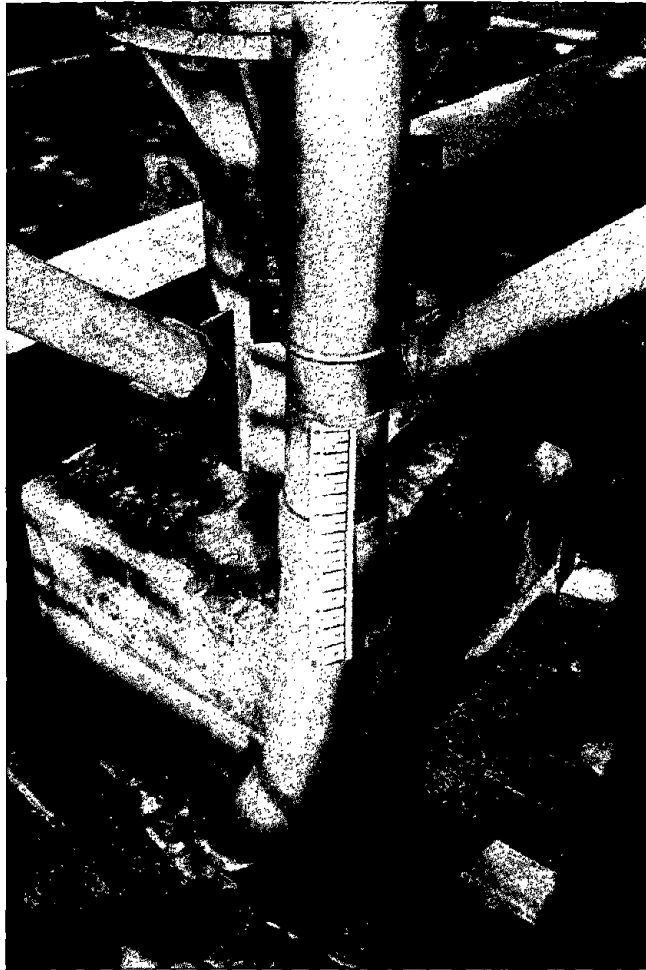
Figure 5.4.52

Conduit attached to the tower and buried in the ground was displaced about 8 cm and has the potential of damaging internal signal cables if they are not provided with adequate slack.

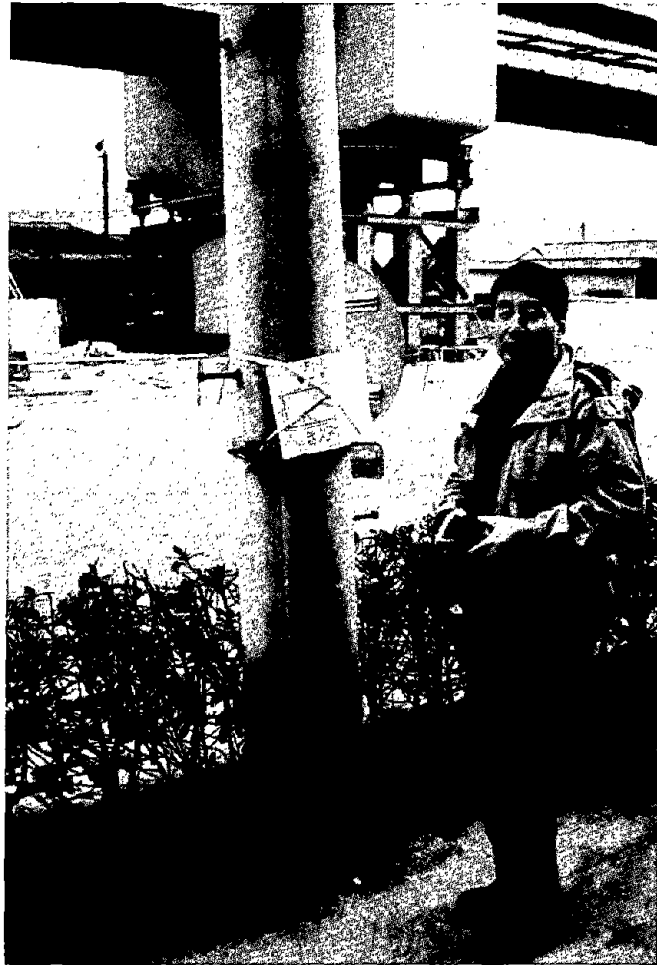
Figure 5.4.72

The conduit and the foundation pad under this transformer pad was disrupted in down town Kobe due to soil liquefaction.

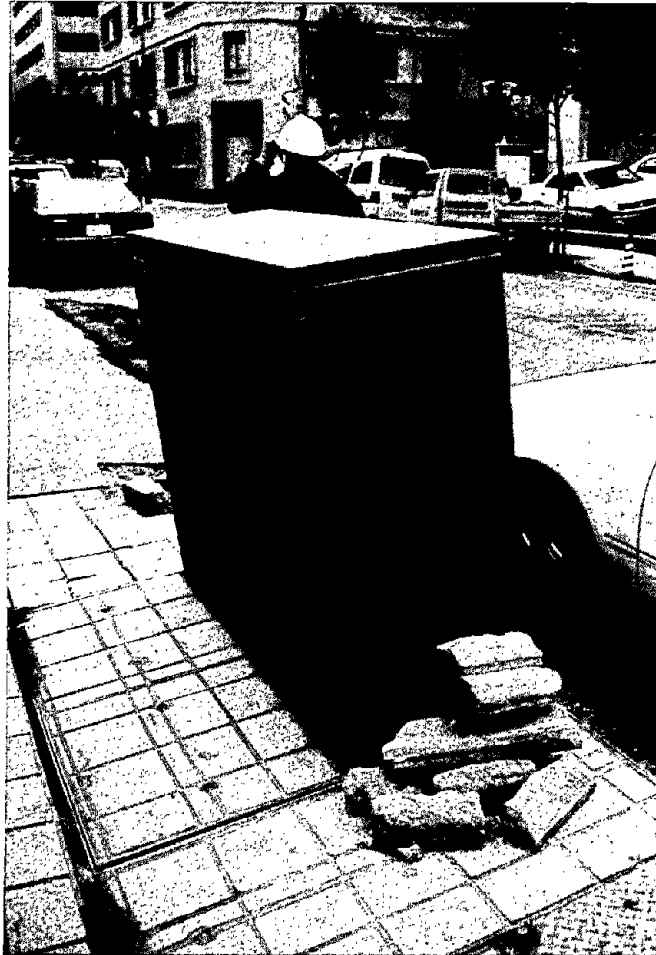
Figure 5.4.73

A primary distribution line of 6.6 kV was temporarily installed to restore power to a building.

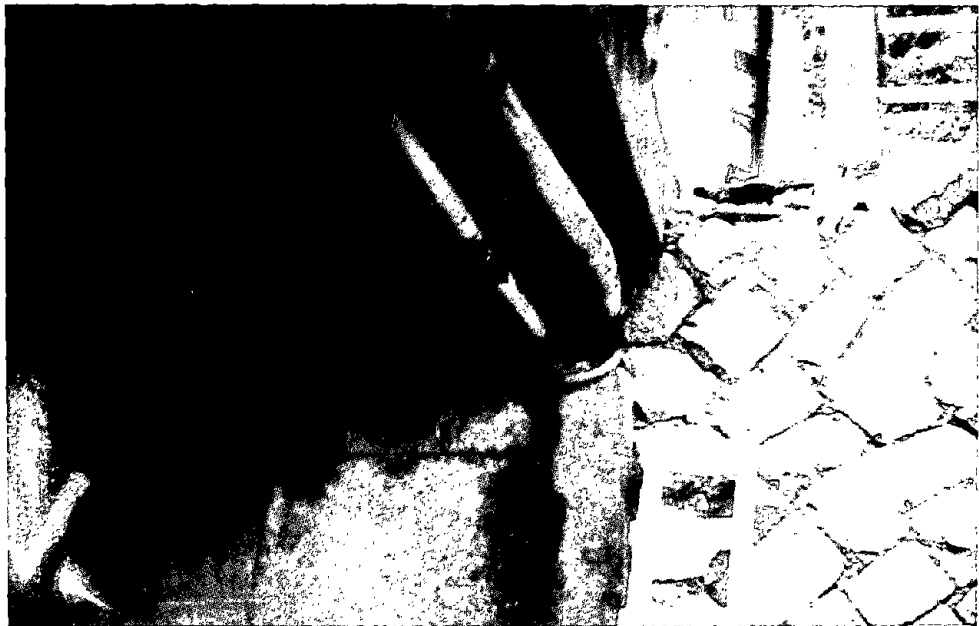
Figure 5.5.10 Large differential settlements in roadways can damage conduit and trunk lines.

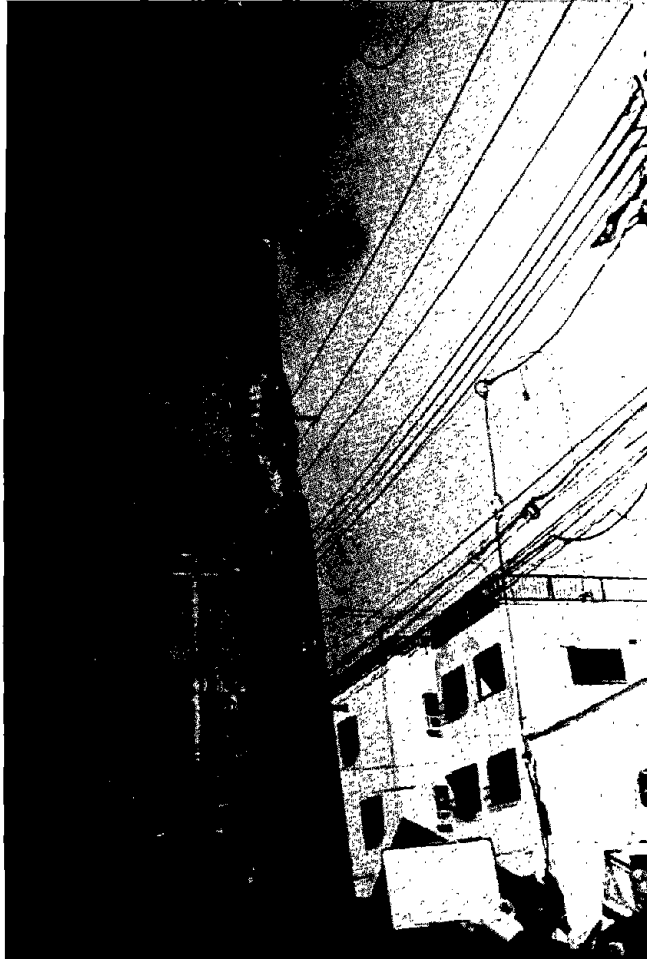
The extensive damage to concrete poles used to carry aerial lines is discussed in Section 5.4.2. In addition to the failure of poles due to liquefaction, inertial loads, interaction with fallen houses and other poles, some lines were damaged due to fire (Figure 5.5.14).

Figure 5.5.14 Fire damaged aerial lines and cables along the pole.

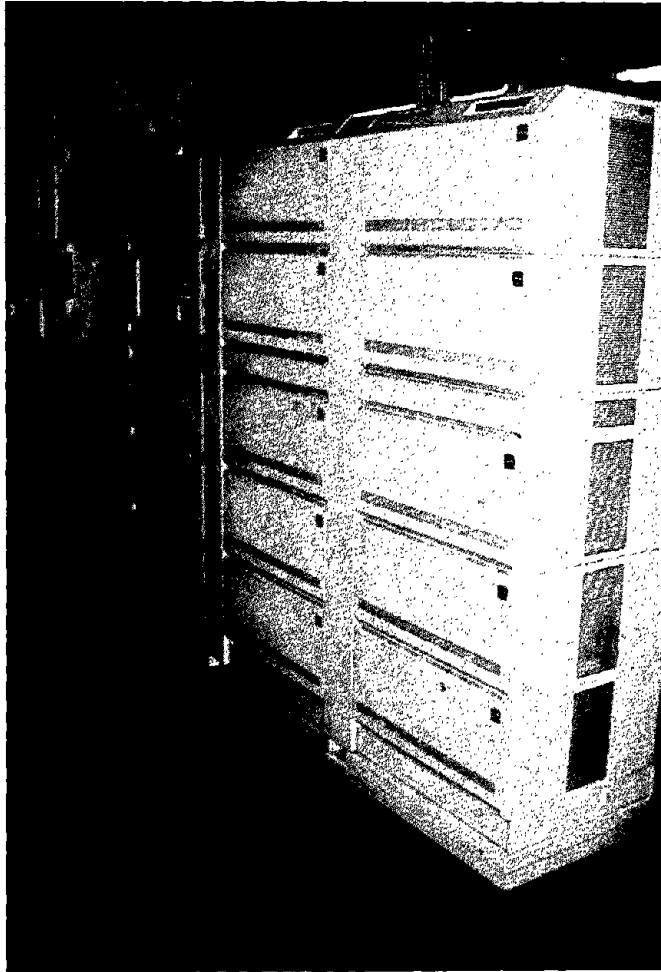
Figure 5.6.9

Main distribution frame for the hospital communication system.

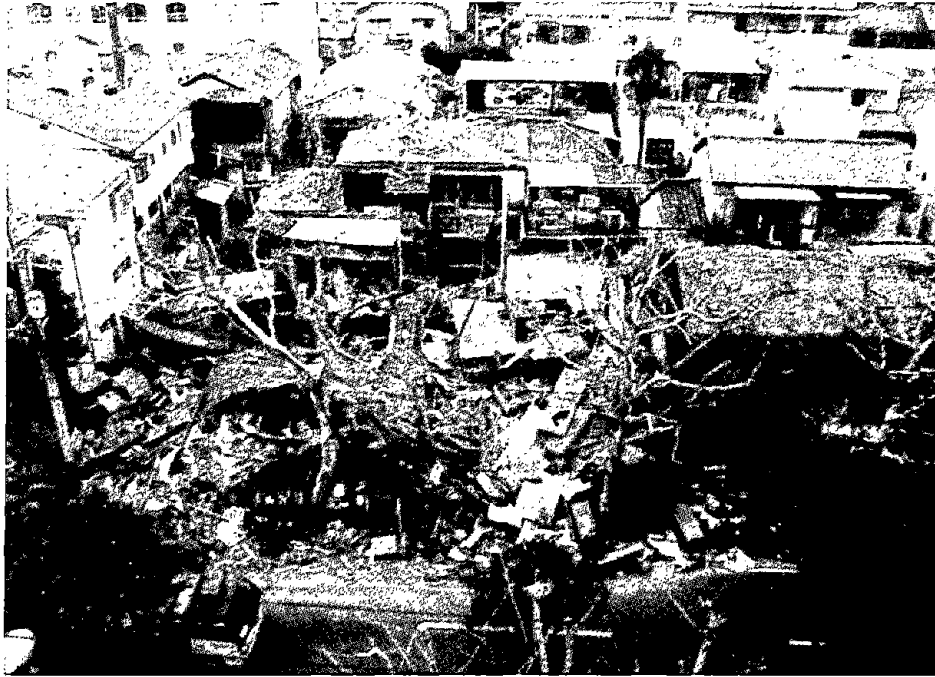
For fire to spread by flame impingement, the flames must be in contact with unburned fuel, i.e., the fire can only spread along a continuous fuel chain. In the earthquake damaged areas continuous fuel chains were prevalent. Rubblized structures are a good

Figure 6.2.9 Collapsed houses. Notice that the pile of debris is in contact with the adjacent houses, forming a continuous fuel chain.
