Specialist Ecological Report:

Construction of a 132 kV power line from the proposed Tshatane switching substation to the existing Lesideng substation within Fetakgomo, Greater Tubatse and Makhudutamaga Local Municipalities of Sekhukhune District.

Dr Wynand Vlok (BioAssets)

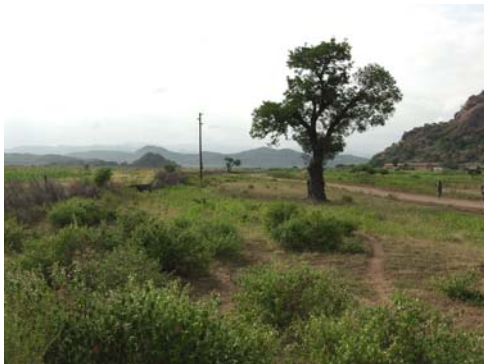
Figure 71: Erosion associated with the roads and culverts.

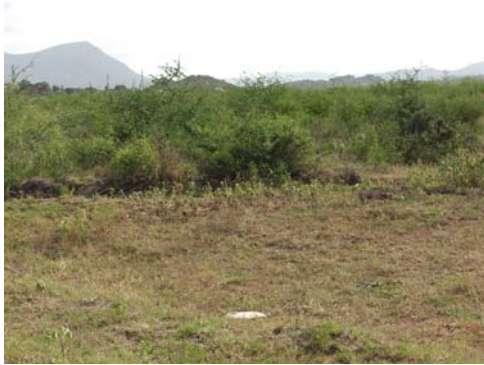
Figure 72: Overgrazing and encroachment modified the natural vegetation.

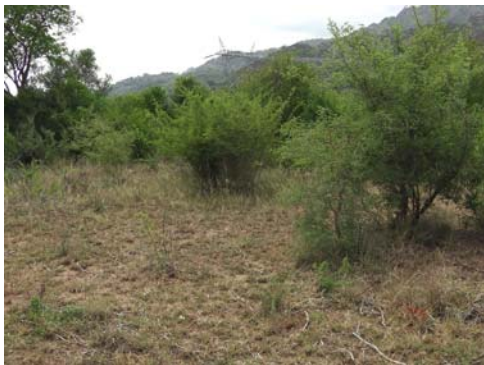
Figure 79: Some grazing and encroachment evident.

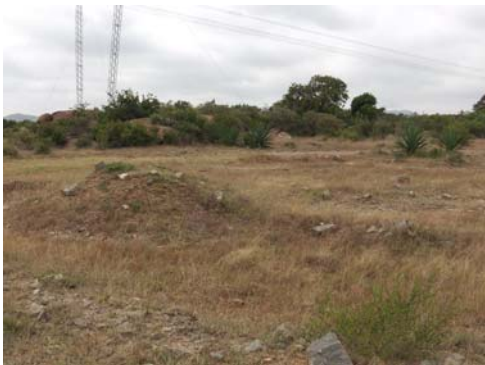
Figure 89: General view of impacts along the corridor.

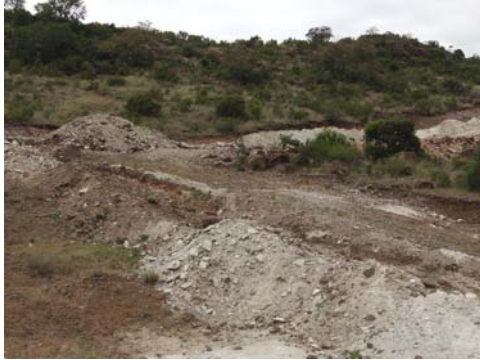
Figure 91: Severe erosion a problem in the area.

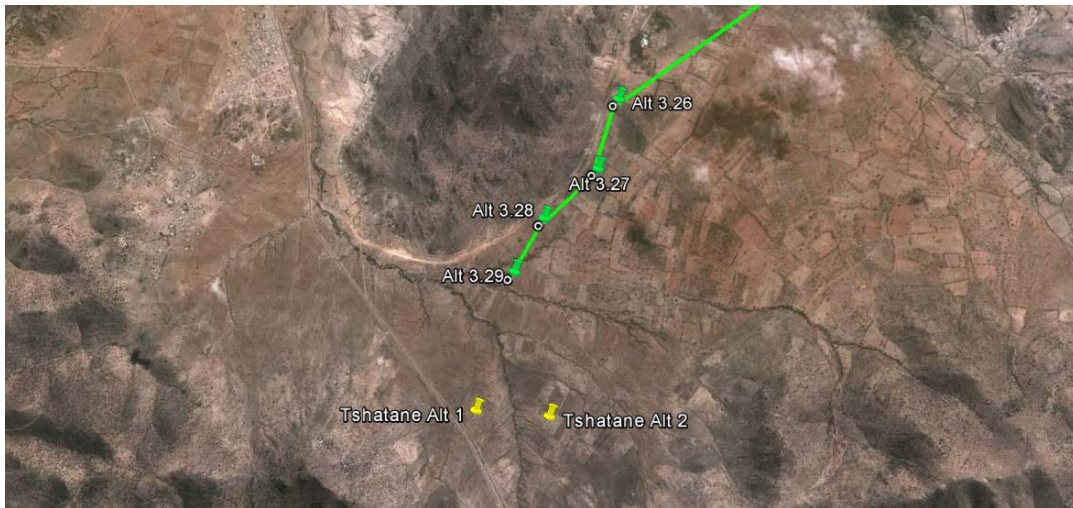
Figure 93: Aerial view of the last sector – note land use and erosion.

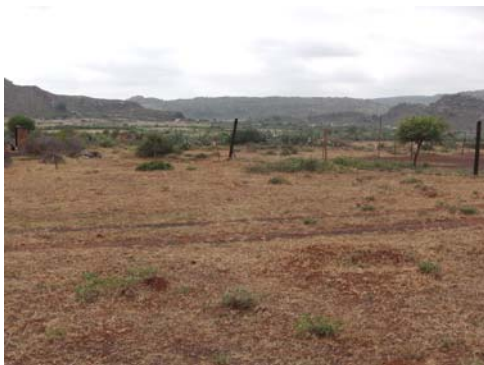
Figure 94: Example of land use impacts on the valley floor.

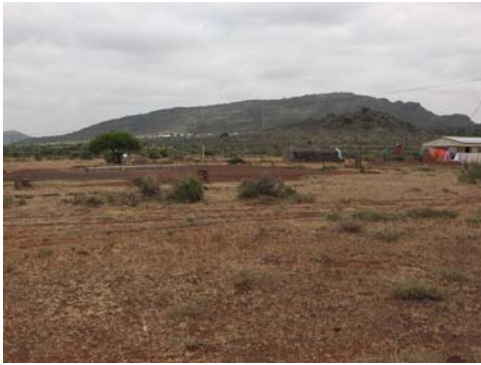
Figure 96: Impacts from grazing, cultivation and wood harvesting evident on the natural vegetation.
