DOCKET NO. 50-301  
REPORT OF STEAM GENERATOR TUBE INSPECTION  
POINT BEACH NUCLEAR PLANT, UNIT NO. 2

EXAMINATION OF POINT BEACH UNIT #2

STEAM GENERATOR TUBE SAMPLE

SG A R15-073 HL

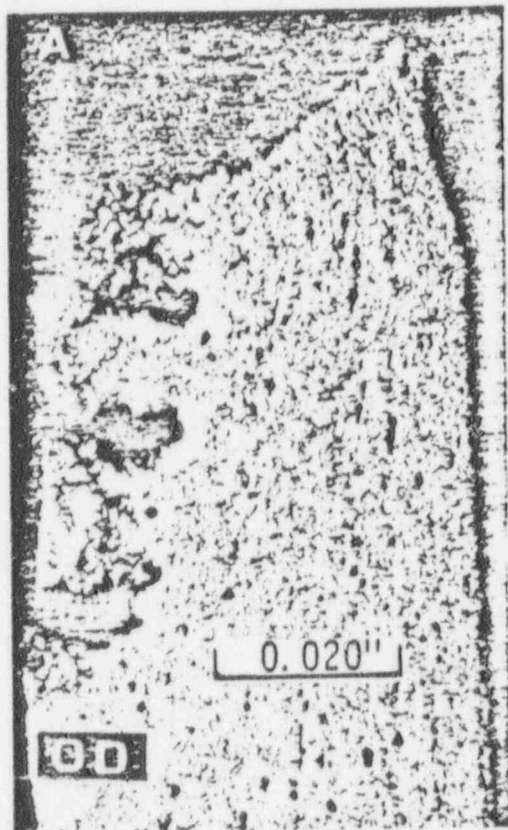
Figure 4

observations, particularly at  $210^\circ$ , to be estimates, since the original OD edges may have been distorted due to the elongation. Essentially, no IGA was observed on the fracture edge at  $90^\circ$  (Figure 5). The axial extent of IGA below the fracture, as shown by Figures 4, 5, 7, and 8, was about 0.10-0.15 in. (for any IGA of  $\pm 0.001$  in.).

A (15-73), Continuation of Axial  
Metallography, on 270° Side, Sec-  
tion 1, Figure 3

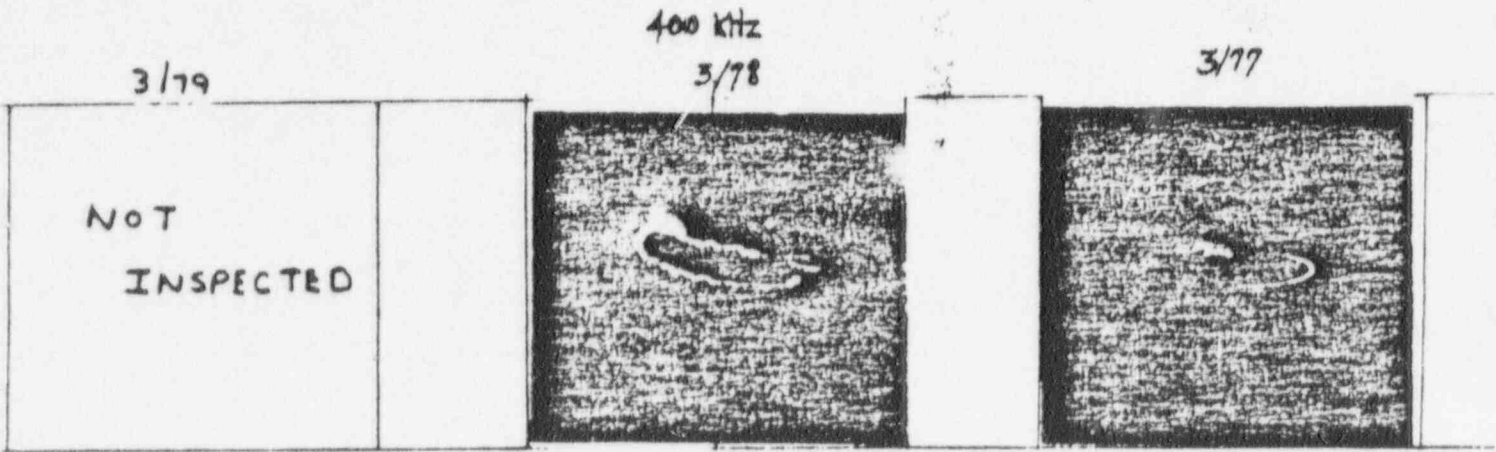
R22044

400 - 100 MIX  
49 %

400 - 100 MIX  
< 20 %

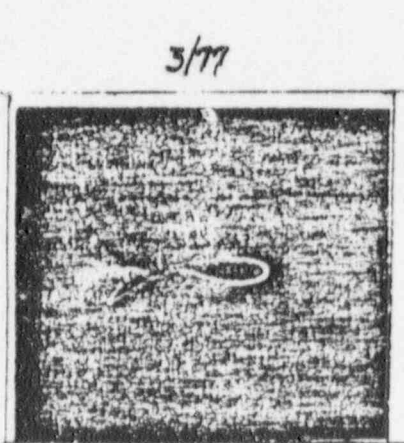
21%
